DeKalb County School District/Middle Schools

Stephenson Middle

School Assessment Report

May 20, 2016

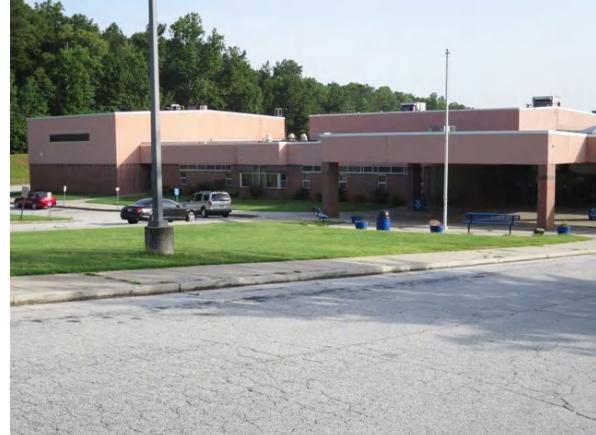
The Stephenson Middle School campus consists of one main school building located at 922 Stephenson Road in Stone Mountain, Georgia. The original campus was constructed in 1994 and an addition to the main school building was constructed in 2004. In addition to the main school building, the campus contains a covered walkway, football field, softball field, tennis courts, and track. This report contains condition and adequacy data collected during the 2015 Facility Condition Assessment (FCA). Detailed condition and deficiency statements are contained in this report for each building and site improvement on the campus.

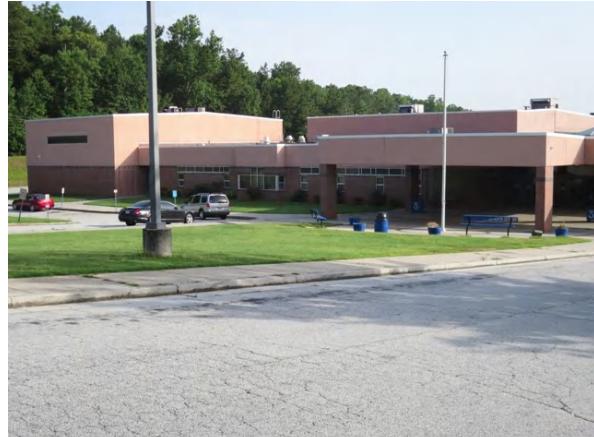
The main building at Stephenson Middle School is a one-story building located at 922 Stephenson Road in Stone Mountain, Georgia. Originally built in 1994, there has been one addition in 2004 and no major renovations. This report contains condition and adequacy data collected during the 2015 Facility Condition Assessment (FCA). Detailed condition and deficiency statements are contained in this report.

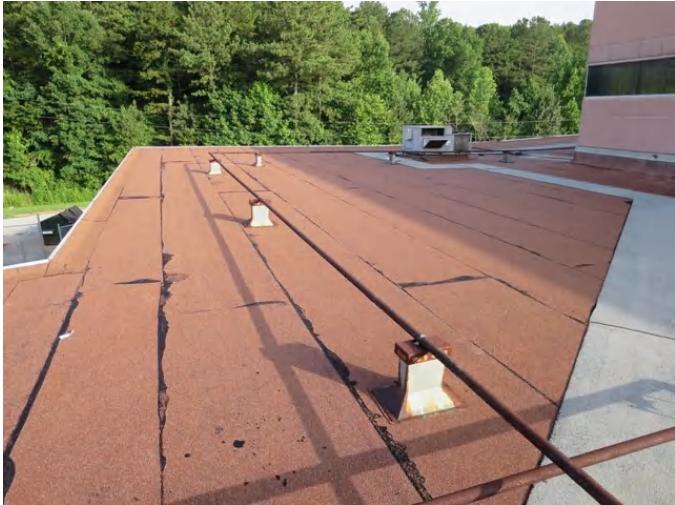
System: B3010 - Roof Coverings - BUR

Location: Roof

Distress: Needs Remediation

Notes: The built-up roof covering is aged, showing signs of failure, and should be scheduled for replacement.

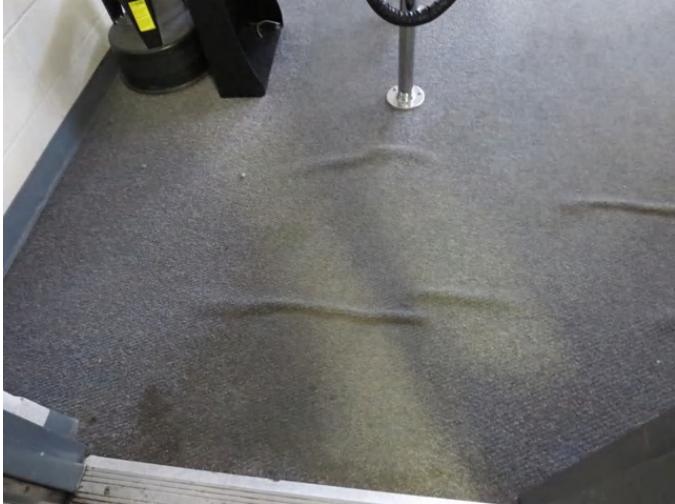
System: C3020 - Floor Finishes - Carpet

Location: Media Center and Offices

Distress: Beyond Service Life

Notes: The carpet is stained, showing signs of failure, and should be replaced.

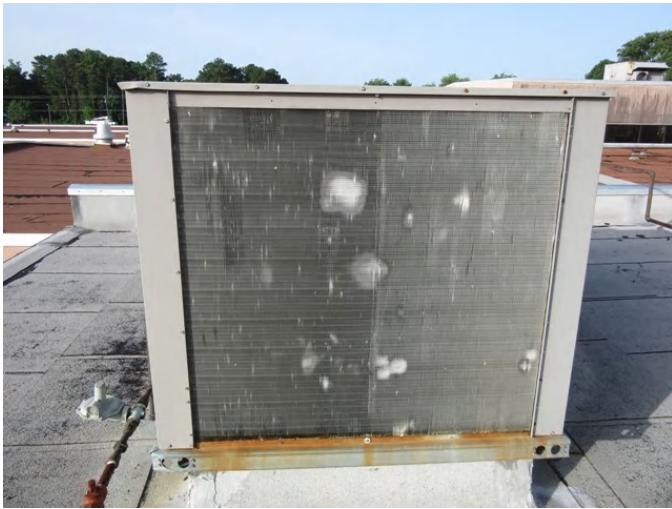
System: D3050 - Terminal & Package Units

Location: Throughout Building

Distress: Beyond Service Life

Notes: The primary water source heat pumps, rooftop package units, and associated control system are beyond their expected service life, damaged, and should be scheduled for replacement.

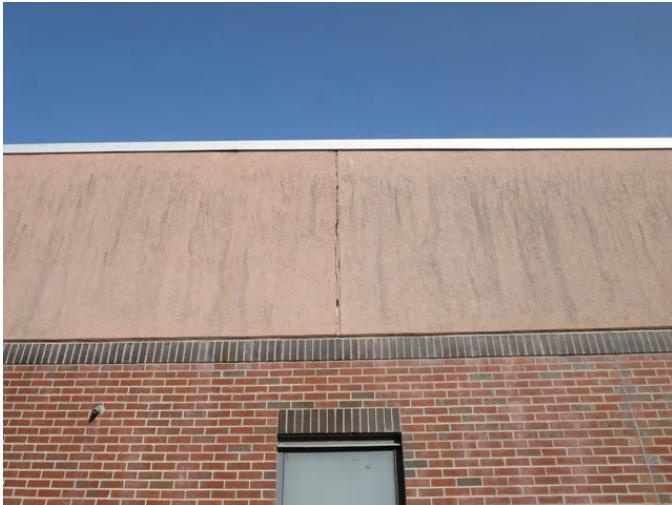
System: B2010 - Exterior Walls

Location: Exterior Stucco Walls

Distress: Inadequate

Notes: The painted exterior wall finish is aged, faded and stained, and should be replaced.

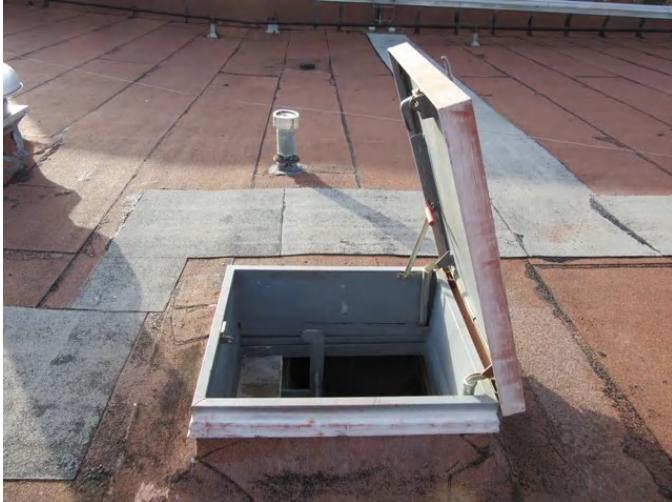
System: B3020 - Roof Openings

Location: Roof

Distress: Inadequate

Notes: The roof hatch does not comply with OSHA standards; roof opening protection and proper extension of fixed ladder to platform is not provided.

Correction: Replace roof hatch and structure single unit

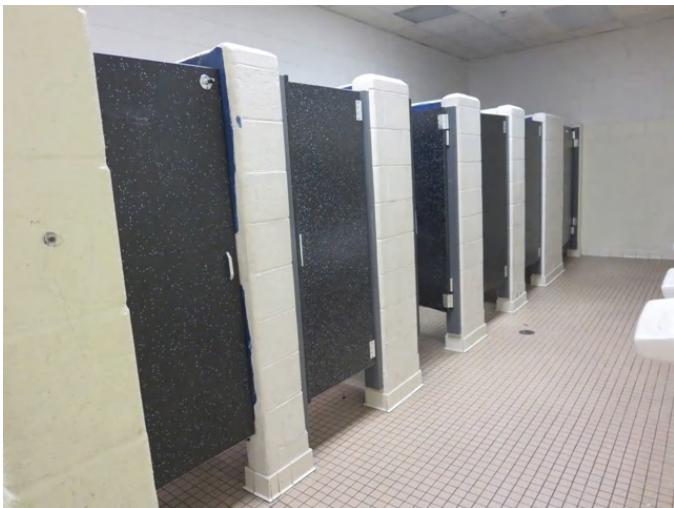
System: C1030 - Fittings

Location: Throughout Building

Distress: Beyond Service Life

Notes: Fittings, such as toilet partitions, mirrors, hand rails and signage, aged, in marginal condition, and should be scheduled for replacement.

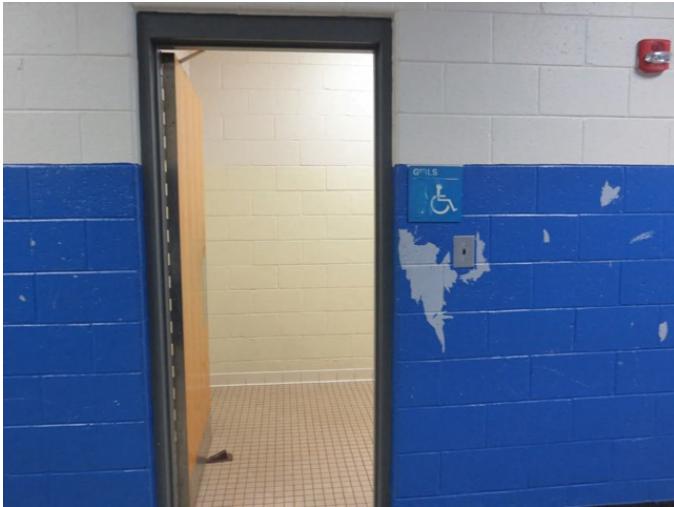
System: C3010 - Wall Finishes - Paint

Location: Throughout Building

Distress: Beyond Service Life

Notes: The painted wall finishes are beyond their expected service life, damaged in areas, and should be replaced.

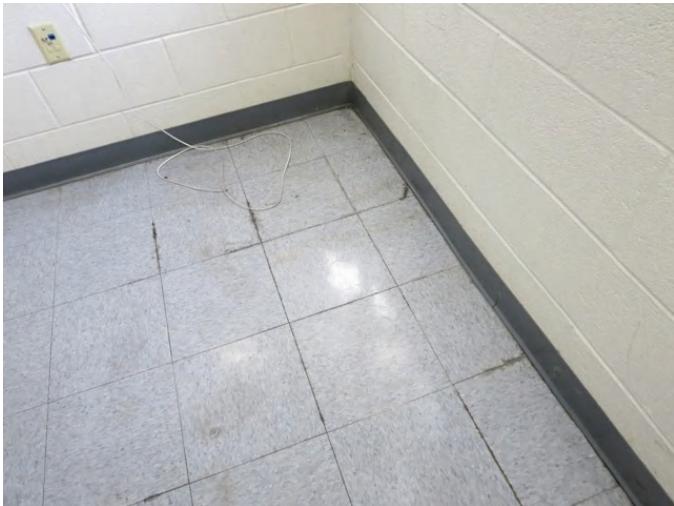
System: C3020 - Floor Finishes - VCT

Location: Throughout Building

Distress: Beyond Service Life

Notes: The VCT flooring is aged, cracked, patched and worn, and should be replaced.

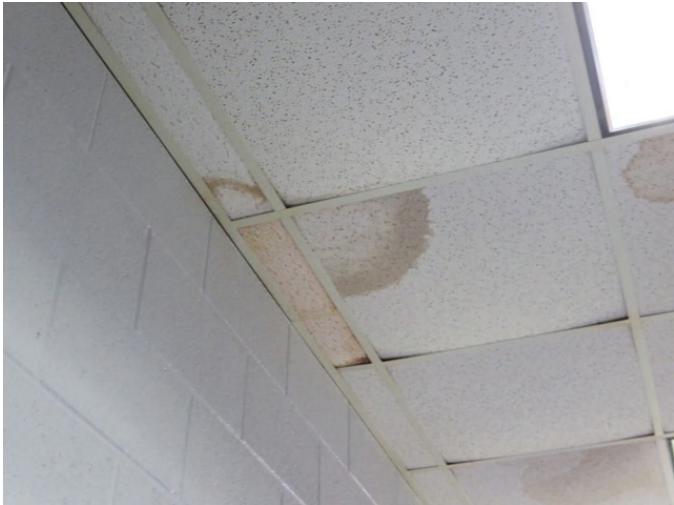
System: C3030 - Ceiling Finishes

Location: Throughout Building

Distress: Beyond Service Life

Notes: The acoustical ceiling tiles and grid system is beyond its expected service life, damaged due to roof leaks, and should be replaced.

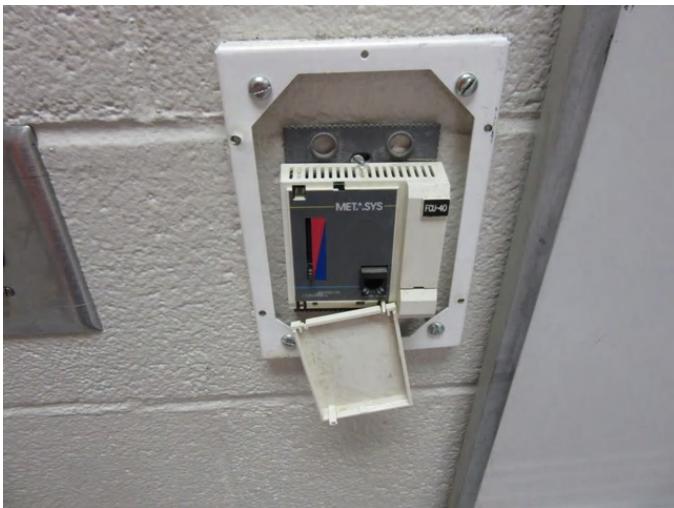
System: D3060 - Controls & Instrumentation

Location: Throughout Building

Distress: Beyond Service Life

Notes: Building controls and instrumentation are beyond their expected service life and should be scheduled for replacement.

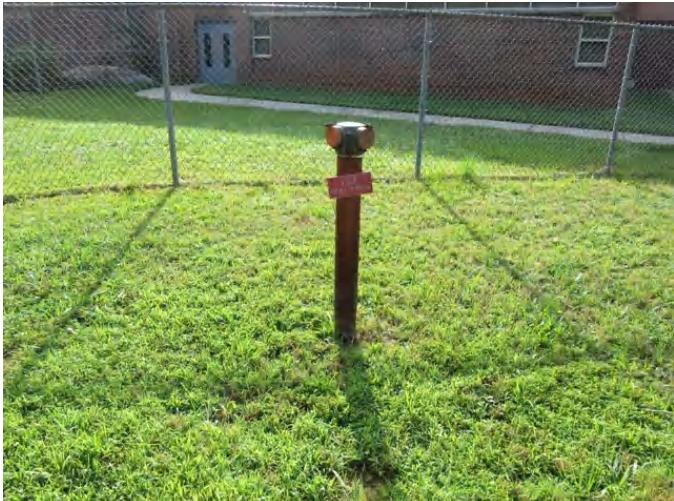
System: D4020 - Standpipes

Location: Site

Distress: Inadequate

Notes: The fire department connection and signage are not visible from the street.

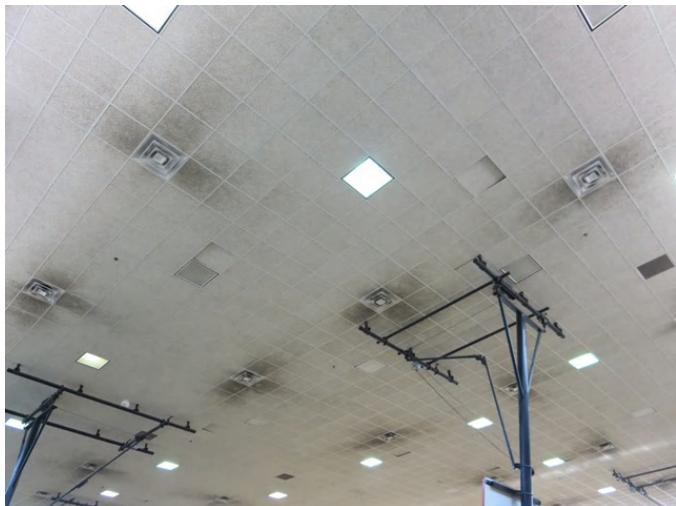
System: D5020 - Lighting

Location: Gym

Distress: Inadequate

Notes: Lighting in gymnasium is inadequate and is recommended to be replaced.

Correction: Remove and replace existing lighting in Gymnasium

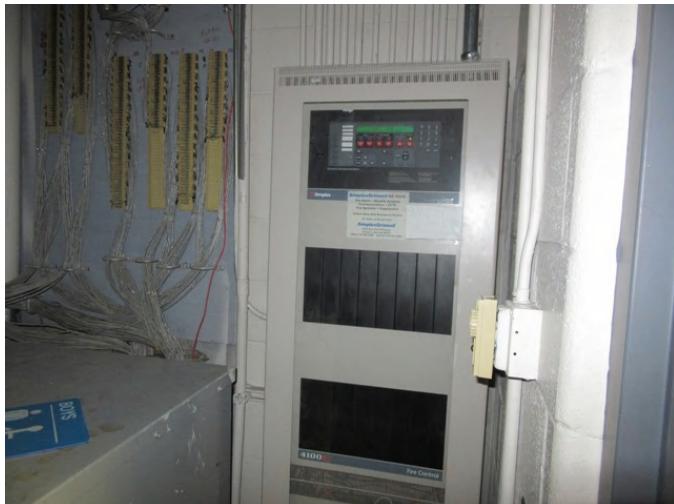
System: D5030 - Communications and Security - Fire Alarm

Location: Throughout Building

Distress: Beyond Service Life

Notes: The fire alarm system is beyond its expected service life and should be scheduled for replacement. Audible and visible alarms are not present in all parts of the building.

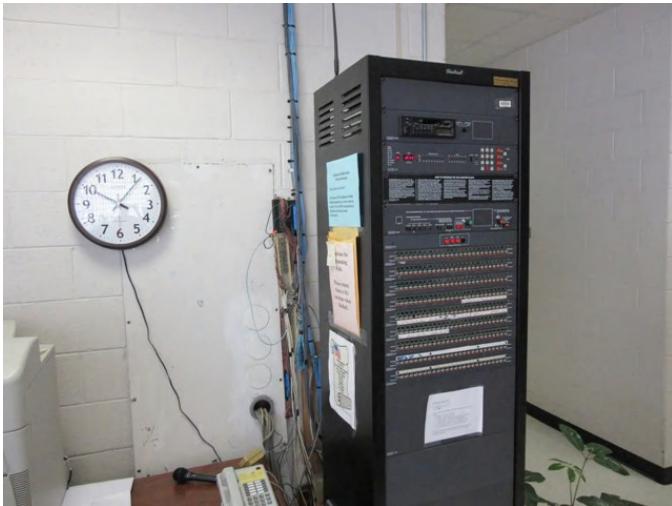
System: D5030 - Communications and Security - PA & Clock Systems

Location: Throughout Building

Distress: Beyond Service Life

Notes: The primary PA and clock system is beyond its expected service life and should be scheduled for replacement.

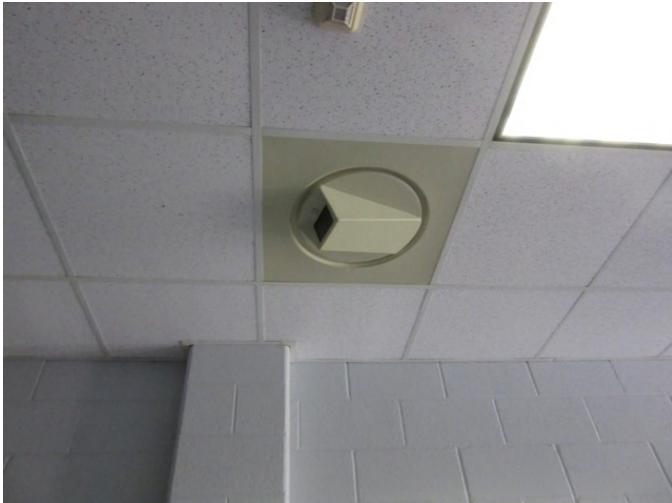
System: D5030 - Communications and Security - Security & CCTV

Location: Throughout Building

Distress: Beyond Service Life

Notes: The security and CCTV system is beyond its expected service life and should be scheduled for replacement.

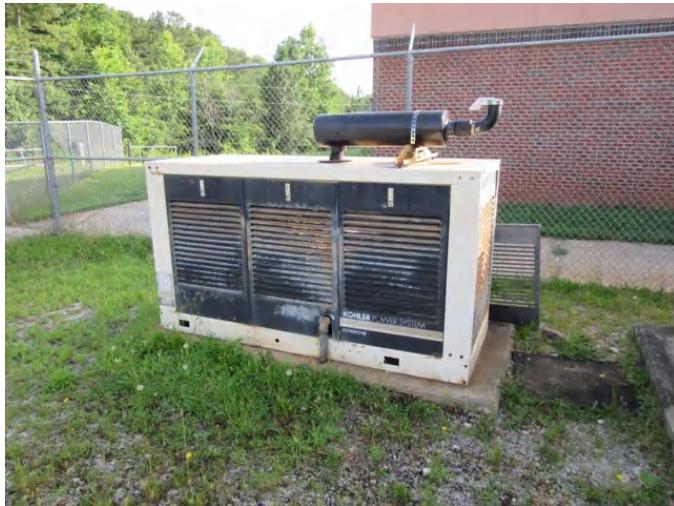
System: D5090 - Other Electrical Systems - Emergency Generator

Location: Northwest Side of Site

Distress: Beyond Service Life

Notes: The emergency generator is beyond its expected service life and should be scheduled for replacement.

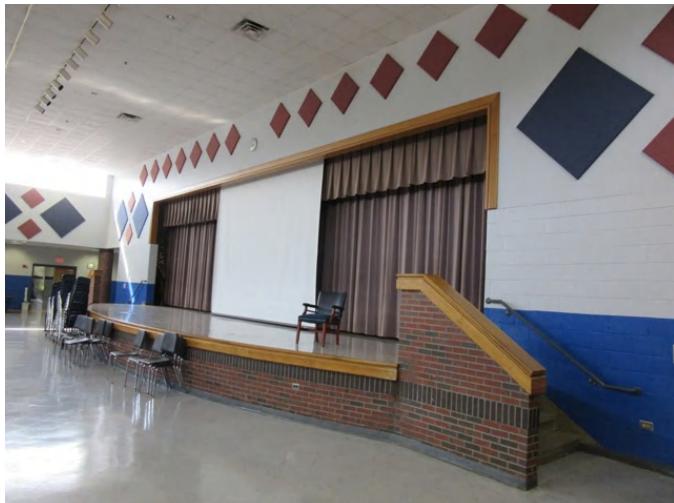
System: E1020 - Institutional Equipment

Location: Throughout Building

Distress: Beyond Service Life

Notes: Institutional equipment, such as theater and stage equipment and audio-visual equipment, is beyond its expected service life and should be scheduled for replacement.

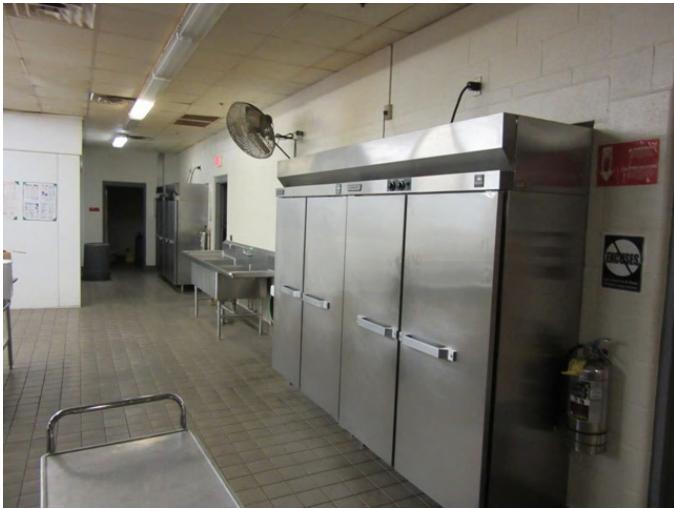
System: E1090 - Other Equipment - Kitchen Equipment

Location: Kitchen

Distress: Beyond Service Life

Notes: The original kitchen equipment is beyond its expected service life and should be scheduled for replacement.

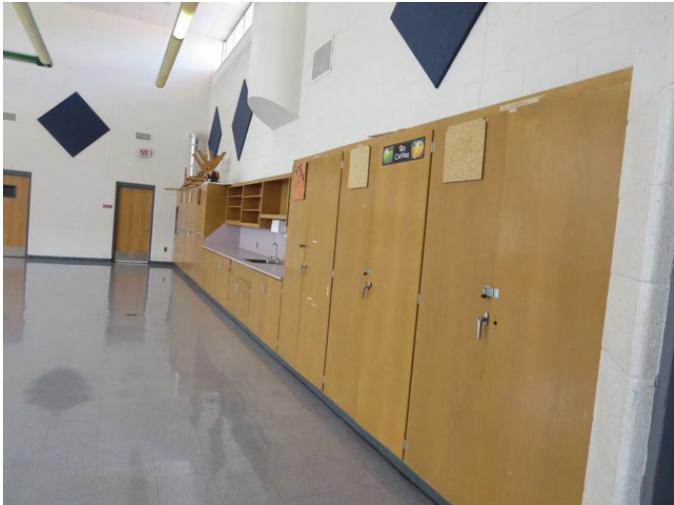
System: E2010 - Fixed Furnishings

Location: Throughout Building

Distress: Beyond Service Life

Notes: Fixed furnishings, such as cabinets and fixed seating, are beyond their expected service life, have some deterioration due to age and use, and should be scheduled for replacement.

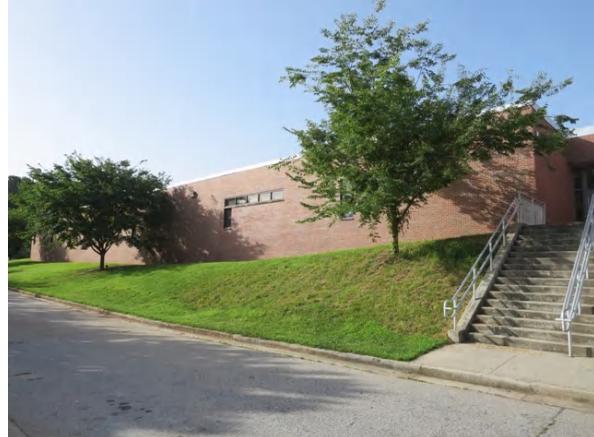
The 2004 classroom addition at Stephenson Middle School is a one-story building located at 922 Stephenson Road in Stone Mountain, Georgia. There have been no additions or major renovations. This report contains condition and adequacy data collected during the 2015 Facility Condition Assessment (FCA). Detailed condition and deficiency statements are contained in this report.

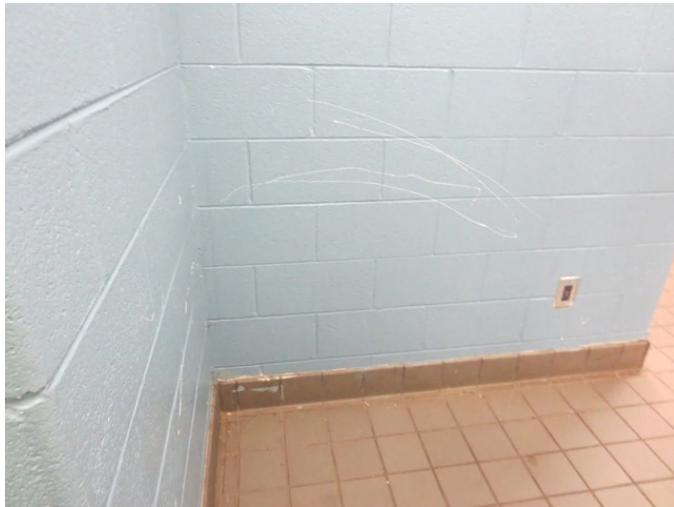
System: C3010 - Wall Finishes - Paint

Location: Throughout Building

Distress: Beyond Service Life

Notes: The painted wall finishes are beyond their expected service life, damaged in areas, and should be scheduled for replacement.

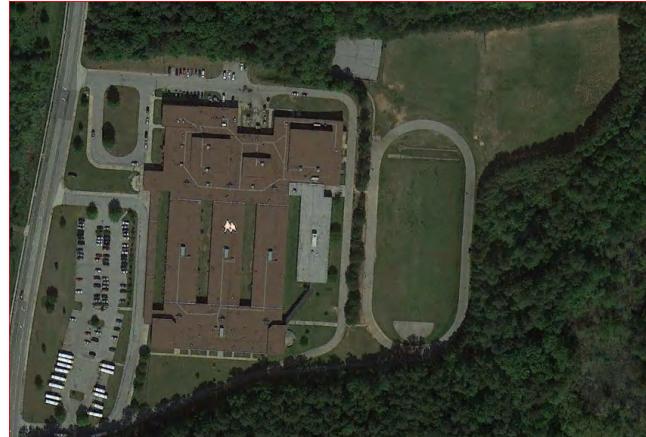
The Stephenson Middle School site was originally constructed in 1994, has a total area of 38.7 acres, and is occupied by approximately 190,158 square feet of permanent building space. Campus site features include paved driveways and parking lots, pedestrian pavement, covered walkways, flag pole, landscaping, football field, track, tennis courts, softball field, playing field, and fencing. Site mechanical and electrical features include water, sewer, natural gas, and site lighting. This report contains condition and adequacy data collected during the 2015 Facility Condition Assessment (FCA). Detailed condition and deficiency statements are contained in this report for the site features.

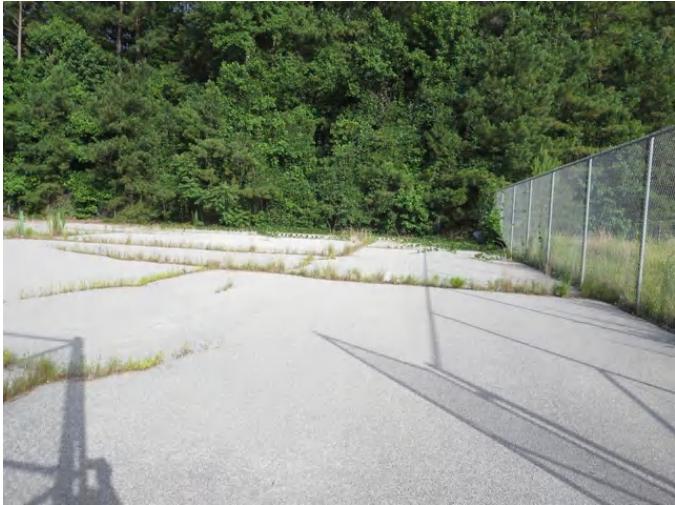
System: G2040 - Tennis Courts

Location: Site

Distress: Beyond Service Life

Notes: The tennis courts are beyond their expected service life, damaged with cracks, and should be replaced.

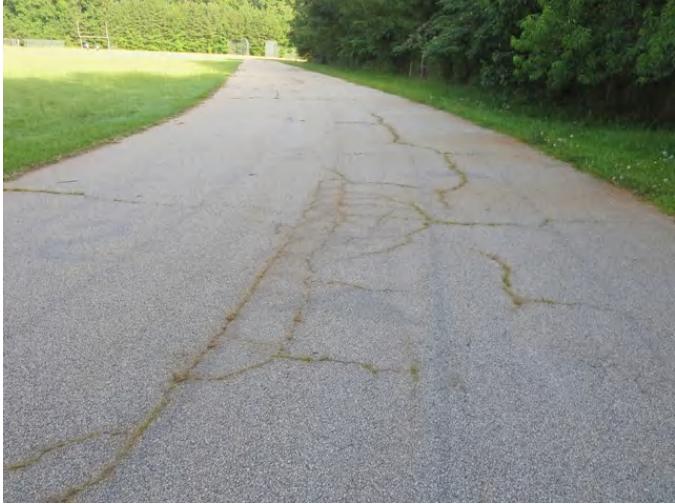
System: G2040 - Track

Location: Site

Distress: Beyond Service Life

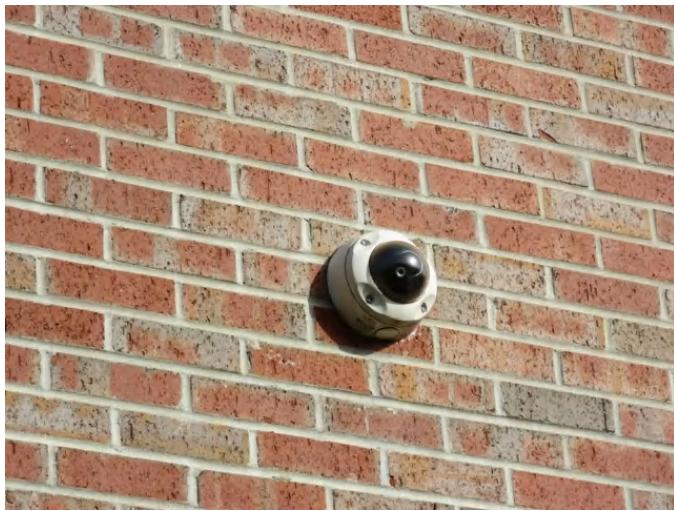
System: G4030 - Site Communications & Security

Location: Site

Distress: Beyond Service Life
