DeKalb County School District/Elementary Schools

Stone Mountain Elementary

School Assessment Report

May 20, 2016

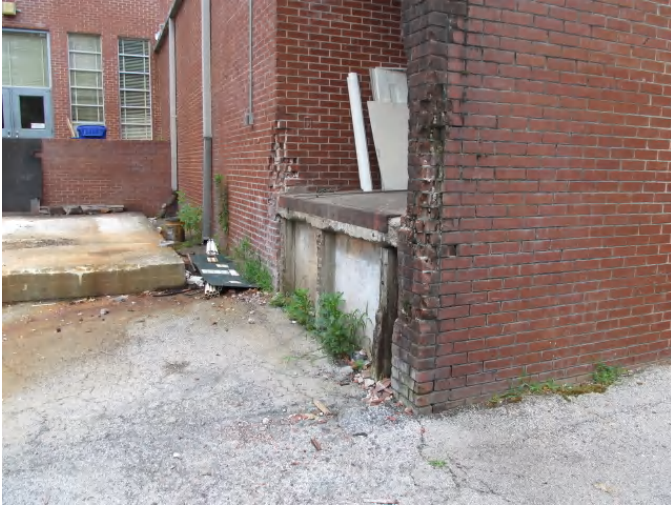
System: B2010 - Exterior Walls

Location: Loading Dock

Distress: Damaged

Notes: The exterior walls at the loading dock are damaged and need to be repaired.

Correction: Replace exterior walls, 20% (\$14.12/sf)

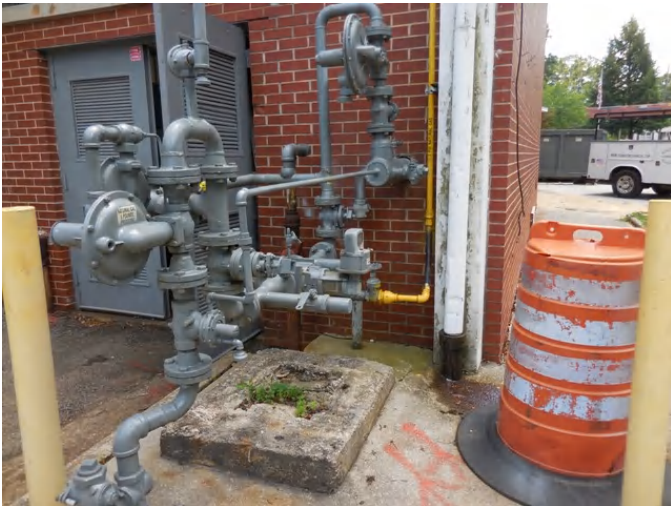
System: D2090 - Other Plumbing Systems - Natural Gas

Location: Throughout Building

Distress: Beyond Service Life

Notes: The natural gas system is beyond its expected service life and should be scheduled for replacement. At time of site visit, contractor appears to be installing new line to the roof AC systems.

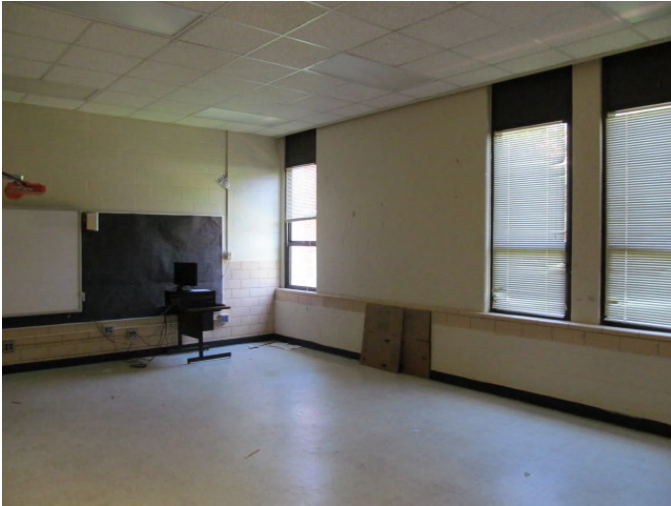
System: B2020 - Exterior Windows

Location: Throughout Building

Distress: Beyond Service Life

Notes: The exterior windows are beyond their expected service life and should be replaced with energy efficient windows.

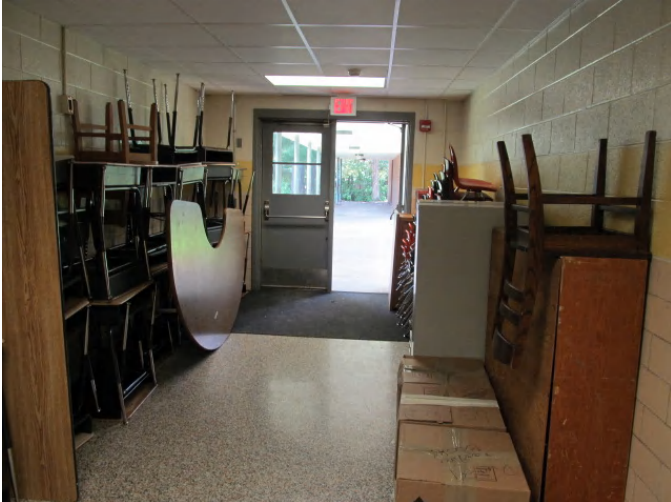
System: B2030 - Exterior Doors

Location: Throughout Building

Distress: Beyond Service Life

Notes: The exterior doors are beyond their expected service life and should be replaced to improve ADA accessibility.

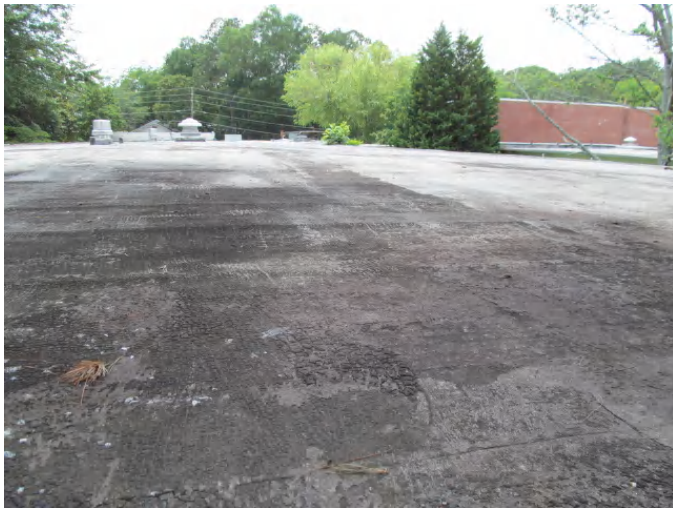
System: B3010 - Roof Coverings - BUR

Location: Roof

Distress: Beyond Service Life

Notes: The roof coverings are beyond their expected service life, leak, and should be replaced. SPLOST project 330-422 to replace the roof on the 1954, 1966, 1970, 1975 buildings.

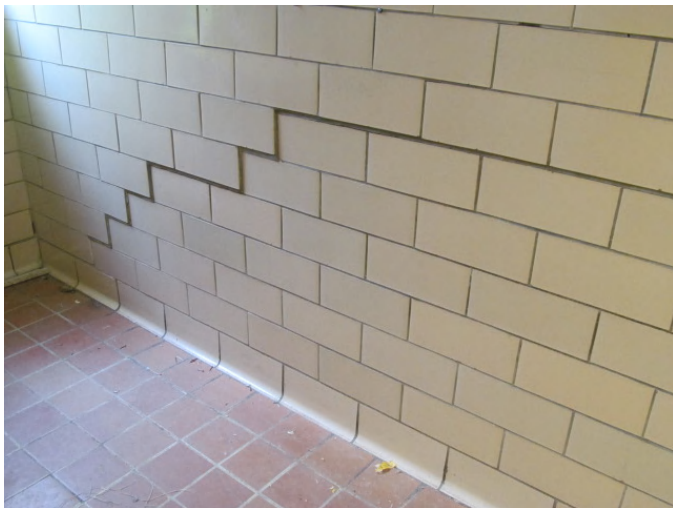
System: C1010 - Partitions

Location: Throughout Building

Distress: Damaged

Notes: The partitions are damaged and need to be repaired or replaced.

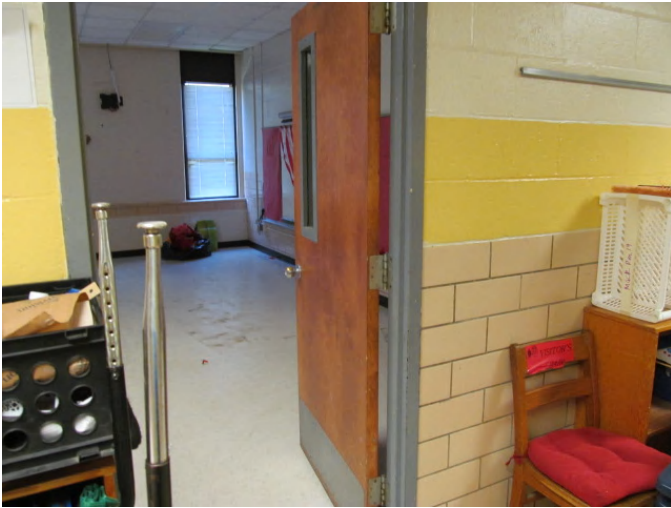
System: C1020 - Interior Doors

Location: Throughout Building

Distress: Beyond Service Life

Notes: Interior doors are beyond their expected service life and should be replaced to improve ADA accessibility and comply with building code.

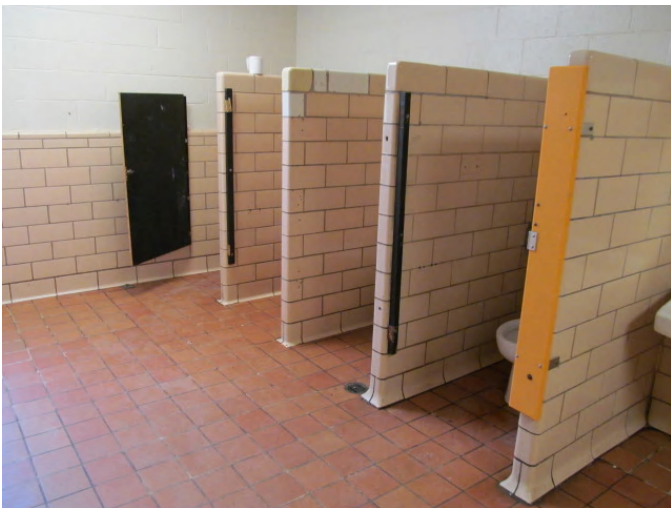
System: C1030 - Fittings

Location: Throughout Building

Distress: Beyond Service Life

Notes: Fittings, such as toilet partitions, handrails and signage, are beyond their expected service life, damaged, not ADA compliant, and should be replaced. Handrails are reported as a safety issue. SPLOST project 421-301-023 to reconfigure / remodel select existing student restrooms, existing staff restroom, and existing special education restroom to provide ADA accessibility.

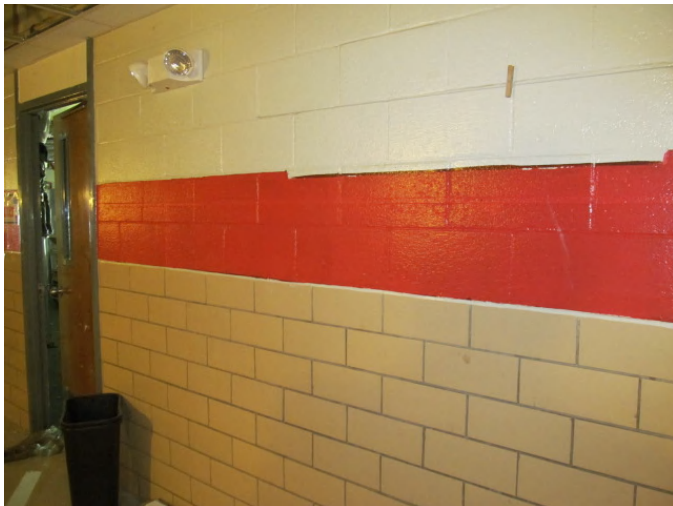
System: C3010 - Wall Finishes - Paint

Location: Throughout Building

Distress: Beyond Service Life

Notes: The painted wall finishes are beyond their expected service life and should be replaced.

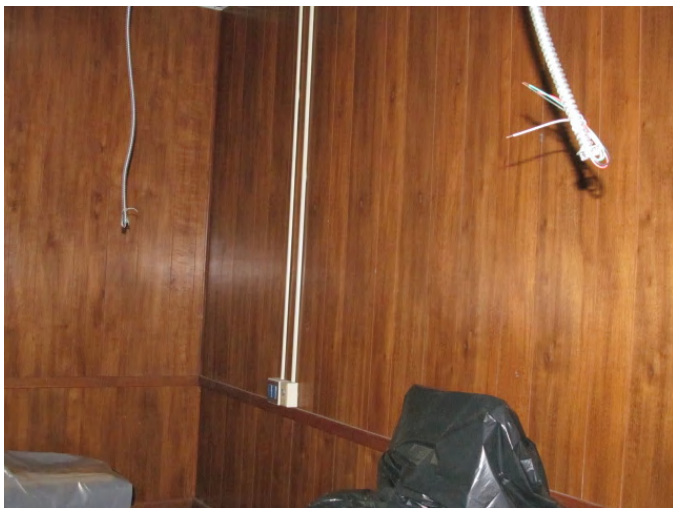
System: C3010 - Wall Finishes - Wood Paneling

Location: Offices

Distress: Beyond Service Life

Notes: The wood paneling is beyond its expected service life and should be replaced.

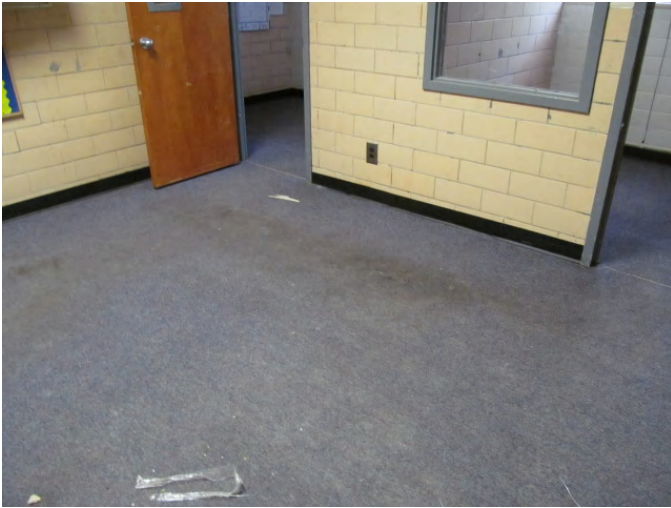
System: C3020 - Floor Finishes - Carpet

Location: Offices, Library

Distress: Beyond Service Life

Notes: The carpet is beyond its expected service life and should be replaced.

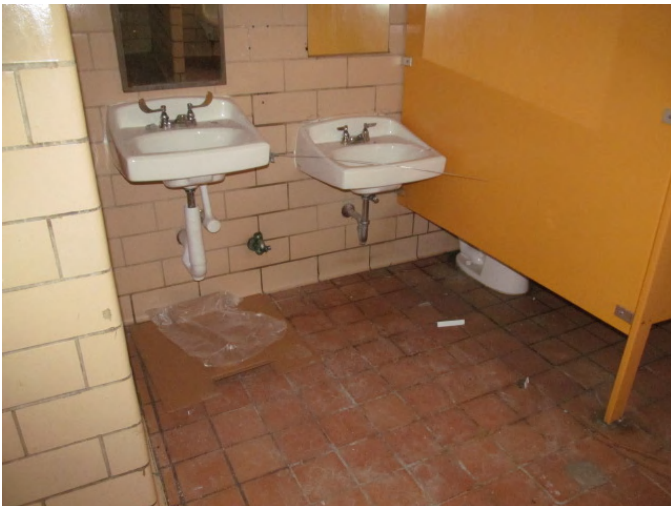
System: C3020 - Floor Finishes - Ceramic & Quarry Tile

Location: Kitchen and Restrooms

Distress: Beyond Service Life

Notes: The tile floor covering is beyond its expected service life and should be replaced.

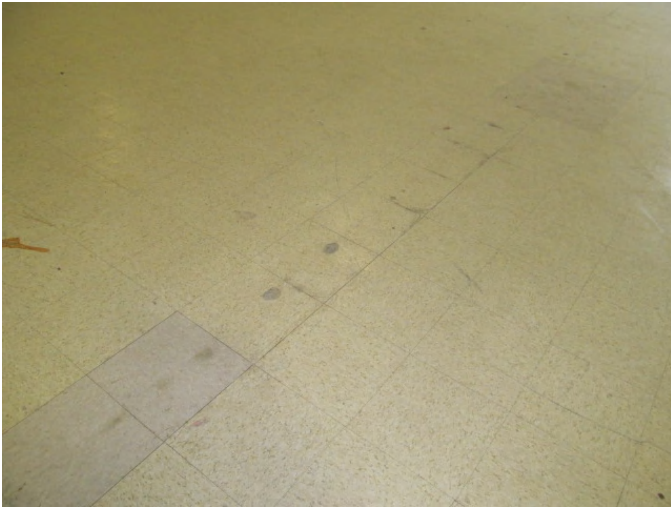
System: C3020 - Floor Finishes - VCT

Location: Throughout Building

Distress: Beyond Service Life

Notes: The VCT floor covering is beyond its expected service life and should be replaced.

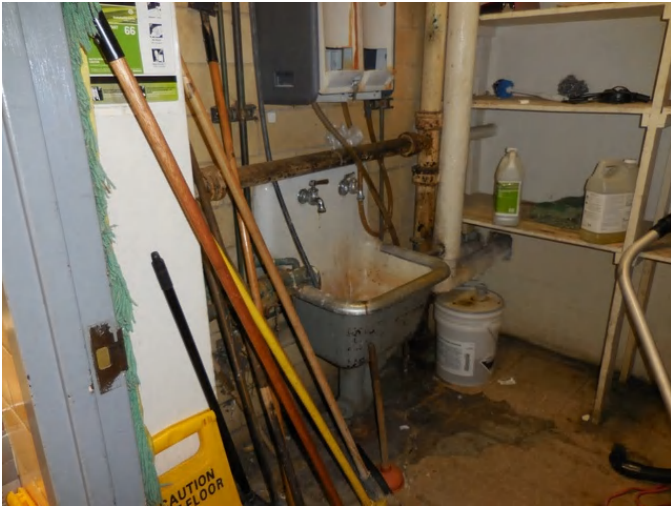
System: D2010 - Plumbing Fixtures

Location: Throughout Building

Distress: Beyond Service Life

Notes: Plumbing fixtures are beyond their expected service life, worn, stained and chipped. Some of the fixtures were replaced in 2011; however, the majority are original and the entire system should be replaced. SPLOST project 421-301-023 to reconfigure / remodel select existing student restrooms, existing staff restroom, and existing special education restroom to provide ADA accessibility.

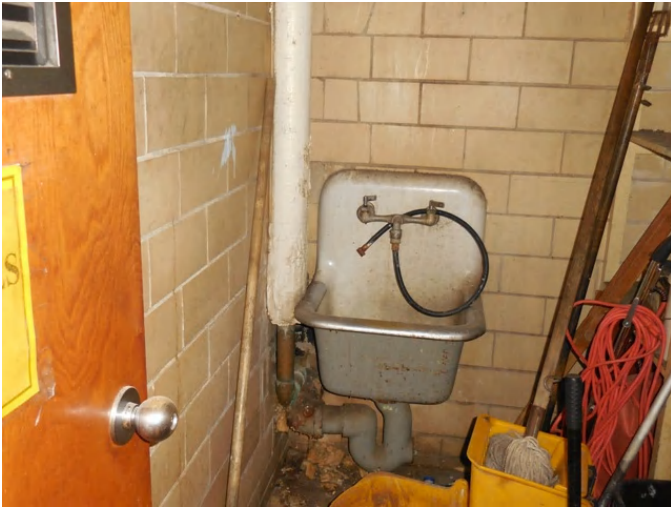
System: D2020 - Domestic Water Distribution

Location: Throughout Building

Distress: Beyond Service Life

Notes: The domestic water distribution system is beyond its expected service life, corroded, has water quality issues, and should be scheduled for replacement. SPLOST project 421-135 to install reduced pressure zone (RPZ) devices on existing domestic and fire water supply lines.

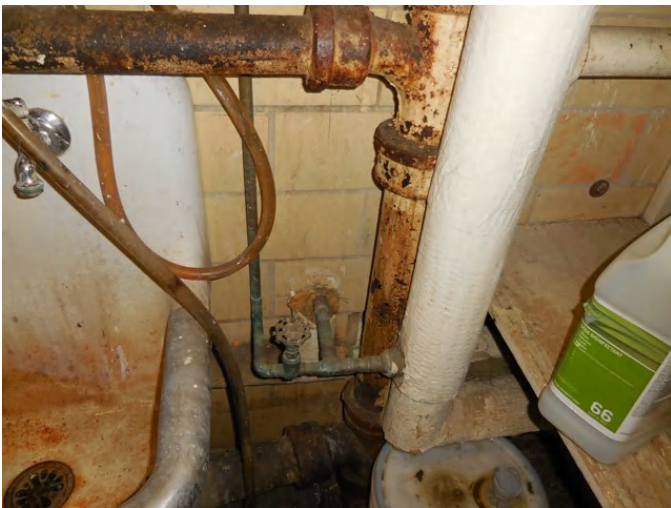
System: D2030 - Sanitary Waste

Location: Throughout Building

Distress: Beyond Service Life

Notes: The sanitary waste system is beyond its expected service life and should be scheduled for replacement. Staff reports odor and clogged drains.

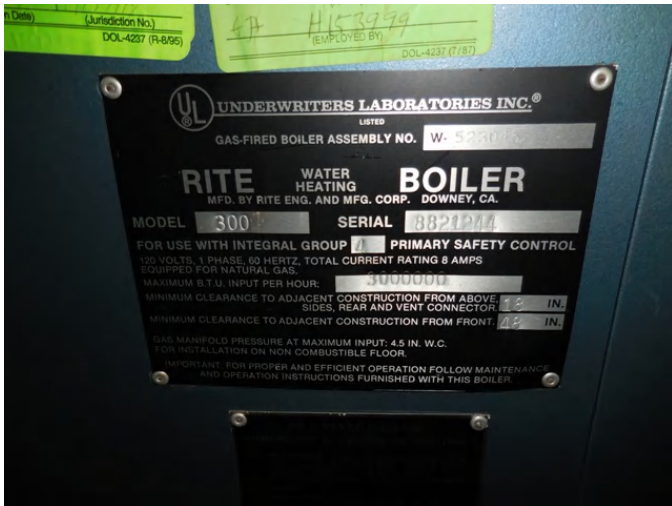
System: D3020 - Heat Generating Systems

Location: Mechanical Room

Distress: Beyond Service Life

Notes: The heat generating system is beyond its expected service life, inadequate, and should be scheduled for replacement.

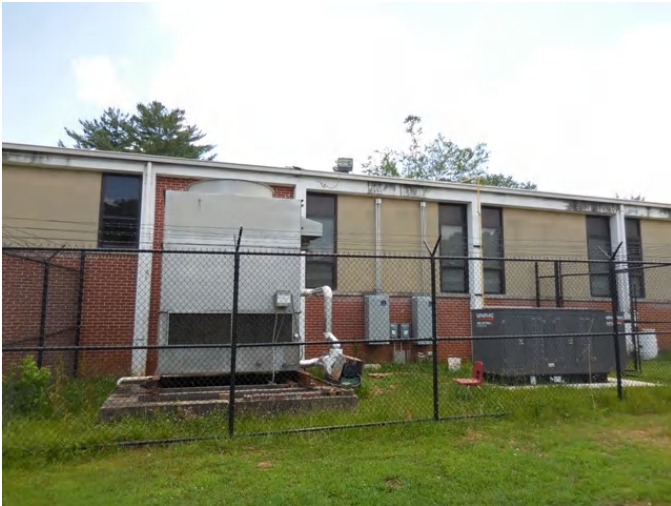
System: D3030 - Cooling Generating Systems

Location: Exterior of Building

Distress: Beyond Service Life

Notes: The cooling generating system is beyond its expected service life with original piping, inadequate, and should be scheduled for replacement.

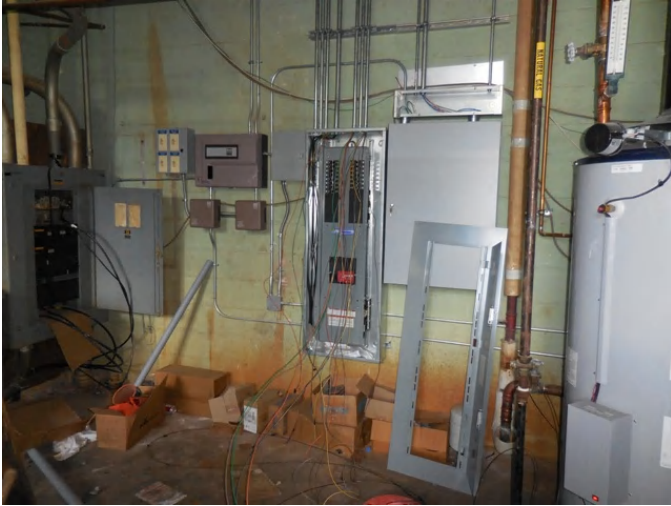
System: D5010 - Electrical Service/Distribution

Location: Main Switch Room/Throughout Building

Distress: Beyond Service Life

Notes: The electrical service/distribution system is beyond its expected service life and should be scheduled for replacement. Several panel boards have been upgraded, but the majority of the system is still original.

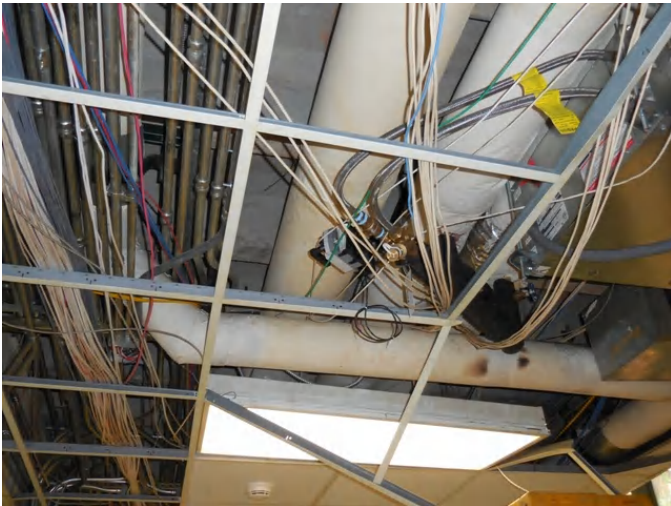
System: D5020 - Branch Wiring

Location: Throughout Building

Distress: Beyond Service Life

Notes: The branch wiring system is beyond its expected service life and should be scheduled for replacement. During the facility assessment, a contractor was installing new light fixtures. Some wiring was upgraded, but the vast majority of the system is still original. Receptacles in the main hall are reported as a safety hazard.

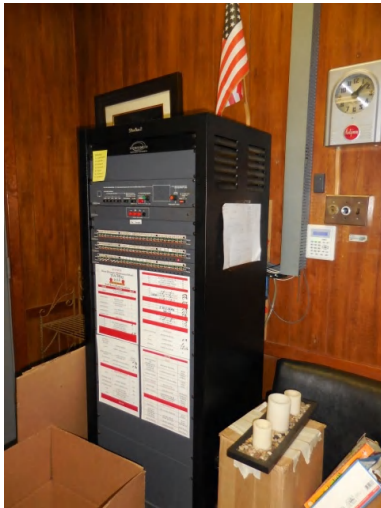
System: D5030 - Communications and Security - Clock & PA Systems

Location: Throughout Building

Distress: Beyond Service Life

Notes: Clock and PA systems are beyond their expected service life, aged, and should be scheduled for replacement.

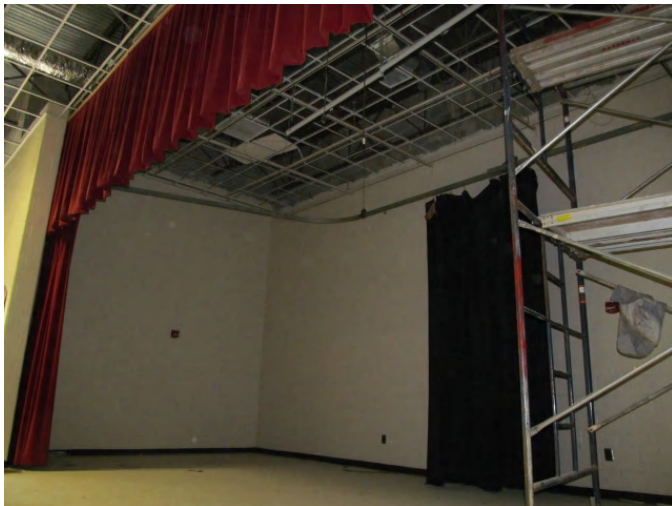
System: E1020 - Institutional Equipment

Location: Throughout Building

Distress: Beyond Service Life

Notes: Institutional equipment, such as theater and stage equipment, library equipment and audio-visual equipment, is beyond its expected service life and should be scheduled for replacement.

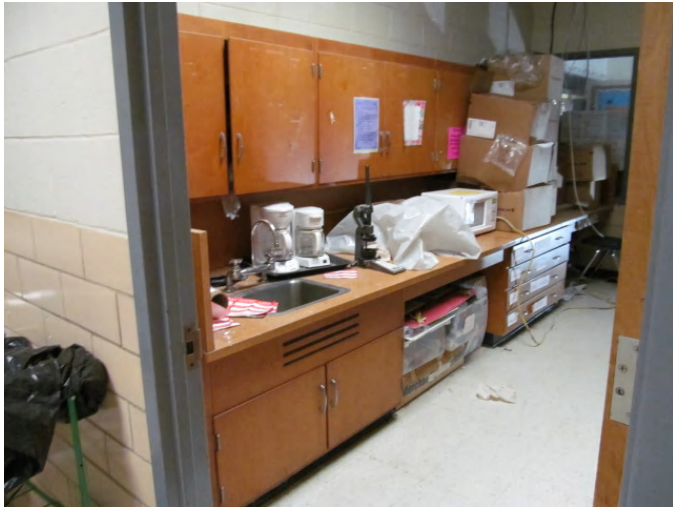
System: E2010 - Fixed Furnishings

Location: Throughout Building

Distress: Beyond Service Life

Notes: Fixed furnishings, such as built-in cabinets, are beyond their expected service life and worn, and should be replaced.

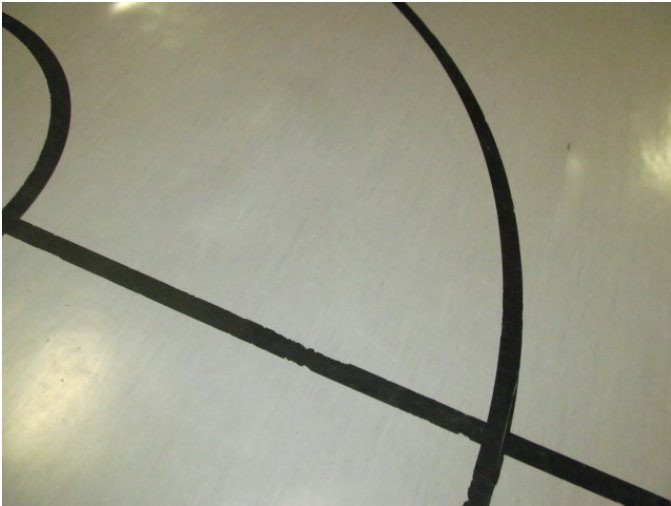
System: C3020 - Floor Finishes - Neoprene

Location: Basketball Court

Distress: Damaged

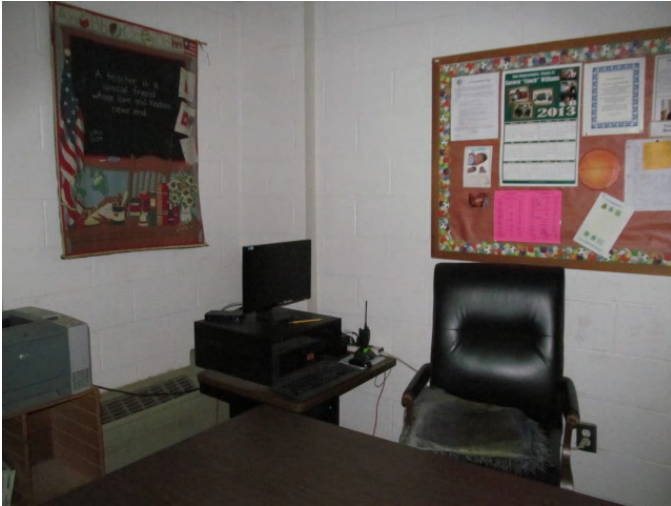
System: C3010 - Wall Finishes - Paint

Location: Throughout Building

Distress: Beyond Service Life

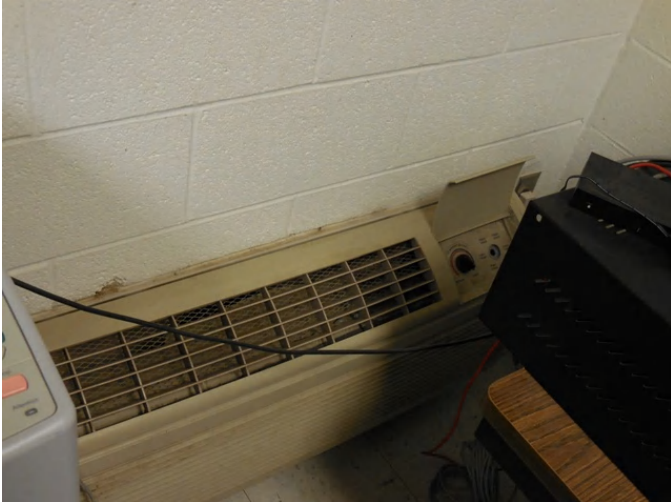
System: D3050 - Terminal & Package Units

Location: Gym

Distress: Missing

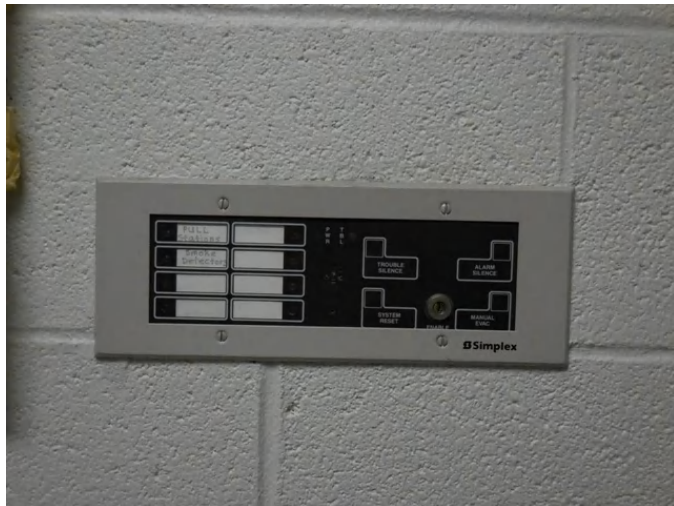
System: D5030 - Communications and Security - Fire Alarm

Location: Throughout Building

Distress: Beyond Service Life

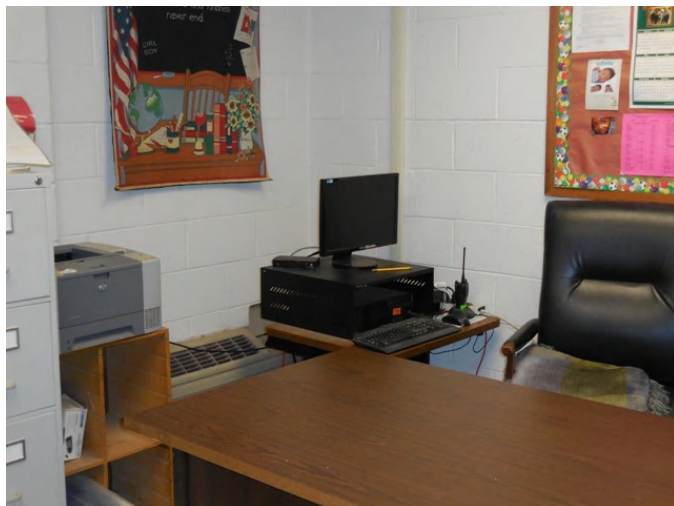
System: D5030 - Communications and Security - Security & CCTV

Location: Throughout Building

Distress: Beyond Service Life

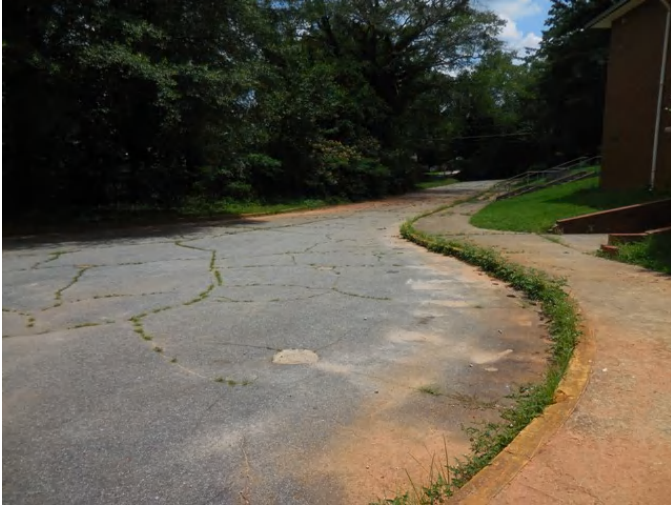
System: G2010 - Roadways

Location: Site

Distress: Beyond Service Life

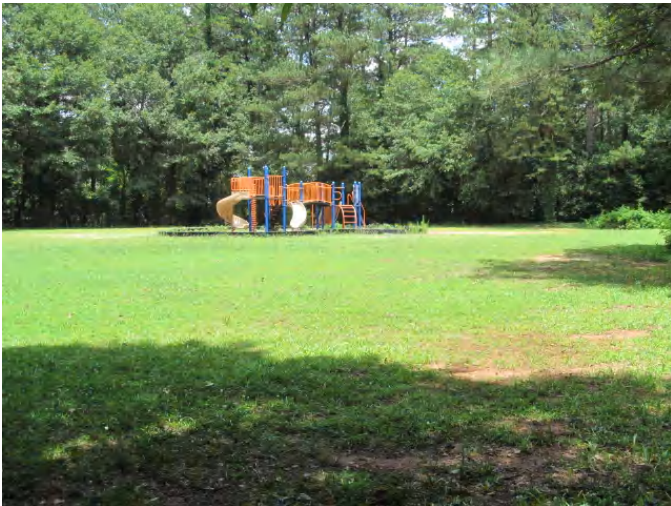
System: G2040 - Playing Field

Location: Site

Distress: Inadequate

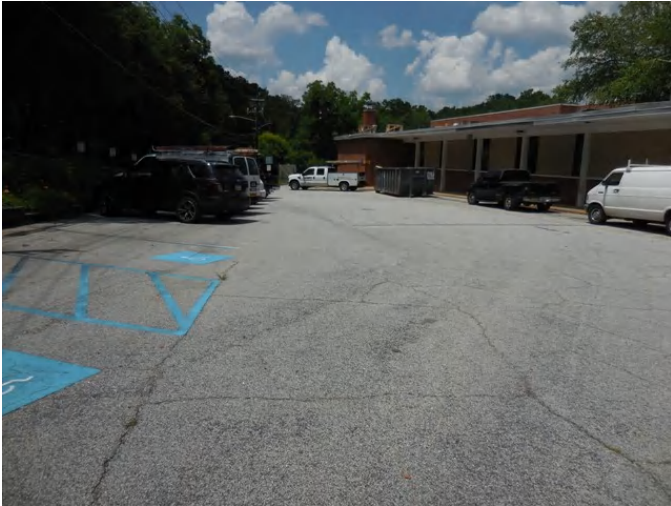
System: G2020 - Parking Lots

Location: Site

Distress: Beyond Service Life

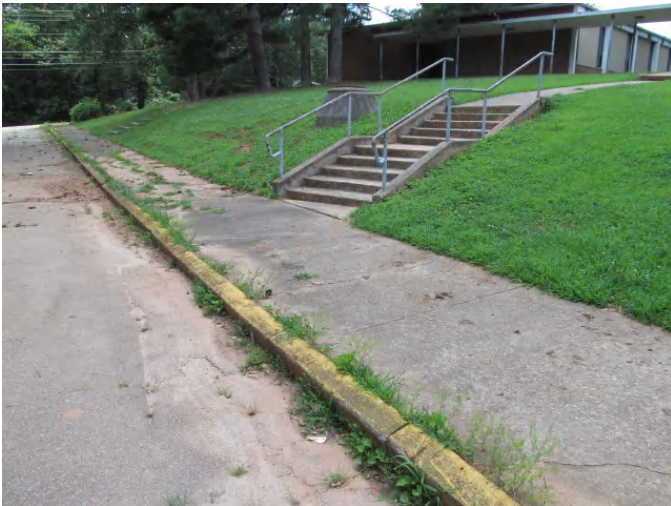
System: G2030 - Pedestrian Paving

Location: Site

Distress: Beyond Service Life

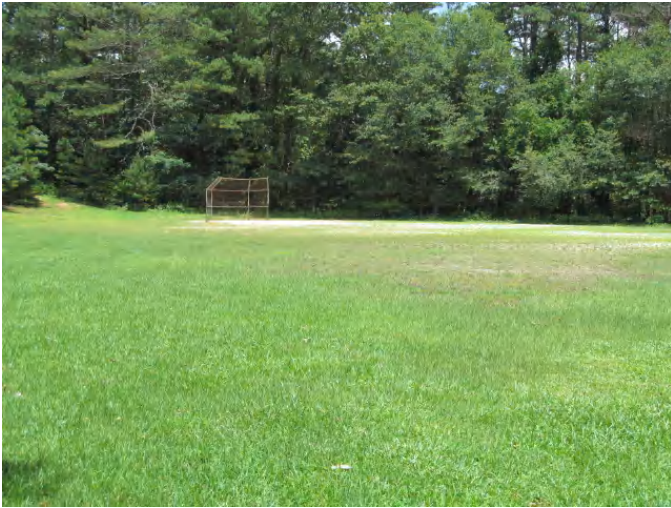
System: G2040 - Fencing & Guardrails

Location: Site

Distress: Beyond Service Life

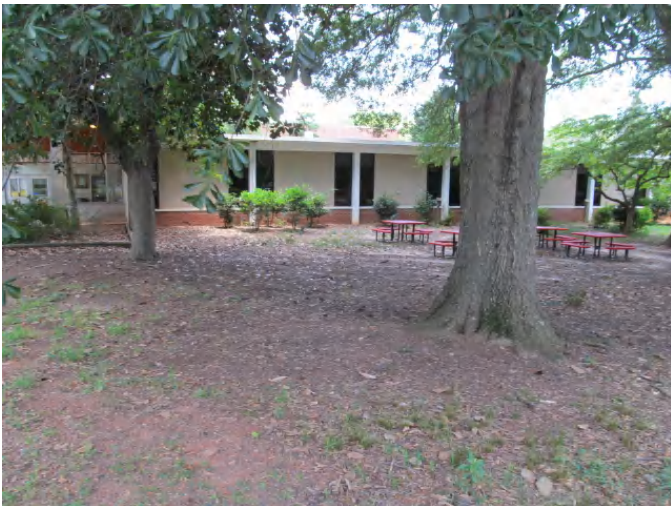
System: G2050 - Landscaping

Location: Site

Distress: Beyond Service Life

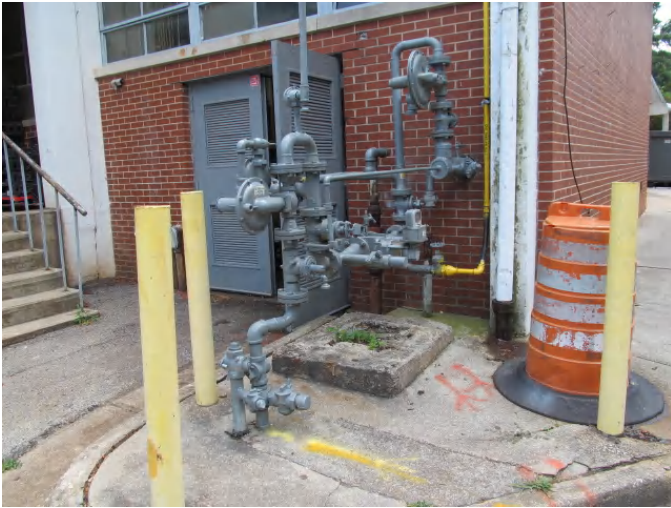
System: G3060 - Fuel Distribution

Location: Site

Distress: Beyond Service Life

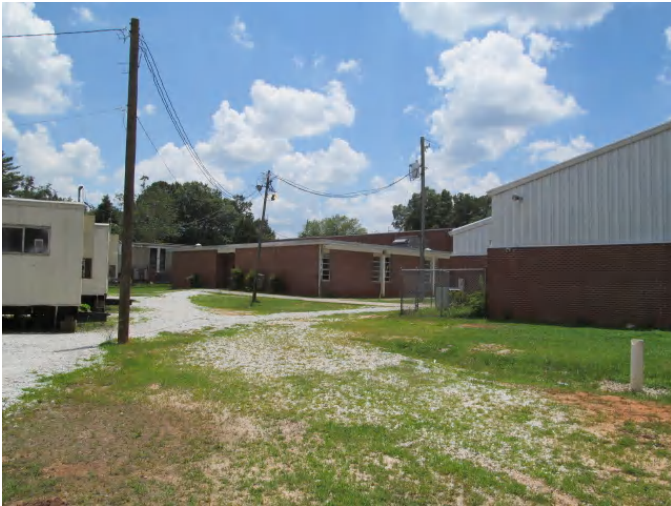
System: G4020 - Site Lighting

Location: Site

Distress: Beyond Service Life
