DeKalb County School District/High Schools

Stone Mountain High

School Assessment Report

May 20, 2016

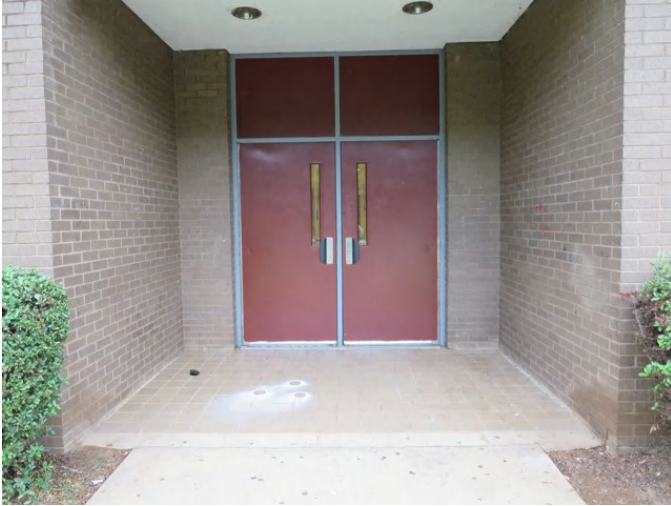
System: B2030 - Exterior Doors

Location: Throughout Building

Distress: Beyond Service Life

Notes: The original exterior doors are aged, rusted, and should be replaced. Some exterior doors do not lock properly, causing safety/security concerns. SPLOST project 515-422 to replace exterior doors/frames.

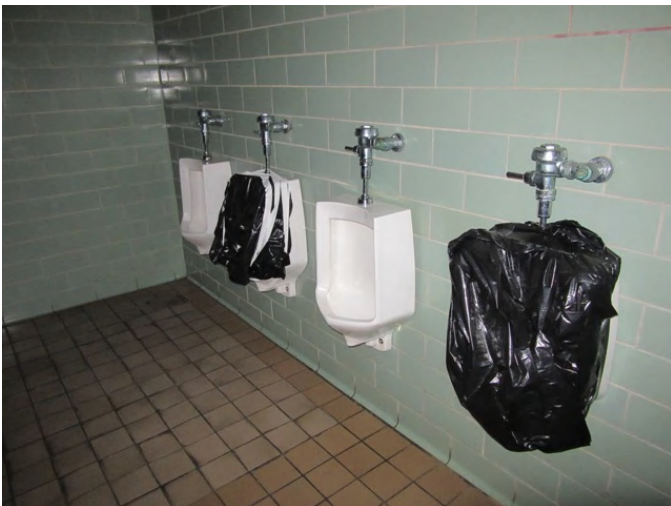
System: D2010 - Plumbing Fixtures

Location: Restrooms, Hallways

Distress: Beyond Service Life

Notes: Plumbing fixtures are beyond service life, inadequate, and should be scheduled for replacement/upgrade to improve ADA accessibility. SPLOST project 515-422 to replace plumbing fixtures (toilets, urinals, sinks, water fountains, valves, etc.) as appropriate. SPLOST project 421-301-023 to reconfigure / remodel two (2) existing staff restrooms, and select existing student restrooms.

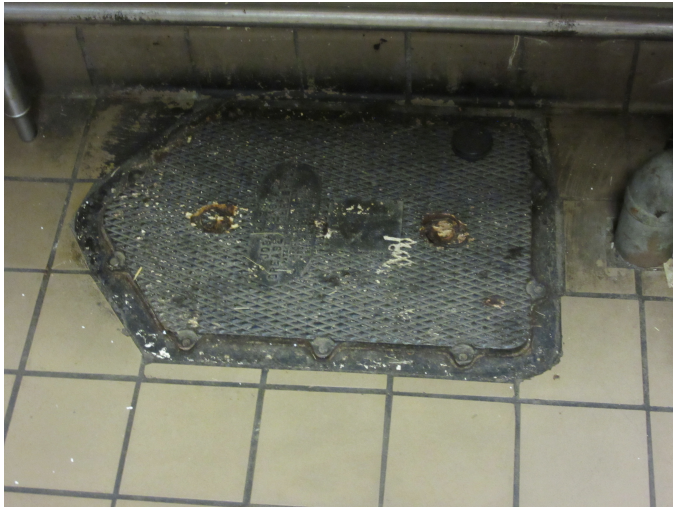
System: D2090 - Other Plumbing Systems - Acid Waste

Location: Kitchen

Distress: Beyond Service Life

Notes: The acid waste collection system is beyond its expected service life and should be scheduled for replacement. The grease trap and backflow prevention device are scheduled for replacement under SPLOST project 515-422.

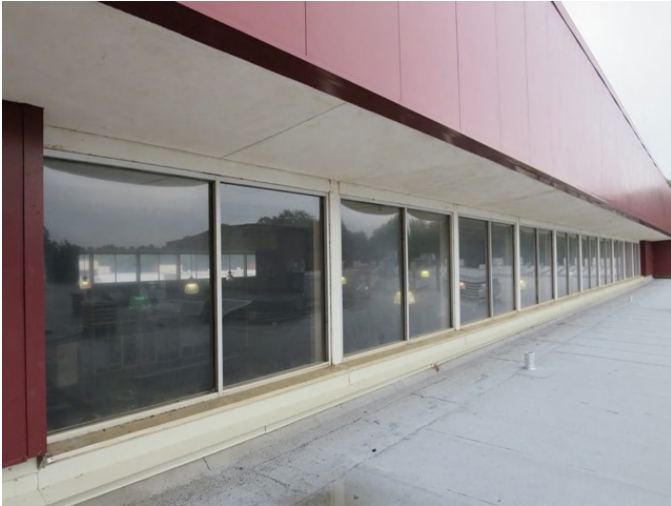
System: B2020 - Exterior Windows

Location: Roof

Distress: Beyond Service Life

Notes: Clerestory windows above the cafeteria are beyond their expected service life and should be scheduled for replacement.

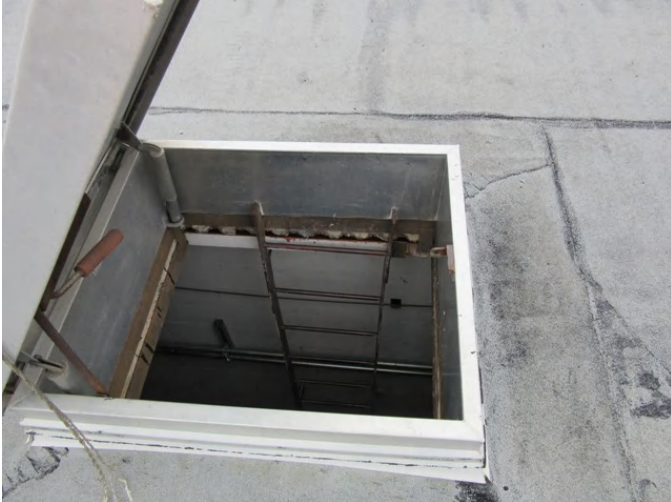
System: B3020 - Roof Openings

Location: Roof

Distress: Beyond Service Life

Notes: The roof openings are beyond their expected service life and roof hatches are not OSHA-compliant for egress. SPLOST project 515-422 to repair/replace roof openings.

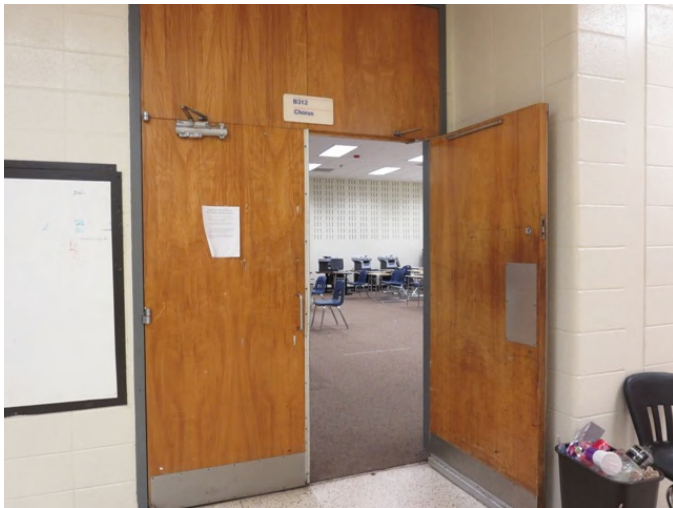
System: C1020 - Interior Doors

Location: Throughout Building

Distress: Beyond Service Life

Notes: The interior doors are aged, failing, not ADA compliant, and should be repaired or replaced.

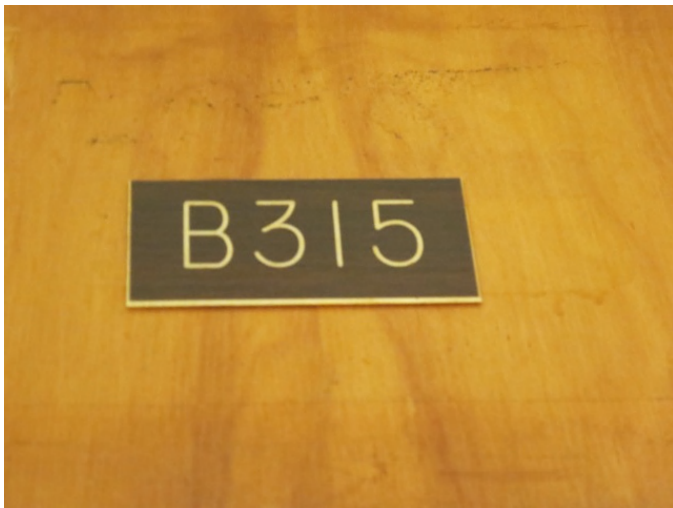
System: C1030 - Fittings

Location: Throughout Building

Distress: Inadequate

Correction: Remove and replace the signage w/ADA compliant signage.

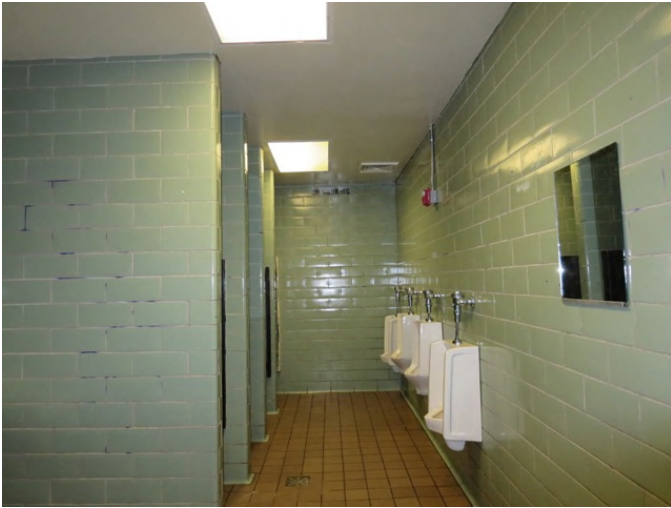
System: C3010 - Wall Finishes - Ceramic & Glazed

Location: Restrooms

Distress: Beyond Service Life

Notes: The wall tiles are aged, scuffed, faded and stained, and should be replaced.

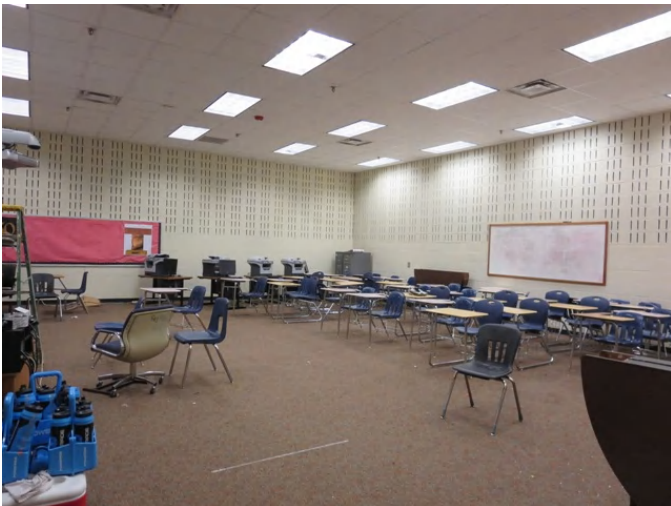
System: C3020 - Floor Finishes - Carpet

Location: Media Center and Offices

Distress: Beyond Service Life

Notes: The carpet is stained, showing signs of failure, and should be replaced. SPLOST project 515-422 to replace carpet throughout the building.

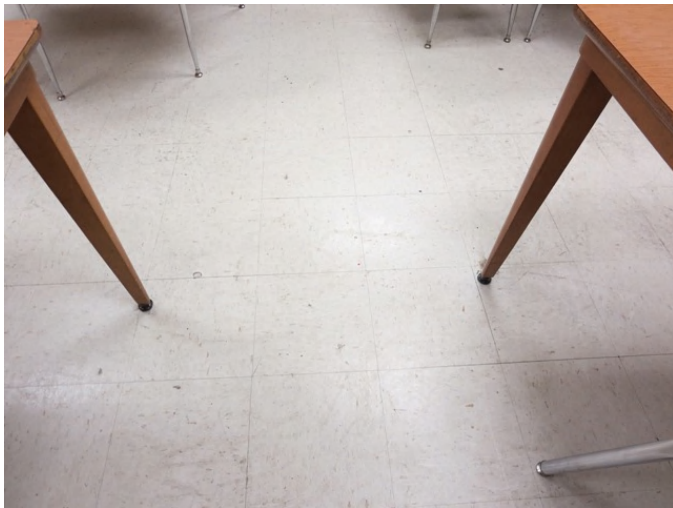
System: C3020 - Floor Finishes - VCT

Location: Throughout Building

Distress: Beyond Service Life

Notes: The VCT floor covering is beyond its expected service life and should be replaced.

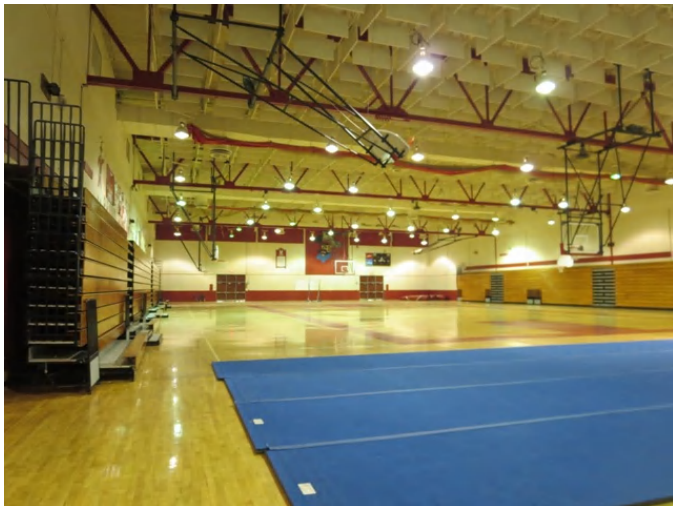
System: C3020 - Floor Finishes - Wood

Location: Gym and Auditorium Stage

Distress: Beyond Service Life

Notes: The wood flooring is beyond its expected service life and should be replaced.

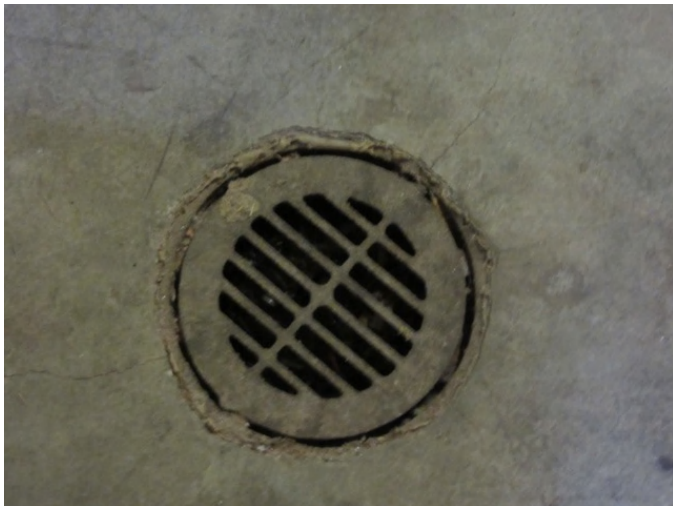
System: D2030 - Sanitary Waste

Location: Throughout Building

Distress: Beyond Service Life

Notes: The sanitary waste system is beyond its expected service life and should be scheduled for replacement. The grease trap and backflow prevention device are scheduled to be replaced under SPLOST project 515-422.

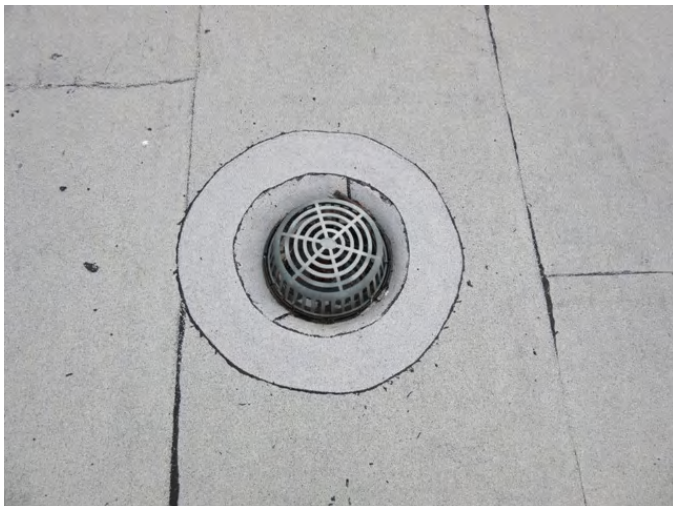
System: D2040 - Rain Water Drainage

Location: Throughout Building

Distress: Beyond Service Life

Notes: The rainwater drainage system is beyond its expected service life and should be scheduled for replacement.

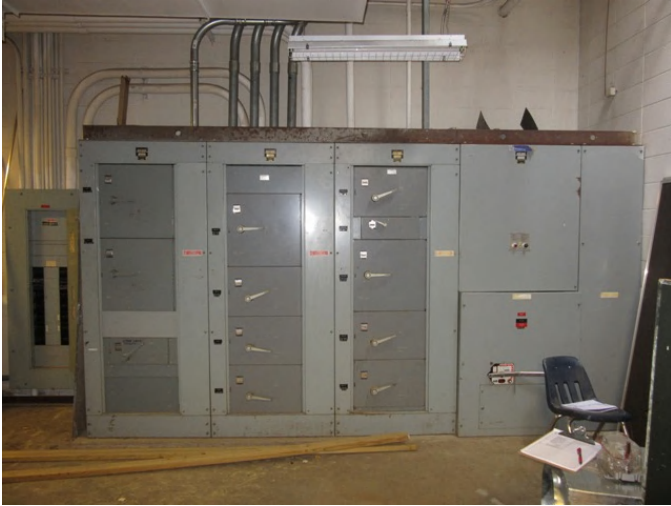
System: D5010 - Electrical Service/Distribution

Location: Throughout Building

Distress: Beyond Service Life

Notes: Electrical service/distribution is nearing the end of its expected service life and should be scheduled for replacement. SPLOST project 515-422 to repair/replace electrical panels (lighting, power, distribution) throughout the buildings.

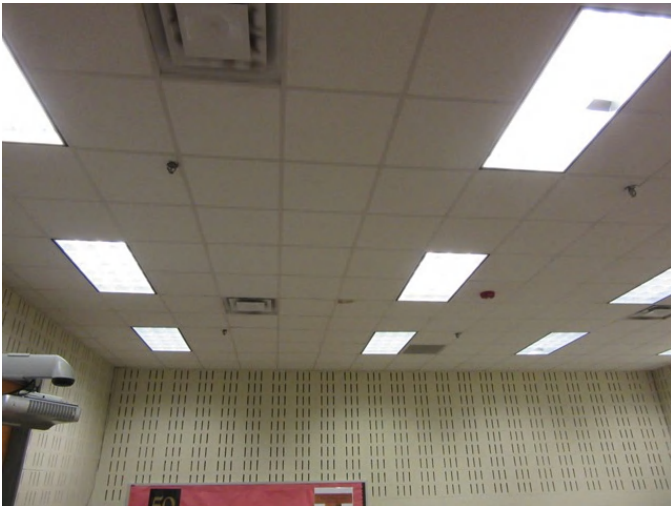
System: D5020 - Branch Wiring

Location: Throughout Building

Distress: Beyond Service Life

Notes: The branch wiring system is beyond its expected service life and should be scheduled for replacement. GFI electrical outlets are missing in wet areas. The facility electrical panels (lighting, power, distribution) are scheduled to be replaced under SPLOST project 515-422. Lighting was replaced in 2009.

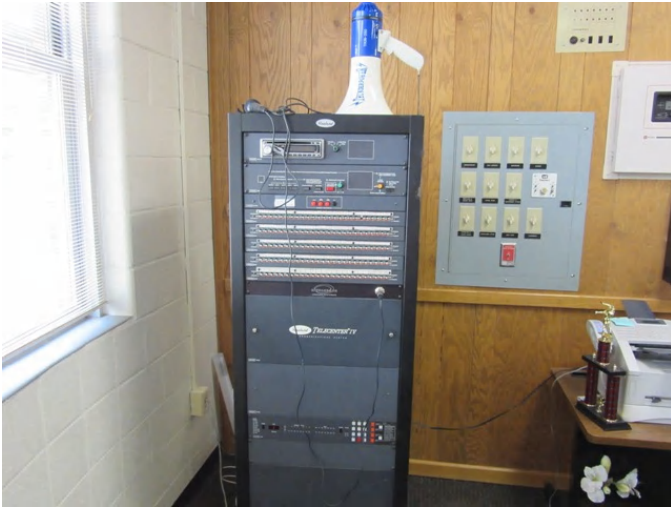
System: D5030 - Communications and Security - PA & Clock Systems

Location: Throughout Building

Distress: Beyond Service Life

Notes: PA and clock systems are beyond their expected service life, inadequate, and should be scheduled for replacement. A sound system is needed in the auditorium. SPLOST project 515-422 to replace PA and clock systems.

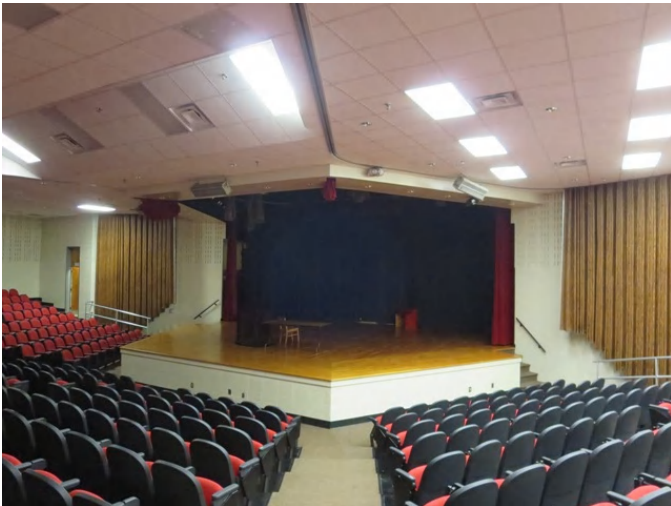
System: F1020 - Institutional Equipment

Location: Throughout Building

Distress: Beyond Service Life

Notes: Institutional equipment, such as laboratory equipment, theater and stage equipment, and audio-visual equipment, is beyond its expected service life and should be scheduled for replacement. SPLOST project 515-422 to review and replace all shop equipment, lab equipment, family/consumer science equipment as appropriate.

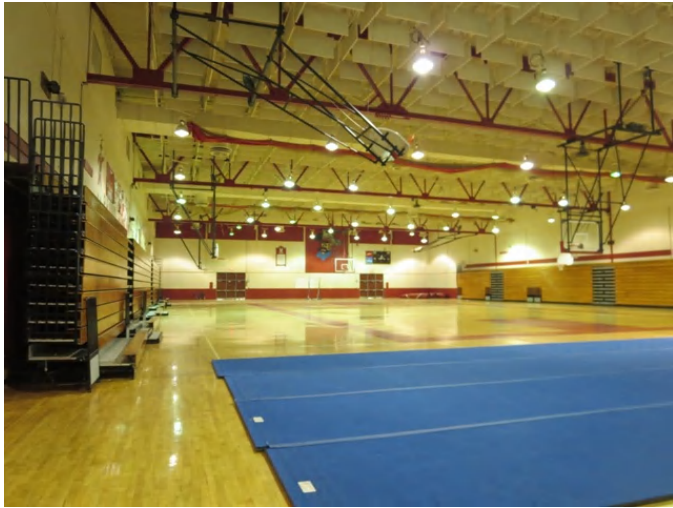
System: E1090 - Other Equipment - Sports Equipment

Location: Gym

Distress: Beyond Service Life

Notes: Sports equipment is beyond its expected service life and should be scheduled for replacement.

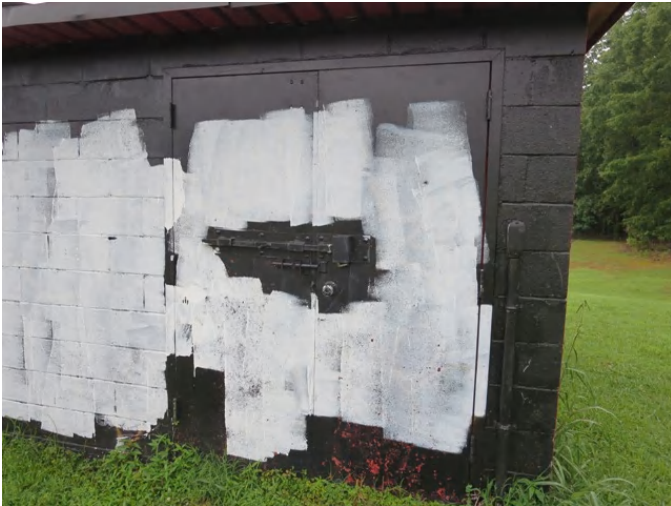
System: B2030 - Exterior Doors

Location: Exterior Wall

Distress: Beyond Service Life

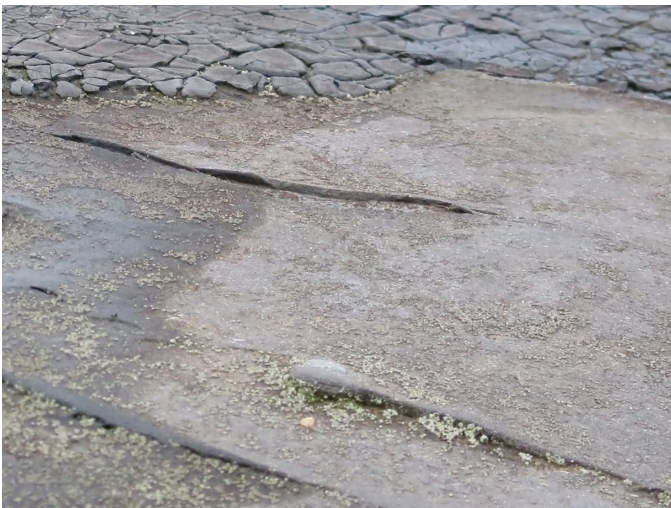
System: B3010 - Roof Coverings

Location: Roof

Distress: Beyond Service Life

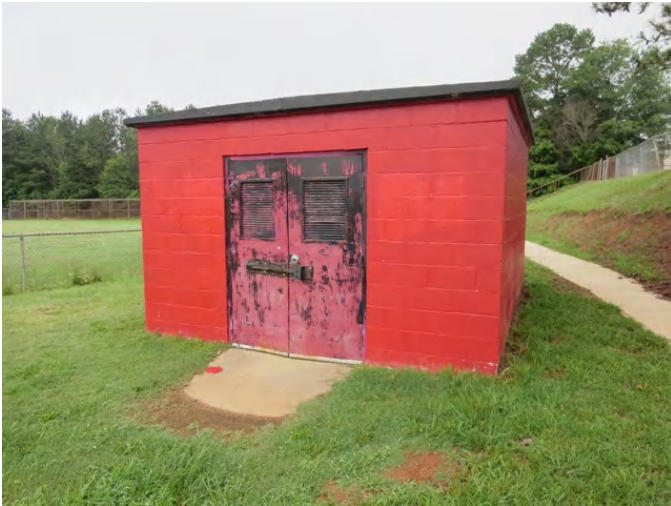
System: B2030 - Exterior Doors

Location: Exterior Wall
Distress: Beyond Service Life
Category: Deferred Maintenance
Priority: 3 Priority
Correction: Renew System
Qty: 250.00
Unit of Measure: S.F.
Estimate: \$539.00
Assessor Name: Sam Mandola
Date Created: 04/11/2015

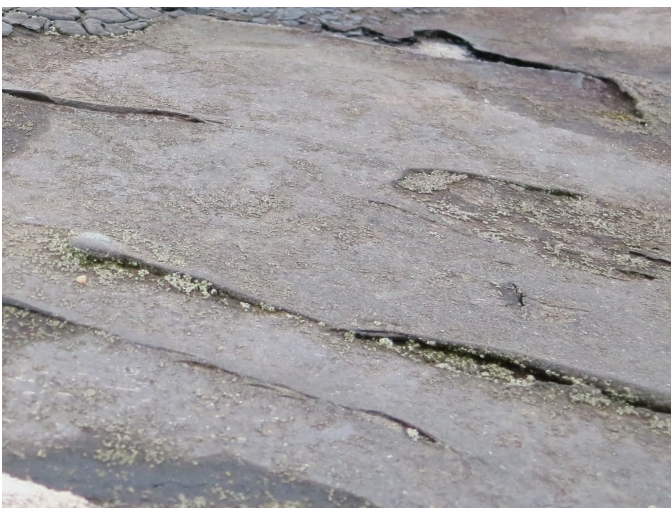
System: B3010 - Roof Coverings

Location: Roof
Distress: Beyond Service Life
Category: Deferred Maintenance
Priority: 3 Priority
Correction: Renew System
Qty: 250.00
Unit of Measure: S.F.
Estimate: \$4,617.00
Assessor Name: Sam Mandola
Date Created: 04/11/2015

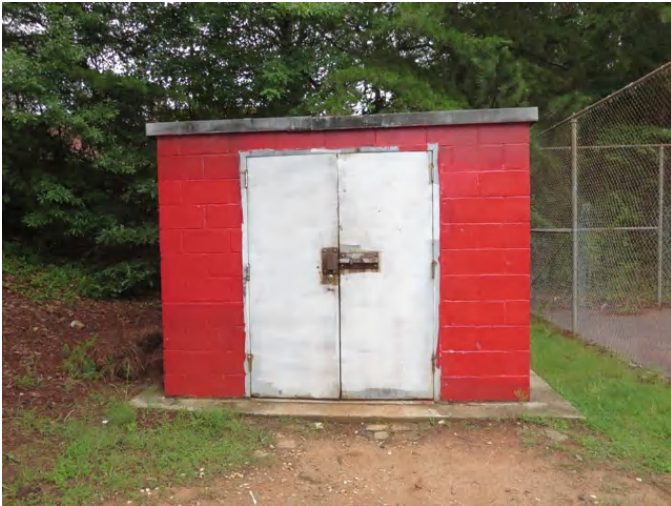
System: B2030 - Exterior Doors

Location: Exterior Wall

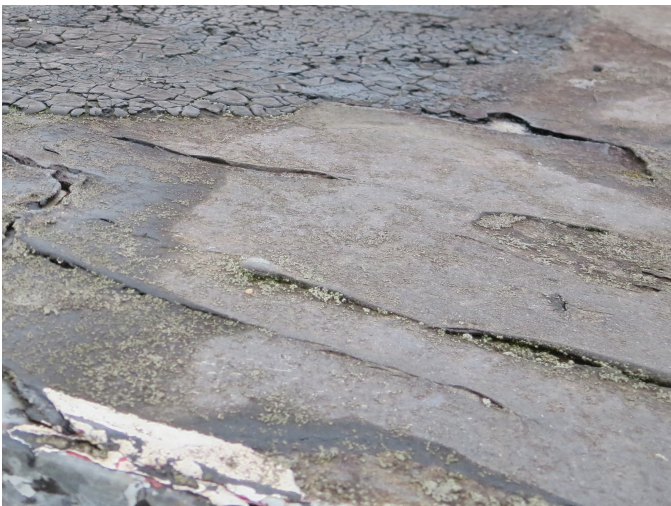
System: B3010 - Roof Coverings

Location: Roof

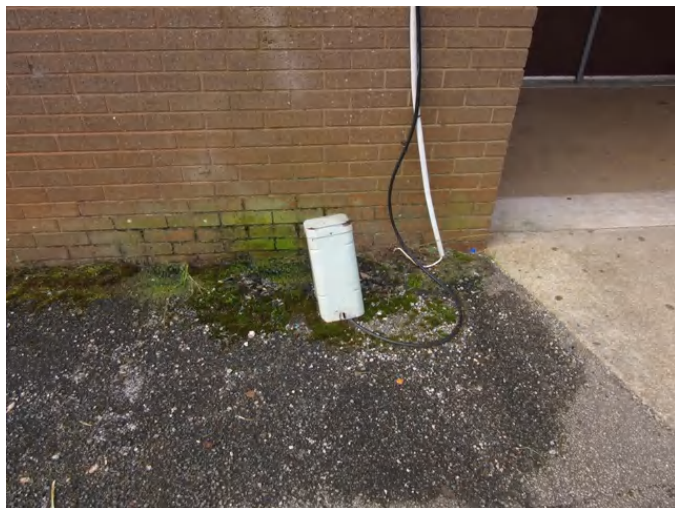
System: G4030 - Site Communications & Security

Location: Site

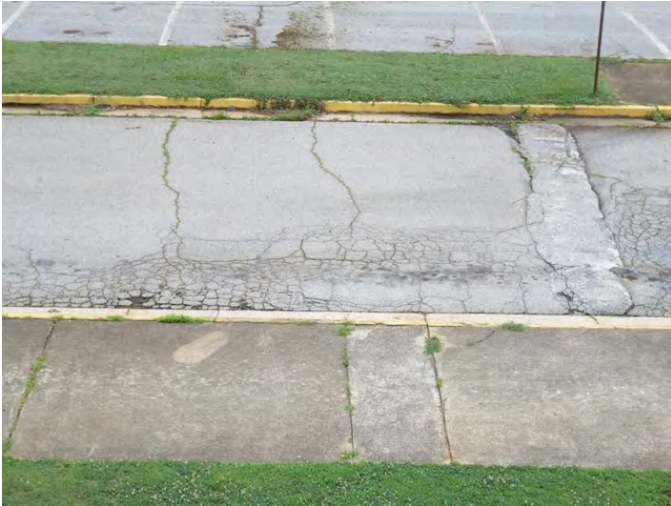
System: G2010 - Roadways

Location: Site

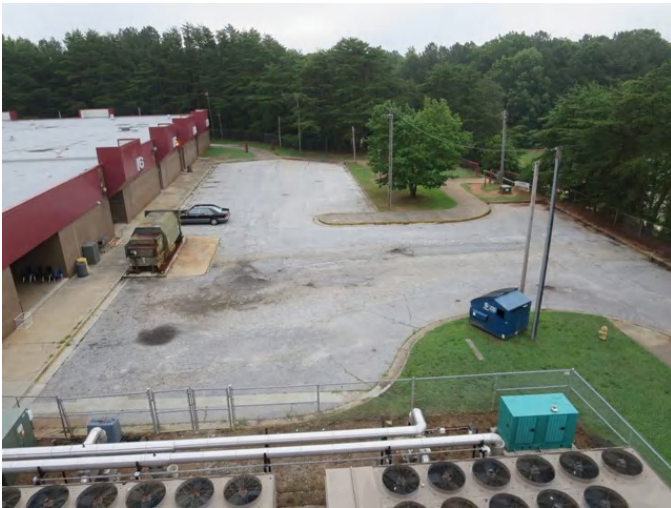
System: G2020 - Parking Lots

Location: Site

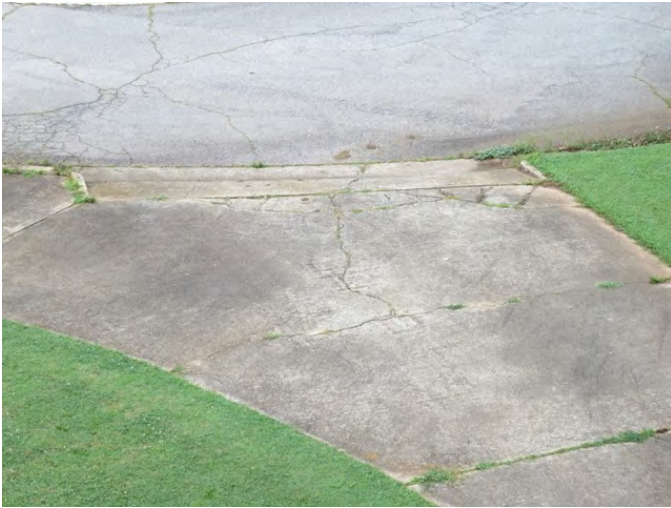
System: G2030 - Pedestrian Paving

Location: Site

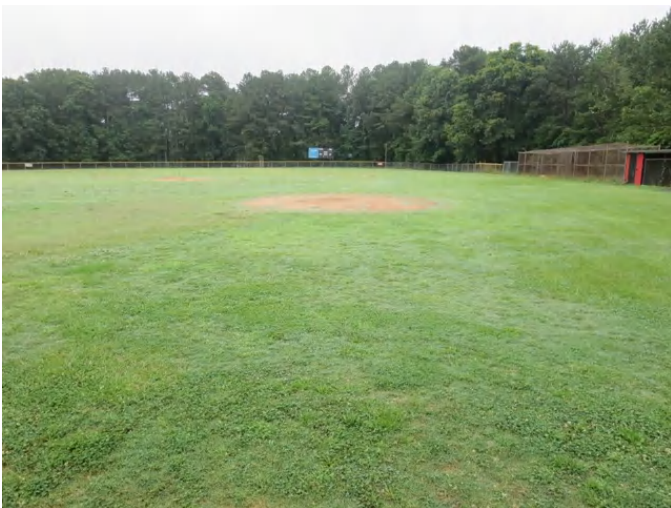
System: G2040 - Baseball Field

Location: Southwest Side of Site

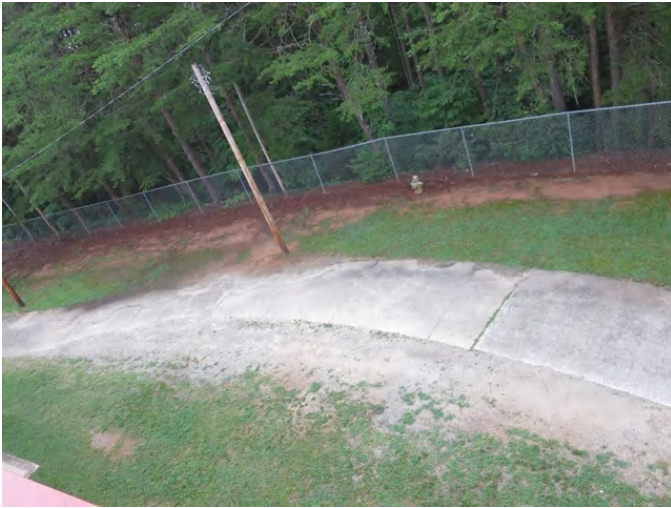
System: G2040 - Fencing & Guardrails

Location: Site

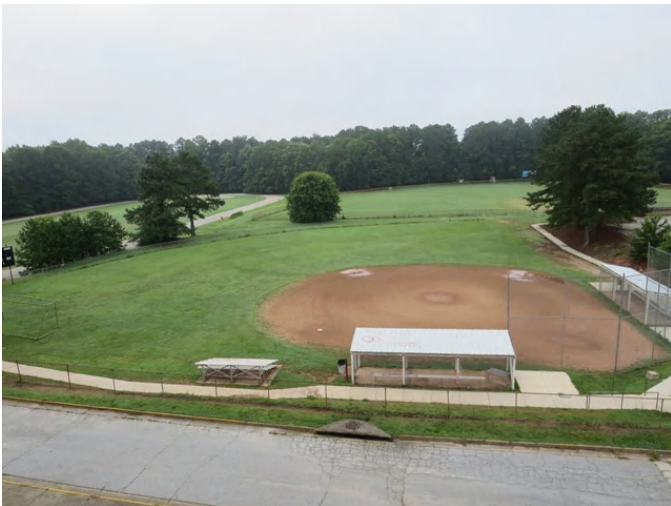
System: G2040 - Softball Field

Location: Site

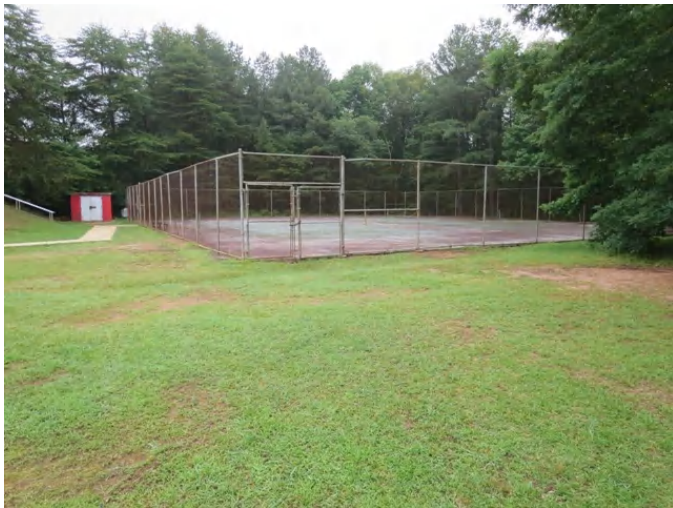
System: G2040 - Tennis Courts

Location: Site

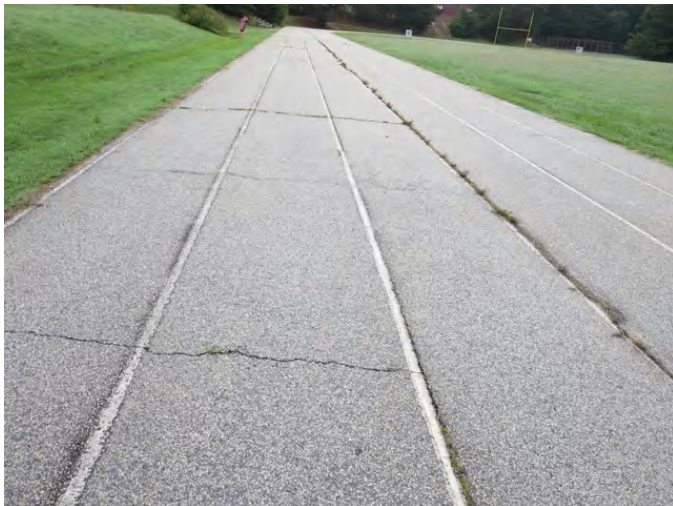
System: G2040 - Track

Location: Site
