DeKalb County School District/High Schools

# Tucker High

## School Assessment Report

May 20, 2016

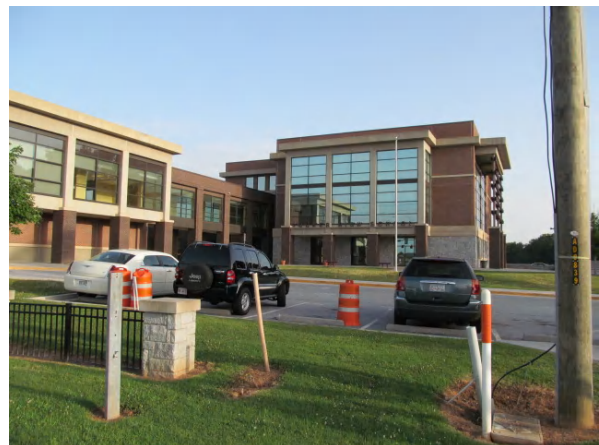
The main building at Tucker High School is a three-story building located at 5036 LaVista Road in Tucker, Georgia. Originally built in 2010, there have been no additions or major renovations. This report contains condition and adequacy data collected during the 2015 Facility Condition Assessment (FCA). The detailed condition and deficiency statements are contained in this report.

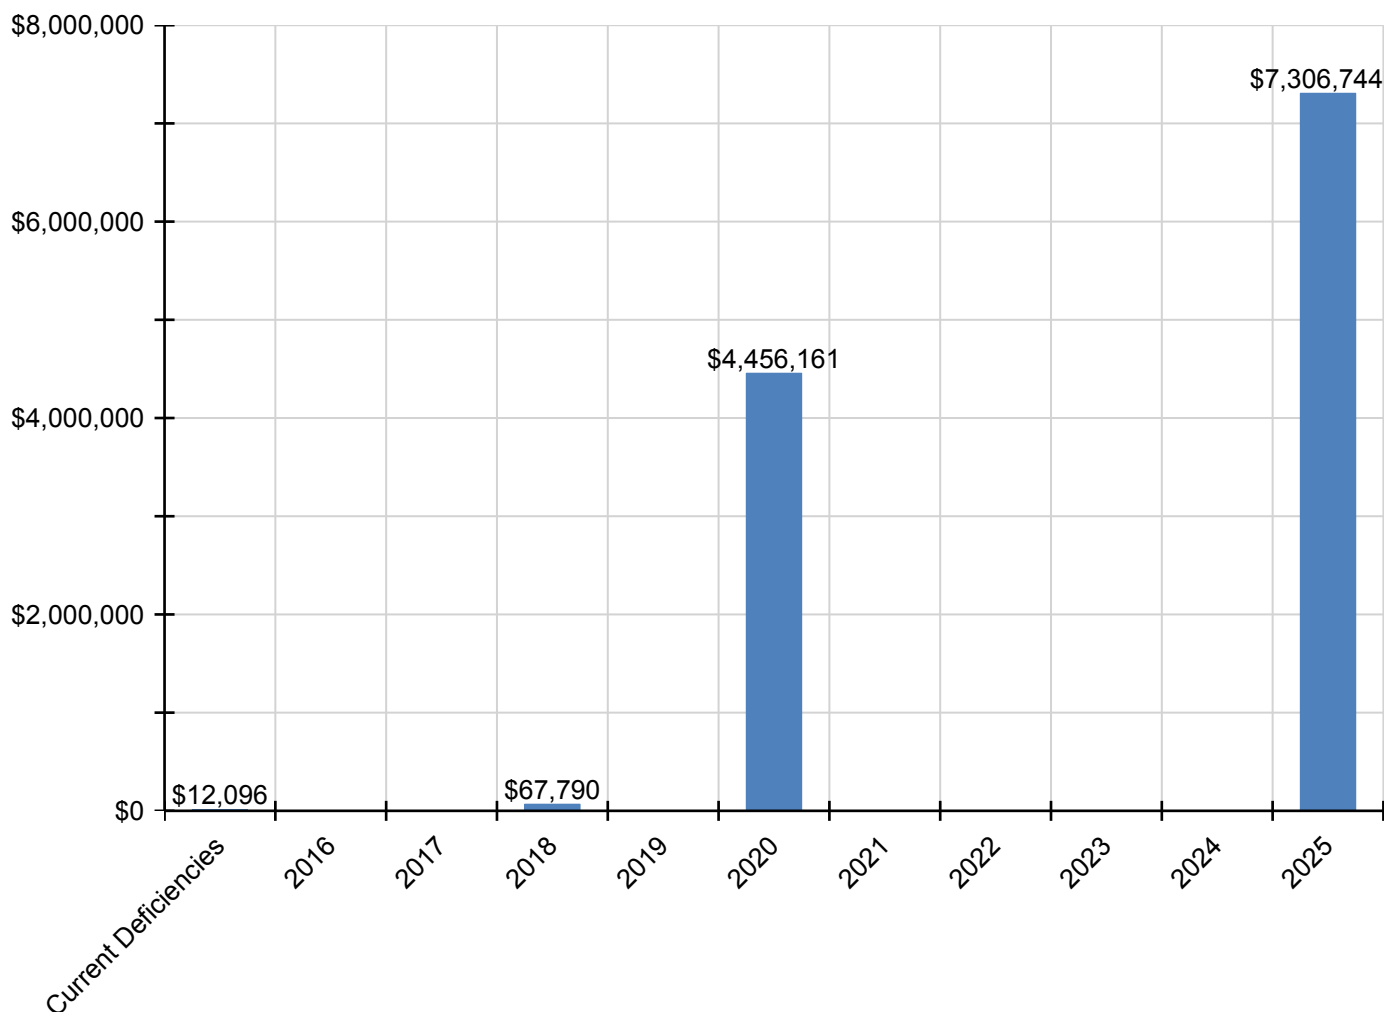
## Forecasted Capital Renewal Requirement

The following chart shows the current building deficiencies and the forecasted capital renewal (system replacement) requirements over the next ten years.

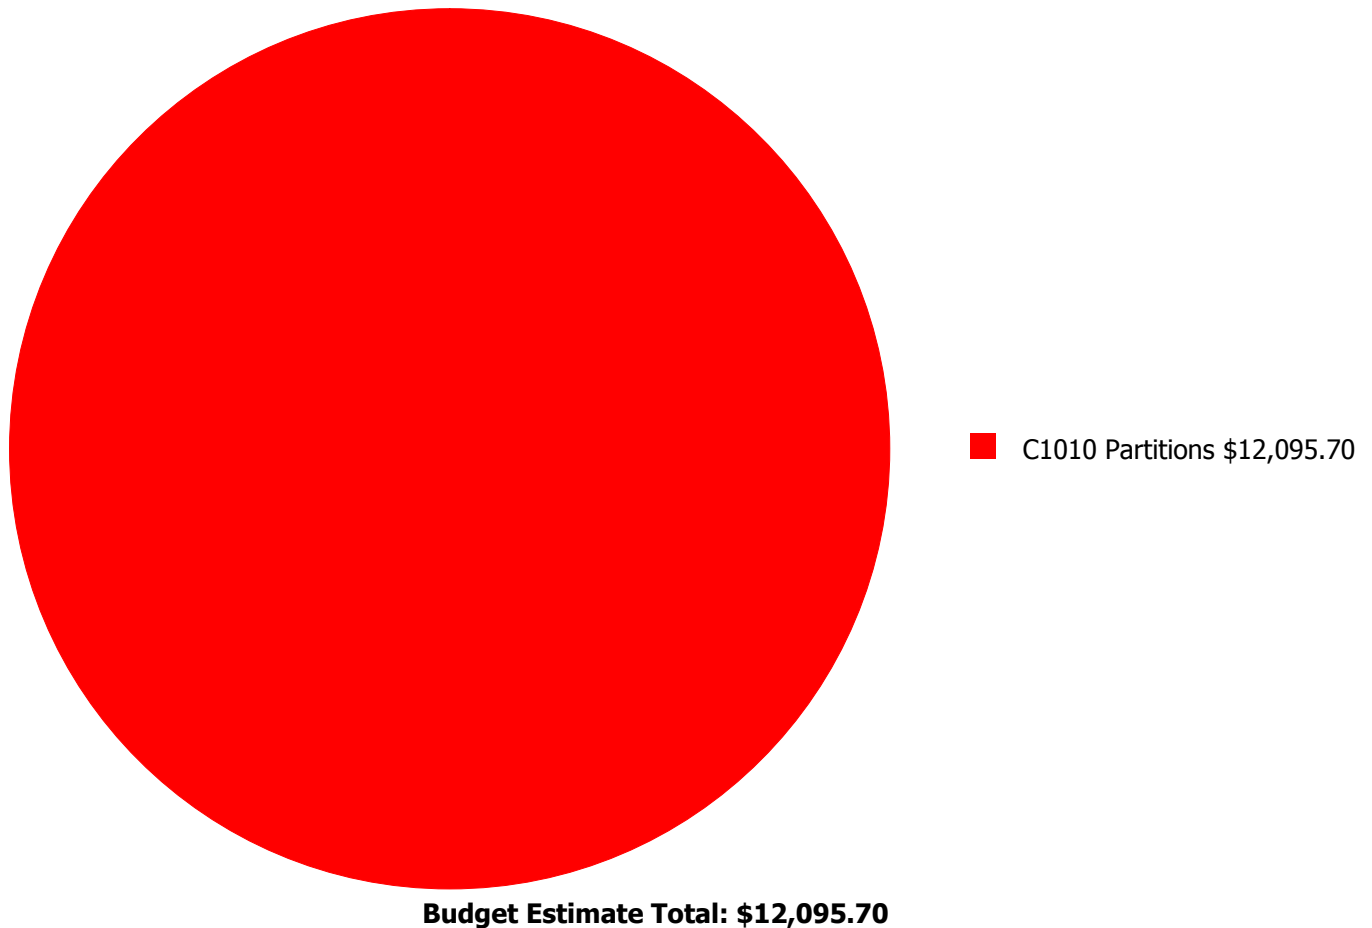
## Deficiency Summary by System

Current deficiencies include assemblies that have reached or exceed their design life or components of the assemblies that are in need of repair. Assemblies that have reached their design life are identified as current deficiencies and assigned the distress 'Beyond Service Life'. The following chart lists all current deficiencies associated with this facility broken down by UNIFORMAT system.

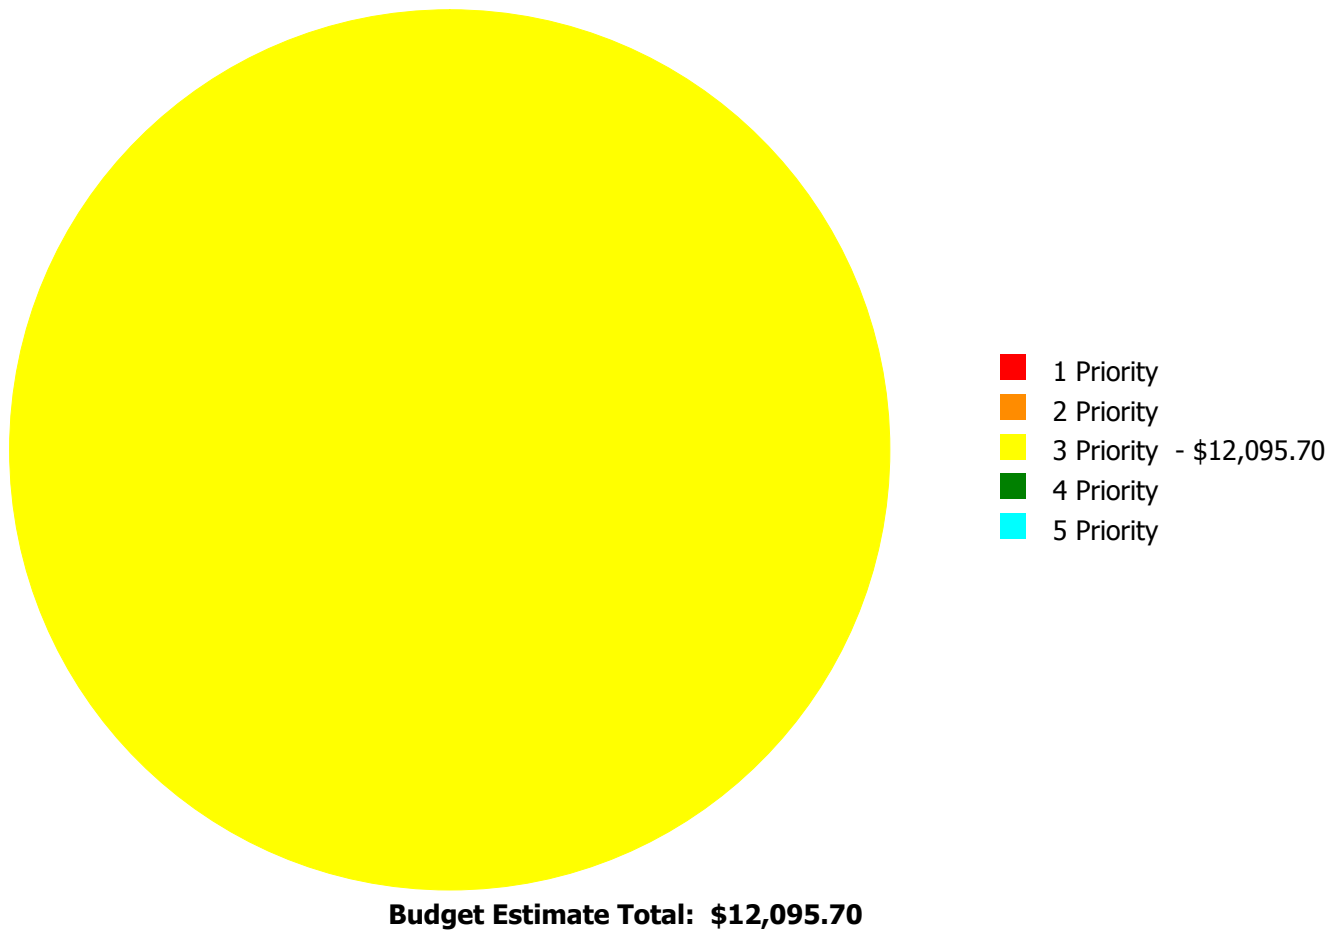
## Deficiency Summary by Priority

The following chart shows the total repair costs broken down by priority. Assessors assigned deficiencies within eCOMET to one of the following priority categories:

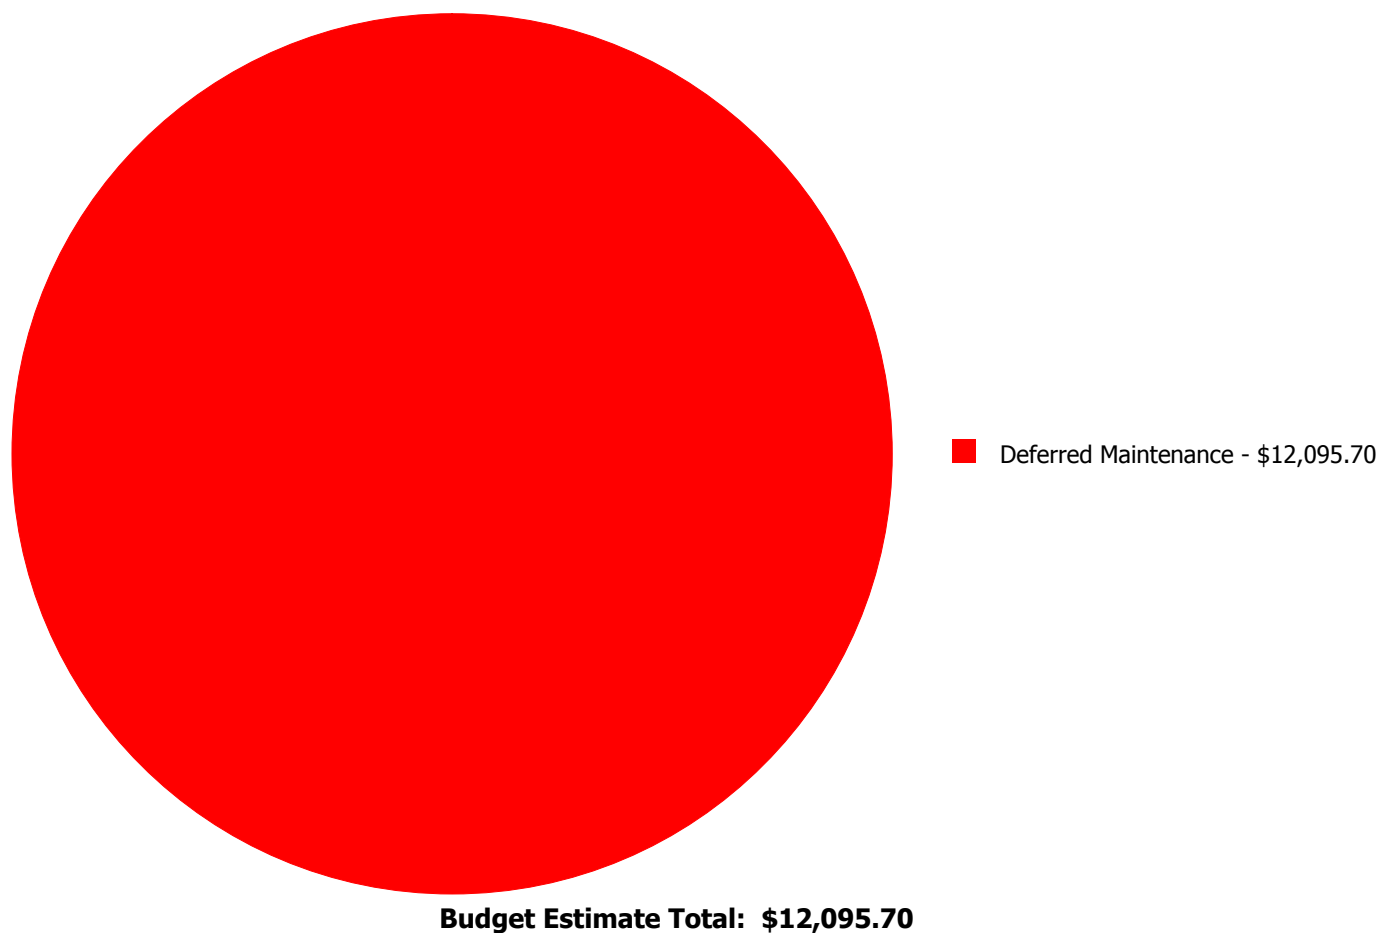
## Deficiency Summary by Category

The following chart shows the total repair costs broken down by deficiency categories. Assessors assigned deficiencies to one of the following categories:

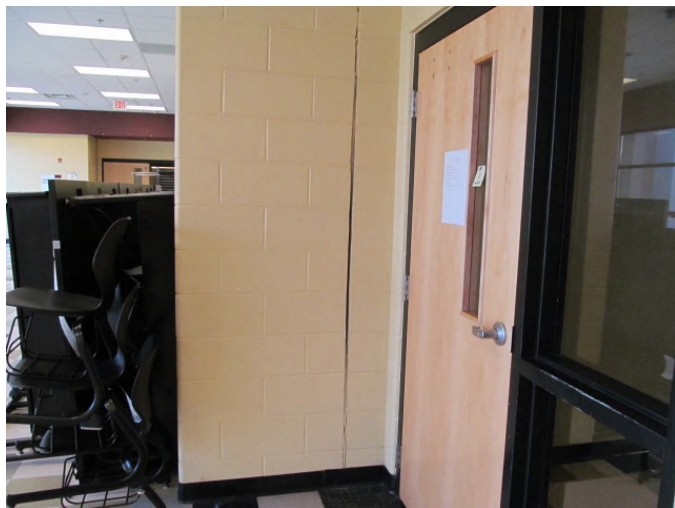
#### System: C1010 - Partitions

**Location:** F-Wing

**Distress:** Inadequate

**Notes:** Expansion joints on wall and flooring are showing signs of settlement and should be repaired. Some floor joints are missing and the VCT is separating or breaking where the missing expansion joint should be and must be provided.

**Correction:** Repair 8" concrete block wall - (2% of walls) painted

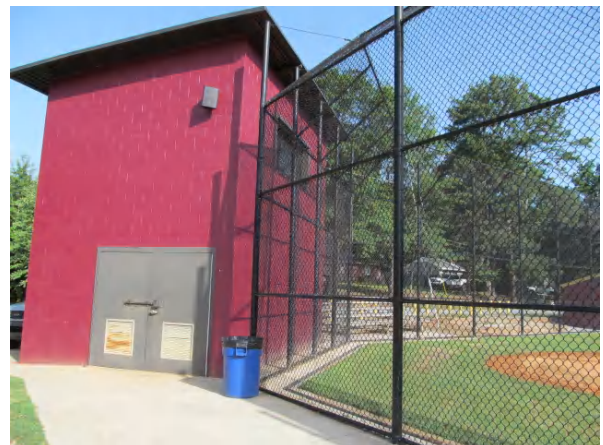
The press box/storage at Tucker High School is located at 5036 LaVista Road in Tucker, Georgia. Originally built in 2010, there have been no additions and no major renovations. This report contains condition and adequacy data collected during the 2015 Facility Condition Assessment (FCA). Detailed condition and deficiency statements are contained in this report.

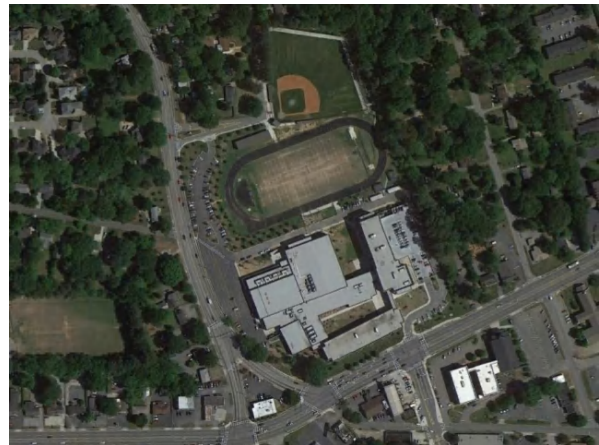
The Tucker High School site was originally constructed in 2010, has a total area of 17.6 acres, and is occupied by approximately 269,388 square feet of permanent building space. Campus site features include paved driveways and parking lots, pedestrian pavement, landscaping, football field, track, baseball field, and fencing. Site mechanical and electrical features include water, sewer, natural gas, and site lighting. This report contains condition and adequacy data collected during the 2015 Facility Condition Assessment (FCA). Detailed condition and deficiency statements are contained in this report for the site features.
