DeKalb County School District/Elementary Schools

Vanderlyn Elementary

School Assessment Report

May 20, 2016

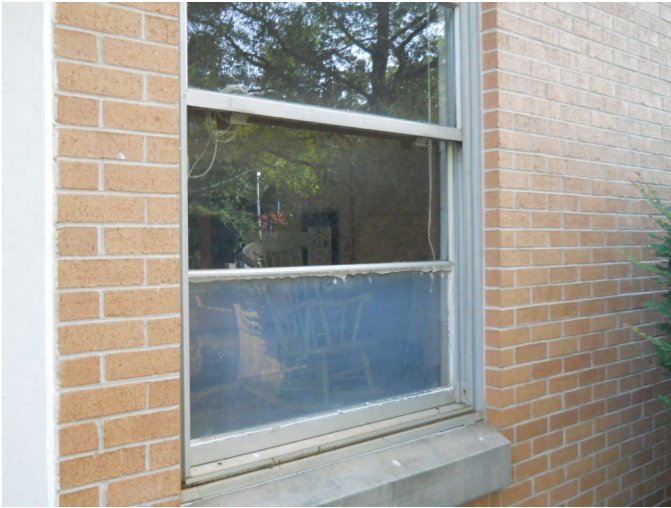
System: B2020 - Exterior Windows

Location: Throughout Building

Distress: Beyond Service Life

Notes: The exterior window system is original construction, beyond its expected service life, and should be replaced.

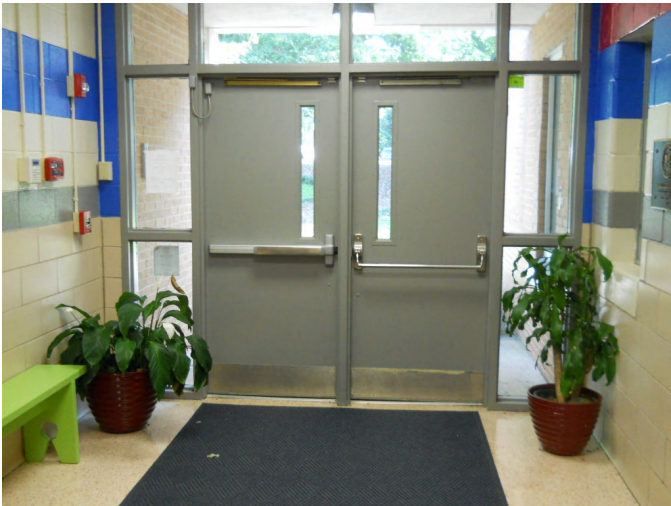
System: B2030 - Exterior Doors

Location: Throughout Building

Distress: Beyond Service Life

Notes: The exterior door system is original, beyond its expected service life, and should be replaced.

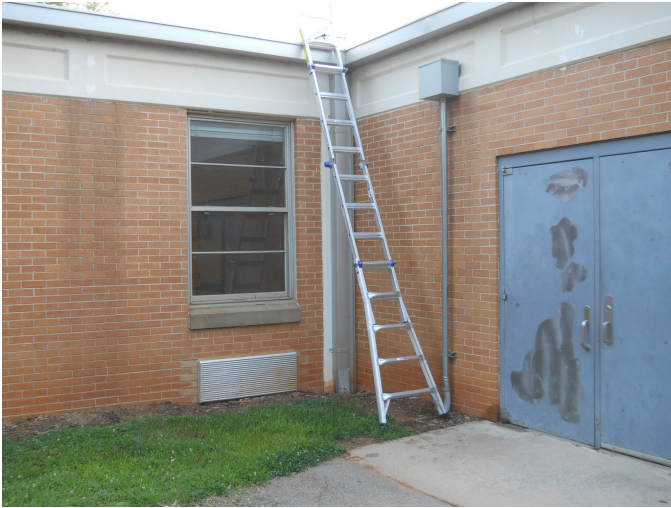
System: B3020 - Roof Openings

Location: Roof

Distress: Missing

Notes: There is no safe roof access for maintenance personnel. Recommend installation of an OSHA-compliant roof hatch/ladder system for safe access.

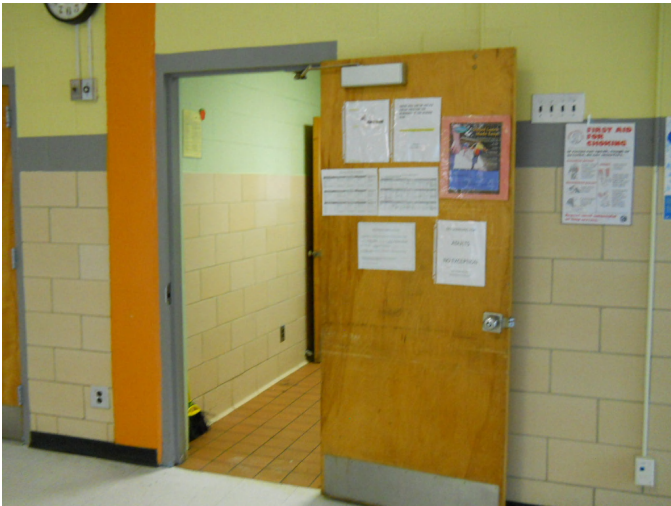
System: C1020 - Interior Doors

Location: Throughout Building

Distress: Beyond Service Life

Notes: The interior doors are original, beyond their expected service life, not ADA compliant, and should be replaced.

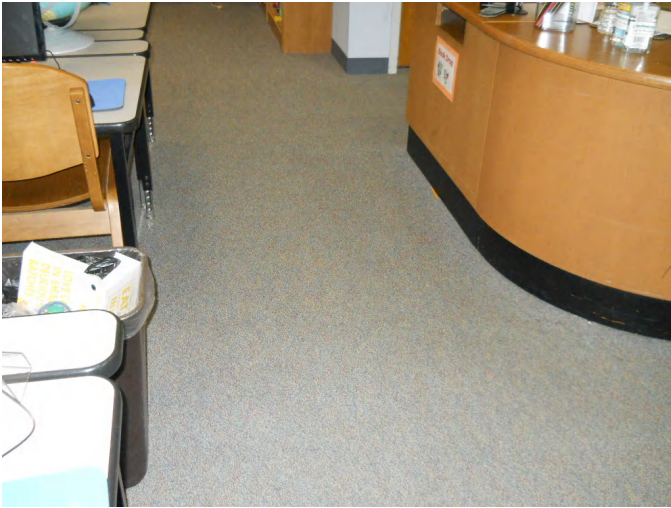
System: C3020 - Floor Finishes - Carpet

Location: Media Center, Offices

Distress: Beyond Service Life

Notes: The carpet is beyond its expected service life, worn, and should be replaced.

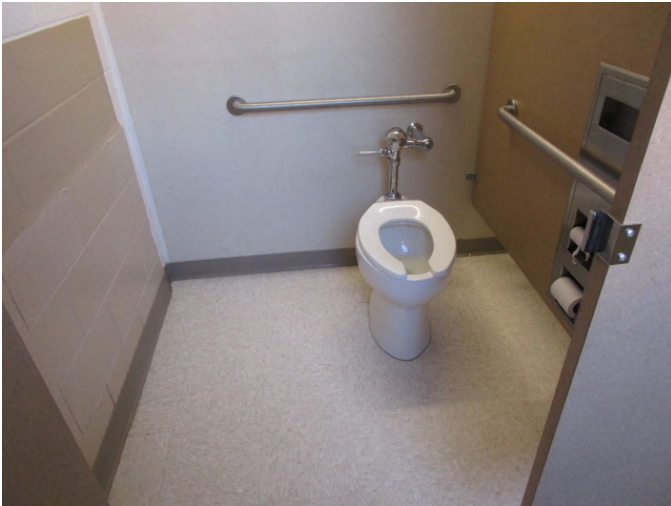
System: D2010 - Plumbing Fixtures

Location: Hallways

Distress: Needs Remediation

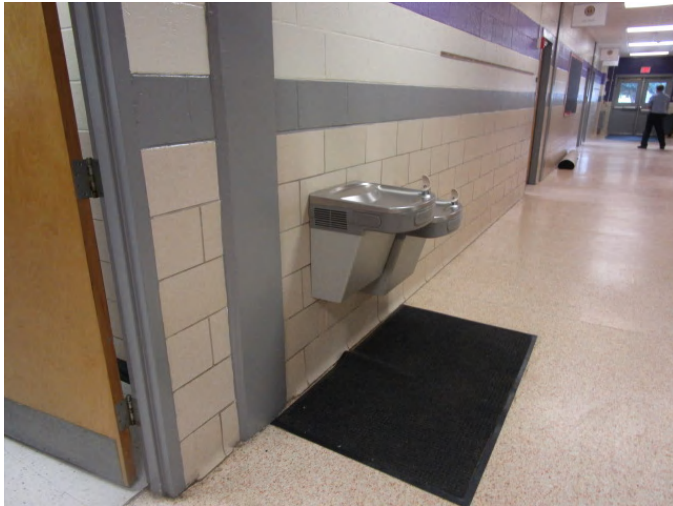
System: D2010 - Plumbing Fixtures

Location: Hallways

Distress: Needs Remediation

Correction: Remove/replace drinking fountain w/recessed ADA compliant drinking fountain

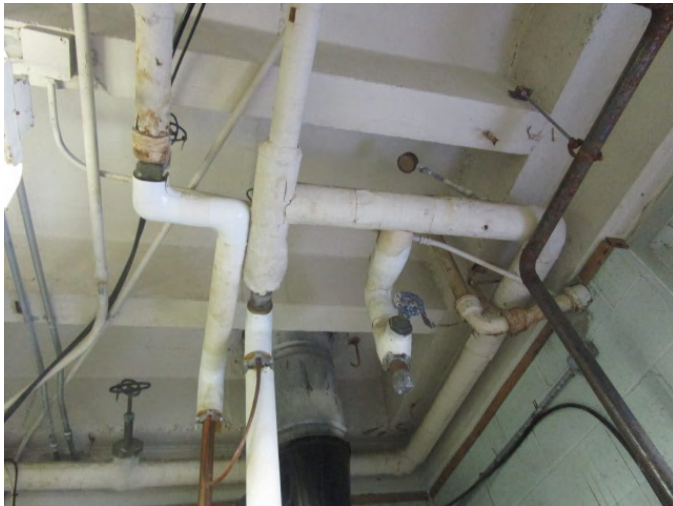
System: D2020 - Domestic Water Distribution

Location: Throughout Building

Distress: Beyond Service Life

Notes: The domestic water distribution system is beyond its expected service life and should be scheduled for replacement.

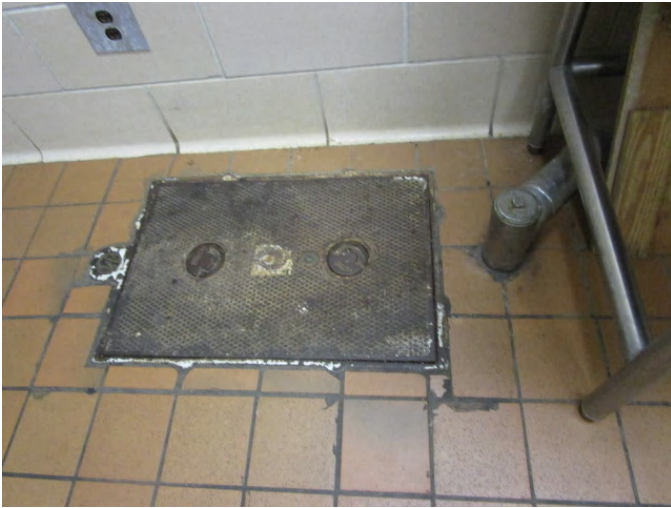
System: D2030 - Sanitary Waste

Location: Throughout Building
Distress: Beyond Service Life
Category: Deferred Maintenance
Priority: 3 Priority
Correction: Renew System
Qty: 53,473.00
Unit of Measure: S.F.
Estimate: \$200,577.00
Assessor Name: Ben Nixon
Date Created: 04/11/2015

Notes: The sanitary waste system is beyond its expected service life and should be scheduled for replacement.

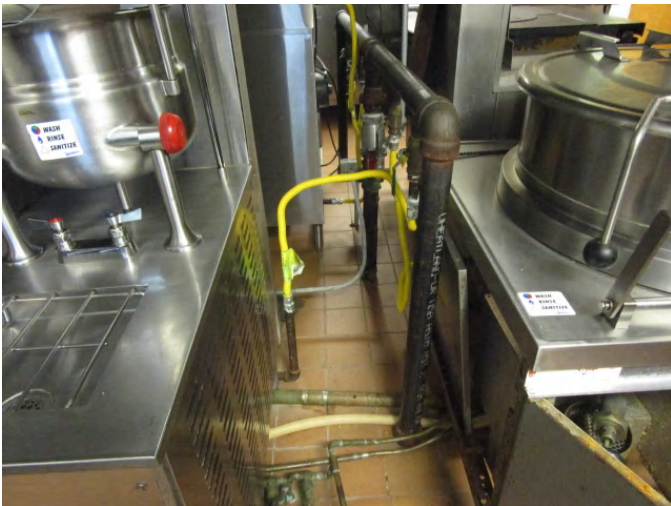
System: D2090 - Other Plumbing Systems - Natural Gas

Location: Throughout Building
Distress: Beyond Service Life
Category: Deferred Maintenance
Priority: 3 Priority
Correction: Renew System
Qty: 53,473.00
Unit of Measure: S.F.
Estimate: \$24,116.00
Assessor Name: Ben Nixon
Date Created: 04/11/2015

Notes: The natural gas system is beyond its expected service life and should be scheduled for replacement. SPLOST project 133-422 to replace grease trap and backflow preventer.

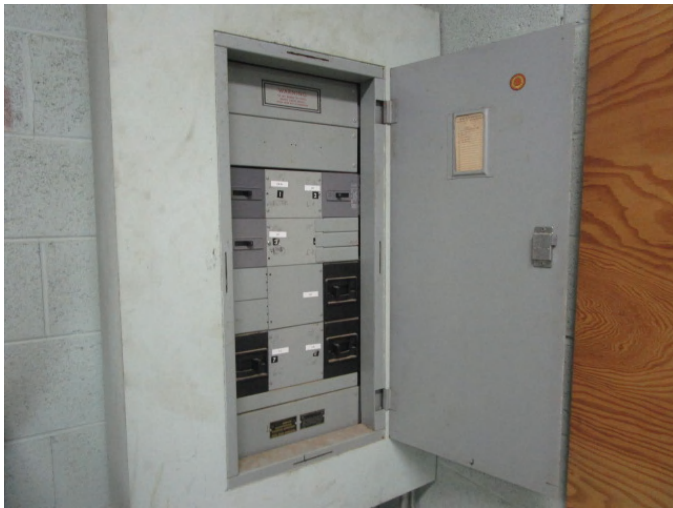
System: D5020 - Branch Wiring

Location: Throughout Building

Distress: Beyond Service Life

Notes: The branch wiring system is beyond its expected service life and should be scheduled for replacement.

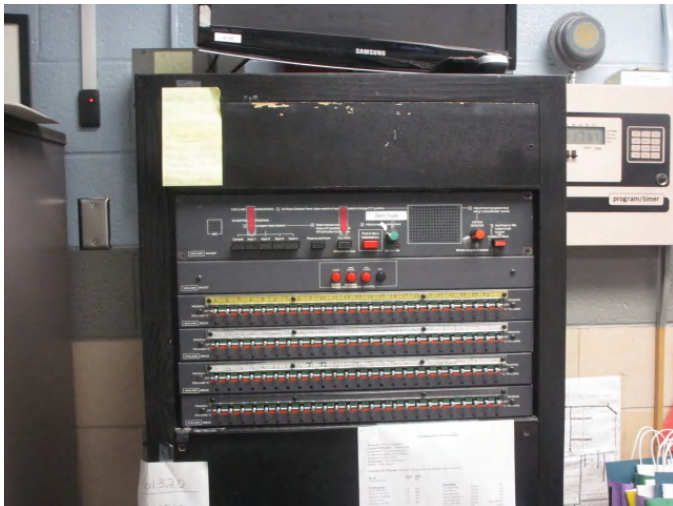
System: D5030 - Communications and Security - Clock & PA Systems

Location: Throughout Building

Distress: Beyond Service Life

Notes: Clock and PA systems are beyond their expected service life and should be scheduled for replacement.

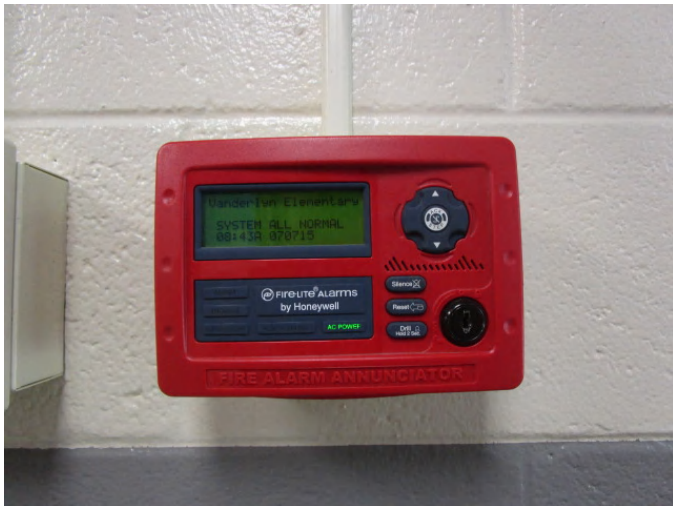
System: D5030 - Communications and Security - Fire Alarm

Location: Throughout Building

Distress: Beyond Service Life

Notes: The fire alarm system is beyond its expected service life and should be scheduled for replacement.

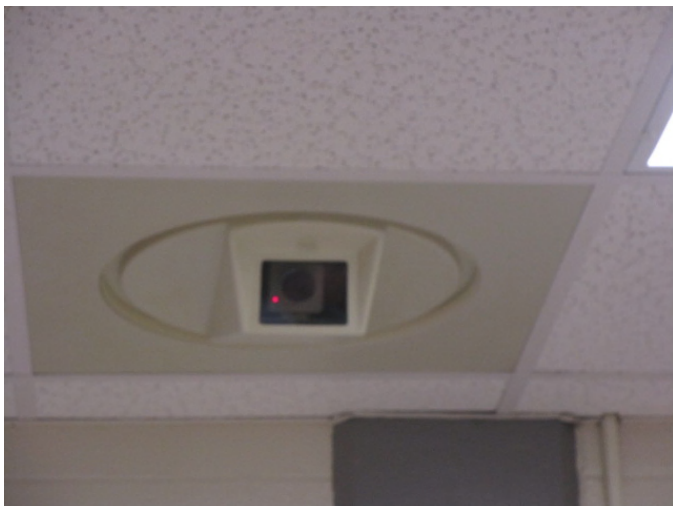
System: D5030 - Communications and Security - Security & CCTV

Location: Throughout Building

Distress: Beyond Service Life

Notes: The security and CCTV systems are beyond their expected service life and should be scheduled for replacement.

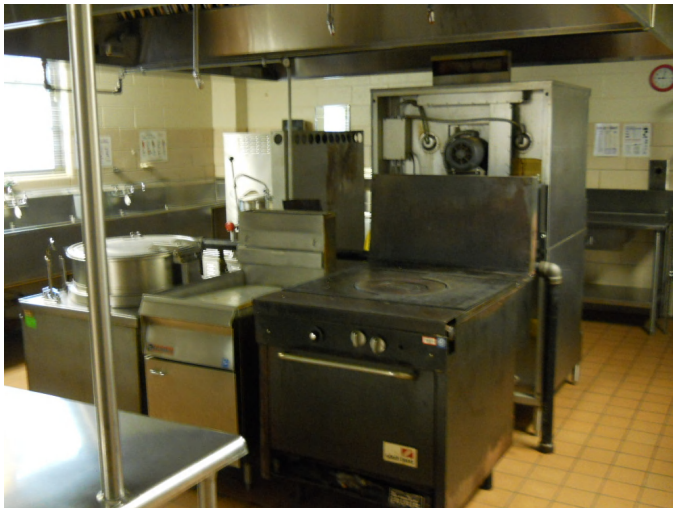
System: E1090 - Other Equipment - Kitchen Equipment

Location: Kitchen

Distress: Beyond Service Life

Notes: Kitchen equipment is beyond its expected service life and should be scheduled for replacement. SPLOST project 133-422 to evaluate kitchen equipment and replace as necessary.

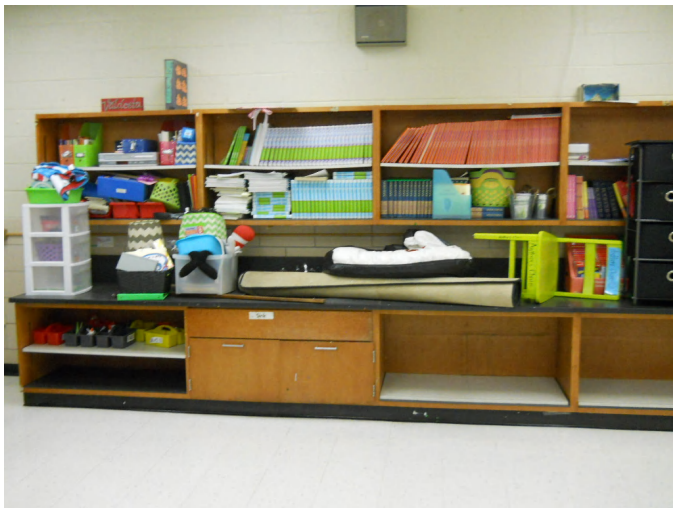
System: E2010 - Fixed Furnishings

Location: Throughout Building

Distress: Beyond Service Life

Notes: Fixed furnishings, such as built-in cabinets, are beyond their expected service life and worn, and should be replaced.

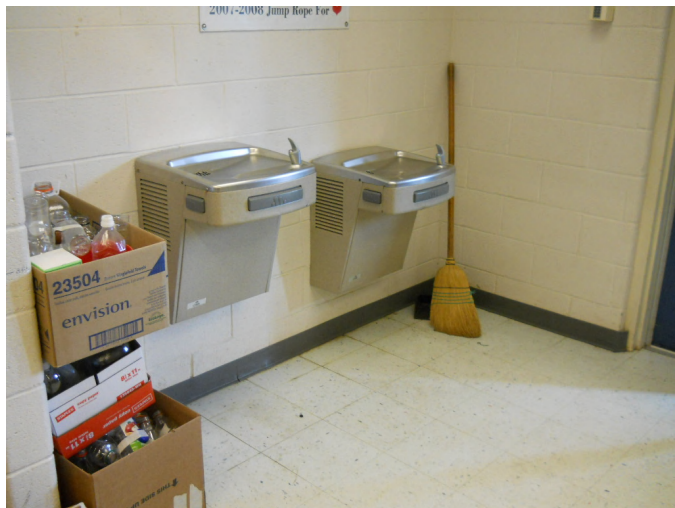
System: C3010 - Wall Finishes - Paint

Location: Throughout Building

Distress: Beyond Service Life

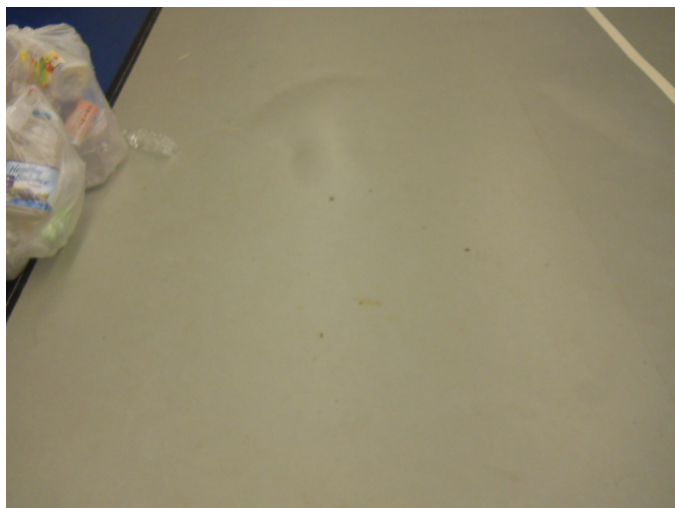
System: C3020 - Floor Finishes - Neoprene

Location: Basketball Court

Distress: Beyond Service Life

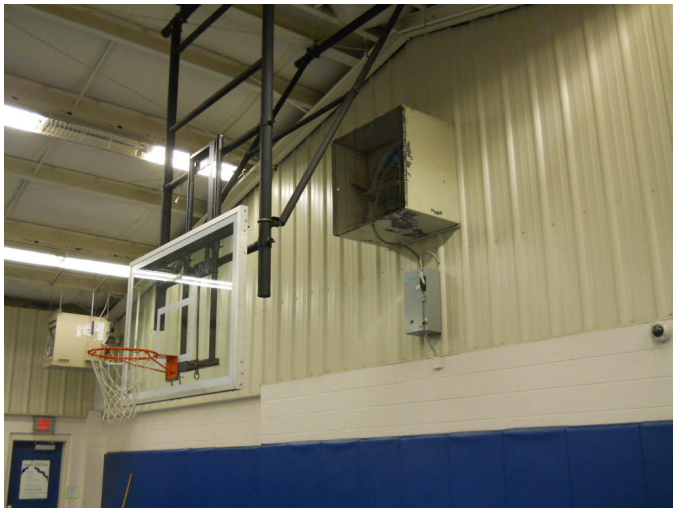
System: D3050 - Terminal & Package Units

Location: Throughout Building

Distress: Inadequate

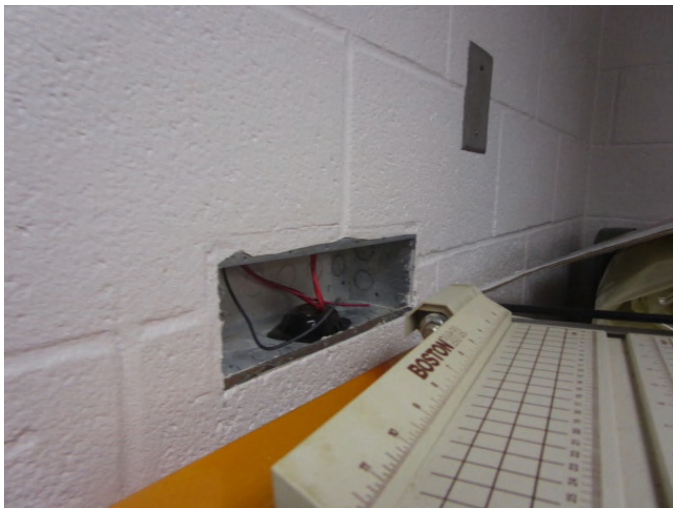
System: D5030 - Communications and Security - Fire Alarm

Location: Throughout Building

Distress: Beyond Service Life

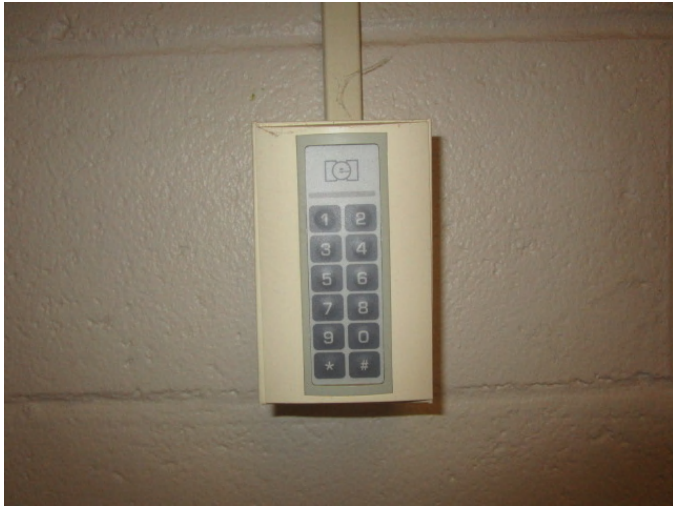
System: D5030 - Communications and Security - Security & CCTV

Location: Throughout Building

Distress: Beyond Service Life

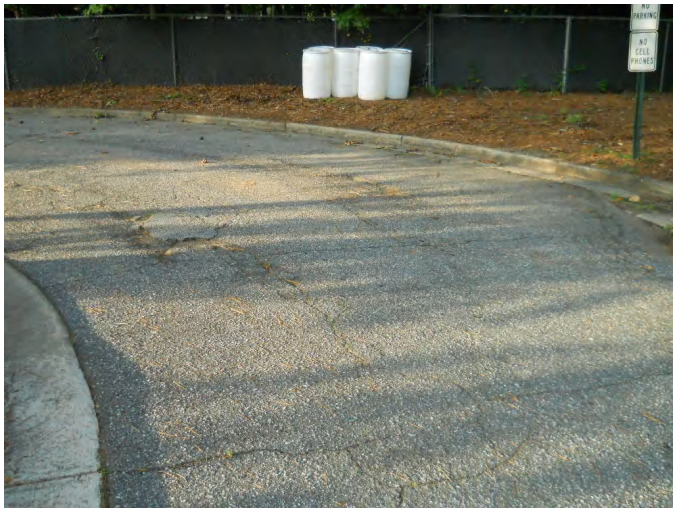
System: G2010 - Roadways

Location: Site

Distress: Beyond Service Life

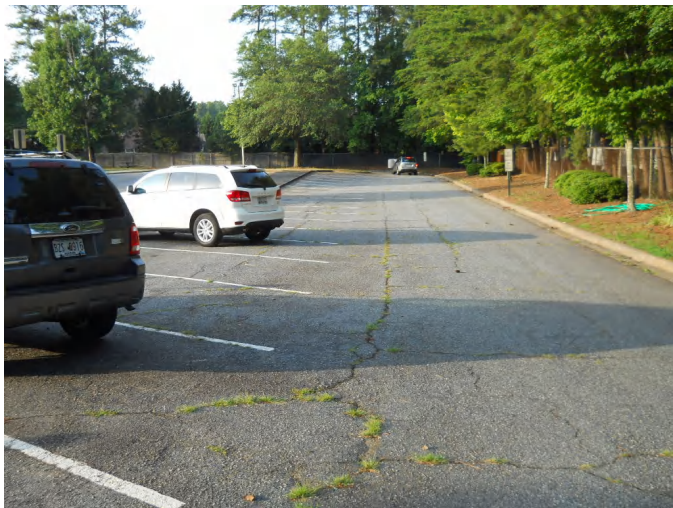
System: G2020 - Parking Lots

Location: Site

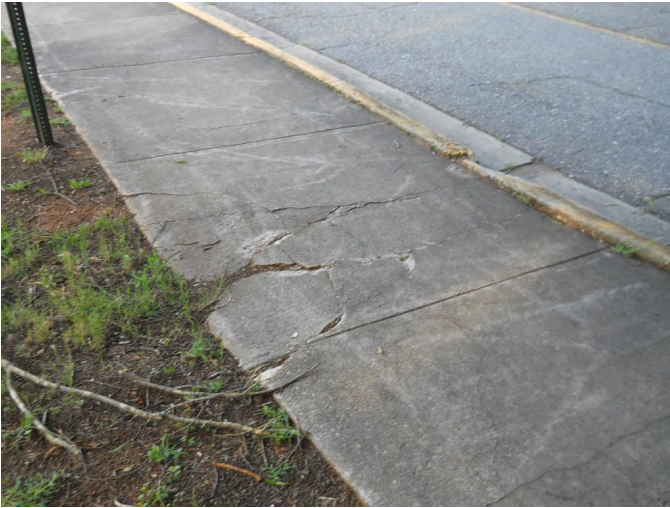
System: G2030 - Pedestrian Paving

Location: Site
Distress: Beyond Service Life
Category: Deferred Maintenance
Priority: 3 Priority
Correction: Renew System
Qty: 59,801.00
Unit of Measure: S.F.
Estimate: \$98,671.65
Assessor Name: Eduardo Lopez
Date Created: 07/07/2015

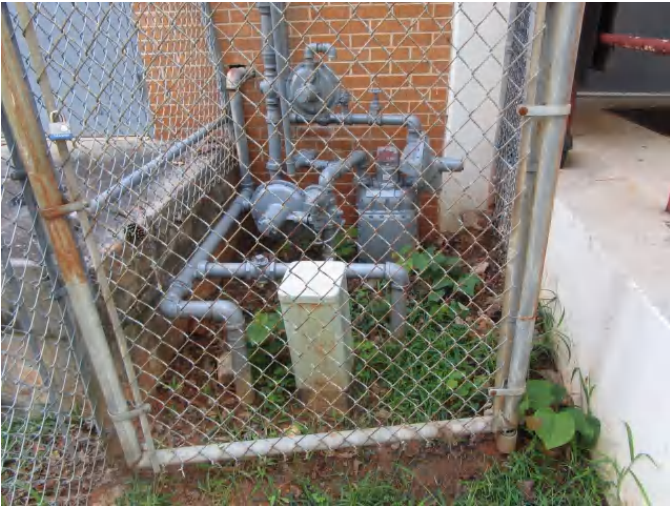
System: G3060 - Fuel Distribution

Location: Site
Distress: Beyond Service Life
Category: Deferred Maintenance
Priority: 3 Priority
Correction: Renew System
Qty: 59,801.00
Unit of Measure: S.F.
Estimate: \$51,309.26
Assessor Name: Eduardo Lopez
Date Created: 07/07/2015

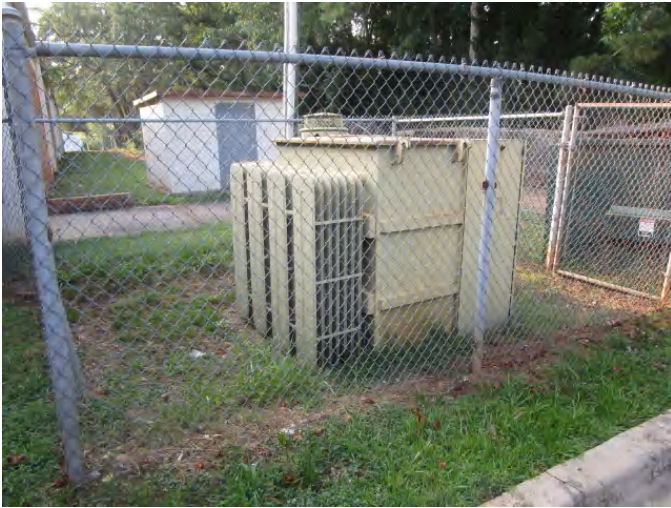
System: G4010 - Electrical Distribution

Location: Site

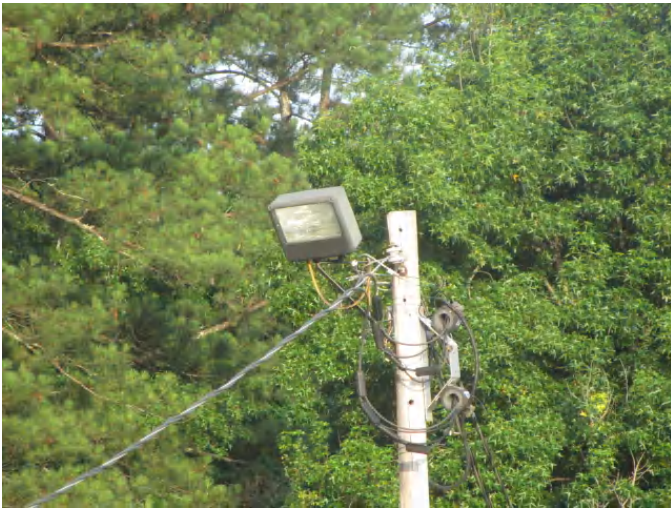
System: G4020 - Site Lighting

Location: Site

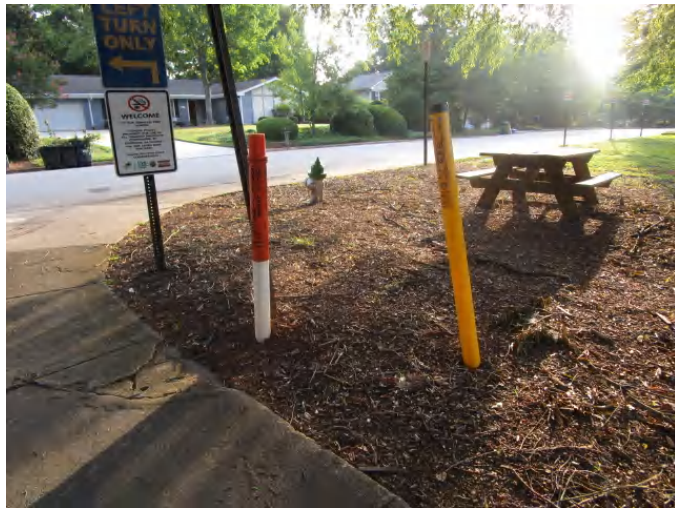
System: G4030 - Site Communications & Security

Location: Site
