# William Buck Godfrey Stadium

## School Assessment Report

May 20, 2016

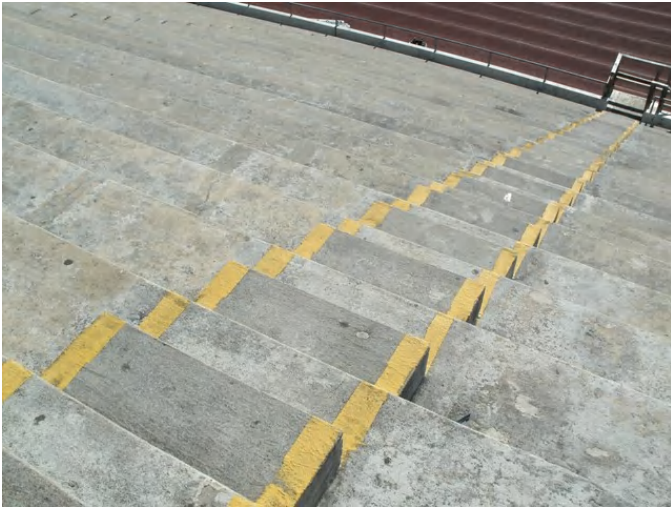
#### System: C2010 - Stair Construction

**Location:** Throughout Stadium

**Distress:** Beyond Service Life

**Notes:** The stadium steps, access ramps, and stairs do not have adequate railing, are damaged, and do not provide ADA accessibility to all areas.

**Correction:** Replace stadium stairs (\$2.08/sf)

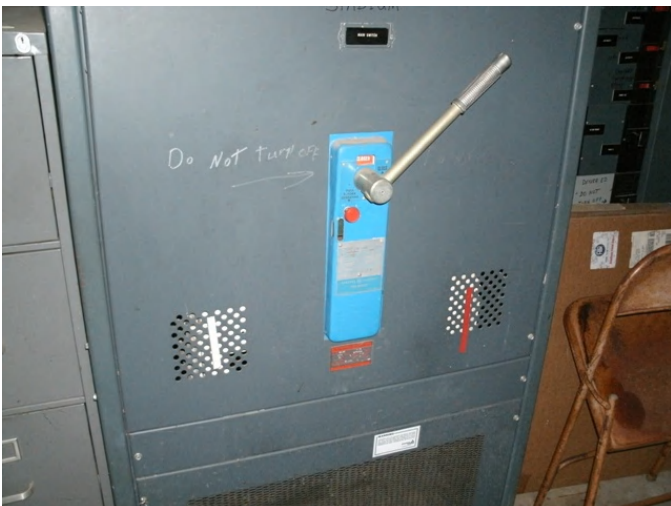
#### System: D5010 - Electrical Service/Distribution

**Location:** Throughout Stadium

**Distress:** Inadequate

**Notes:** The original electrical service and distribution system does not have proper clearance for maintenance, is beyond service life, and should be replaced and relocated to meet current code.

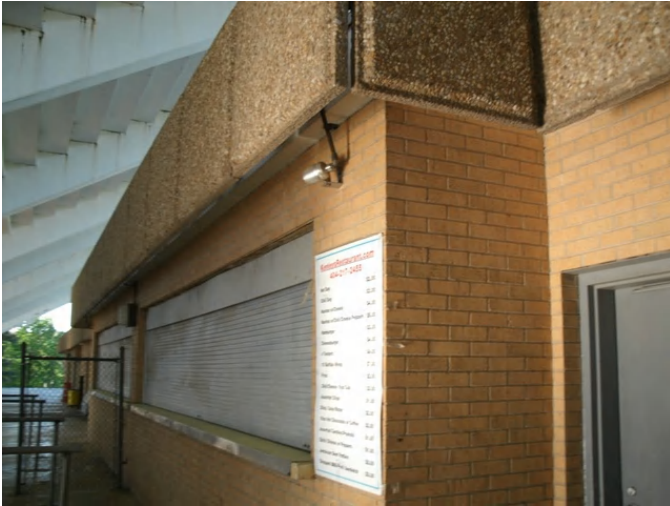
**System: B2020 - Exterior Windows**

**Location:** Concessions/Restroom Area

**Distress:** Beyond Service Life

**Notes:** The exterior windows are beyond service life and should be scheduled for replacement.

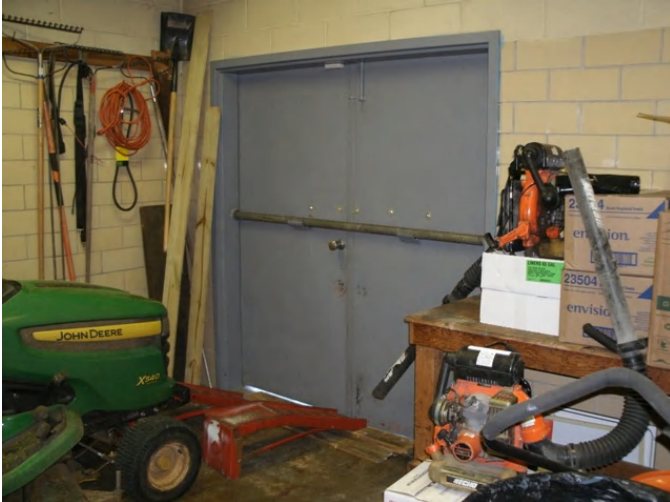
**System: B2030 - Exterior Doors**

**Location:** Throughout Stadium

**Distress:** Beyond Service Life

**Notes:** The exterior doors are beyond service life, not ADA compliant, and should be scheduled for replacement.

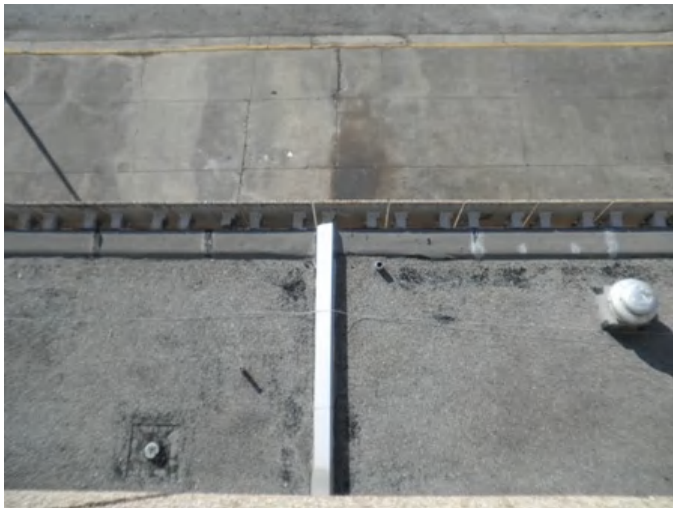
**System: B3010 - Roof Coverings - Built Up**

**Location:** Roof  
**Distress:** Beyond Service Life  
**Category:** Deferred Maintenance  
**Priority:** 3 Priority  
**Correction:** Renew System  
**Qty:** 13,675.00  
**Unit of Measure:** S.F.  
**Estimate:** \$252,564.00  
**Assessor Name:** Sam Mandola  
**Date Created:** 05/07/2015

**Notes:** The roof coverings are beyond service life and should be scheduled for replacement.

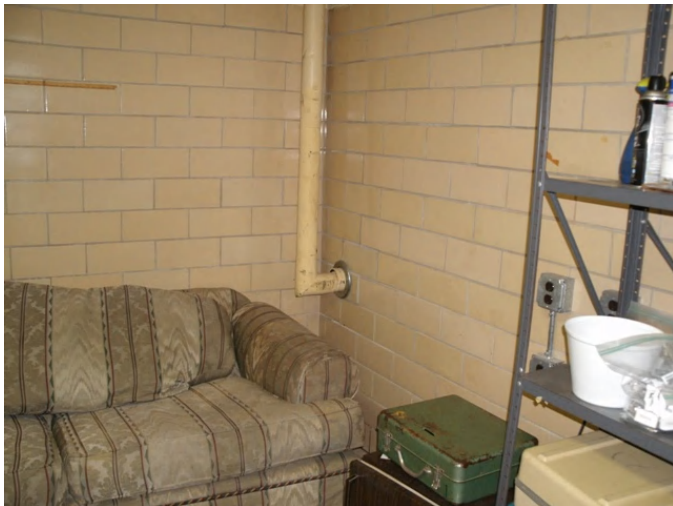
**System: C1010 - Partitions**

**Location:** Throughout Stadium  
**Distress:** Beyond Service Life  
**Category:** Deferred Maintenance  
**Priority:** 3 Priority  
**Correction:** Renew System  
**Qty:** 13,675.00  
**Unit of Measure:** S.F.  
**Estimate:** \$196,154.00  
**Assessor Name:** Sam Mandola  
**Date Created:** 05/15/2015

**Notes:** The original partitions are beyond service life and should be scheduled for replacement.

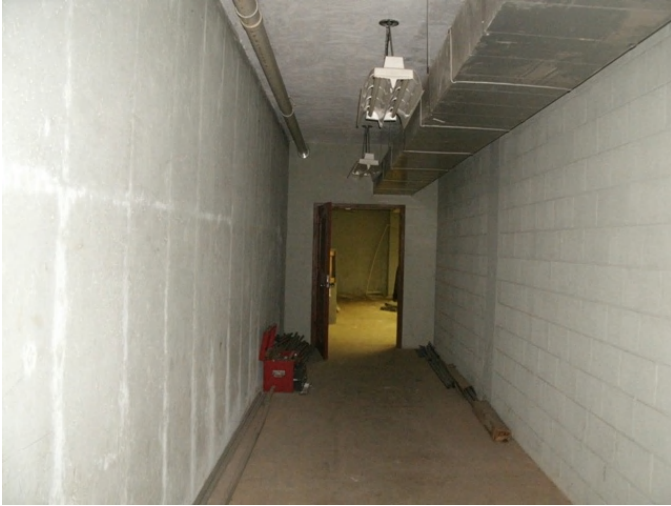
**System: C1020 - Interior Doors**

**Location:** Throughout Stadium

**Distress:** Beyond Service Life

**Notes:** The interior doors are beyond service life, not ADA compliant, and should be scheduled for replacement.

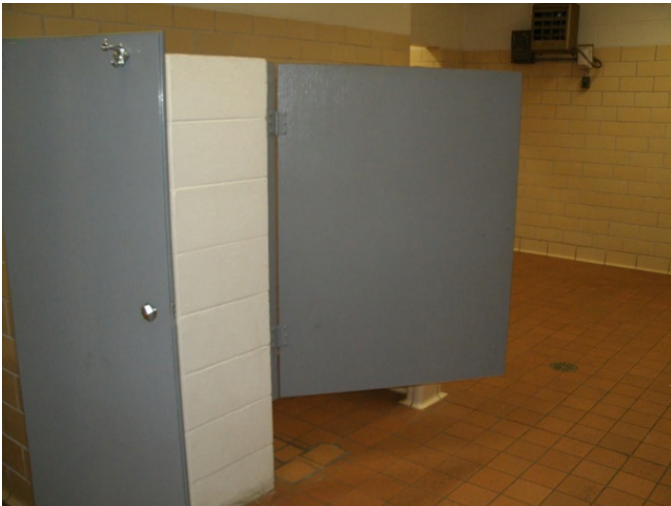
**System: C1030 - Fittings**

**Location:** Throughout Stadium

**Distress:** Beyond Service Life

**Notes:** The fittings, including toilet partitions, signage and handrails, are beyond service life, not ADA compliant, and should be scheduled for replacement.

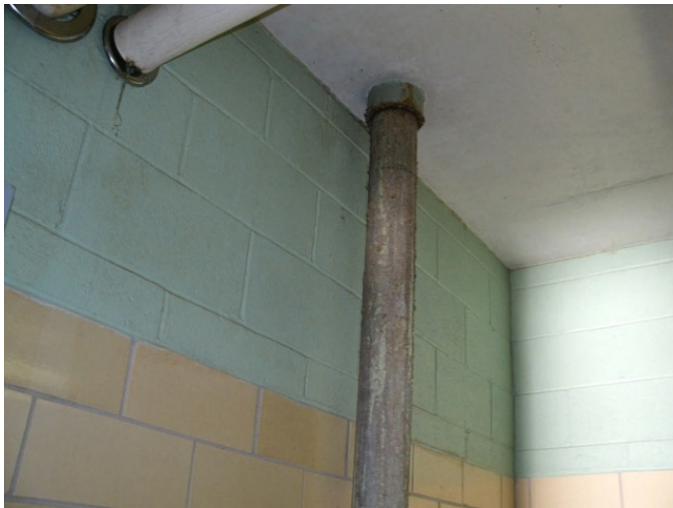
**System: C3010 - Wall Finishes**

**Notes:** The wall finishes need repainting.

**Location:** Throughout Stadium

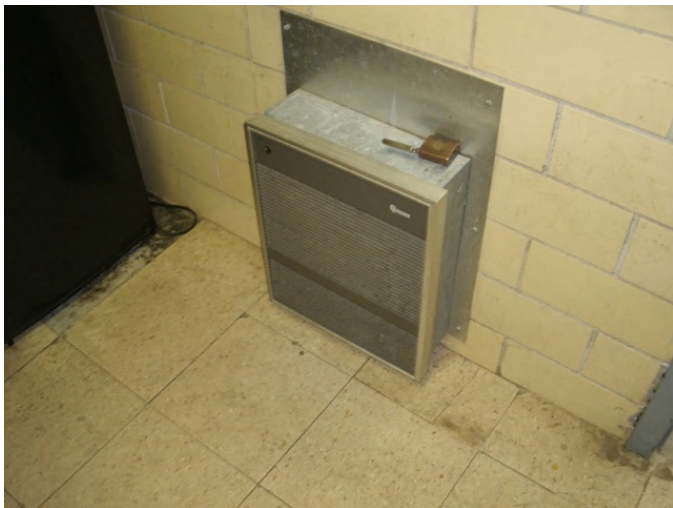
**System: C3020 - Floor Finishes - VCT**

**Notes:** The VCT flooring is aged and worn and should be scheduled for replacement.

**Location:** Concessions, Storage, Locker Rooms, Maintenance Office

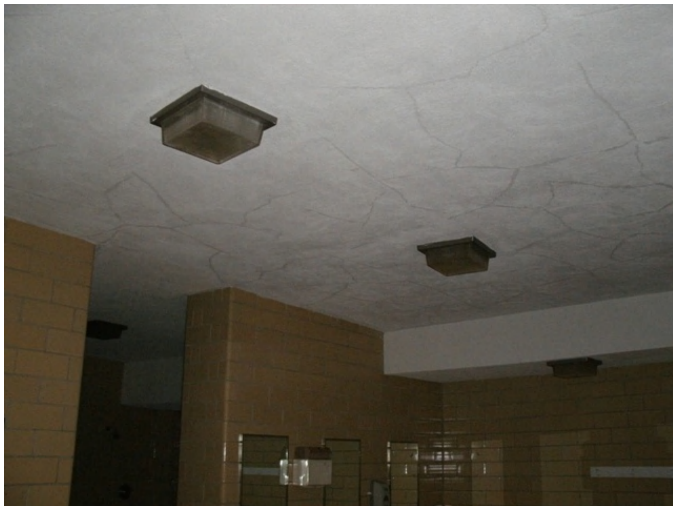
**System: C3030 - Ceiling Finishes**

**Location:** Concessions/Restroom Area

**Distress:** Damaged

**Notes:** The ceiling finishes are damaged and should be replaced.

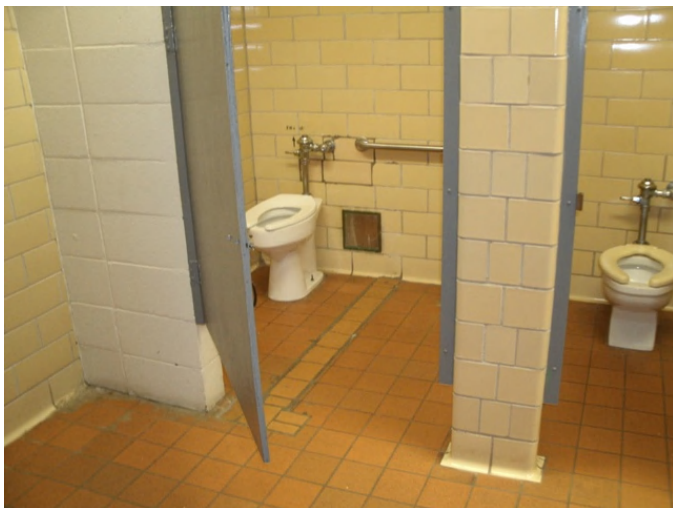
**System: D2010 - Plumbing Fixtures**

**Location:** Concessions/Restroom Area

**Distress:** Inadequate

**Notes:** The plumbing fixtures are beyond service life, not ADA compliant, and should be scheduled for replacement.

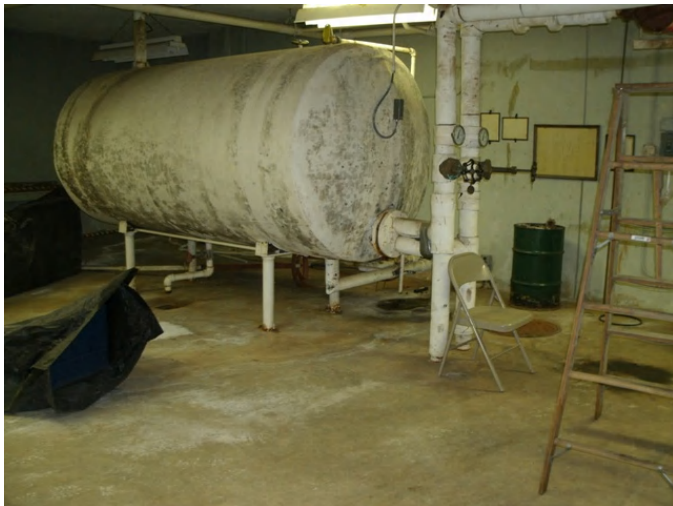
**System: D2020 - Domestic Water Distribution**

**Location:** Throughout Stadium

**Distress:** Beyond Service Life

**Notes:** The domestic water system is beyond service life and should be scheduled for replacement.

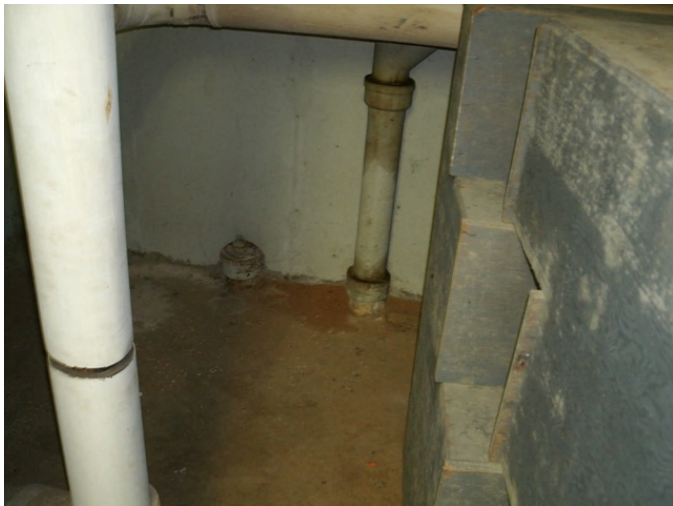
**System: D2030 - Sanitary Waste**

**Location:** Throughout Stadium

**Distress:** Beyond Service Life

**Notes:** The sanitary sewer system is beyond service life and should be scheduled for replacement.

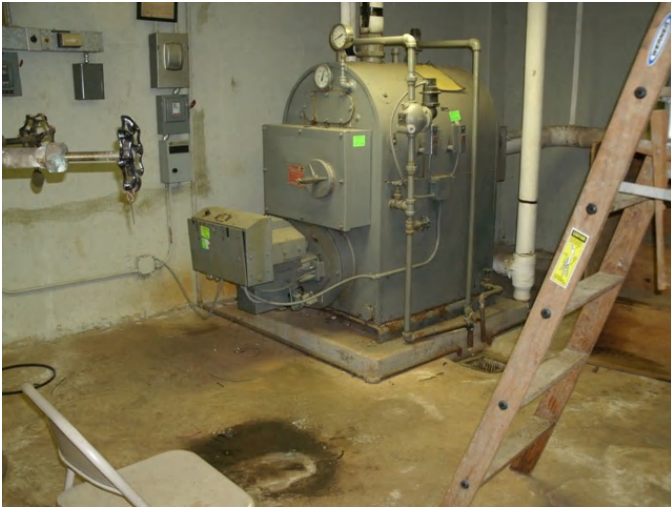
**System: D3020 - Heat Generating Systems**

**Location:** Mechanical Room

**Distress:** Beyond Service Life

**Notes:** The heating system, including gas fired boiler, pumps, piping, and valves are aged, rusted, inefficient, and becoming logistically unsupportable, and should be replaced with energy efficient equipment.

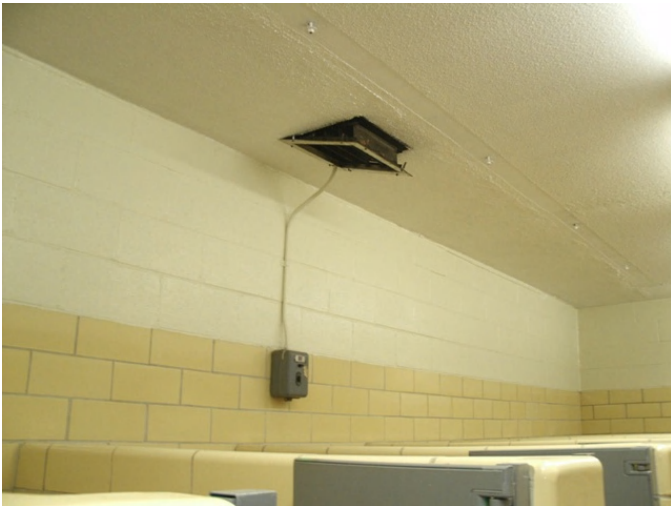
**System: D3040 - Distribution Systems**

**Location:** Concessions/Restroom Area

**Distress:** Beyond Service Life

**Notes:** The exhaust fans and duct systems are beyond service life, failing in some locations, and should be replaced.

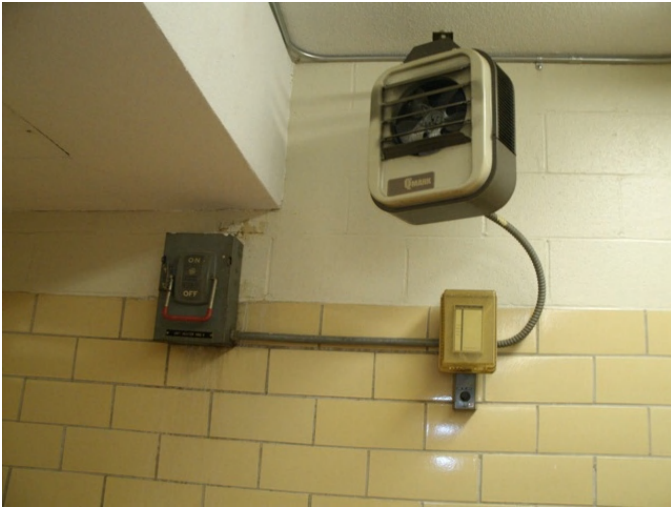
**System: D3050 - Controls & Instrumentation**

**Location:** Throughout Building

**Distress:** Beyond Service Life

**Notes:** The controls and instrumentation system is outdated and inadequate and should be scheduled for replacement.

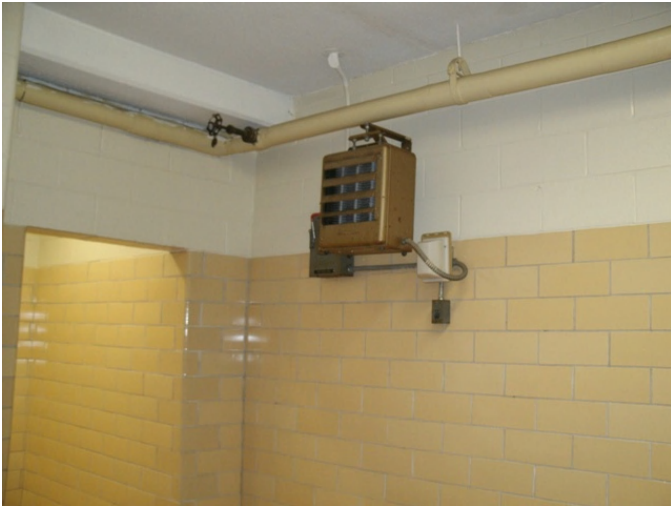
**System: D3050 - Terminal & Package Units**

**Location:** Throughout Stadium

**Distress:** Beyond Service Life

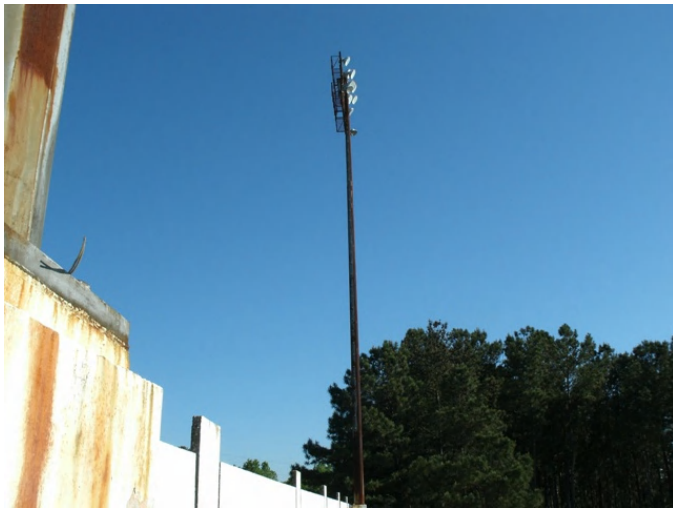
**System: D5020 - Lighting and Branch Wiring**

**Location:** Throughout Stadium

**Distress:** Beyond Service Life

**Notes:** The lighting and branch wiring system is beyond service life and should be scheduled for replacement.

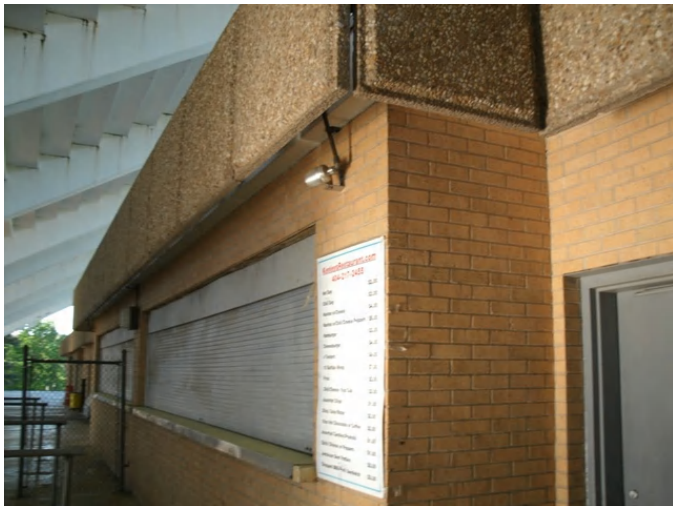
**System: D5030 - Communications and Security - Fire Alarm**

**Location:** Throughout Building

**Distress:** Missing

**Notes:** The fire alarm system is missing and should be installed.

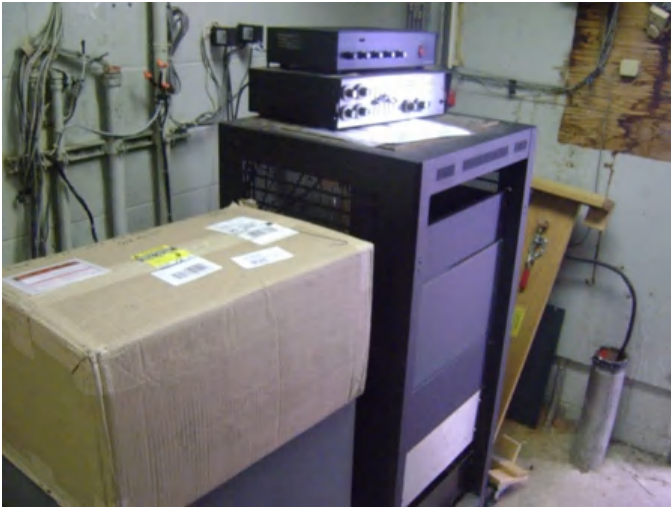
**System: D5030 - Communications and Security - PA & Clock Systems**

**Location:** Throughout Building  
**Distress:** Beyond Service Life  
**Category:** Deferred Maintenance  
**Priority:** 3 Priority  
**Correction:** Renew System  
**Qty:** 13,675.00  
**Unit of Measure:** S.F.  
**Estimate:** \$62,878.00  
**Assessor Name:** Sam Mandola  
**Date Created:** 08/20/2015

**Notes:** The PA and clock system is beyond its expected service life and should be scheduled for replacement.

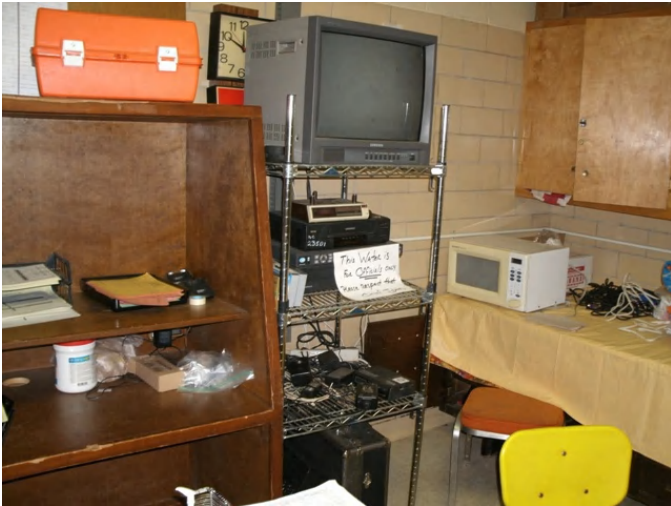
**System: D5030 - Communications and Security - Telephone & Data**

**Location:** Throughout Building  
**Distress:** Beyond Service Life  
**Category:** Deferred Maintenance  
**Priority:** 3 Priority  
**Correction:** Renew System  
**Qty:** 13,675.00  
**Unit of Measure:** S.F.  
**Estimate:** \$29,935.00  
**Assessor Name:** Sam Mandola  
**Date Created:** 08/20/2015

**Notes:** The telephone and data system is beyond its expected service life and should be scheduled for replacement.

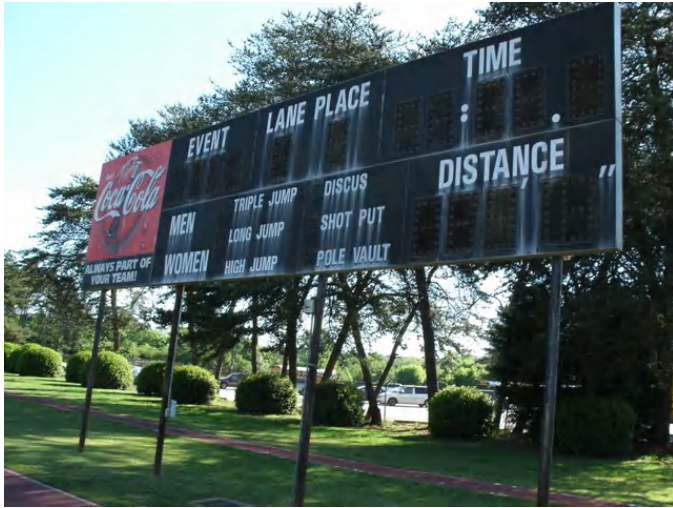
**System: E1090 - Other Equipment - Track Score Board**

**Location:** Stadium

**Distress:** Beyond Service Life

**Notes:** The score board for the track is aged, worn, and weathered, and should be replaced.

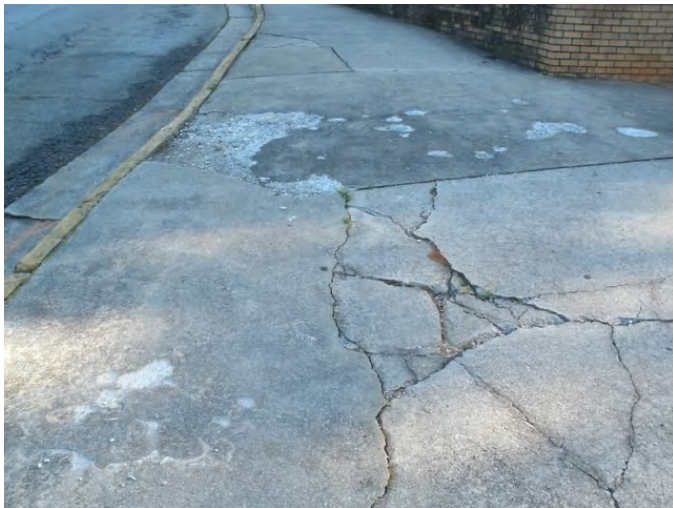
#### **System: G2030 - Pedestrian Paving**

**Location:** Site

**Distress:** Damaged

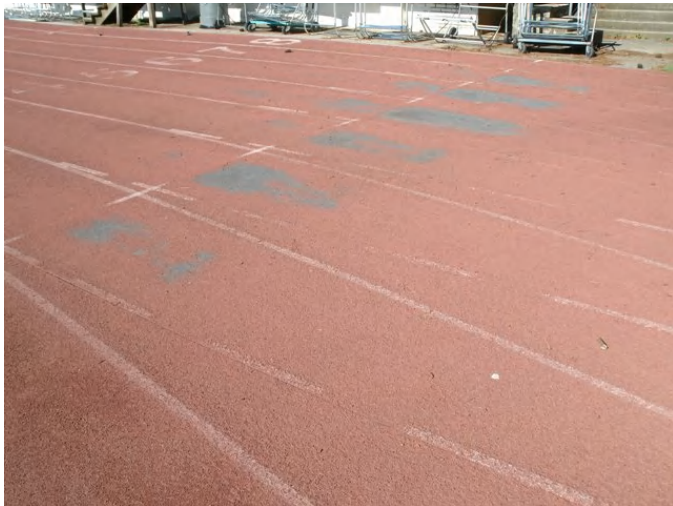
#### **System: G2040 - Track**

**Location:** Site

**Distress:** Damaged

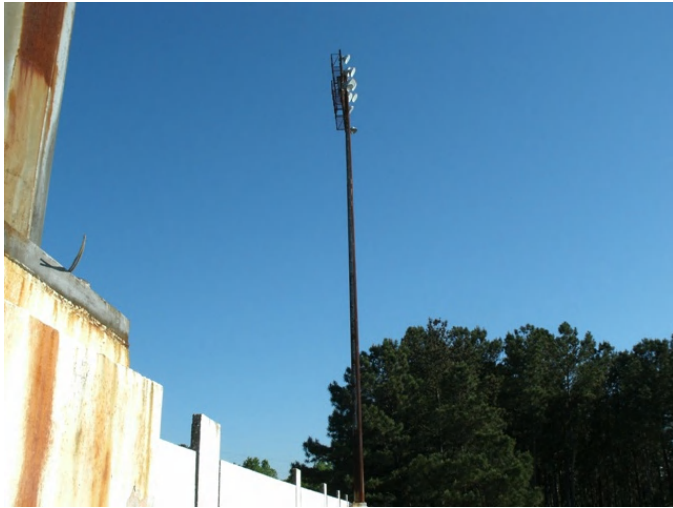
**System: G4020 - Site Lighting**

**Location:** Throughout Site and Stadium

**Distress:** Damaged

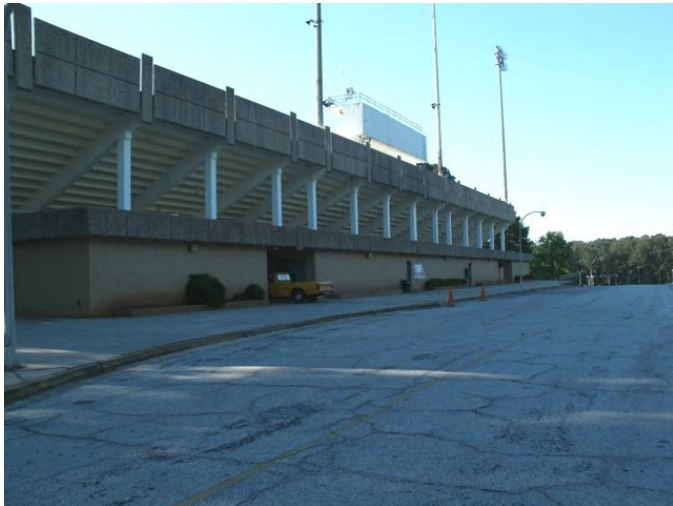
**System: G2010 - Roadways**

**Location:** Site

**Distress:** Damaged

**Notes:** The roadways are damaged and should be replaced.

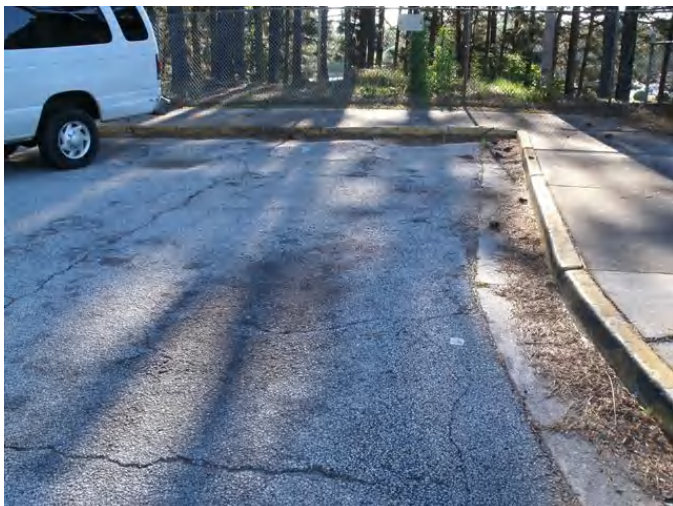
**System: G2020 - Parking Lots**

**Location:** Site

**Distress:** Damaged

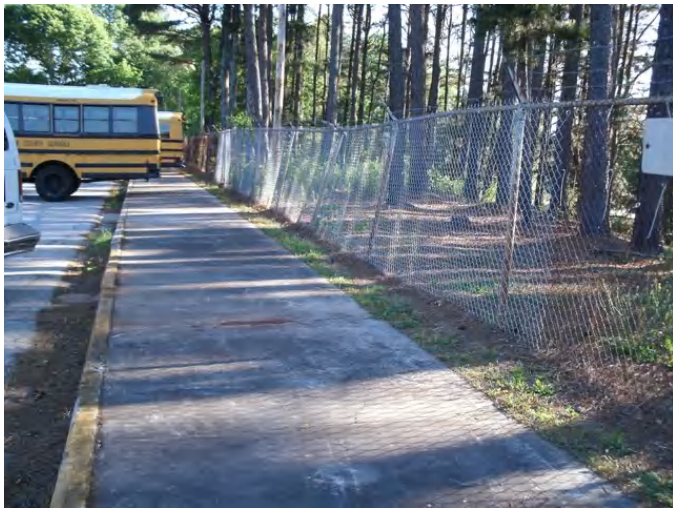
**System: G2040 - Fencing & Guardrails**

**Location:** Site  
**Distress:** Damaged  
**Category:** Deferred Maintenance  
**Priority:** 3 Priority  
**Correction:** Renew System  
**Qty:** 47,624.00  
**Unit of Measure:** S.F.  
**Estimate:** \$47,671.62  
**Assessor Name:** Eduardo Lopez  
**Date Created:** 05/07/2015

**Notes:** The fencing is beyond service life and damaged and should be replaced.

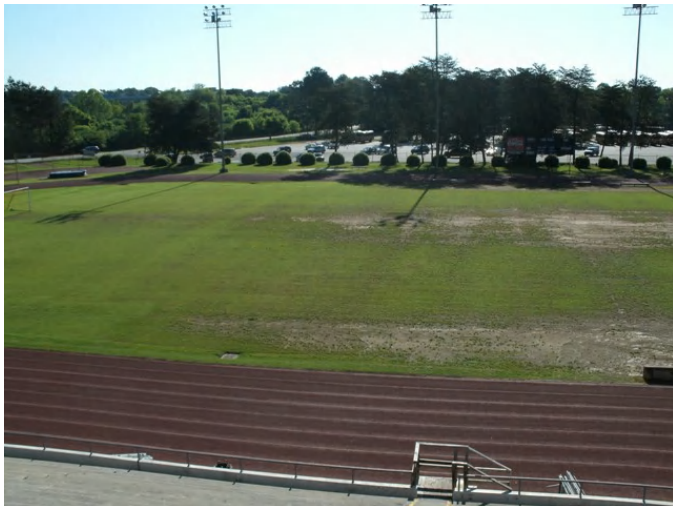
**System: G2040 - Football Field**

**Location:** Site  
**Distress:** Damaged  
**Category:** Deferred Maintenance  
**Priority:** 3 Priority  
**Correction:** Renew System  
**Qty:** 102,838.00  
**Unit of Measure:** S.F.  
**Estimate:** \$661,762.53  
**Assessor Name:** Eduardo Lopez  
**Date Created:** 05/07/2015

**Notes:** The football field is worn and damaged and should be replaced.

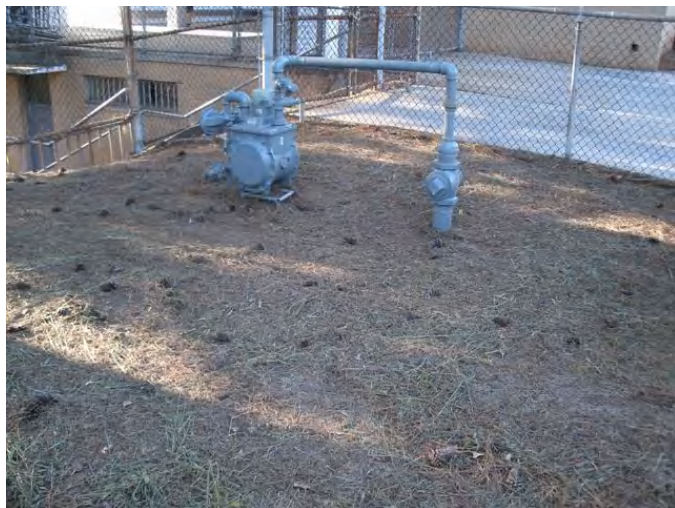
**System: G3060 - Fuel Distribution**

**Location:** Site

**Distress:** Beyond Service Life
