DeKalb County School District/Elementary Schools

Wynbrooke Elementary

School Assessment Report

May 20, 2016

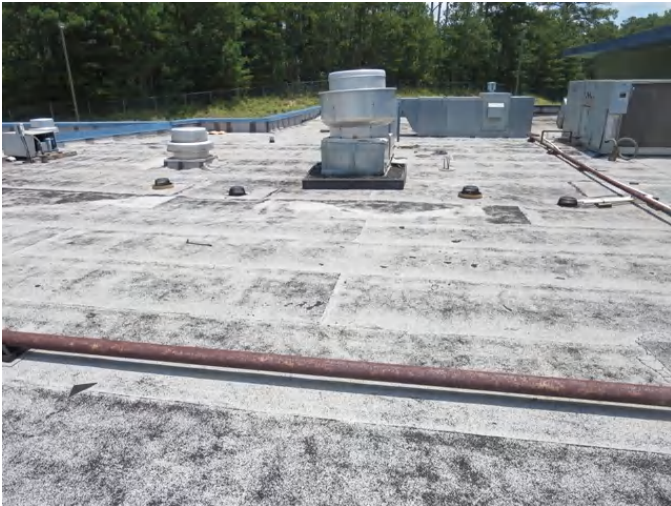
System: B3010 - Roof Coverings - BUR

Location: Roof

Distress: Needs Remediation

Notes: The built-up roof covering is aged, showing signs of failure, damaging interiors, and should be replaced.

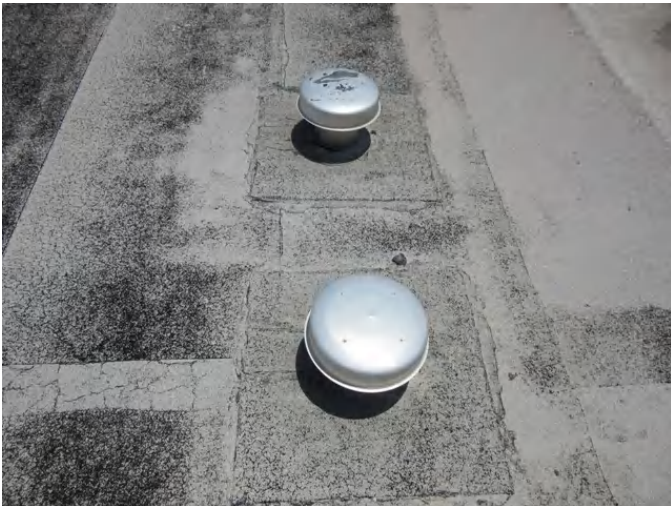
System: D3040 - Distribution & Exhaust Systems

Location: Restrooms

Distress: Damaged

Notes: Restroom exhaust fans do not function as intended and should be scheduled for maintenance or replacement.

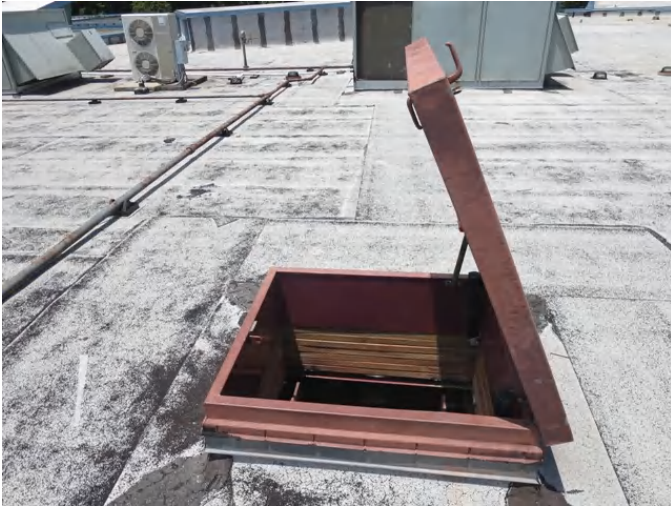
System: B3020 - Roof Openings

Location: Roof

Distress: Inadequate

Notes: The roof opening does not meet OSHA guidelines for access and egress and should be replaced.

Correction: Replace roof hatch and structure single unit

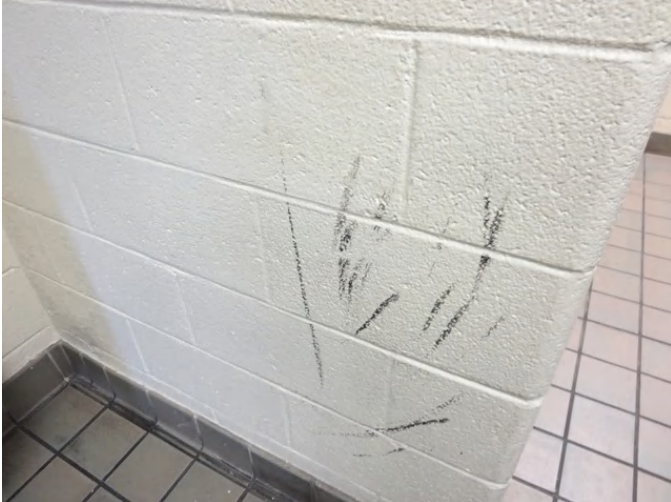
System: C3010 - Wall Finishes - Paint

Location: Throughout Building

Distress: Beyond Service Life

Notes: The painted wall finishes are beyond their expected service life, scuffed and stained, and should be replaced.

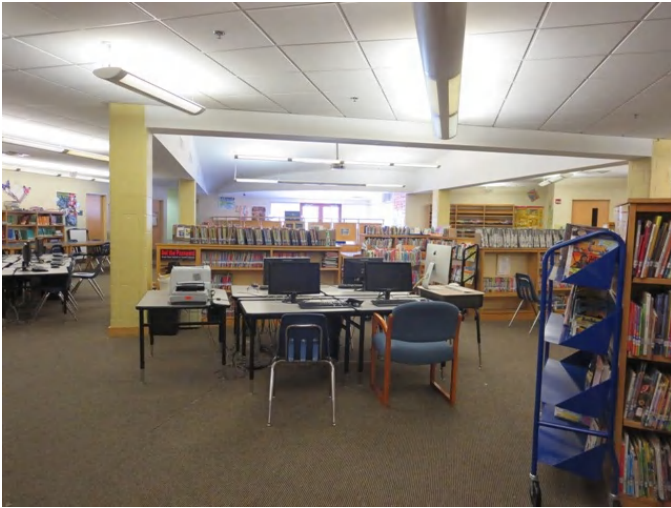
System: C3020 - Floor Finishes - Carpet

Location: Media Center, Offices

Distress: Beyond Service Life

Notes: The carpet in the media center and offices is stained, showing signs of failure, and should be replaced.

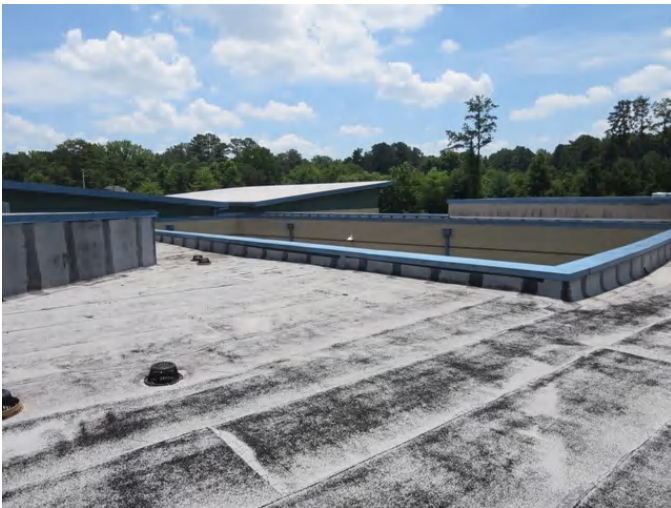
System: D2040 - Rain Water Drainage

Location: Throughout Building

Distress: Needs Remediation

Notes: The roof water collection system is reported as inadequate; the drains fill and water leaks down classroom walls.

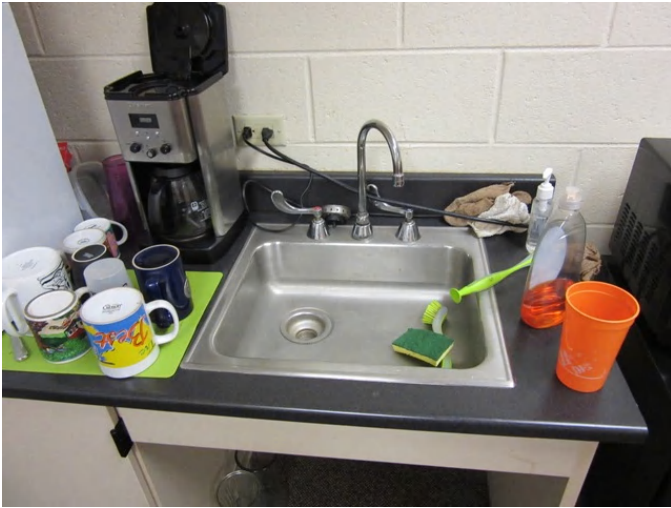
System: D5020 - Branch Wiring

Location: Wet Area

Distress: Inadequate

Notes: Replace receptacles with GFCI in wet area.

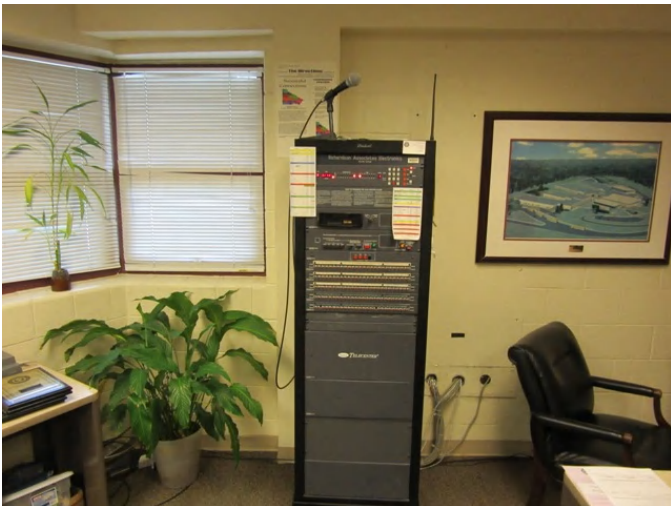
System: D5030 - Communications and Security - Clock & PA Systems

Location: Throughout Building

Distress: Inadequate

Notes: Clock and PA systems are beyond their expected service life and should be scheduled for replacement. The public address system does not cover the entire facility, e.g., in some offices.

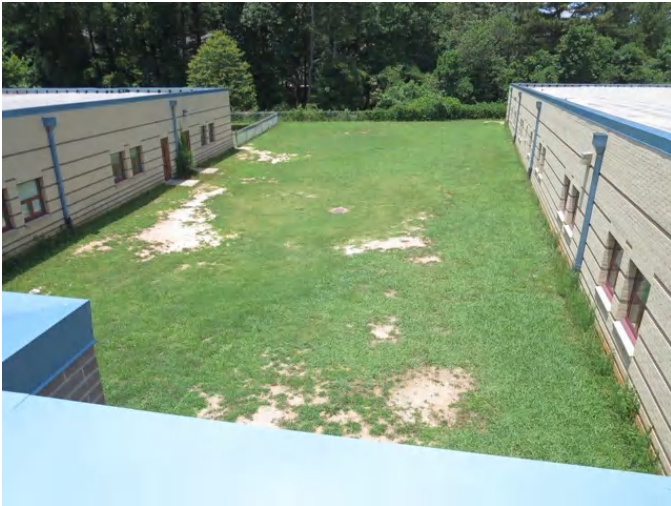
System: G2050 - Landscaping

Location: North and West Side of Site

Distress: Beyond Service Life

Notes: Landscaping is beyond its expected service life, damaged, and should be replaced.

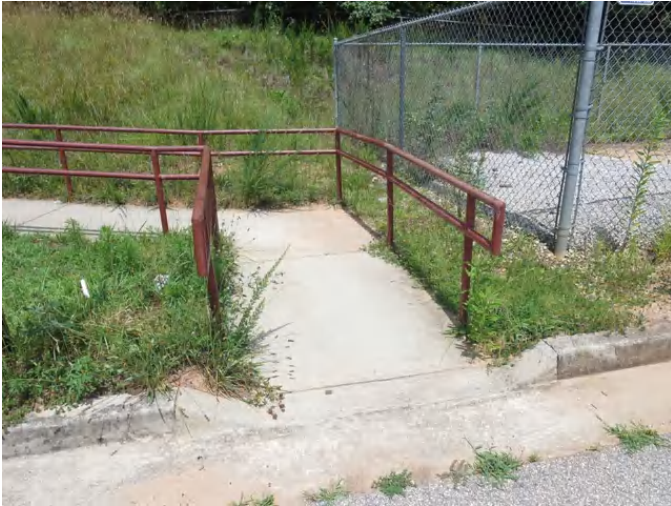
System: G2030 - Pedestrian Paving

Location: Main Entrance

Distress: Needs Remediation

Correction: Remove and replace concrete curb or berm
