Facility Condition Assessment Report

Austin Elementary Facility Executive Summary ReportReport Date: 30 Jun 2011

Facility: \Elementary Schools\Austin Elementary
Address: 5435 Roberts Drive, Dunwoody, GA 30338**Attributes:****Facility Code** 0175
Super Cluster 1**General Information:****Function:** Elementary School
Gross Area: 60,581 S.F.
Year Built:
Last Renovation:**Facility Description:**

Austin Elementary Facility Executive Summary Report

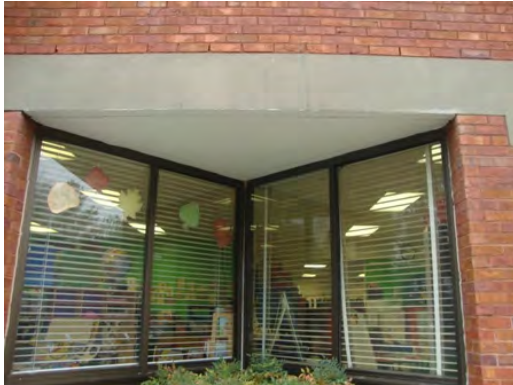
Assembly: **B2020**
System: **Exterior Windows**
Material: **System**
Distress: **Beyond Service Life**
Category: **Deferred Maintenance**
Correction: **Renew System**
Note: **The original metal frame, single pane, operable windows are aged, worn, and inefficient and should be replaced.**

Raw Cost	\$277,608.91
Plus or (Minus) Additional Cost	\$105,491.39
Total Estimated Amount	\$383,100.30

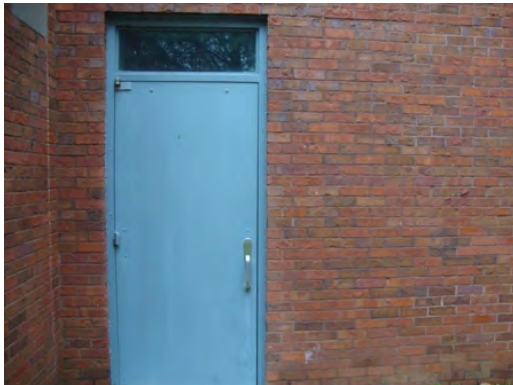
Assembly: **B2030**
System: **Exterior Doors**
Material: **System**
Distress: **Beyond Service Life**
Category: **Deferred Maintenance**
Correction: **Renew System**
Note: **The original metal exterior doors are aged, rusted, and damaged, and should be replaced.**

Raw Cost	\$38,186.38
Plus or (Minus) Additional Cost	\$14,510.82
Total Estimated Amount	\$52,697.20

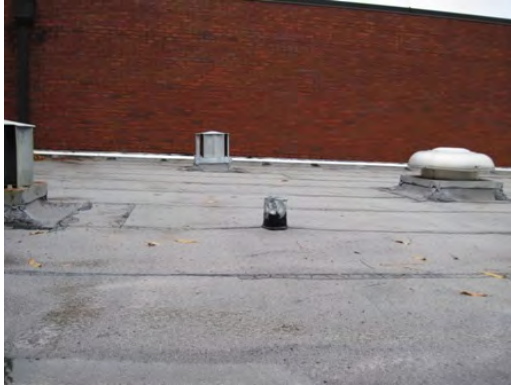
Assembly: **B3010**
System: **Roof Coverings - BUR System**
Material: **System**
Distress: **Needs Remediation**
Category: **Deferred Maintenance**
Correction: **Renew System**

Note: **The roof covering is aged, has reported leaks, and should be replaced.**

Raw Cost	\$243,665.47
Plus or (Minus) Additional Cost	\$92,592.88
Total Estimated Amount	\$336,258.35

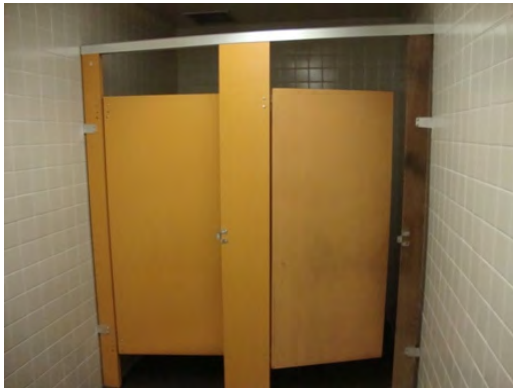
Assembly: **C1030**
System: **Fittings**
Material: **System**
Distress: **Beyond Service Life**
Category: **Deferred Maintenance**
Correction: **Renew System**
Note: **Fittings, such as chalk and tack boards, toilet and bath accessories, toilet partitions, and shelving, are aged, worn, and damaged, and should be replaced.**

Raw Cost	\$112,134.61
Plus or (Minus) Additional Cost	\$42,611.15
Total Estimated Amount	\$154,745.76

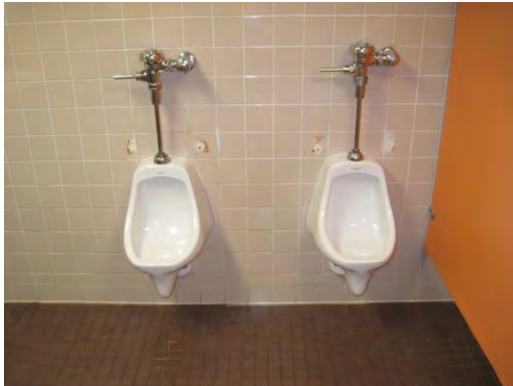
Assembly: **C3010**
System: **Wall Finishes - Ceramic & Glazed**
Material: **System**
Distress: **Damaged**
Category: **Deferred Maintenance**
Correction: **Renew System**
Note: **The original ceramic tile walls are aged, chipped, and damaged, and should be replaced.**

Raw Cost	\$38,956.30
Plus or (Minus) Additional Cost	\$14,803.39
Total Estimated Amount	\$53,759.69

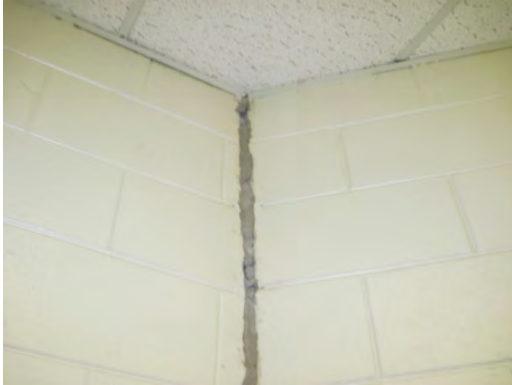
Note: **The wall paint is aged and the walls should be repainted.**

Raw Cost	\$57,640.00
Plus or (Minus) Additional Cost	\$21,903.20
Total Estimated Amount	\$79,543.20

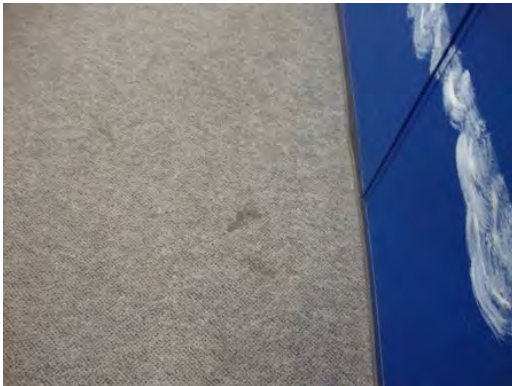
Assembly: **C3020**
System: **Floor Finishes - Carpet**
Material: **System**
Distress: **Beyond Service Life**
Category: **Deferred Maintenance**
Correction: **Renew System**
Note: **The carpet is aged, worn, stained, and faded, and should be replaced.**

Raw Cost	\$94,677.00
Plus or (Minus) Additional Cost	\$35,977.26
Total Estimated Amount	\$130,654.26

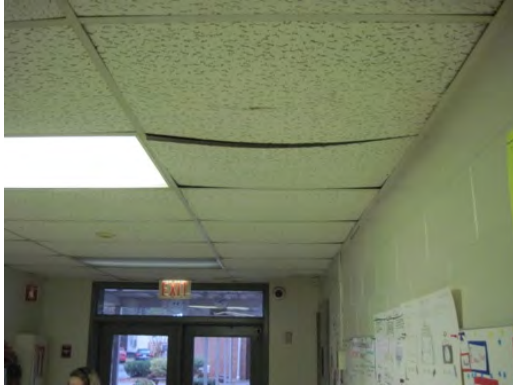
Assembly: **C3030**
System: **Ceiling Finishes System**
Material: **Needs Remediation**
Distress: **Needs Remediation**
Category: **Deferred Maintenance**
Correction: **Renew System**
Note: **The ceiling tile and grid system is stained and warped and should be replaced.**

Raw Cost	\$394,592.58
Plus or (Minus) Additional Cost	\$149,945.18
Total Estimated Amount	\$544,537.76

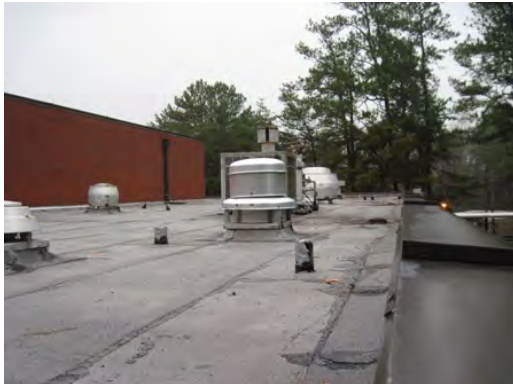
Assembly: **D2040**
System: **Rain Water Drainage System**
Material: **System**
Distress: **Beyond Service Life**
Category: **Deferred Maintenance**
Correction: **Renew System**
Note: **The rain water drainage system is operating properly with no reported stoppages, but is aged and should be replaced with the roof covering.**

Raw Cost	\$38,792.51
Plus or (Minus) Additional Cost	\$14,741.15
Total Estimated Amount	\$53,533.66

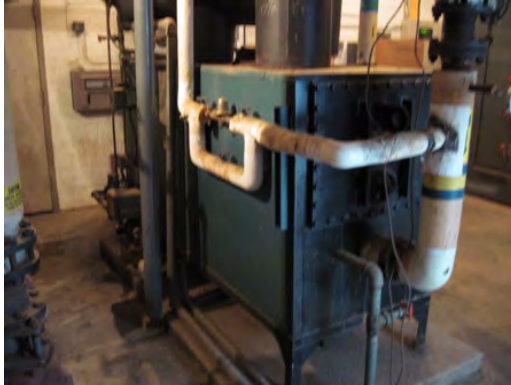
Note: **The existing boiler is operable, but aged and should be replaced.**

Raw Cost	\$182,446.03
Plus or (Minus) Additional Cost	\$69,329.49
Total Estimated Amount	\$251,775.52

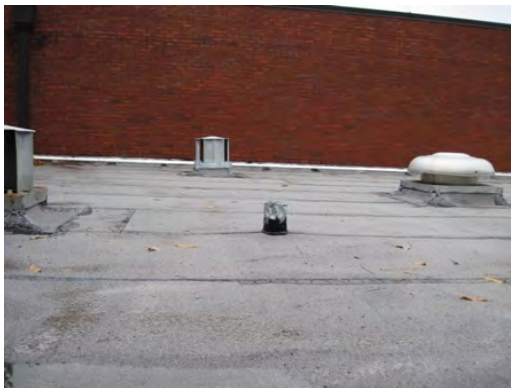
Note: **The exhaust system is original, reported to have odors in all restrooms, and should be replaced.**

Raw Cost	\$204,872.95
Plus or (Minus) Additional Cost	\$77,851.72
Total Estimated Amount	\$282,724.67

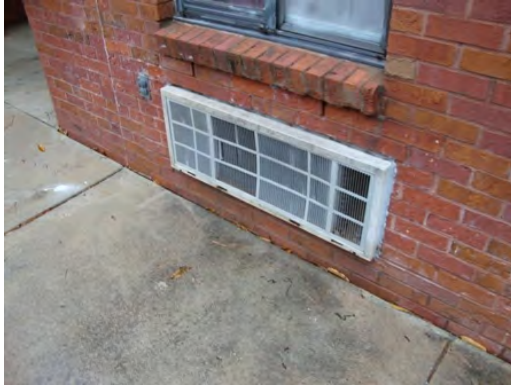
Note: **The wall mounted heat pumps are aged and worn and should be replaced.**

Raw Cost	\$759,484.65
Plus or (Minus) Additional Cost	\$288,604.17
Total Estimated Amount	\$1,048,088.82

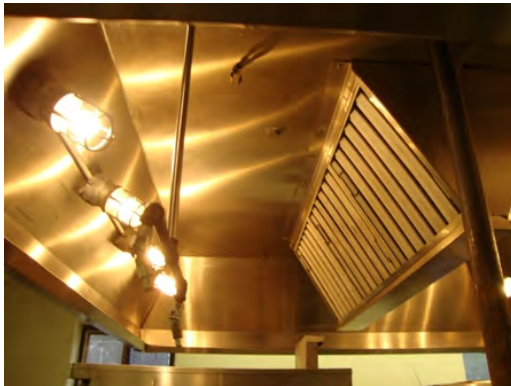
Note: **The existing kitchen hood and exhaust system is operable, but is aged and should be replaced.**

Raw Cost	\$51,521.31
Plus or (Minus) Additional Cost	\$19,578.10
Total Estimated Amount	\$71,099.41

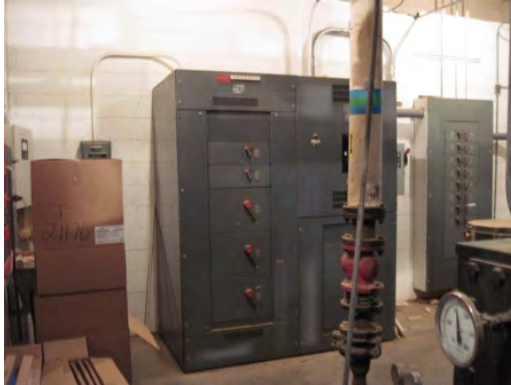
Note: **The original electrical distribution system is operable, but is aged and should be replaced.**

Raw Cost	\$85,464.75
Plus or (Minus) Additional Cost	\$32,476.61
Total Estimated Amount	\$117,941.36

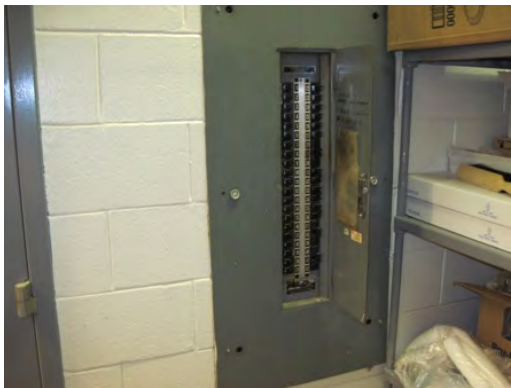
Note: **The branch wiring is original and operable, but is aged and should be replaced.**

Raw Cost	\$286,700.91
Plus or (Minus) Additional Cost	\$108,946.35
Total Estimated Amount	\$395,647.26

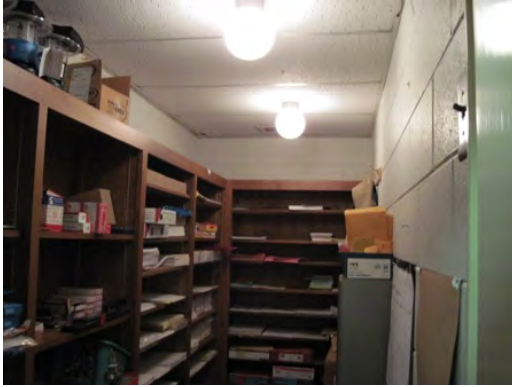
Note: **The lighting system has received a partial upgrade to T-8 model fixtures, but the remaining 50% of the system is original, aged, and should be replaced.**

Raw Cost	\$171,370.33
Plus or (Minus) Additional Cost	\$65,120.73
Total Estimated Amount	\$236,491.06

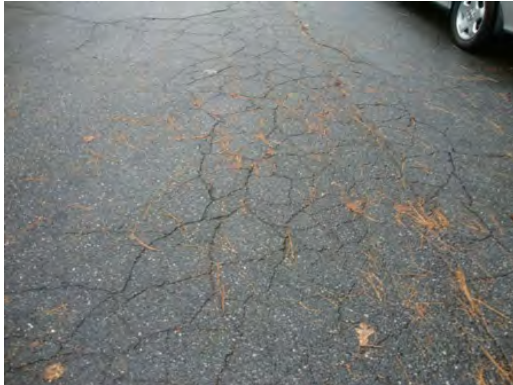
Assembly: **G2010**
System: **Roadways**
Material: **System**
Distress: **Beyond Service Life**
Category: **Deferred Maintenance**
Correction: **Renew System**
Note: **The asphaltic roadways are aged, have many road cuts and repairs, and should be resurfaced.**

Raw Cost	\$171,928.88
Plus or (Minus) Additional Cost	\$44,701.51
Total Estimated Amount	\$216,630.39

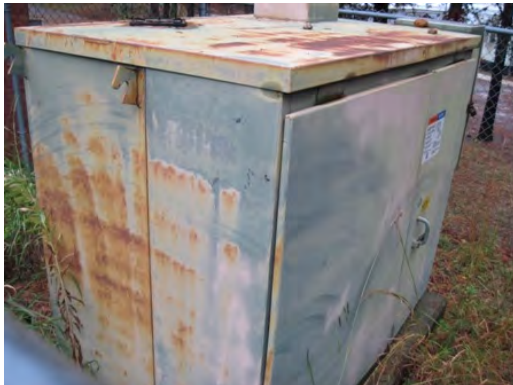
Assembly: **G4010**
System: **Electrical Distribution**
Material: **System**
Distress: **Beyond Service Life**
Category: **Deferred Maintenance**
Correction: **Renew System**
Note: **The original site electrical distribution system is operable, but is aged and should be replaced.**

Raw Cost	\$27,322.03
Plus or (Minus) Additional Cost	\$7,103.73
Total Estimated Amount	\$34,425.76

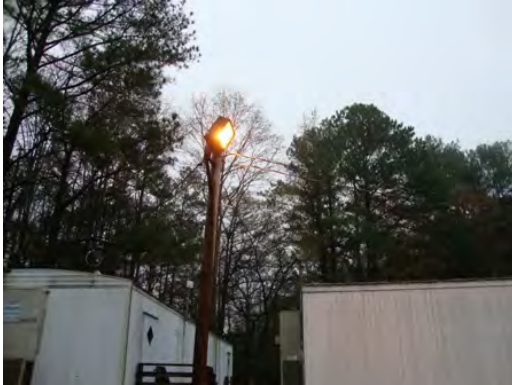
Assembly: **G4020**
System: **Site Lighting**
Material: **System**
Distress: **Inadequate**
Category: **Deferred Maintenance**
Correction: **Renew System**
Note: **Site lighting is inadequate and should be replaced.**

Raw Cost	\$36,651.51
Plus or (Minus) Additional Cost	\$9,529.39
Total Estimated Amount	\$46,180.90
