Facility Condition Assessment Report

COMET4 Facility Report

Cedar Grove Elementary Facility Executive Summary ReportReport Date: 28 Jun 2011

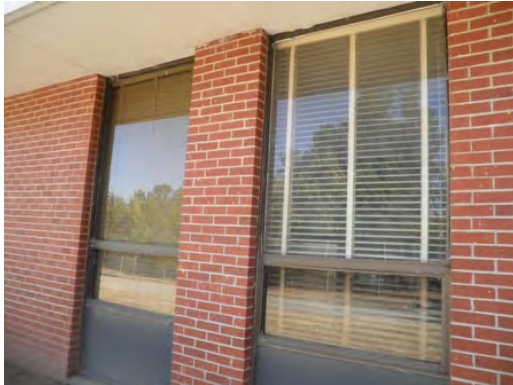
Assembly: **B2020**
System: **Exterior Windows**
Material: **System**
Distress: **Beyond Service Life**
Category: **Deferred Maintenance**
Correction: **Renew System**
Note: **The original metal frame, single pane windows are aged, worn, and inefficient, and should be replaced.**

Raw Cost	\$266,711.72
Plus or (Minus) Additional Cost	\$101,350.45
Total Estimated Amount	\$368,062.17

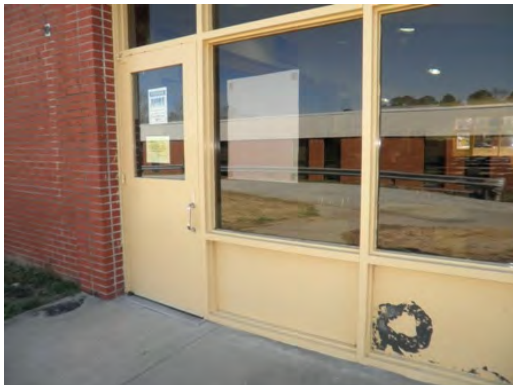
Assembly: **B2030**
System: **Exterior Doors**
Material: **System**
Distress: **Beyond Service Life**
Category: **Deferred Maintenance**
Correction: **Renew System**
Note: **The original metal exterior doors are aged, rusted, and damaged, and should be replaced with energy efficient doors.**

Raw Cost	\$36,687.42
Plus or (Minus) Additional Cost	\$13,941.22
Total Estimated Amount	\$50,628.64

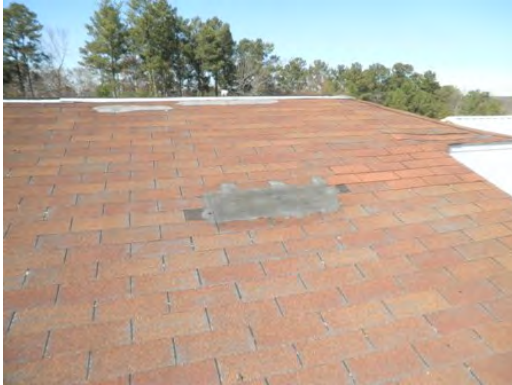
Note: **The asphalt shingles are aged, worn, and patched, and should be replaced.**

Raw Cost	\$78,033.56
Plus or (Minus) Additional Cost	\$29,652.75
Total Estimated Amount	\$107,686.31

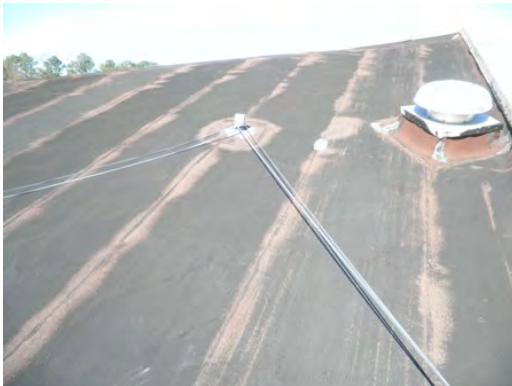
Note: **The built-up roofing is aged, has reported leaks, and should be replaced.**

Raw Cost	\$117,050.34
Plus or (Minus) Additional Cost	\$44,479.13
Total Estimated Amount	\$161,529.47

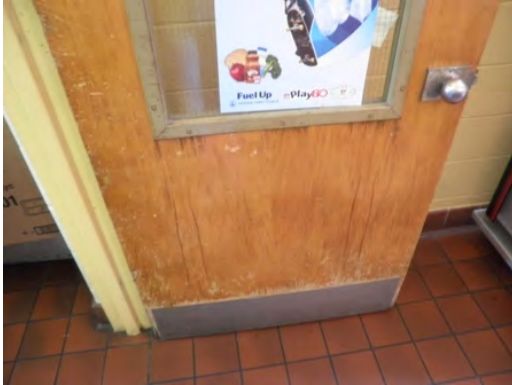
Note: **The original wood interior doors are aged and worn and should be replaced.**

Raw Cost	\$63,951.52
Plus or (Minus) Additional Cost	\$24,301.58
Total Estimated Amount	\$88,253.10

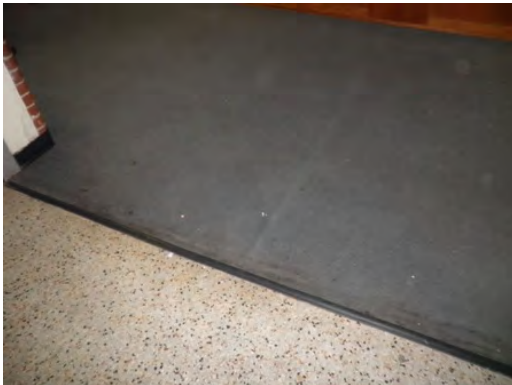
Note: **Although the carpet in the media center has been recently replaced, the carpet throughout the offices and halls is aged and stained and should be replaced.**

Raw Cost	\$33,193.38
Plus or (Minus) Additional Cost	\$12,613.48
Total Estimated Amount	\$45,806.86

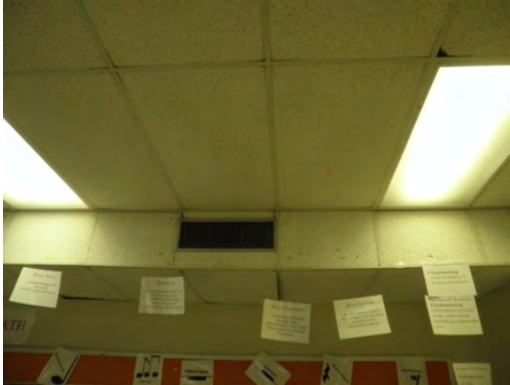
Assembly: **C3030**
 System: **Ceiling Finishes**
 Material: **System**
 Distress: **Beyond Service Life**
 Category: **Deferred Maintenance**
 Correction: **Renew System**
 Note: **The acoustical ceiling tile and grid system is aged and stained and should be replaced.**

Raw Cost	\$379,103.34
Plus or (Minus) Additional Cost	\$144,059.27
Total Estimated Amount	\$523,162.61

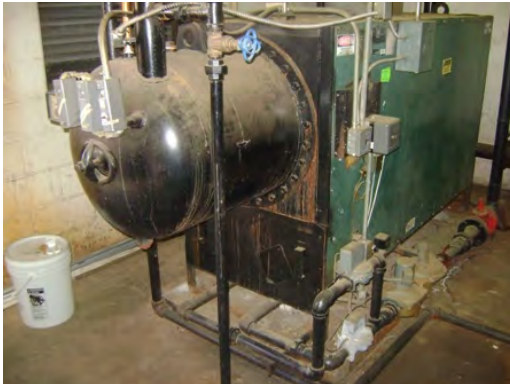
Assembly: **D3020**
 System: **Heat Generating Systems**
 Material: **System**
 Distress: **Beyond Service Life**
 Category: **Deferred Maintenance**
 Correction: **Renew System**
 Note: **The heating system, including gas fired boiler, pumps, piping, and valves are aged, rusted, inefficient, and becoming logistically unsupportable, and should be replaced with energy efficient equipment.**

Raw Cost	\$175,284.34
Plus or (Minus) Additional Cost	\$66,608.05
Total Estimated Amount	\$241,892.39

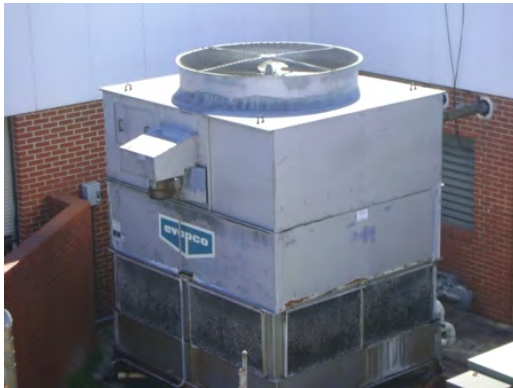
Note: **The cooling system, including cooling tower, pumps, piping, and valves are aged, rusted, inefficient, and becoming logistically unsupportable, and should be replaced with energy efficient equipment.**

Raw Cost	\$178,196.04
Plus or (Minus) Additional Cost	\$67,714.50
Total Estimated Amount	\$245,910.54

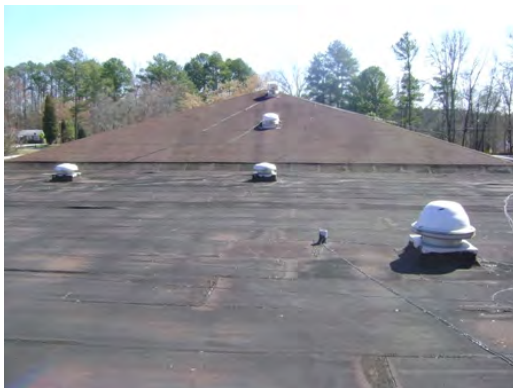
Note: **The exhaust fans and duct systems are inadequate, dirty, and damaged; they do not ventilate restrooms and other spaces properly; and should be replaced.**

Raw Cost	\$196,830.92
Plus or (Minus) Additional Cost	\$74,795.75
Total Estimated Amount	\$271,626.67

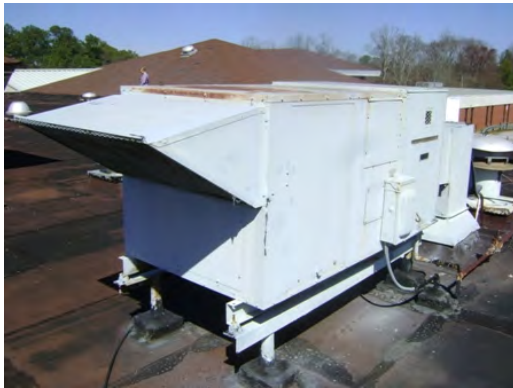
Note: **The roof top package units and fan coil units are aged, worn, rusted, inefficient, and becoming logistically unsupportable, and should be replaced with energy efficient models.**

Raw Cost	\$729,672.02
Plus or (Minus) Additional Cost	\$277,275.37
Total Estimated Amount	\$1,006,947.39

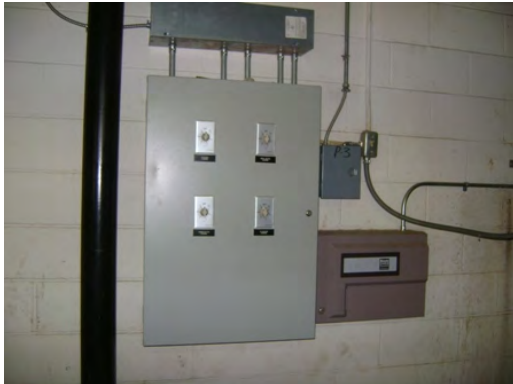
Note: **The HVAC controls are inadequate, have obsolete parts and equipment, and should be replaced.**

Raw Cost	\$136,267.56
Plus or (Minus) Additional Cost	\$51,781.67
Total Estimated Amount	\$188,049.23

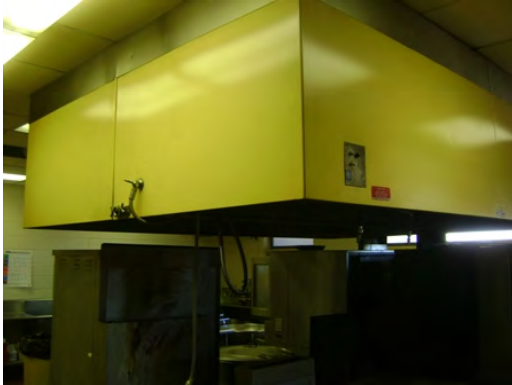
Assembly: **D3090**
System: **Other HVAC Systems/Equip - Kitchen Hood System**
Material: **Beyond Service Life**
Distress: **Beyond Service Life**
Category: **Deferred Maintenance**
Correction: **Renew System**
Note: **The kitchen hood and exhaust system is aged and worn and should be replaced.**

Raw Cost	\$49,498.90
Plus or (Minus) Additional Cost	\$18,809.58
Total Estimated Amount	\$68,308.48

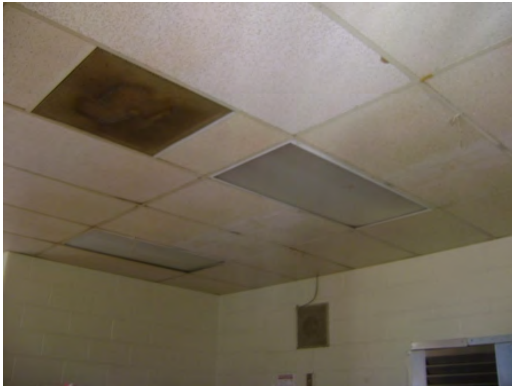
Assembly: **D5020**
System: **Lighting System**
Material: **Beyond Service Life**
Distress: **Beyond Service Life**
Category: **Deferred Maintenance**
Correction: **Renew System**
Note: **The lighting system is aged, inefficient, and in poor condition, and should be replaced with an energy efficient system.**

Raw Cost	\$362,215.48
Plus or (Minus) Additional Cost	\$137,641.88
Total Estimated Amount	\$499,857.36

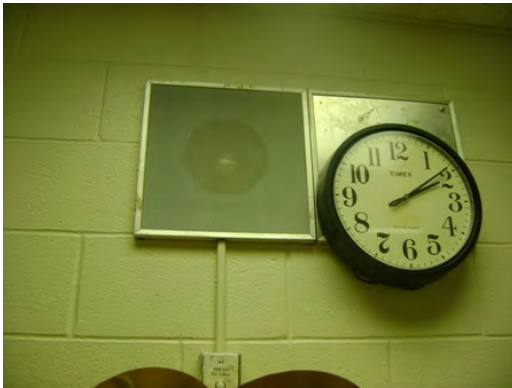
Note: **The clock and PA systems are aged, have reported outages, and should be replaced.**

Raw Cost	\$232,353.66
Plus or (Minus) Additional Cost	\$88,294.39
Total Estimated Amount	\$320,648.05

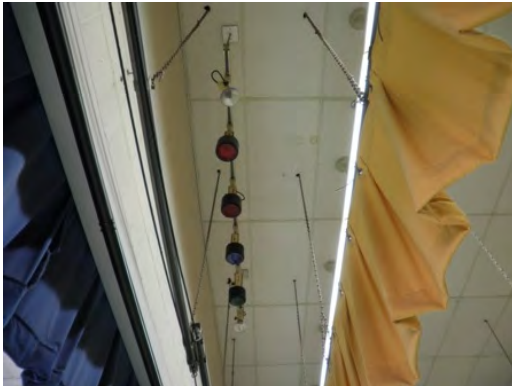
Note: **The stage lighting and curtain are aged and should be replaced.**

Raw Cost	\$16,887.86
Plus or (Minus) Additional Cost	\$6,417.39
Total Estimated Amount	\$23,305.25

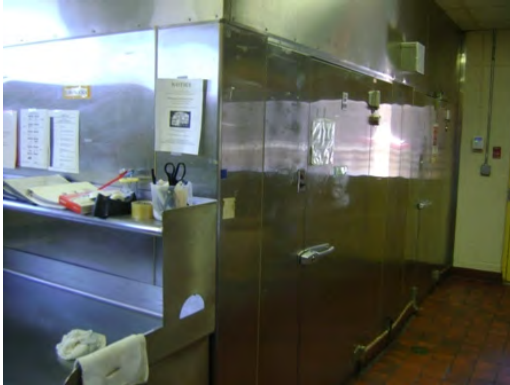
Note: **The food service equipment and walk-in refrigerator and freezer are aged and worn and should be replaced.**

Raw Cost	\$319,122.32
Plus or (Minus) Additional Cost	\$121,266.48
Total Estimated Amount	\$440,388.80

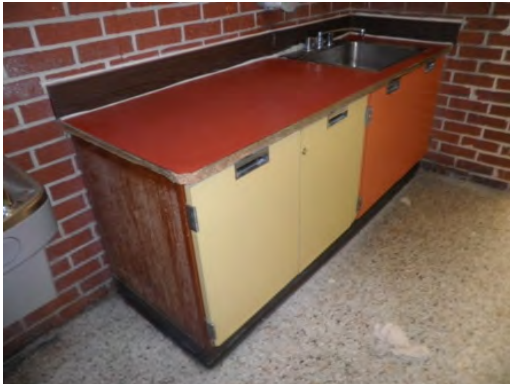
Note: **Fixed furnishings, such as the base/wall cabinets, counter tops, window shades, and fixed seating, are damaged, beyond their service life, and should be replaced.**

Raw Cost	\$178,196.04
Plus or (Minus) Additional Cost	\$67,714.50
Total Estimated Amount	\$245,910.54

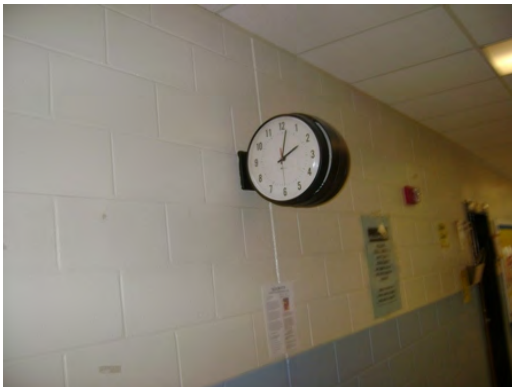
Assembly: **D5030**
System: **Communications and Security - Clock & PA**
Material: **System**
Distress: **Beyond Service Life**
Category: **Deferred Maintenance**
Correction: **Renew System**
Note: **The clock and PA systems are aged, have reported outages, and should be replaced.**

Raw Cost	\$76,732.89
Plus or (Minus) Additional Cost	\$29,158.50
Total Estimated Amount	\$105,891.39

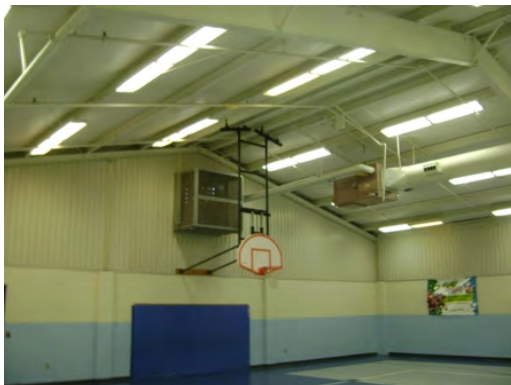
Assembly: **D3050**
 System: **Terminal & Package Units**
 Material: **Packaged A/C, Elec. Ht., Const. Volume**
 Distress: **Missing**
 Category: **Capital Improvement**
 Correction: **Install Package A/C - 20 ton**
 Note: **An air conditioning system is missing in the gymnasium and should be installed.**

Raw Cost	\$40,691.00
Plus or (Minus) Additional Cost	\$15,462.58
Total Estimated Amount	\$56,153.58

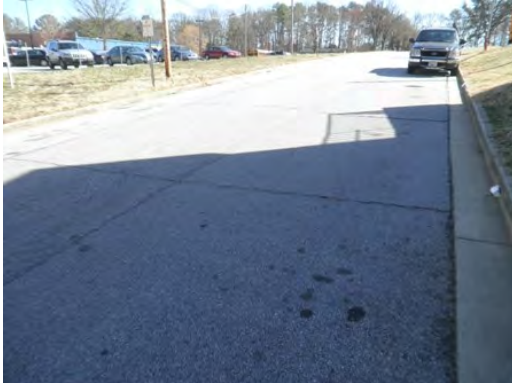
Assembly: **G2010**
System: **Roadways**
Material: **System**
Distress: **Beyond Service Life**
Category: **Deferred Maintenance**
Correction: **Renew System**
Note: **The roadways are aged and cracked and should be sealed, coated, and restriped.**

Raw Cost	\$215,407.04
Plus or (Minus) Additional Cost	\$56,005.83
Total Estimated Amount	\$271,412.87

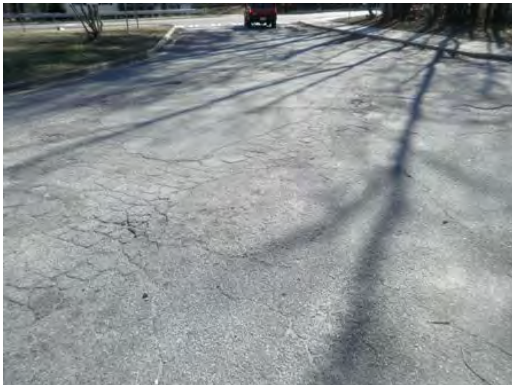
Assembly: **G2020**
System: **Parking Lots**
Material: **System**
Distress: **Beyond Service Life**
Category: **Deferred Maintenance**
Correction: **Renew System**
Note: **The parking lots are aged and cracking and should be resurfaced and restriped.**

Raw Cost	\$97,684.59
Plus or (Minus) Additional Cost	\$25,397.99
Total Estimated Amount	\$123,082.58

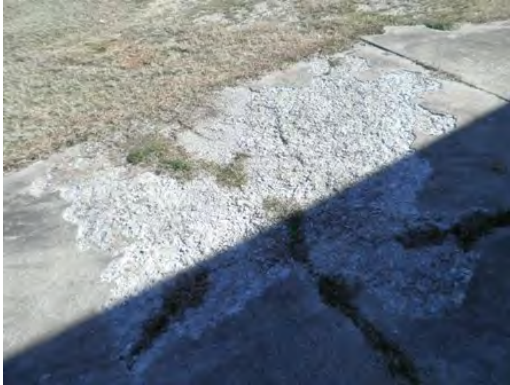
Note: **The sidewalks are aged, cracked, and damaged, and should be replaced.**

Raw Cost	\$109,373.34
Plus or (Minus) Additional Cost	\$28,437.07
Total Estimated Amount	\$137,810.41

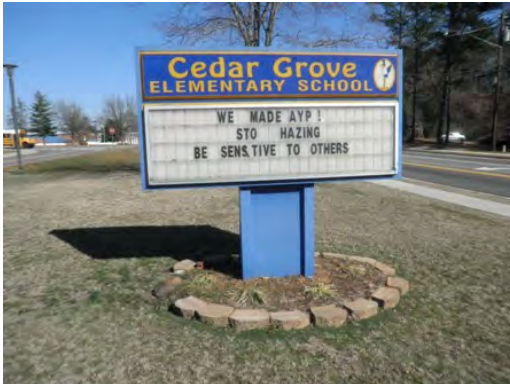
Note: **The site development features, such as site furnishings, flag pole, and signage, are beyond their service life and should be replaced.**

Raw Cost	\$17,533.13
Plus or (Minus) Additional Cost	\$4,558.61
Total Estimated Amount	\$22,091.74

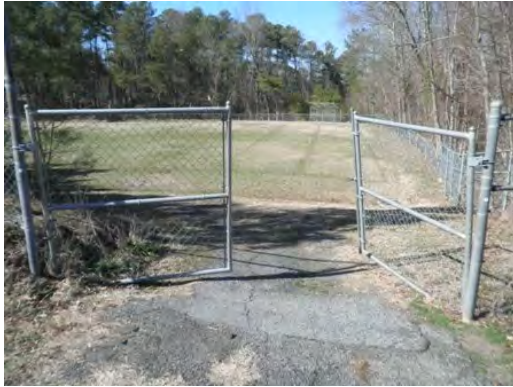
Assembly: **G2040105**
System: **Fence & Guardrails**
Material: **System**
Distress: **Damaged**
Category: **Deferred Maintenance**
Correction: **Renew System**

Note: **The fencing is aged and damaged and should be replaced.**

Raw Cost	\$119,164.57
Plus or (Minus) Additional Cost	\$30,982.79
Total Estimated Amount	\$150,147.36

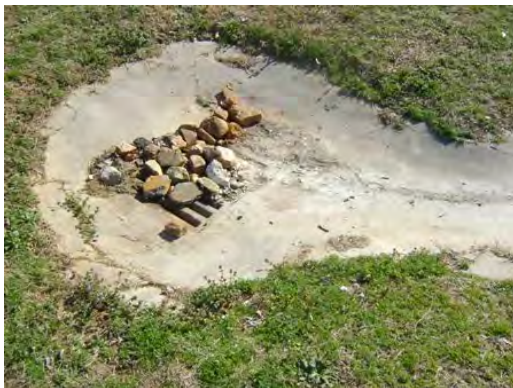
Note: **The storm drain inlet near the front (south) driveway is clogged with debris and should be cleaned out.**

Raw Cost	\$500.00
Plus or (Minus) Additional Cost	\$130.00
Total Estimated Amount	\$630.00

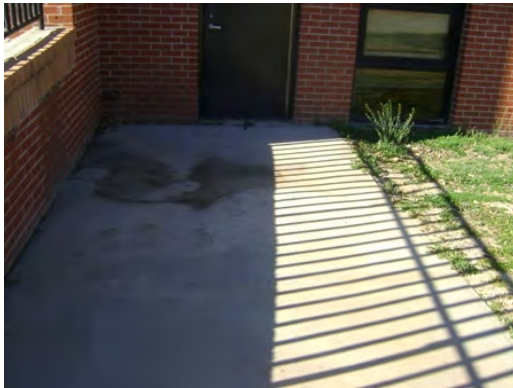
Assembly: **G3030**
System: **Storm Sewer**
Material: **Storm Sewer**
Distress: **Inadequate**
Category: **Deferred Maintenance**
Correction: **Slope and Regrade Soil**
Note: **The entry sidewalk at the southwest entrance of the 1998 addition (sprinkler control room) floods during heavy rain. Regrading and sloping of the soil to take rain water away from this area is needed.**

Raw Cost	\$2,000.00
Plus or (Minus) Additional Cost	\$520.00
Total Estimated Amount	\$2,520.00
