Facility Condition Assessment Report

Chapel Hill Middle Facility Executive Summary ReportReport Date: 24 Jun 2011

Facility: \Middle Schools\Chapel Hill Middle**Address:** 3535 Dogwood Farm Road, Decatur, GA 30034**Attributes:**

Chapel Hill Middle Detailed Facility Needs Assessment Report

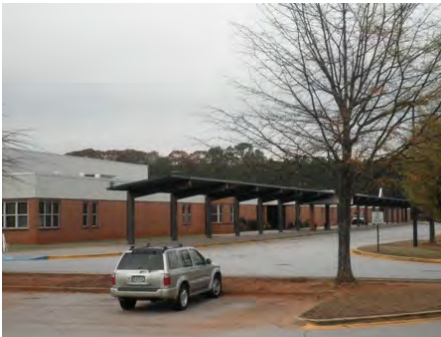
08-Dec-2010
East Elevation

The Chapel Hill Middle School main building is a one-story building located at 3535 Dogwood Farm Road in Decatur, Georgia. Originally built in 1991, there have been no additions or major renovations. This report contains condition and adequacy data collected during the 2010/2011 Facility Condition Assessment (FCA). The detailed condition and deficiency statements are contained in this report.

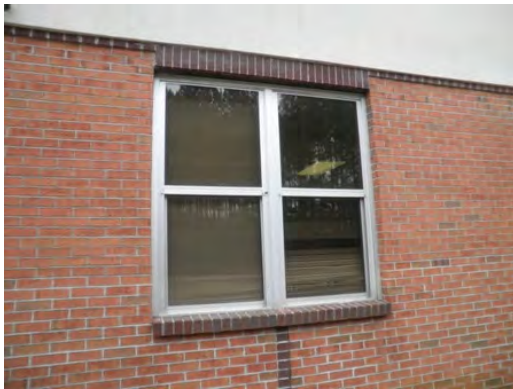
Assembly: **B2020**
System: **Exterior Windows**
Material: **System**
Distress: **Needs Remediation**
Category: **Deferred Maintenance**
Correction: **Renew System**
Note: **The original windows are malfunctioning and should be replaced. The hinges are broken, making them difficult to operate and a safety hazard.**

Raw Cost	\$988,140.78
Plus or (Minus) Additional Cost	\$375,493.50
Total Estimated Amount	\$1,363,634.28

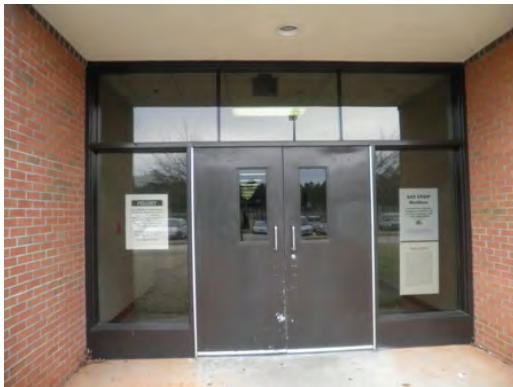
Assembly: **B2030**
System: **Exterior Doors**
Material: **Door Opener**
Distress: **Missing**
Category: **Code Compliance**
Correction: **Install Door Opener**
Note: **The main entrance to the building lacks an automatic door opener.**

Raw Cost	\$4,350.00
Plus or (Minus) Additional Cost	\$1,653.00
Total Estimated Amount	\$6,003.00

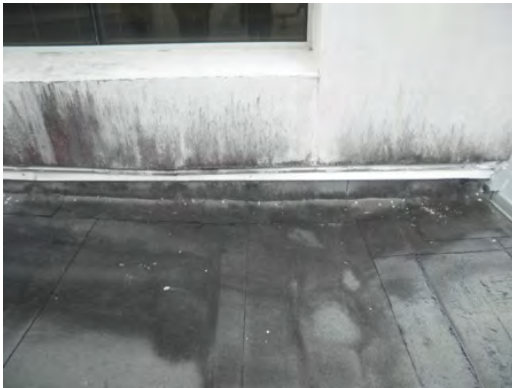
Assembly: **B3010**
System: **Roof Coverings - BUR System**
Material: **Needs Remediation**
Distress: **Needs Remediation**
Category: **Deferred Maintenance**
Correction: **Renew System**

Note: **The built up roof is blistering in several locations and the flashing is deteriorating. In addition, there are missing gutters and downspouts in several locations.**

Raw Cost	\$684,883.78
Plus or (Minus) Additional Cost	\$260,255.84
Total Estimated Amount	\$945,139.62

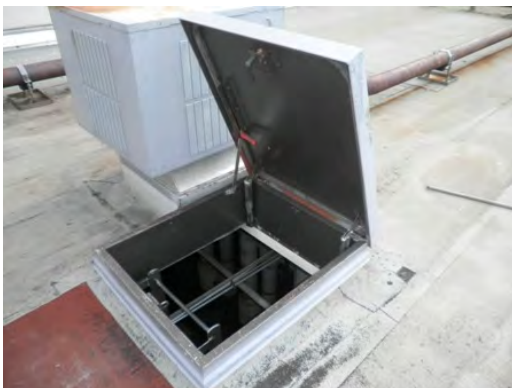
Assembly: **B3020**
System: **Roof Openings**
Material: **Roof Hatches, Skylights**
Distress: **Inadequate**
Category: **Safety**
Correction: **Replace Roof Hatches, Skylights**
Note: **The roof hatch is not OSHA compliant.**

Raw Cost	\$986.92
Plus or (Minus) Additional Cost	\$375.03
Total Estimated Amount	\$1,361.95

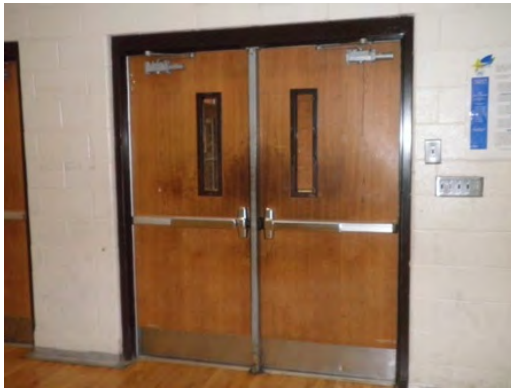
Assembly: **C1020**
 System: **Interior Doors**
 Material: **System**
 Distress: **Inadequate**
 Category: **Deferred Maintenance**
 Correction: **Renew System**
 Note: **The interior doors need refinishing. The master key system is a safety concern and replacing the lock cylinders is recommended. Further, interior access doors are missing and plywood has been used to cover the openings.**

Raw Cost	\$175,944.82
Plus or (Minus) Additional Cost	\$66,859.03
Total Estimated Amount	\$242,803.85

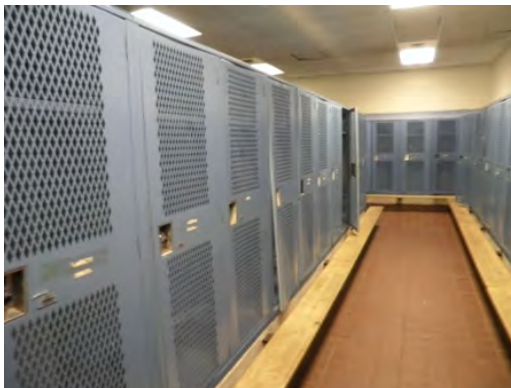
Assembly: **C1030**
 System: **Fittings**
 Material: **System**
 Distress: **Inadequate**
 Category: **Deferred Maintenance**
 Correction: **Renew System**
 Note: **Fittings, such as chalk and tack boards, lockers, toilet and bath accessories, toilet partitions, shelving, and building signage are beyond their service life and should be replaced.**

Raw Cost	\$233,405.67
Plus or (Minus) Additional Cost	\$88,694.15
Total Estimated Amount	\$322,099.82

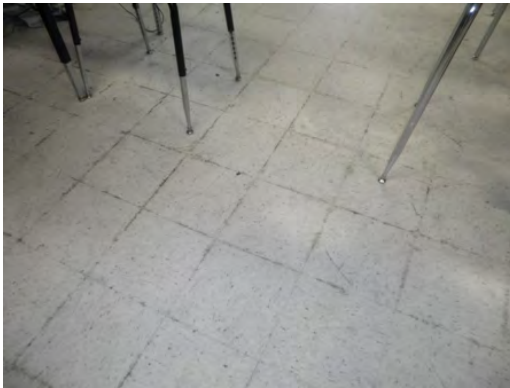
Assembly: **C3020**
 System: **Floor Finishes - VCT**
 Material: **System**
 Distress: **Needs Remediation**
 Category: **Deferred Maintenance**
 Correction: **Renew System**
 Note:

The original VCT is beyond its service life and should be replaced. The VCT that was replaced in 90% of the classrooms in 2004 should also be replaced because it is aging early.

Raw Cost	\$517,347.83
Plus or (Minus) Additional Cost	\$196,592.18
Total Estimated Amount	\$713,940.01

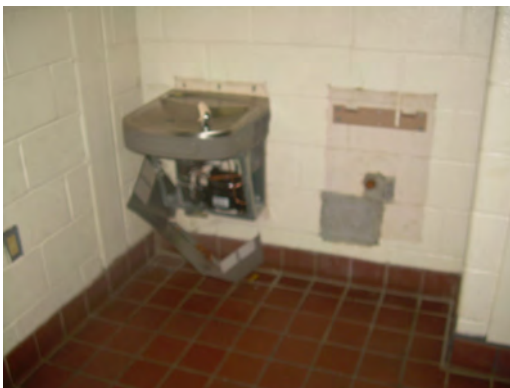
Assembly: **D2010**
 System: **Plumbing Fixtures**
 Material: **Drinking Fountain Systems**
 Distress: **Damaged**
 Category: **Deferred Maintenance**
 Correction: **Replace Drinking Fountain Systems**
 Note:

The water fountains are aged, rusted, and damaged, and should be replaced.

Raw Cost	\$12,104.00
Plus or (Minus) Additional Cost	\$4,599.52
Total Estimated Amount	\$16,703.52

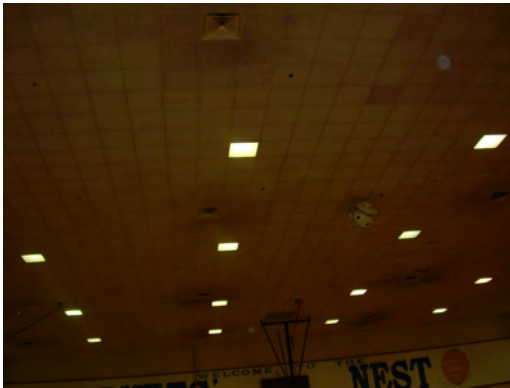
Assembly: **D5020**
 System: **Lighting**
 Material: **Lighting, High Intensity**
 Distress: **Inadequate**
 Category: **Deferred Maintenance**
 Correction: **Replace Lighting, High Intensity**

Note: **The fluorescent light fixtures in the gymnasium are very dim and inadequate, and should be replaced with higher intensity fixtures.**

Raw Cost	\$31,176.00
Plus or (Minus) Additional Cost	\$11,846.88
Total Estimated Amount	\$43,022.88

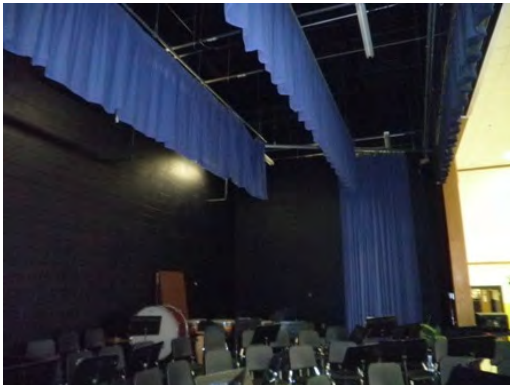
Note: **Institutional equipment, such as library equipment, theater and stage equipment, audio-visual equipment, and laboratory equipment, is worn, beyond its service life, and should be replaced. There is currently not enough lighting on the stage.**

Raw Cost	\$333,923.44
Plus or (Minus) Additional Cost	\$126,890.91
Total Estimated Amount	\$460,814.35

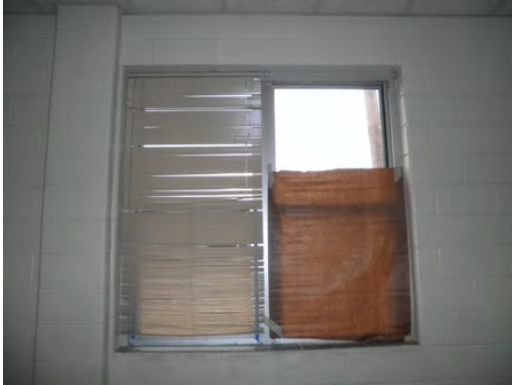
Assembly: **E2010**
System: **Fixed Furnishings**
Material: **System**
Distress: **Damaged**
Category: **Deferred Maintenance**
Correction: **Renew System**

Note: **Fixed furnishings, such as the base/wall cabinets, counter tops, window shades, and fixed seating, are worn, beyond their service life, and should be replaced.**

Raw Cost	\$637,180.43
Plus or (Minus) Additional Cost	\$242,128.56
Total Estimated Amount	\$879,308.99

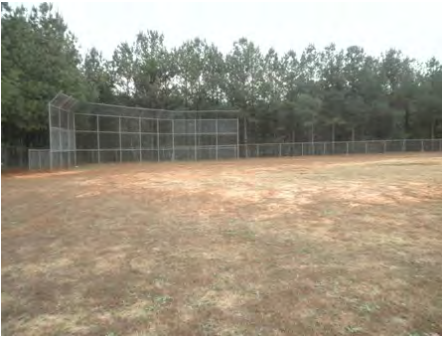
The Baseball Field at Chapel Hill Middle School is located on the campus grounds. There have been no additions or major renovations. This report contains condition and adequacy data collected during the 2010/2011 Facility Condition Assessment (FCA). The detailed condition and deficiency statements are contained in this report.

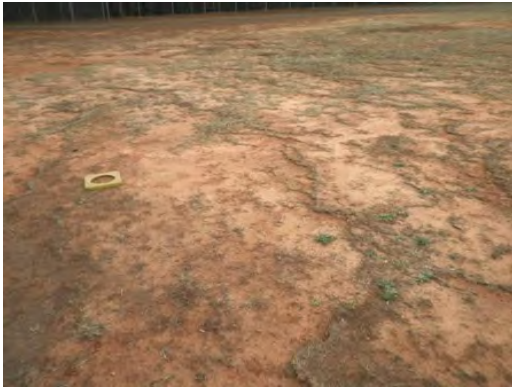
Assembly: **F1040**
System: **Special Facilities - Sports Field - Natural Turf System**
Material: **System**
Distress: **Beyond Service Life**
Category: **Deferred Maintenance**
Correction: **Renew System**
Note: **The baseball field turf is worn and should be reseeded.**

Raw Cost	\$21,560.00
Plus or (Minus) Additional Cost	\$5,605.60
Total Estimated Amount	\$27,165.60

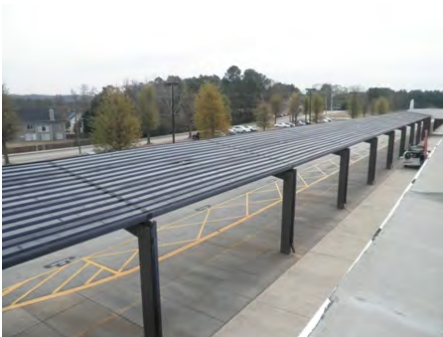
08-Dec-2010
Northwest Elevation

An engineered metal covered walkway connects the student drop off/pick up area and the main school building and provides some weather protection for the students.

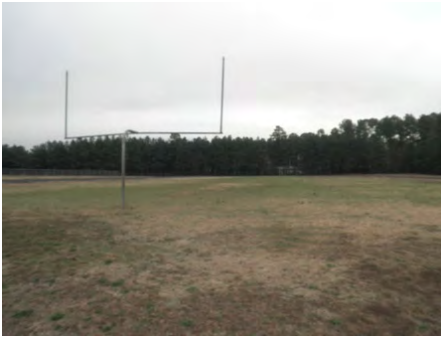
08-Dec-2010
Football Field at Chapel Hill Middle
School

The Football Field at Chapel Hill Middle School is located on the campus grounds. There have been no additions or major renovations. This report contains condition and adequacy data collected during the 2010/2011 Facility Condition Assessment (FCA). The detailed condition and deficiency statements are contained in this report.

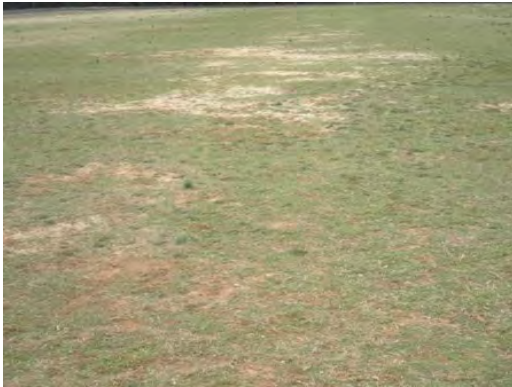
Assembly: **F1040**
System: **Special Facilities - Footbal Field - Natural Turf System**
Material: **System**
Distress: **Beyond Service Life**
Category: **Deferred Maintenance**
Correction: **Renew System**
Note: **The football field turf is worn and should be reseeded.**

Raw Cost	\$11,880.00
Plus or (Minus) Additional Cost	\$3,088.80
Total Estimated Amount	\$14,968.80

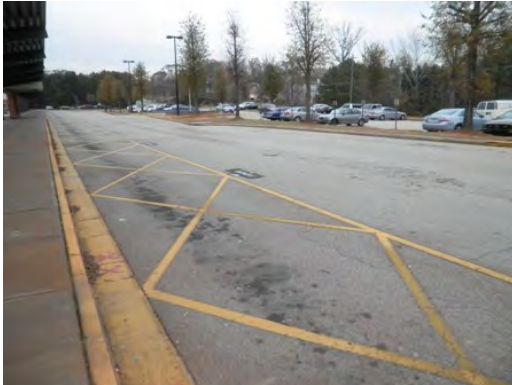
Assembly: **G2010**
System: **Roadways**
Material: **System**
Distress: **Needs Remediation**
Category: **Deferred Maintenance**
Correction: **Renew System**
Note: **The roadways are aged and cracking and should be resurfaced and restriped.**

Raw Cost	\$134,591.59
Plus or (Minus) Additional Cost	\$34,993.81
Total Estimated Amount	\$169,585.40

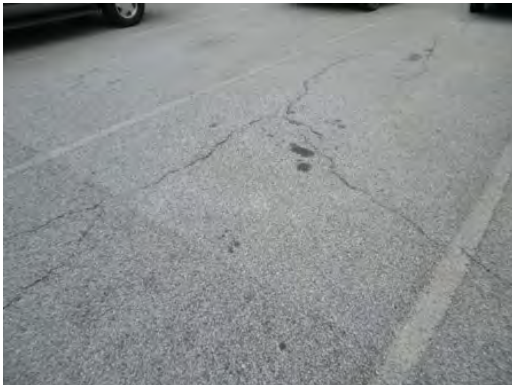
Assembly: **G2020**
System: **Parking Lots**
Material: **System**
Distress: **Needs Remediation**
Category: **Deferred Maintenance**
Correction: **Renew System**
Note: **The parking lots are aged and cracking, and should be resurfaced and restriped.**

Raw Cost	\$129,480.52
Plus or (Minus) Additional Cost	\$33,664.93
Total Estimated Amount	\$163,145.45

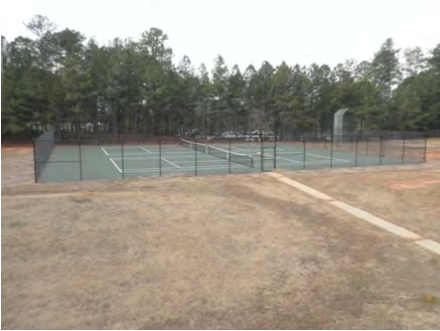
The Tennis Courts at Chapel Hill Middle School are located on the campus grounds. There have been no additions or major renovations. This report contains condition and adequacy data collected during the 2010/2011 Facility Condition Assessment (FCA). The detailed condition and deficiency statements are contained in this report.

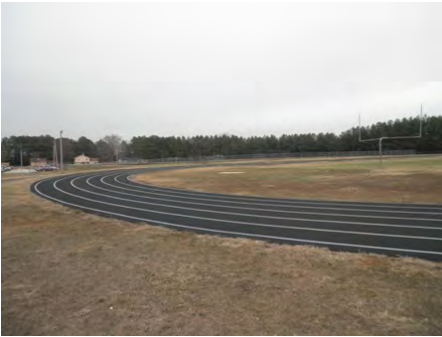
08-Dec-2010
Track at Chapel Hill Middle School

The Track at Chapel Hill Middle School is located on the campus grounds, has six lanes, and black latex surfacing. There have been no additions or major renovations. This report contains condition and adequacy data collected during the 2010/2011 Facility Condition Assessment (FCA). The detailed condition and deficiency statements are contained in this report.
