# **Facility Condition Assessment Report**

**DeKalb County School System**1701 Mountain Industrial Blvd  
Stone Mountain, GA 30083COMET4 Facility Report  
**Coralwood Diagnostic Center Facility Executive Summary Report**Report Date: 28 Jun 2011  
Page 1

**Facility:** \Elementary Schools\Coralwood Diagnostic Center  
**Address:** 2477 Coralwood Drive, Decatur, GA 30033**Attributes:****Facility Code** 5016  
**Super Cluster** 6**General Information:****Function:** Elementary School  
**Gross Area:** 38,102 S.F.  
**Year Built:**  
**Last Renovation:****Facility Description:**

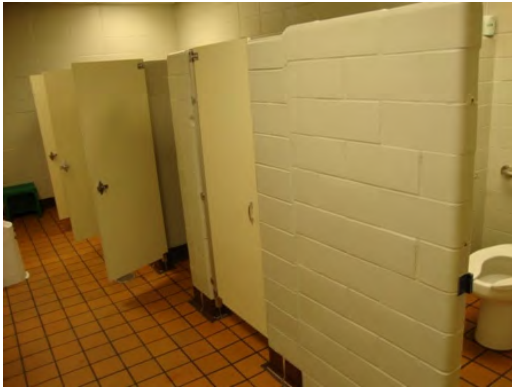
Assembly: **C1030**  
System: **Fittings**  
Material: **System**  
Distress: **Beyond Service Life**  
Category: **Deferred Maintenance**  
Correction: **Renew System**  
Note: **Fittings, such as chalk and tack boards, toilet and bath accessories, toilet partitions, and signage, are aged, worn, and damaged, and should be replaced.**

Raw Cost	<b>\$65,543.28</b>
Plus or (Minus) Additional Cost	<b>\$24,906.45</b>
Total Estimated Amount	<b>\$90,449.73</b>

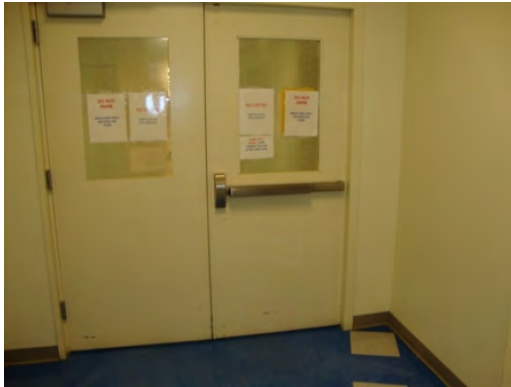
Material: **Security and Detection Systems**  
Distress: **Missing**  
Category: **Deferred Maintenance**  
Correction: **Install keyless door entry system**  
Note: **Keyless door entry and control system is missing and should be installed.**

Raw Cost	<b>\$1,055.00</b>
Plus or (Minus) Additional Cost	<b>\$400.90</b>
Total Estimated Amount	<b>\$1,455.90</b>

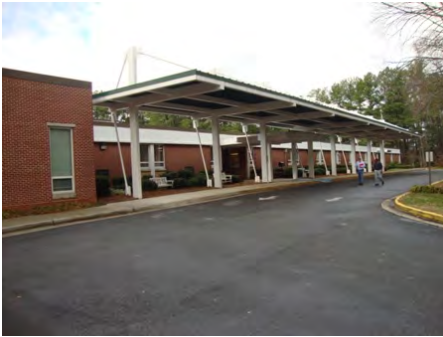
25-Feb-2011  
East Elevation

An engineered metal covered walkway connects the student drop off/pick up area with the main school building and provides some weather protection for the students.

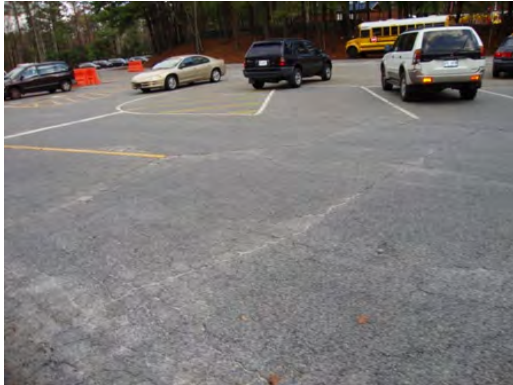
Assembly: **G2020**  
System: **Parking Lots**  
Material: **System**  
Distress: **Beyond Service Life**  
Category: **Deferred Maintenance**  
Correction: **Renew System**  
Note: **The parking lots are aged and cracked and should be resurfaced.**

Raw Cost	<b>\$49,037.27</b>
Plus or (Minus) Additional Cost	<b>\$12,749.69</b>
Total Estimated Amount	<b>\$61,786.96</b>

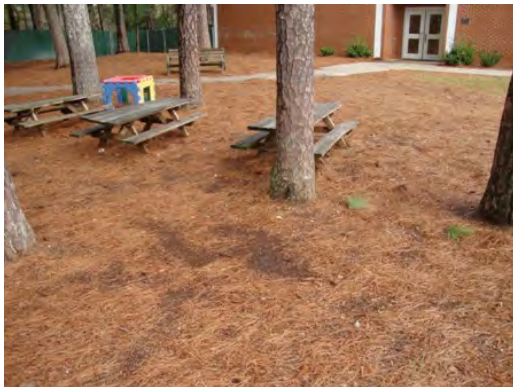
Assembly: **G2040**  
System: **Site Development**  
Material: **System**  
Distress: **Beyond Service Life**  
Category: **Deferred Maintenance**  
Correction: **Renew System**  
Note: **Site development features, such as the flagpole, site furnishings, and signage, are beyond their service life and should be replaced.**

Raw Cost	<b>\$8,801.56</b>
Plus or (Minus) Additional Cost	<b>\$2,288.41</b>
Total Estimated Amount	<b>\$11,089.97</b>

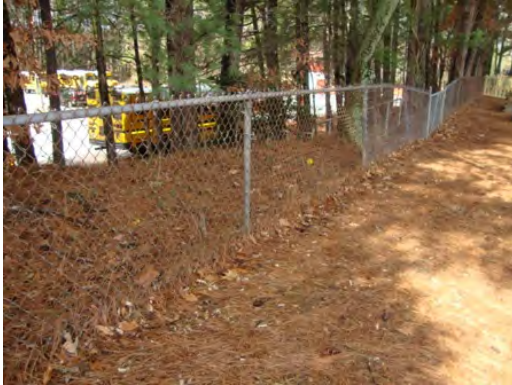
Note: **The fencing is aged, rusted, and damaged, and should be replaced.**

Raw Cost	<b>\$59,820.14</b>
Plus or (Minus) Additional Cost	<b>\$15,553.24</b>
Total Estimated Amount	<b>\$75,373.38</b>

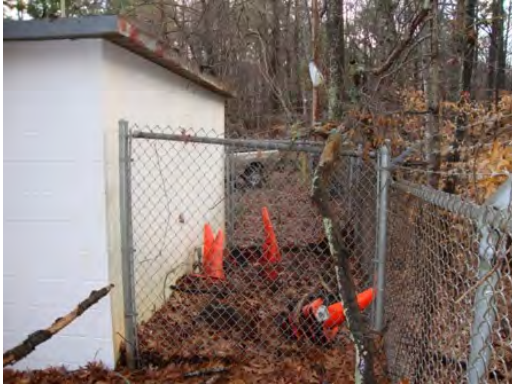
Assembly: **B1020**  
System: **Roof Construction**  
Material: **System**  
Distress: **Needs Remediation**  
Category: **Deferred Maintenance**  
Correction: **Renew System**  
Note: **The roof construction is rusted and should be replaced.**

Raw Cost	<b>\$1,179.60</b>
Plus or (Minus) Additional Cost	<b>\$448.25</b>
Total Estimated Amount	<b>\$1,627.85</b>

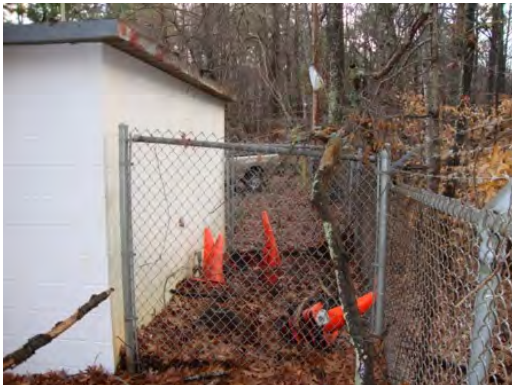
Assembly: **B3010**  
System: **Roof Coverings**  
Material: **System**  
Distress: **Needs Remediation**  
Category: **Deferred Maintenance**  
Correction: **Renew System**  
Note: **The roof covering should be replaced in conjunction with the rusted roof construction.**

Raw Cost	<b>\$1,374.12</b>
Plus or (Minus) Additional Cost	<b>\$522.17</b>
Total Estimated Amount	<b>\$1,896.29</b>
