Facility Condition Assessment Report

DeKalb County School System1701 Mountain Industrial Blvd
Stone Mountain, GA 30083COMET4 Facility Report
DeKalb HS of Technology South Facility Executive Summary ReportReport Date: 24 Jun 2011

COMET4 Survey Report DeKalb HS of Technology South Detailed Facility Needs Assessment Report

Facility: \High Schools\DeKalb HS of Technology South\1977 Building**Address:** 3303 Panthersville Road, Decatur, GA 30034**Attributes:****Building Codes** 3010
Fire Sprinkler System No**General Information:****Function:** High School **Year Built:** 1977
Gross Area: 47,467 S.F. **Last Renovation:****Facility Description:**

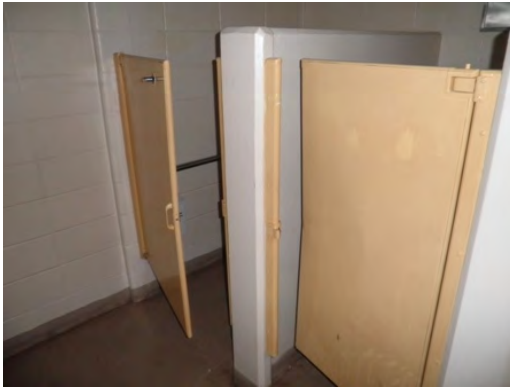
Assembly: **C1030**
 System: **Fittings**
 Material: **System**
 Distress: **Beyond Service Life**
 Category: **Deferred Maintenance**
 Correction: **Renew System**
 Note: **Fittings, such as chalk and tack boards, lockers, toilet and bath accessories, toilet partitions, and shelving, are aged, worn and damaged, and should be replaced.**

Raw Cost	\$214,598.31
Plus or (Minus) Additional Cost	\$81,547.36
Total Estimated Amount	\$296,145.67

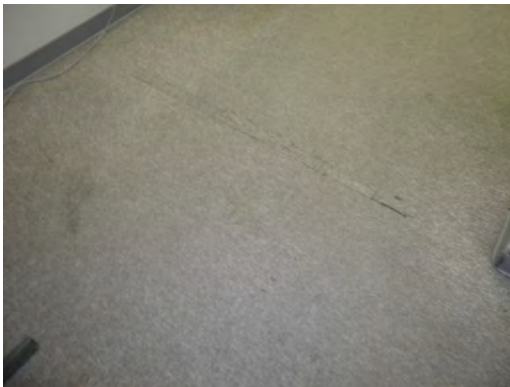
Assembly: **C3020**
 System: **Floor Finishes - Carpet**
 Material: **System**
 Distress: **Beyond Service Life**
 Category: **Deferred Maintenance**
 Correction: **Renew System**
 Note: **The carpet in the administration area and offices is aged, worn, stained, and frayed, and should be replaced.**

Raw Cost	\$23,807.19
Plus or (Minus) Additional Cost	\$9,046.73
Total Estimated Amount	\$32,853.92

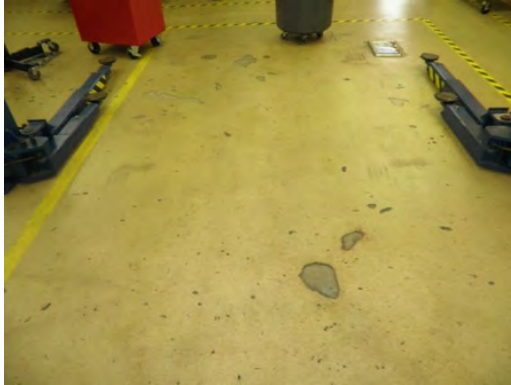
Assembly: **C3020**
 System: **Floor Finishes - Epoxy Coating**
 Material: **System**
 Distress: **Damaged**
 Category: **Deferred Maintenance**
 Correction: **Renew System**
 Note: **The epoxy coated floor is worn and chipped and should be replaced.**

Raw Cost	\$124,265.24
Plus or (Minus) Additional Cost	\$47,220.79
Total Estimated Amount	\$171,486.03

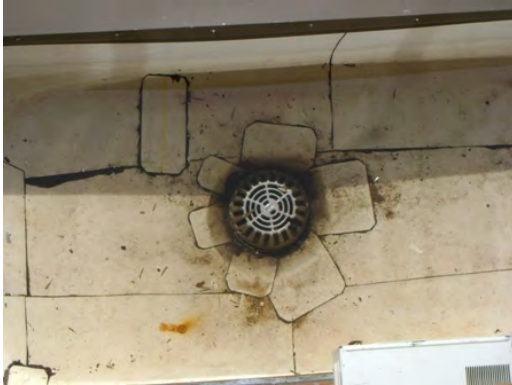
Assembly: **D2040**
System: **Rain Water Drainage**
Material: **Roof Drain Systems**
Distress: **Needs Remediation**
Category: **Deferred Maintenance**
Correction: **Repair Roof Drain Systems**
Note: **A roof drain is clogged with standing water and needs to be rodded and cleaned out.**

Raw Cost	\$150.00
Plus or (Minus) Additional Cost	\$57.00
Total Estimated Amount	\$207.00

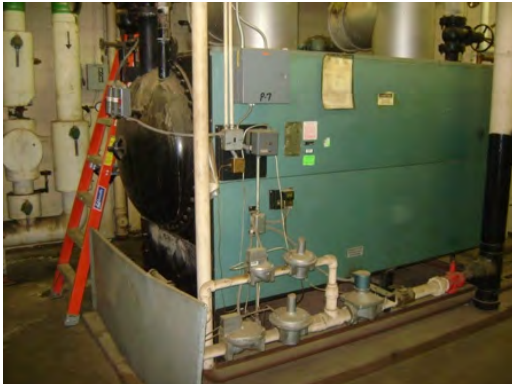
Assembly: **D3020**
System: **Heat Generating Systems**
Material: **System**
Distress: **Beyond Service Life**
Category: **Deferred Maintenance**
Correction: **Renew System**
Note: **The heating system, including gas fired boiler, pumps, piping, and valves, are aged, rusted, inefficient, and becoming logistically unsupportable, and should be replaced with energy efficient equipment.**

Raw Cost	\$157,163.24
Plus or (Minus) Additional Cost	\$59,722.03
Total Estimated Amount	\$216,885.27

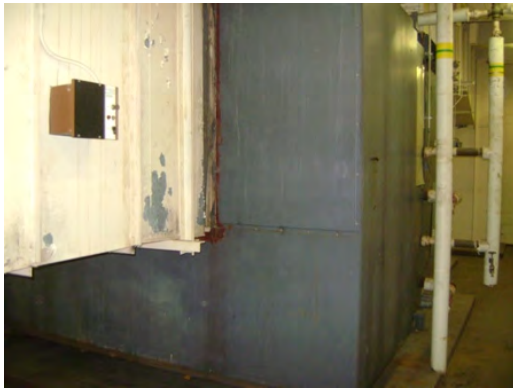
Assembly: **D3040**
System: **Distribution Systems & Exhaust Systems**
Material: **System**
Distress: **Beyond Service Life**
Category: **Deferred Maintenance**
Correction: **Renew System**

Note: **The large central station air handling unit and the exhaust fans and duct systems are aged, inadequate, and dirty, and should be replaced.**

Raw Cost	\$188,491.46
Plus or (Minus) Additional Cost	\$71,626.75
Total Estimated Amount	\$260,118.21

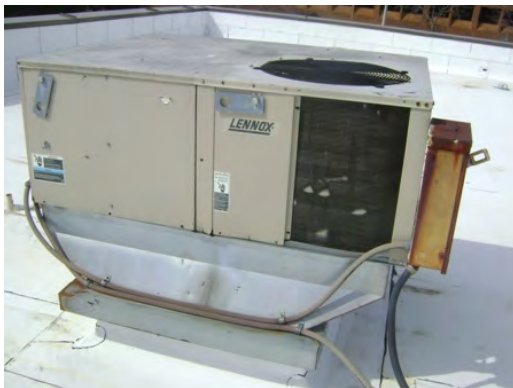
Assembly: **D3050**
System: **Terminal & Package Units**
Material: **System**
Distress: **Beyond Service Life**
Category: **Deferred Maintenance**
Correction: **Renew System**

Note: **The roof top package units, fan coil units, unit heaters, and shop air conditioners are aged, rusted, inefficient, and becoming logistically unsupportable, and should be replaced with energy efficient models.**

Raw Cost	\$654,237.66
Plus or (Minus) Additional Cost	\$248,610.31
Total Estimated Amount	\$902,847.97

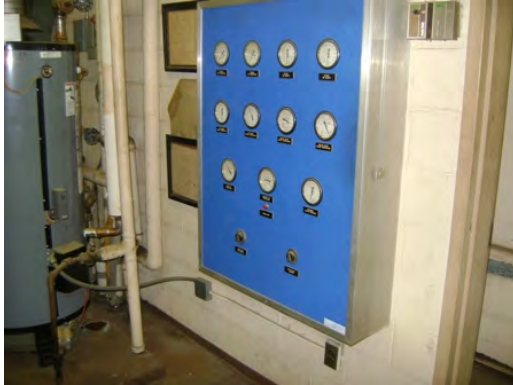
Assembly: **D3060**
System: **Controls & Instrumentation System**
Material: **Beyond Service Life**
Distress: **Beyond Service Life**
Category: **Deferred Maintenance**
Correction: **Renew System**

Note: **The HVAC controls are inadequate, have obsolete parts and equipment, and should be replaced.**

Raw Cost	\$108,082.36
Plus or (Minus) Additional Cost	\$41,071.30
Total Estimated Amount	\$149,153.66

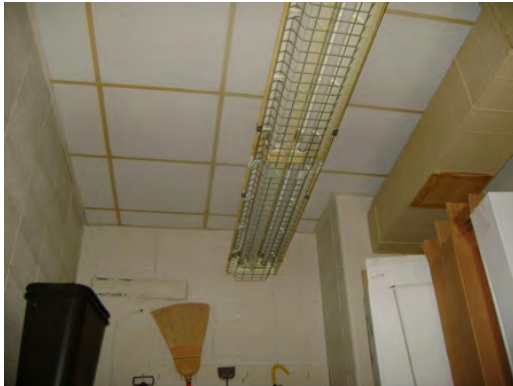
Assembly: **D5020**
System: **Lighting System**
Material: **Beyond Service Life**
Distress: **Beyond Service Life**
Category: **Deferred Maintenance**
Correction: **Renew System**

Note: **While some classrooms have been updated with T-8 fixtures, a majority of the lighting system is aged, inefficient T-12 and incandescent fixtures that should be replaced with an energy efficient system.**

Raw Cost	\$303,883.73
Plus or (Minus) Additional Cost	\$115,475.82
Total Estimated Amount	\$419,359.55

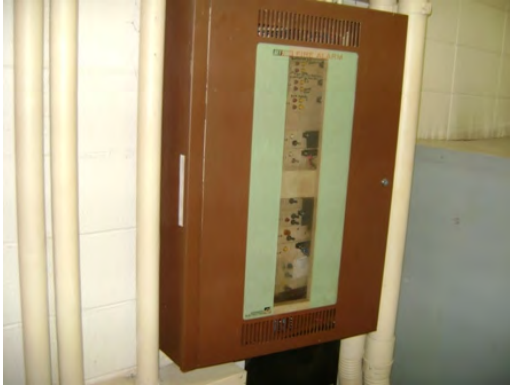
Assembly: **D5030**
 System: **Communications and Security - Fire Alarm System**
 Material: **System**
 Distress: **Beyond Service Life**
 Category: **Deferred Maintenance**
 Correction: **Renew System**

Note: The fire alarm system is aged, has reported outages, and should be replaced.

Raw Cost	\$28,717.54
Plus or (Minus) Additional Cost	\$10,912.66
Total Estimated Amount	\$39,630.20

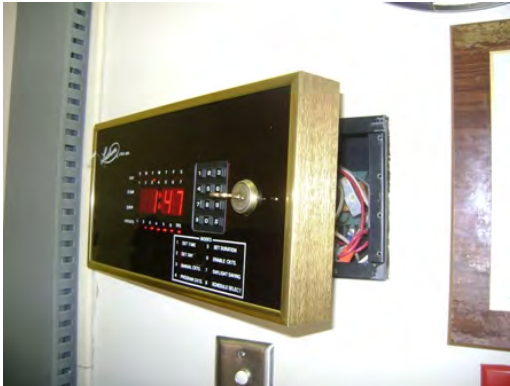
Assembly: **D5030**
 System: **Communications and Security - PA & Clock Systems**
 Material: **System**
 Distress: **Beyond Service Life**
 Category: **Deferred Maintenance**
 Correction: **Renew System**

Note: The PA and clock systems are aged, have reported outages, and should be replaced.

Raw Cost	\$178,048.72
Plus or (Minus) Additional Cost	\$67,658.51
Total Estimated Amount	\$245,707.23

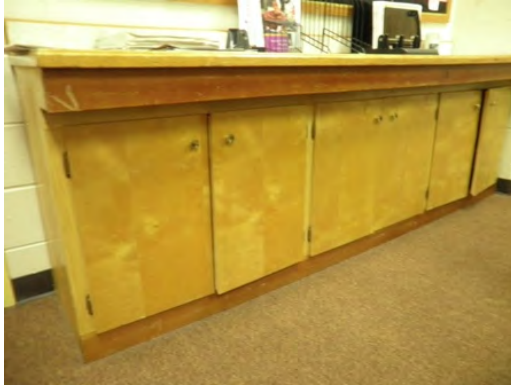
Assembly: **E2010**
System: **Fixed Furnishings**
Material: **System**
Distress: **Beyond Service Life**
Category: **Deferred Maintenance**
Correction: **Renew System**

Note: **Fixed furnishings, such as the base/wall cabinets, counter tops, window shades, and fixed seating, are worn, beyond their service life, and should be replaced.**

Raw Cost	\$273,599.79
Plus or (Minus) Additional Cost	\$103,967.92
Total Estimated Amount	\$377,567.71

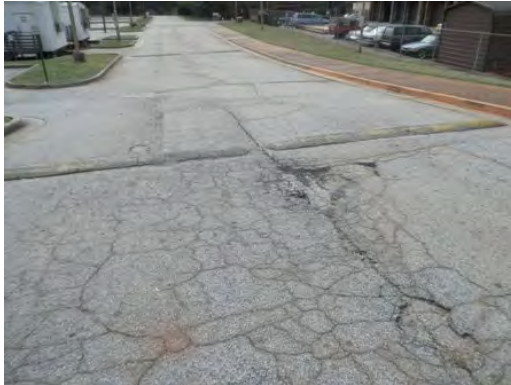
Assembly: **G2010**
System: **Roadways**
Material: **System**
Distress: **Beyond Service Life**
Category: **Deferred Maintenance**
Correction: **Renew System**
Note: **The roadways are aged and cracked, have many road cuts and repairs, and should be resurfaced and restriped.**

Raw Cost	\$202,067.02
Plus or (Minus) Additional Cost	\$52,537.42
Total Estimated Amount	\$254,604.44

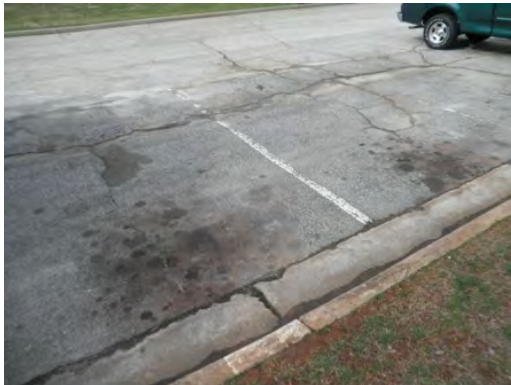
Assembly: **G2020**
System: **Parking Lots**
Material: **System**
Distress: **Beyond Service Life**
Category: **Deferred Maintenance**
Correction: **Renew System**
Note: **The parking lots are aged, cracking, and patched, and should be resurfaced and restriped.**

Raw Cost	\$263,679.19
Plus or (Minus) Additional Cost	\$68,556.59
Total Estimated Amount	\$332,235.78

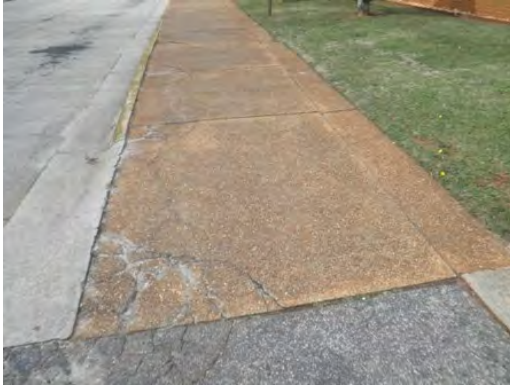
Assembly: **G2030**
 System: **Pedestrian Paving System**
 Material: **Beyond Service Life**
 Distress: **Deferred Maintenance**
 Category: **Renew System**
 Correction: **Renew System**

Note: **The sidewalks are aged, cracked, and damaged, and should be replaced.**

Raw Cost	\$39,160.28
Plus or (Minus) Additional Cost	\$10,181.67
Total Estimated Amount	\$49,341.95

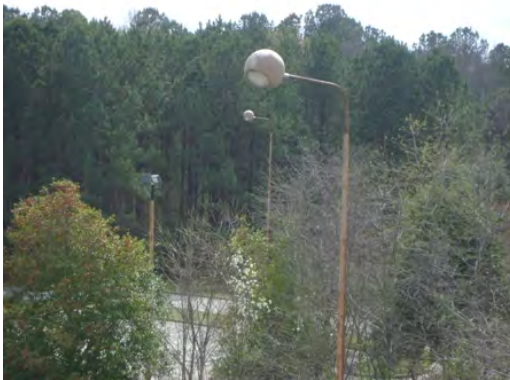
Assembly: **G4020**
 System: **Site Lighting System**
 Material: **Beyond Service Life**
 Distress: **Deferred Maintenance**
 Category: **Renew System**
 Correction: **Renew System**

Note: **The site lighting fixtures and poles are aged, weathered, outdated, and inoperative in some cases, and should be replaced.**

Raw Cost	\$28,717.54
Plus or (Minus) Additional Cost	\$7,466.56
Total Estimated Amount	\$36,184.10
