Facility Condition Assessment Report

Fairington Elementary Facility Executive Summary ReportReport Date: 30 Jun 2011

Facility: \Elementary Schools\Fairington Elementary
Address: 5505 Phillip Bradley Drive, Lithonia, GA 30038**Attributes:****Facility Code** 0375
Super Cluster 4**General Information:****Function:** Elementary School
Gross Area: 66,977 S.F.
Year Built:
Last Renovation:**Facility Description:**

The Farrington Elementary School campus consists of one main building located at 5505 Phillip Bradley Drive in Lithonia, Georgia. The original campus was constructed in 1975, a classroom addition was constructed in 1979, and a gymnasium building was constructed in 2003. In addition to these buildings, the campus contains a covered walkway and a hard surface play area. This report contains condition and adequacy data collected during the 2010/2011 Facility Condition Assessment (FCA). The detailed condition and deficiency statements are contained in this report for each building or other facility on the campus.

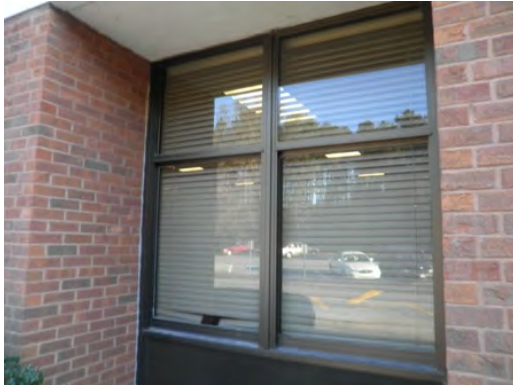
Assembly: **B2020**
System: **Exterior Windows**
Material: **System**
Distress: **Beyond Service Life**
Category: **Deferred Maintenance**
Correction: **Renew System**
Note: **The original metal frame windows are aged and inefficient and should be replaced.**

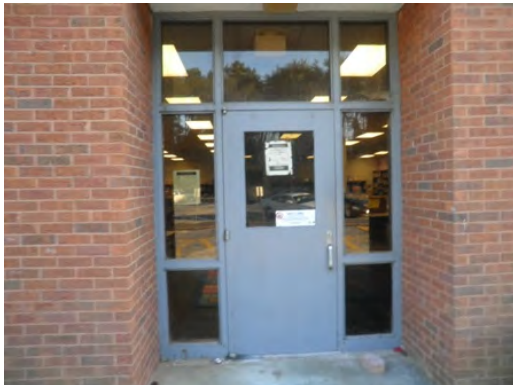
Assembly: **B2030**
System: **Exterior Doors**
Material: **System**
Distress: **Beyond Service Life**
Category: **Deferred Maintenance**
Correction: **Renew System**
Note: **The original exterior doors are aged and should be replaced with energy efficient doors.**

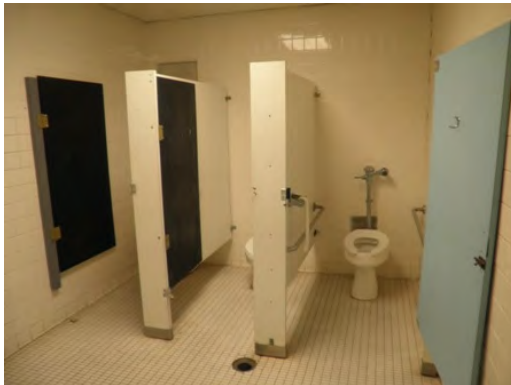
Assembly: **C1030**
 System: **Fittings**
 Material: **System**
 Distress: **Beyond Service Life**
 Category: **Deferred Maintenance**
 Correction: **Renew System**
 Note: **Fittings, such as chalk and tack boards, toilet and bath accessories, toilet partitions, and shelving, are aged, worn, and damaged, and should be replaced.**

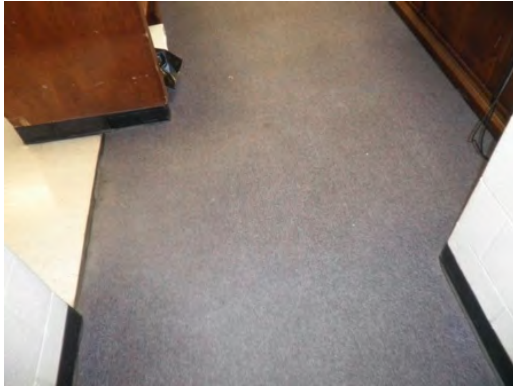
Assembly: **C3020**
System: **Floor Finishes - Carpet**
Material: **System**
Distress: **Beyond Service Life**
Category: **Deferred Maintenance**
Correction: **Renew System**
Note: **The carpet is aged and frayed and should be replaced.**

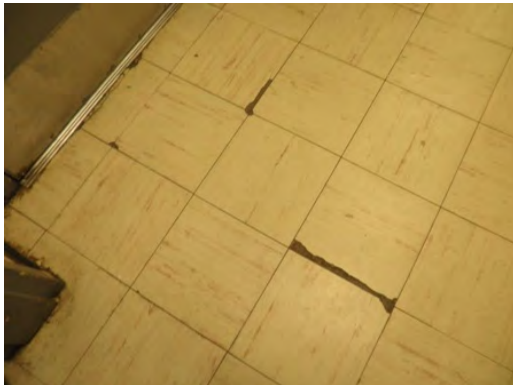
Assembly: **C3020**
System: **Floor Finishes - VCT**
Material: **System**
Distress: **Beyond Service Life**
Category: **Deferred Maintenance**
Correction: **Renew System**
Note: **The VCT tile is beyond its service life in many of the classrooms and halls. Some VCT tile was replaced in 2003, however, a majority of the system is worn and damaged and the entire system should be replaced.**

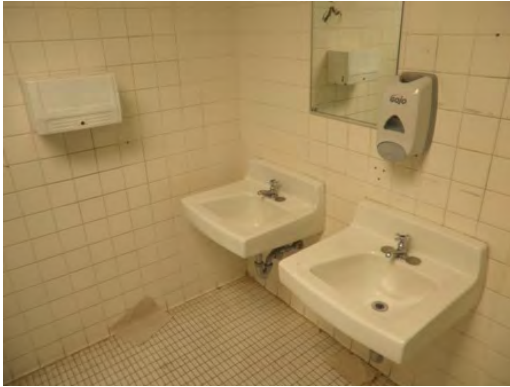
Assembly: **D2010**
 System: **Plumbing Fixtures**
 Material: **System**
 Distress: **Beyond Service Life**
 Category: **Deferred Maintenance**
 Correction: **Renew System**
 Note:

While the plumbing fixtures in the gang restrooms were replaced in 2010, the remaining plumbing fixtures in the classrooms, kitchen, staff lounge, janitor's closets, and mechanical spaces are original and worn and should be replaced.

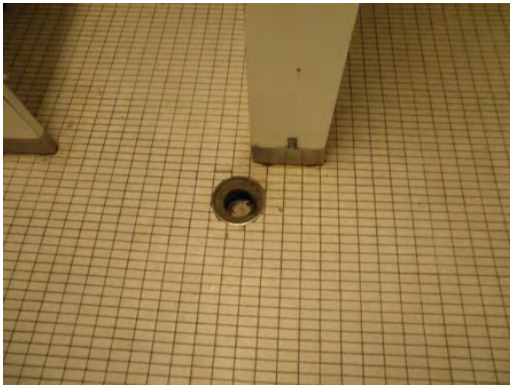
Assembly: **D2030**
 System: **Sanitary Waste**
 Material: **System**
 Distress: **Beyond Service Life**
 Category: **Deferred Maintenance**
 Correction: **Renew System**
 Note:

The original cast iron sanitary waste system is aged, has reported odors and multiple stoppages, and should be replaced.

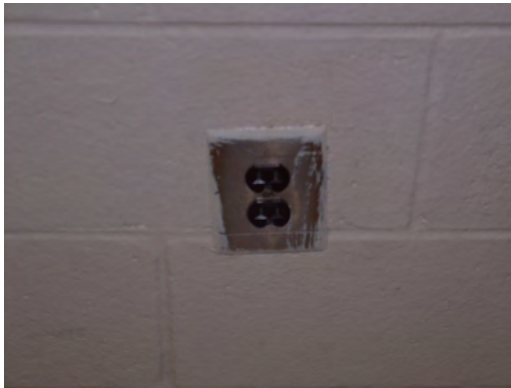
Assembly: **D5020**
System: **Branch Wiring System**
Material: **System**
Distress: **Beyond Service Life**
Category: **Deferred Maintenance**
Correction: **Renew System**

Note: **The original branch wiring system is operating, but is aged, nearing capacity, in poor condition, and should be replaced.**

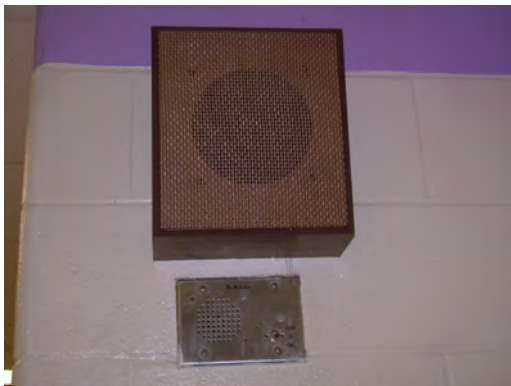
Note: **The original clock and PA systems are aged and should be replaced.**

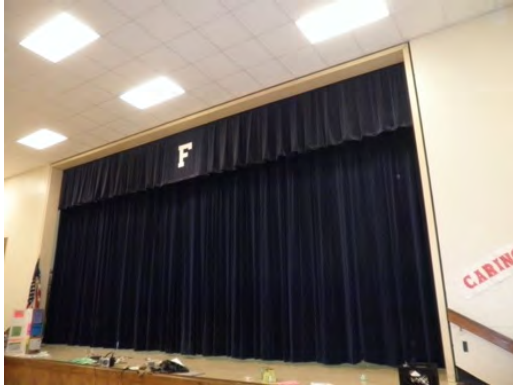
Note: **The stage lighting, curtain, and sound system are aged beyond their service life and should be replaced.**

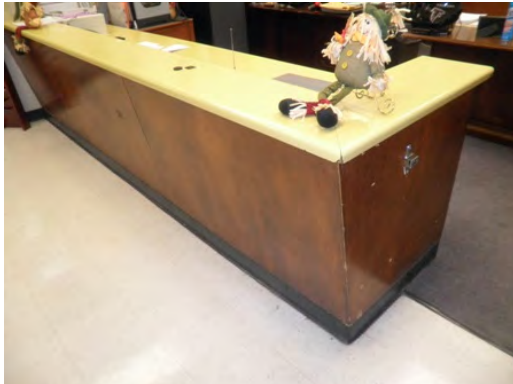
Note: **Fixed furnishings, such as the base/wall cabinets, counter tops, window shades, and fixed seating, are worn and damaged, and should be replaced.**

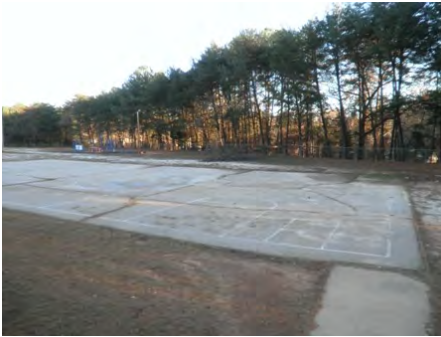
The Hard Surface Play Area at Farrington Elementary School is located at located on the campus grounds. There have been no additions and no major renovations. This report contains condition and adequacy data collected during the 2010/2011 Facility Condition Assessment (FCA). The detailed condition and deficiency statements are contained in this report.

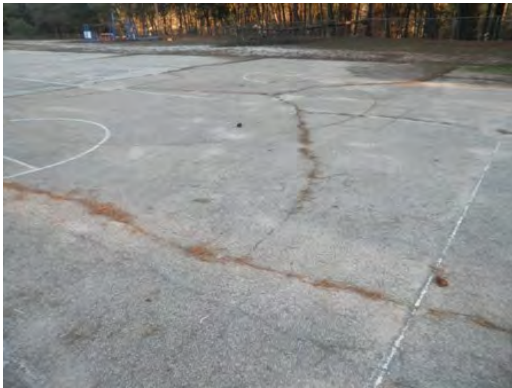
Assembly: **F1040**
System: **Special Facilities - Basketball Court Hard Surface System**
Material: **Beyond Service Life**
Distress: **Deferred Maintenance**
Category: **Renew System**
Correction: **The basketball court hard surface is aged and cracked and should be resurfaced and restriped.**

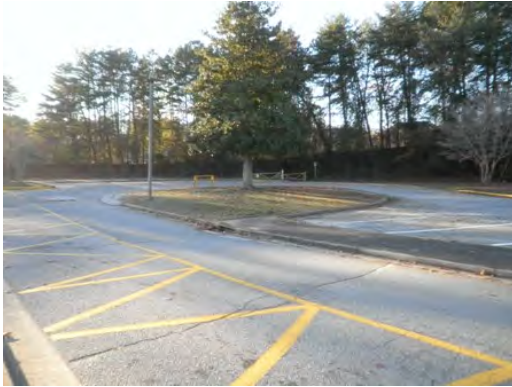
Assembly: **G2010**
System: **Roadways**
Material: **System**
Distress: **Beyond Service Life**
Category: **Deferred Maintenance**
Correction: **Renew System**
Note: **The roadways are aged and cracking, and should be re-surfaced and re-stripped.**

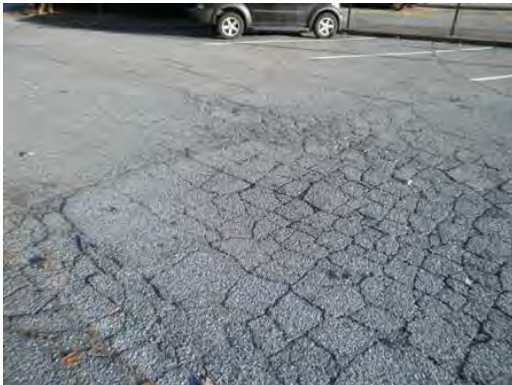
Assembly: **G2020**
System: **Parking Lots**
Material: **System**
Distress: **Beyond Service Life**
Category: **Deferred Maintenance**
Correction: **Renew System**
Note: **The parking lots are aged and cracked and should be resurfaced and restriped.**

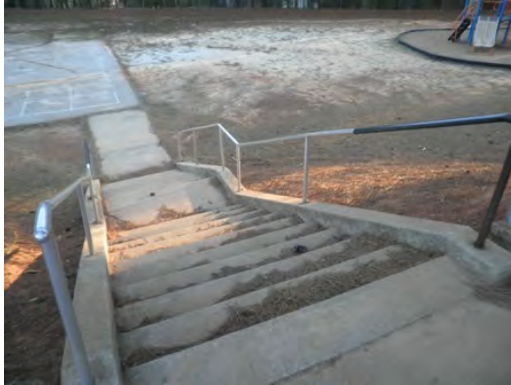
Note: **The pedestrian paving and walkways are aged and damaged and should be replaced.**

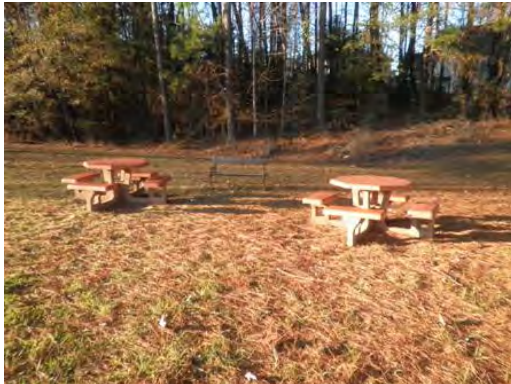
Note: **Site development features, such as the flagpole, site furnishings, and signage, are beyond their service life and should be replaced.**

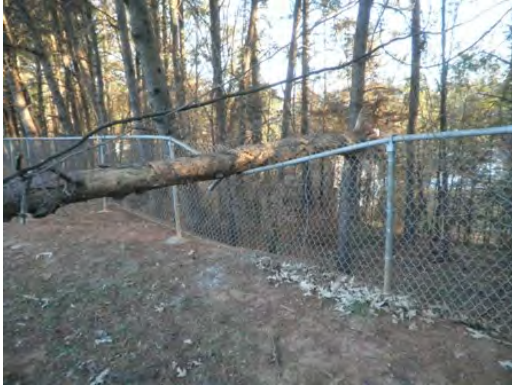
Note: **The fencing is beyond its service life, is damaged in some places, and should be replaced.**
