# **Facility Condition Assessment Report**

**DeKalb County School System**1701 Mountain Industrial Blvd  
Stone Mountain, GA 30083COMET4 Facility Report  
**International Student Center Facility Executive Summary Report**Report Date: 24 Jun 2011

**Facility:** \Middle Schools\International Student Center**Address:** 2383 N. Druid Hills Road, Atlanta, GA 30329**Attributes:****Facility Code** 0288  
**Super Cluster** 6**General Information:****Function:** Middle School  
**Gross Area:** 47,808 S.F.**Year Built:**  
**Last Renovation:****Facility Description:**

The International Student Center (Druid Hills) campus consists of two buildings located at 2383 N. Druid Hills Road in Atlanta, Georgia. The original campus was constructed in 1958, additions to the main school building were constructed in 1960 and 1963, and a gymnasium building was constructed in 2000. In addition to these buildings, the campus contains a storage building and covered walkway. This report contains condition and adequacy data collected during the 2010/2011 Facility Condition Assessment (FCA). The detailed condition and deficiency statements are contained in this report for each building and other facilities on

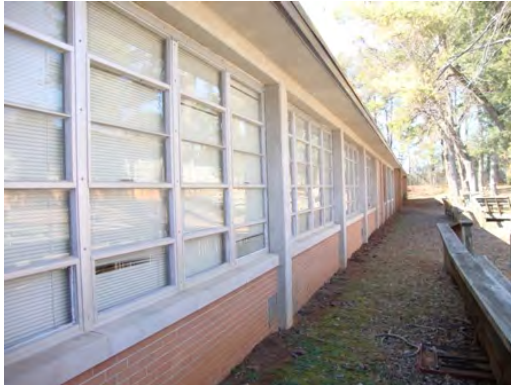
Assembly: **B2020**  
System: **Exterior Windows**  
Material: **System**  
Distress: **Beyond Service Life**  
Category: **Deferred Maintenance**  
Correction: **Renew System**  
Note: **The original metal frame, single pane, operable windows are aged, worn, and inefficient, and should be replaced.**

Raw Cost	<b>\$270,065.40</b>
Plus or (Minus) Additional Cost	<b>\$102,624.85</b>
Total Estimated Amount	<b>\$372,690.25</b>

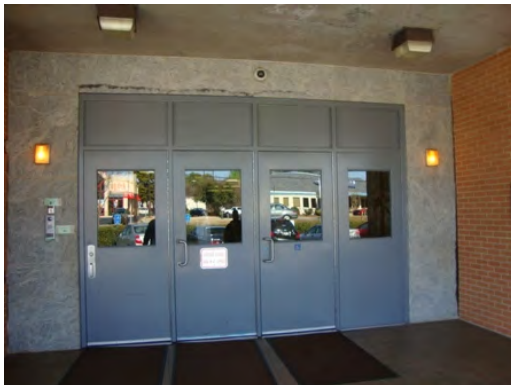
Assembly: **B2030**  
System: **Exterior Doors**  
Material: **System**  
Distress: **Beyond Service Life**  
Category: **Deferred Maintenance**  
Correction: **Renew System**  
Note: **The original metal exterior doors are aged, rusted, and damaged, and should be replaced with energy efficient doors.**

Raw Cost	<b>\$26,075.28</b>
Plus or (Minus) Additional Cost	<b>\$9,908.61</b>
Total Estimated Amount	<b>\$35,983.89</b>

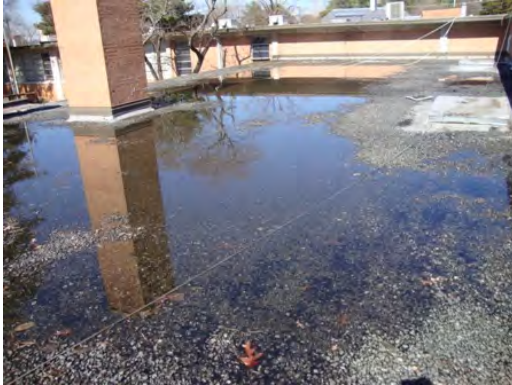
Assembly: **B3010**  
System: **Roof Coverings - BUR System**  
Material: **Beyond Service Life**  
Distress: **Beyond Service Life**  
Category: **Deferred Maintenance**  
Correction: **Renew System**

Note: **The roof covering is beyond its service life, has standing water, and should be scheduled for replacement.**

Raw Cost	<b>\$187,183.26</b>
Plus or (Minus) Additional Cost	<b>\$71,129.64</b>
Total Estimated Amount	<b>\$258,312.90</b>

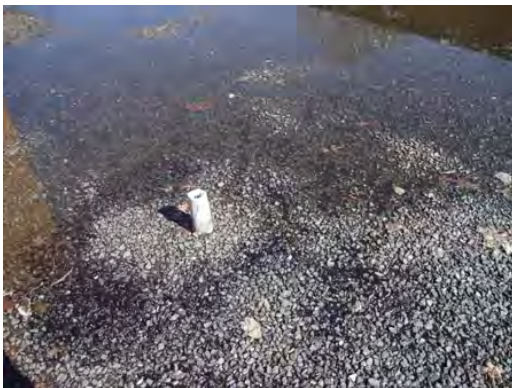
Assembly: **B3020**  
System: **Roof Openings System**  
Material: **Beyond Service Life**  
Distress: **Beyond Service Life**  
Category: **Deferred Maintenance**  
Correction: **Renew System**

Note: **The roof openings are aged, worn, and should be replaced in conjunction with the roof.**

Raw Cost	<b>\$931.26</b>
Plus or (Minus) Additional Cost	<b>\$353.88</b>
Total Estimated Amount	<b>\$1,285.14</b>

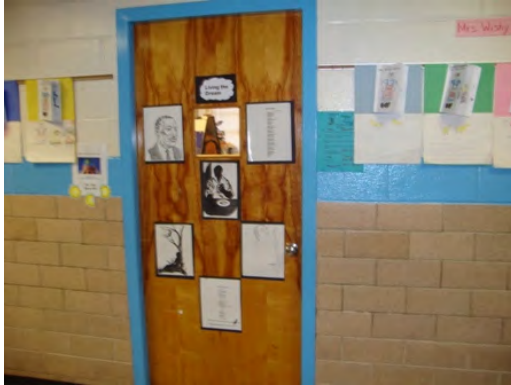
Note: **The doors are original and worn and should be replaced.**

Raw Cost	<b>\$48,086.88</b>
Plus or (Minus) Additional Cost	<b>\$18,273.01</b>
Total Estimated Amount	<b>\$66,359.89</b>

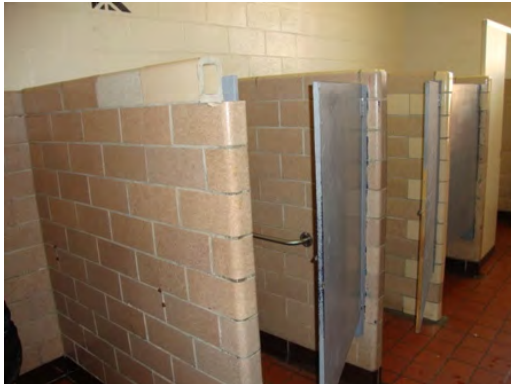
Note: **Fittings, such as chalk and tack boards, toilet and bath accessories, toilet partitions, and shelving, are aged, worn, and damaged, and should be replaced.**

Raw Cost	<b>\$63,791.31</b>
Plus or (Minus) Additional Cost	<b>\$24,240.70</b>
Total Estimated Amount	<b>\$88,032.01</b>

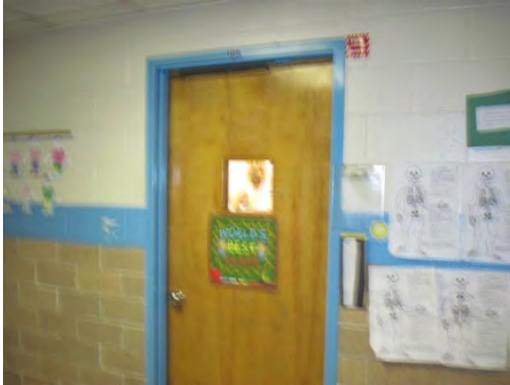
**Note:** The wall paint is aged and scuffed and should be repainted.

Raw Cost	<b>\$24,399.01</b>
Plus or (Minus) Additional Cost	<b>\$9,271.62</b>
Total Estimated Amount	<b>\$33,670.63</b>

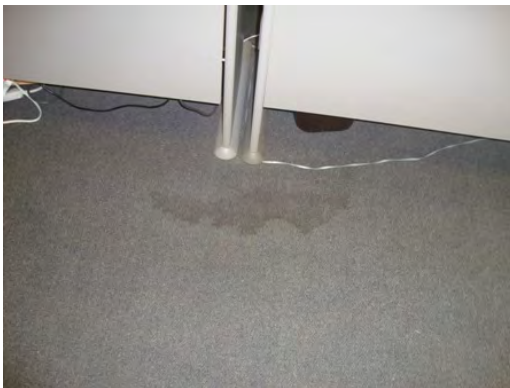
**Note:** The carpet is aged, worn, and stained, and should be replaced.

Raw Cost	<b>\$13,273.59</b>
Plus or (Minus) Additional Cost	<b>\$5,043.96</b>
Total Estimated Amount	<b>\$18,317.55</b>

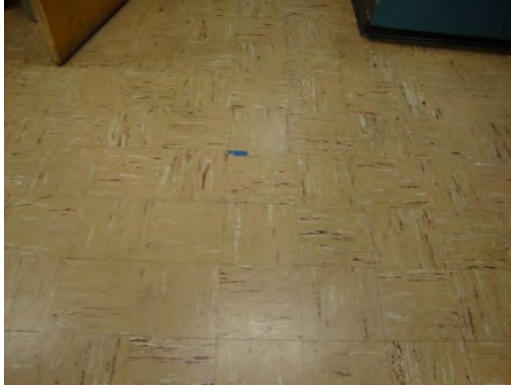
Note: **The VCT and VAT are beyond their service life, worn, and separating, and should be replaced.**

Raw Cost	<b>\$207,624.42</b>
Plus or (Minus) Additional Cost	<b>\$78,897.28</b>
Total Estimated Amount	<b>\$286,521.70</b>

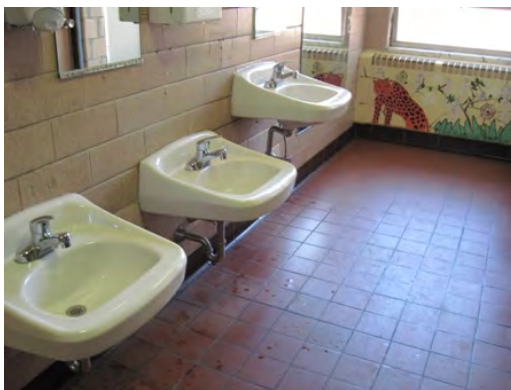
Note: **While the plumbing fixtures in the gang restrooms were replaced in 2010, the remaining plumbing fixtures in the hallways, classrooms, kitchen restrooms, staff lounge restrooms, janitor's closets, and mechanical spaces were not. These plumbing fixtures should also be replaced, as they are aged and worn.**

Raw Cost	<b>\$249,577.68</b>
Plus or (Minus) Additional Cost	<b>\$94,839.52</b>
Total Estimated Amount	<b>\$344,417.20</b>

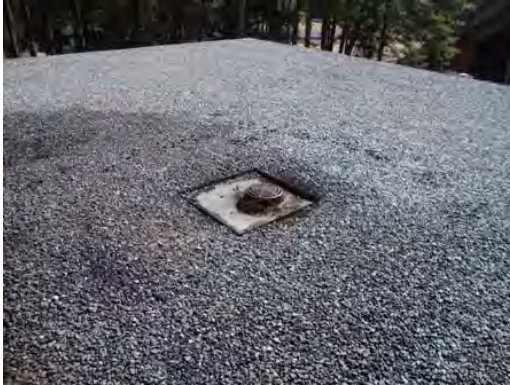
Note: **The rain water drainage system is aged, causing standing water on the roof, and should be replaced.**

Raw Cost	<b>\$28,403.43</b>
Plus or (Minus) Additional Cost	<b>\$10,793.30</b>
Total Estimated Amount	<b>\$39,196.73</b>

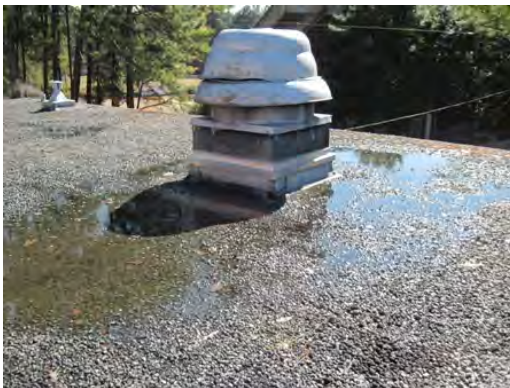
Assembly: **D3040**  
System: **Distribution Systems & Exhaust Systems**  
Material:  
Distress: **Beyond Service Life**  
Category: **Deferred Maintenance**  
Correction: **Renew System**  
Note: **The exhaust fans are inadequate and damaged, they do not ventilate restrooms properly, and should be replaced.**

Raw Cost	<b>\$157,382.94</b>
Plus or (Minus) Additional Cost	<b>\$59,805.52</b>
Total Estimated Amount	<b>\$217,188.46</b>

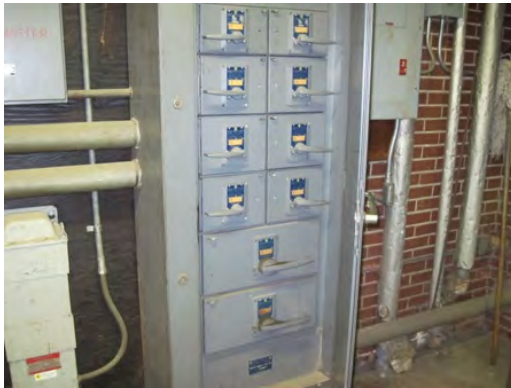
Note: **The original electrical service and distribution system is aged and inadequate for modern technology loads and should be replaced.**

Raw Cost	<b>\$62,394.42</b>
Plus or (Minus) Additional Cost	<b>\$23,709.88</b>
Total Estimated Amount	<b>\$86,104.30</b>

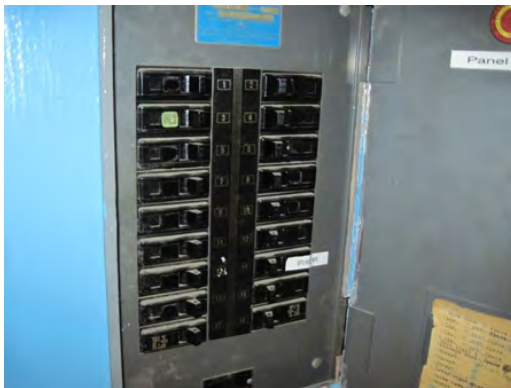
Note: **The original branch wiring system is operational, but is aged, nearing capacity, in poor condition, and should be replaced.**

Raw Cost	<b>\$179,267.55</b>
Plus or (Minus) Additional Cost	<b>\$68,121.67</b>
Total Estimated Amount	<b>\$247,389.22</b>

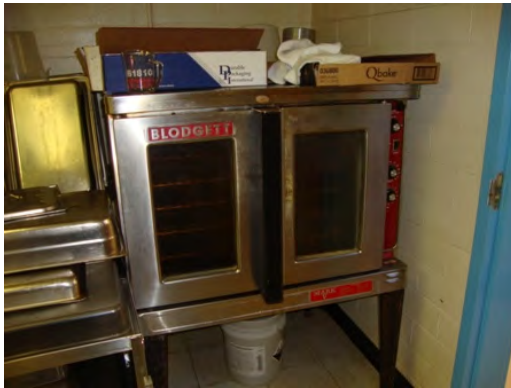
Assembly: **E1090**  
 System: **Other Equipment - Kitchen Equipment**  
 Material: **System**  
 Distress: **Inadequate**  
 Category: **Deferred Maintenance**  
 Correction: **Renew System**

Note: **The kitchen equipment is inadequate to support the entire middle school and should be scheduled for replacement.**

Raw Cost	<b>\$321,284.70</b>
Plus or (Minus) Additional Cost	<b>\$122,088.19</b>
Total Estimated Amount	<b>\$443,372.89</b>

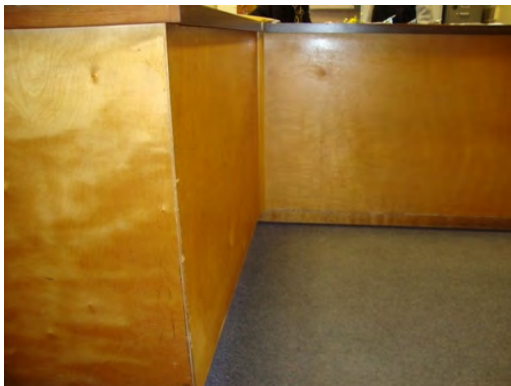
Note: **Fixed furnishings, such as the base/wall cabinets, counter tops, window shades, and fixed seating, are worn, beyond their service life, and should be replaced.**

Raw Cost	<b>\$174,145.62</b>
Plus or (Minus) Additional Cost	<b>\$66,175.34</b>
Total Estimated Amount	<b>\$240,320.96</b>

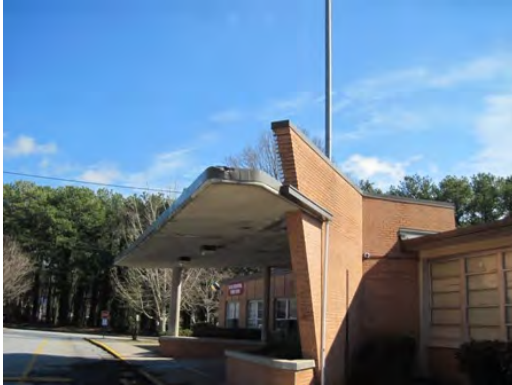
Note: **The main entrance canopy is leaking and cracking and should be repaired.**

Raw Cost	<b>\$40,044.18</b>
Plus or (Minus) Additional Cost	<b>\$15,216.79</b>
Total Estimated Amount	<b>\$55,260.97</b>

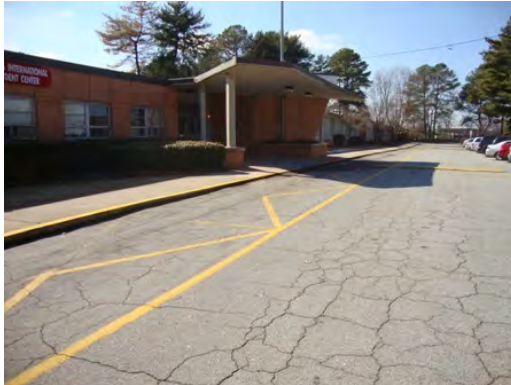
Assembly: **G2010**  
System: **Roadways**  
Material: **System**  
Distress: **Beyond Service Life**  
Category: **Deferred Maintenance**  
Correction: **Renew System**  
Note: **The roadways are aged and cracked, have many road cuts and repairs, and should be resurfaced and restriped.**

Raw Cost	<b>\$41,545.15</b>
Plus or (Minus) Additional Cost	<b>\$10,801.74</b>
Total Estimated Amount	<b>\$52,346.89</b>

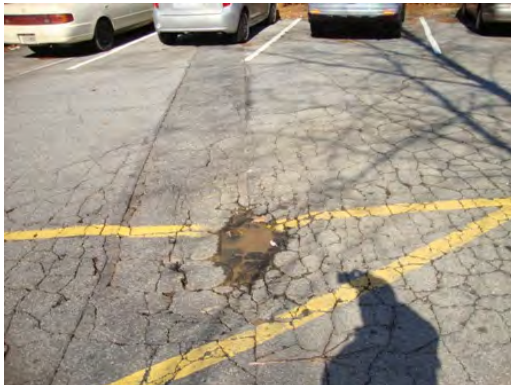
Assembly: **G2020**  
System: **Parking Lots**  
Material: **System**  
Distress: **Beyond Service Life**  
Category: **Deferred Maintenance**  
Correction: **Renew System**  
Note: **The parking lots are aged, cracking, and should be resurfaced and restriped.**

Raw Cost	<b>\$39,967.49</b>
Plus or (Minus) Additional Cost	<b>\$10,391.55</b>
Total Estimated Amount	<b>\$50,359.04</b>

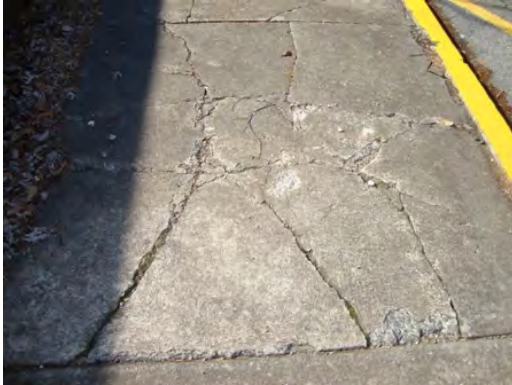
Note: **The pedestrian paving and walkways are aged and damaged and should be replaced.**

Raw Cost	<b>\$78,883.20</b>
Plus or (Minus) Additional Cost	<b>\$20,509.63</b>
Total Estimated Amount	<b>\$99,392.83</b>

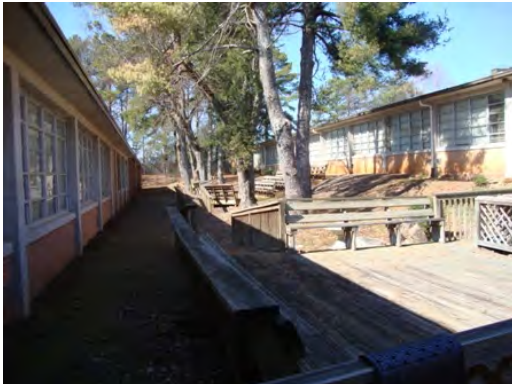
Note: **Site development features, such as site furnishings and signage, are beyond their service life and should be scheduled for replacement.**

Raw Cost	<b>\$11,043.65</b>
Plus or (Minus) Additional Cost	<b>\$2,871.35</b>
Total Estimated Amount	<b>\$13,915.00</b>

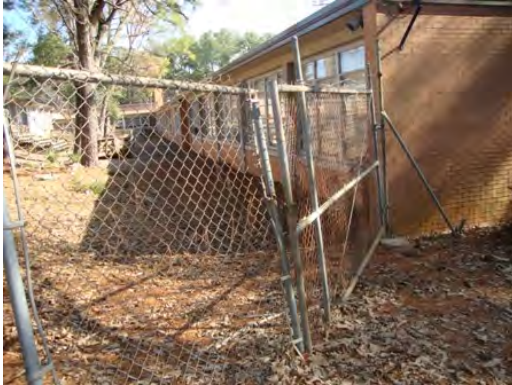
Assembly: **G2040105**  
System: **Fence & Guardrails**  
Material: **System**  
Distress: **Beyond Service Life**  
Category: **Deferred Maintenance**  
Correction: **Renew System**  
Note: **The fence is rusted and damaged and should be replaced.**

Raw Cost	<b>\$80,795.52</b>
Plus or (Minus) Additional Cost	<b>\$21,006.84</b>
Total Estimated Amount	<b>\$101,802.36</b>
