Facility Condition Assessment Report

DeKalb County School System1701 Mountain Industrial Blvd
Stone Mountain, GA 30083

McLendon Elementary Facility Executive Summary ReportReport Date: 01 Jul 2011

The McLendon Elementary School main building is a one-story building located at 3169 Hollywood Drive in Decatur, Georgia. Originally built in 1958, there have been additions in 1960, 1963, and 1969, and a major renovation in 2010. This report contains condition and adequacy data collected during the 2010/2011 Facility Condition Assessment (FCA). The detailed condition and deficiency statements are contained in this report.

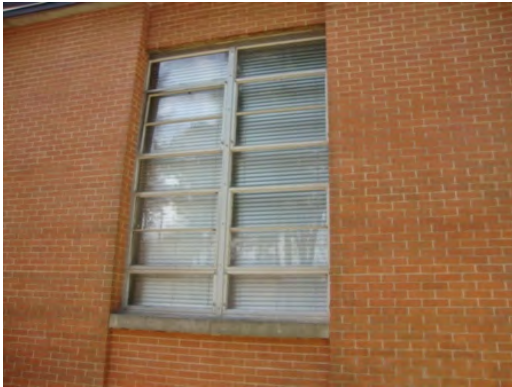
Assembly: **B2020**
System: **Exterior Windows**
Material: **System**
Distress: **Beyond Service Life**
Category: **Deferred Maintenance**
Correction: **Renew System**
Note:

The original metal frame, single pane, operable windows in the kitchen and dinning area are aged, worn, and inefficient and should be replaced.

Raw Cost	\$268,852.87
Plus or (Minus) Additional Cost	\$102,164.09
Total Estimated Amount	\$371,016.96

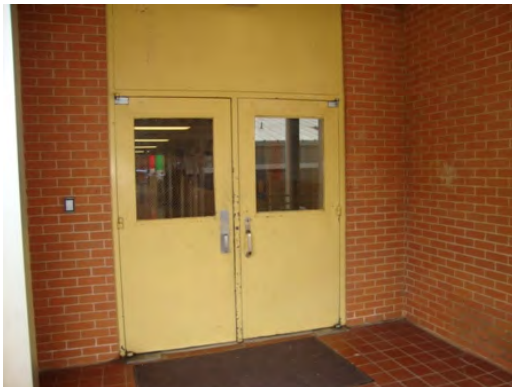
Assembly: **B2030**
System: **Exterior Doors**
Material: **System**
Distress: **Beyond Service Life**
Category: **Deferred Maintenance**
Correction: **Renew System**
Note:

The original metal exterior doors are aged, rusted, and damaged, and should be replaced.

Raw Cost	\$36,981.95
Plus or (Minus) Additional Cost	\$14,053.14
Total Estimated Amount	\$51,035.09

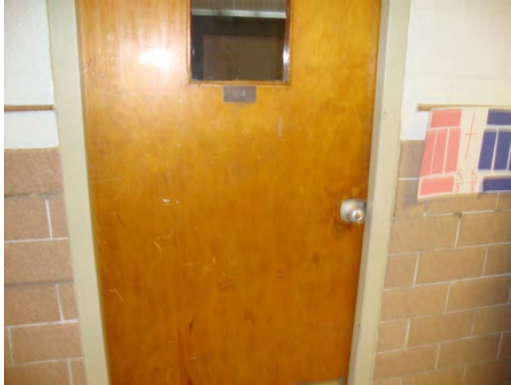
Assembly: **C1020**
 System: **Interior Doors**
 Material: **System**
 Distress: **Beyond Service Life**
 Category: **Deferred Maintenance**
 Correction: **Renew System**
 Note: **The doors and hardware are original and worn and should be replaced.**

Raw Cost	\$64,464.92
Plus or (Minus) Additional Cost	\$24,496.67
Total Estimated Amount	\$88,961.59

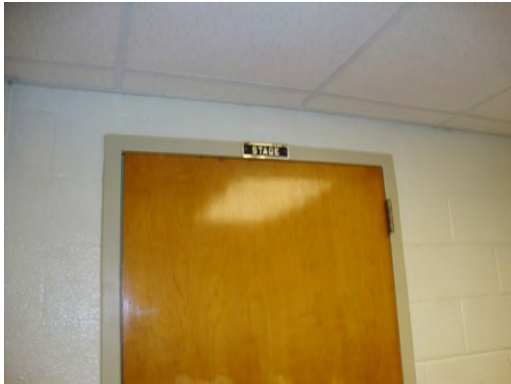
Assembly: **C1030**
 System: **Fittings**
 Material: **System**
 Distress: **Inadequate**
 Category: **Deferred Maintenance**
 Correction: **Renew System**
 Note: **Fittings, such as chalk and tack boards, toilet and bath accessories, toilet partitions, and signage, are aged, worn, and damaged, and should be replaced.**

Raw Cost	\$108,597.78
Plus or (Minus) Additional Cost	\$41,267.15
Total Estimated Amount	\$149,864.93

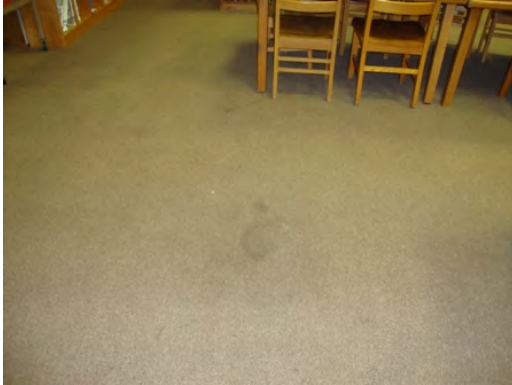
Assembly: **C3020**
 System: **Floor Finishes - Carpet**
 Material: **System**
 Distress: **Beyond Service Life**
 Category: **Deferred Maintenance**
 Correction: **Renew System**
 Note: **The carpet is aged, worn, and stained, and should be replaced.**

Raw Cost	\$36,898.95
Plus or (Minus) Additional Cost	\$14,021.60
Total Estimated Amount	\$50,920.55

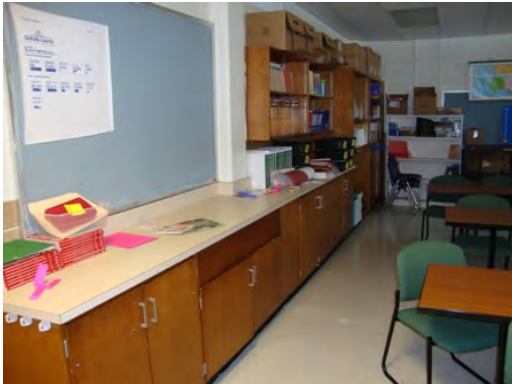
Assembly: **E2010**
 System: **Fixed Furnishings**
 Material: **System**
 Distress: **Beyond Service Life**
 Category: **Deferred Maintenance**
 Correction: **Renew System**
 Note: **Fixed furnishings, such as the base/wall cabinets, counter tops, window shades, and fixed seating, are worn, beyond their service life, and should be replaced.**

Raw Cost	\$179,626.59
Plus or (Minus) Additional Cost	\$68,258.10
Total Estimated Amount	\$247,884.69

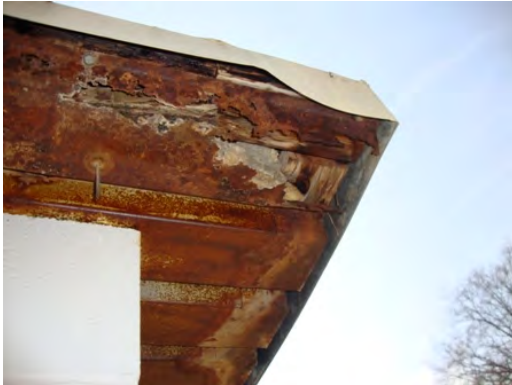
Assembly: **B1020**
System: **Roof Construction**
Material: **System**
Distress: **Damaged**
Category: **Deferred Maintenance**
Correction: **Renew System**
Note: **The metal roof deck is rusted, pitted with holes, and damaged, and should be replaced.**

Raw Cost	\$1,179.60
Plus or (Minus) Additional Cost	\$448.25
Total Estimated Amount	\$1,627.85

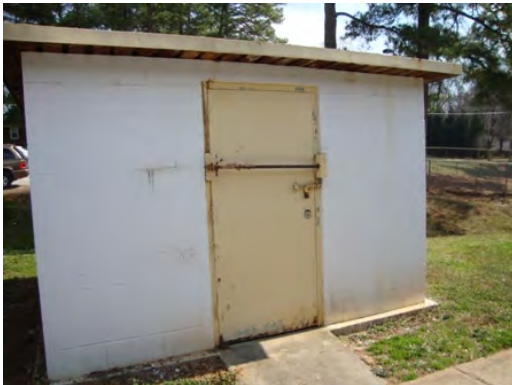
Assembly: **B2030**
System: **Exterior Doors**
Material: **System**
Distress: **Beyond Service Life**
Category: **Deferred Maintenance**
Correction: **Renew System**
Note: **The door is original aged and weathered and should be replaced.**

Raw Cost	\$462.00
Plus or (Minus) Additional Cost	\$175.56
Total Estimated Amount	\$637.56

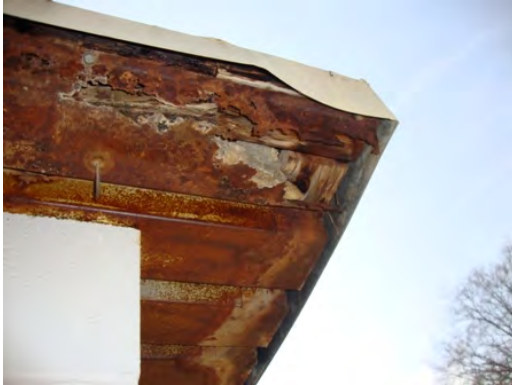
Assembly: **B3010**
System: **Roof Coverings**
Material: **System**
Distress: **Beyond Service Life**
Category: **Deferred Maintenance**
Correction: **Renew System**
Note: **The roof covering is aged and should be replaced in conjunction with the roof deck.**

Raw Cost	\$1,374.12
Plus or (Minus) Additional Cost	\$522.17
Total Estimated Amount	\$1,896.29

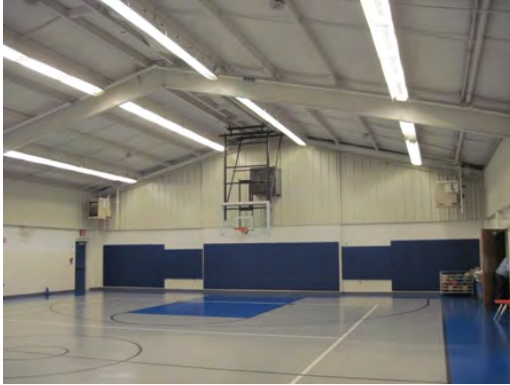
Assembly: **D3050**
System: **Terminal & Package Units**
Material: **Packaged A/C, Elec. Ht., Const. Volume**
Distress: **Missing**
Category: **Capital Improvement**
Correction: **Install Package A/C - 20 ton**
Note: **An air conditioning system is missing in the gymnasium and should be installed.**

Raw Cost	\$40,691.00
Plus or (Minus) Additional Cost	\$15,462.58
Total Estimated Amount	\$56,153.58

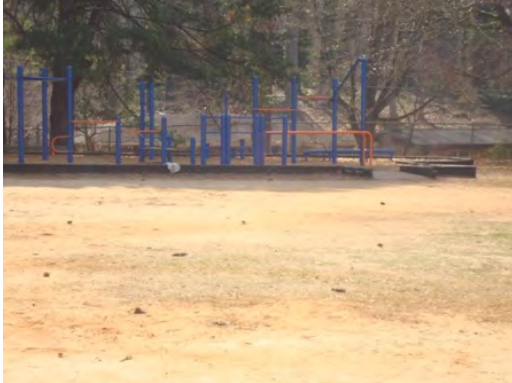
Assembly: **F1040**
System: **Special Facilities - Sports Field - Natural Turf System**
Material: **Beyond Service Life**
Distress: **Beyond Service Life**
Category: **Deferred Maintenance**
Correction: **Renew System**
Note: **The playfield turf is worn and should be reseeded.**

Raw Cost	\$10,560.00
Plus or (Minus) Additional Cost	\$2,745.60
Total Estimated Amount	\$13,305.60

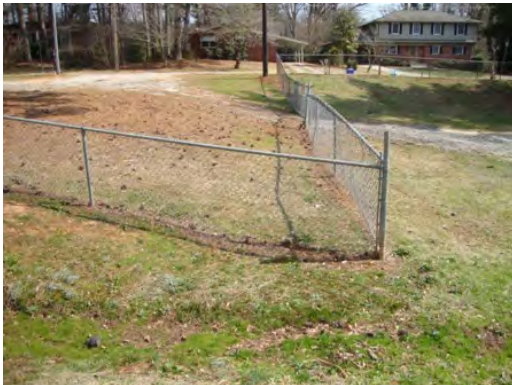
Assembly: **G2040**
System: **Site Development - Fencing System**
Material: **Beyond Service Life**
Distress: **Beyond Service Life**
Category: **Deferred Maintenance**
Correction: **Renew System**
Note: **The fence is rusted and damaged and should be replaced.**

Raw Cost	\$58,080.00
Plus or (Minus) Additional Cost	\$15,100.80
Total Estimated Amount	\$73,180.80

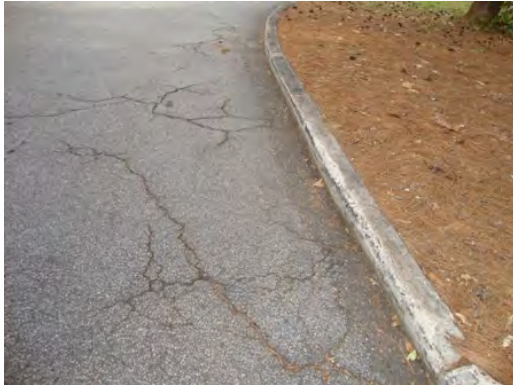
Assembly: **G2010**
System: **Roadways**
Material: **System**
Distress: **Beyond Service Life**
Category: **Deferred Maintenance**
Correction: **Renew System**
Note: **The roadways are aged and cracked, have many road cuts and repairs, and should be resurfaced.**

Raw Cost	\$166,996.43
Plus or (Minus) Additional Cost	\$43,419.07
Total Estimated Amount	\$210,415.50

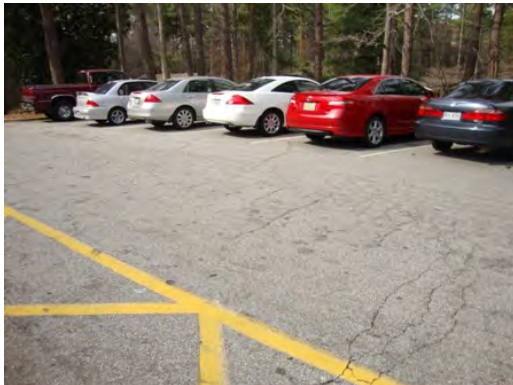
Assembly: **G2020**
System: **Parking Lots**
Material: **System**
Distress: **Beyond Service Life**
Category: **Deferred Maintenance**
Correction: **Renew System**
Note: **The parking lots are aged and cracked and should be resurfaced and expanded.**

Raw Cost	\$75,730.94
Plus or (Minus) Additional Cost	\$19,690.04
Total Estimated Amount	\$95,420.98

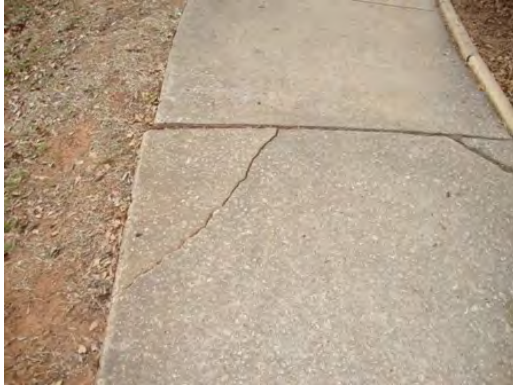
Note: **The pedestrian paving and walkways are aged and damaged and should be replaced.**

Raw Cost	\$84,792.76
Plus or (Minus) Additional Cost	\$22,046.12
Total Estimated Amount	\$106,838.88

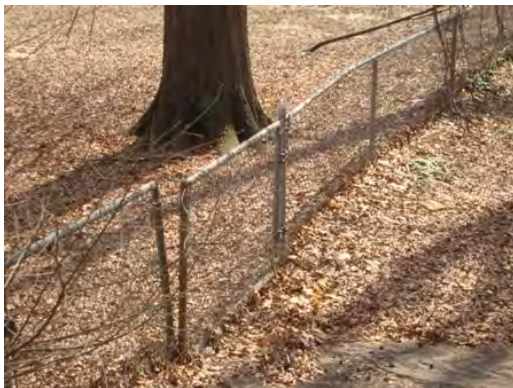
Note: **The fencing is aged, rusted, and damaged, and should be replaced.**

Raw Cost	\$92,383.51
Plus or (Minus) Additional Cost	\$24,019.71
Total Estimated Amount	\$116,403.22
