Facility Condition Assessment Report

DeKalb County School System1701 Mountain Industrial Blvd
Stone Mountain, GA 30083

Narvie Harris Elementary Facility Executive Summary ReportReport Date: 05 Jul 2011

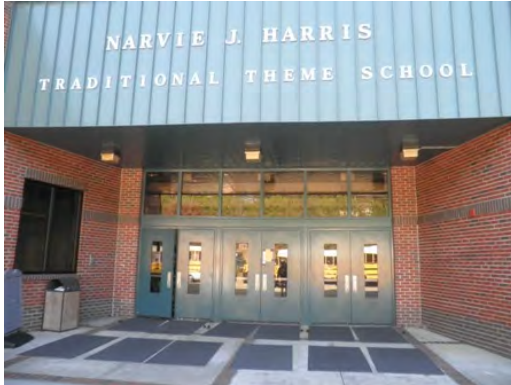
Assembly: **B2030**
System: **Exterior Doors**
Material: **Door Opener**
Distress: **Missing**
Category: **Code Compliance**
Correction: **Install Door Opener**
Note: **The main entrance to the building lacks an automatic door opener.**

Raw Cost	\$4,350.00
Plus or (Minus) Additional Cost	\$1,653.00
Total Estimated Amount	\$6,003.00

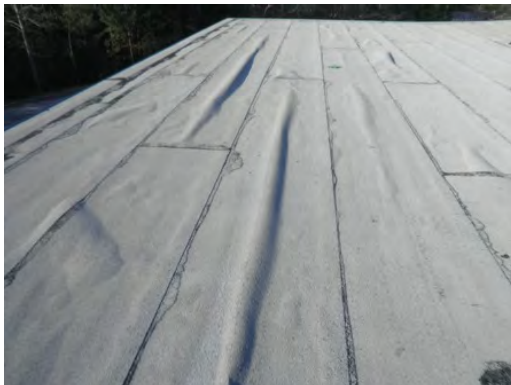
Assembly: **B3010**
System: **Roof Coverings - BUR**
Material: **System**
Distress: **Needs Remediation**
Category: **Deferred Maintenance**
Correction: **Renew System**
Note: **The built up roof covering should be scheduled for replacement due to blistering, ice-water shield damage, and leaks through the school.**

Raw Cost	\$197,375.97
Plus or (Minus) Additional Cost	\$75,002.87
Total Estimated Amount	\$272,378.84

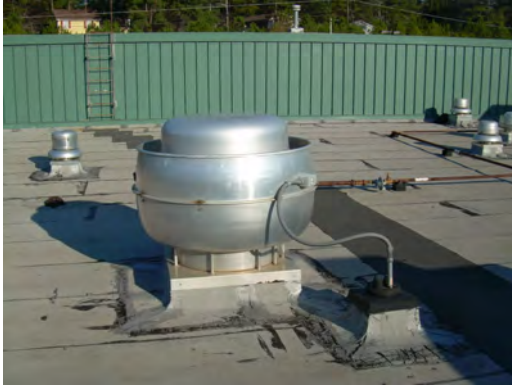
Assembly: **D3040**
System: **Distribution & Exhaust Systems**
Material: **Roof Exhaust Fan Systems**
Distress: **Needs Remediation**
Category: **Deferred Maintenance**
Correction: **Replace Exhaust System**

Note: **The restrooms exhaust fans are inadequate, do not ventilate restrooms properly, and should be replaced.**

Raw Cost	\$36,925.00
Plus or (Minus) Additional Cost	\$14,031.50
Total Estimated Amount	\$50,956.50

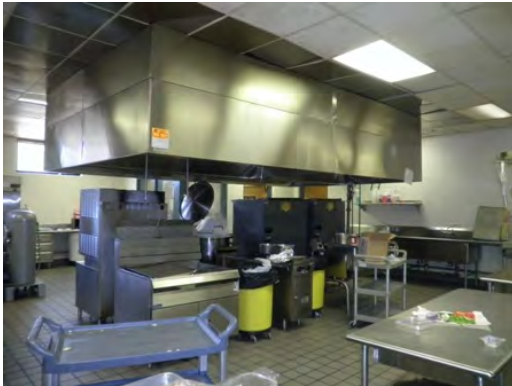
Assembly: **D3050**
System: **Terminal & Package Units**
Material: **Package A/C Gas Ht. Multi-Zone**
Distress: **Missing**
Category: **Deferred Maintenance**
Correction: **Install 15 ton Multi-Zone RTU**

Note: **The kitchen has no cooling system and the area is uncomfortable to work in. Install a new packaged AC unit to serve this area.**

Raw Cost	\$38,550.00
Plus or (Minus) Additional Cost	\$14,649.00
Total Estimated Amount	\$53,199.00

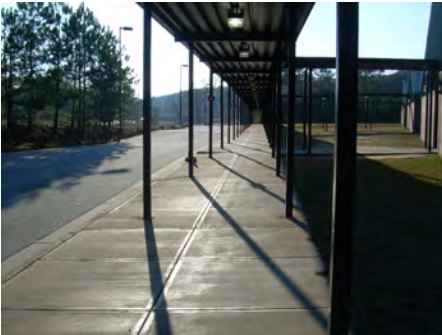
07-Dec-2010
Northwest Elevation

An engineered metal covered walkway connects the main building to the school bus loading/unloading zone and provides some weather protection for the students.

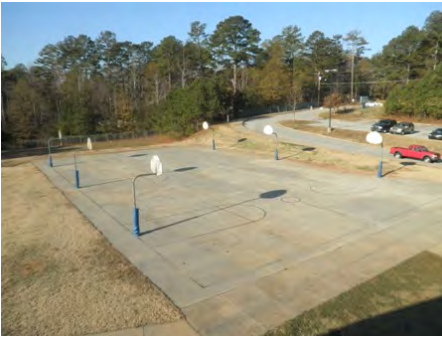
The Hard Surface Play Area at Narvie Harris Elementary School is located on the campus grounds. There have been no additions or renovations. This report contains condition and adequacy data collected during the 2010/2011 Facility Condition Assessment (FCA). The detailed condition and deficiency statements are contained in this report.

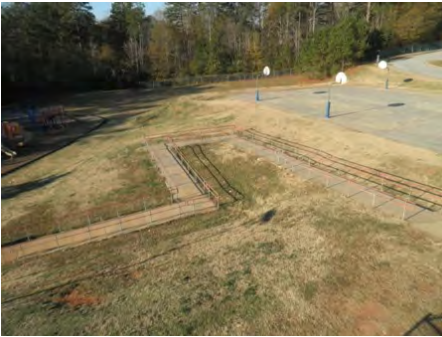
07-Dec-2010
Playfield at Narvie Harris Elementary
School

The Playfield at Narvie Harris Elementary School is located on the campus grounds. There have been no additions and no renovations. This report contains condition and adequacy data collected during the 2010/2011 Facility Condition Assessment (FCA). The detailed condition and deficiency statements are contained in this report.

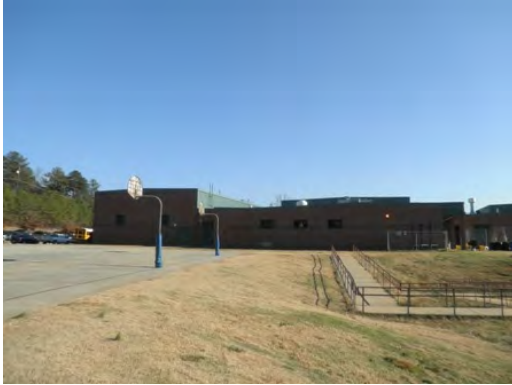
Assembly: **F1040**
System: **Special Facilities - Sports Field - Natural Turf System**
Material: **System**
Distress: **Beyond Service Life**
Category: **Deferred Maintenance**
Correction: **Renew System**
Note: **The field turf is in need of reseeding.**

Raw Cost	\$2,541.00
Plus or (Minus) Additional Cost	\$660.66
Total Estimated Amount	\$3,201.66
