Facility Condition Assessment Report

Oakcliff Elementary Facility Executive Summary ReportReport Date: 05 Jul 2011

COMET4 Survey Report
Oakcliff Elementary Detailed Facility Needs Assessment Report

Facility: \Elementary Schools\Oakcliff Elementary\ 1964, 1966, 1970 Building**Address:** 3150 Willow Oak Way, Doraville, GA 30340**Attributes:****Building Codes** 2010, 2011, 2012
Fire Sprinkler System No**General Information:****Function:** Elementary School **Year Built:** 1964
Gross Area: 66,750 S.F. **Last Renovation:** 1999**Facility Description:**

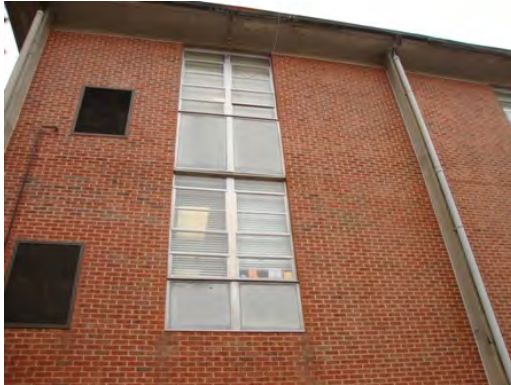
Assembly: **B2020**
System: **Exterior Windows**
Material: **System**
Distress: **Beyond Service Life**
Category: **Deferred Maintenance**
Correction: **Renew System**
Note: **The original metal frame, single pane, operable windows are aged, worn, and inefficient, and should be replaced.**

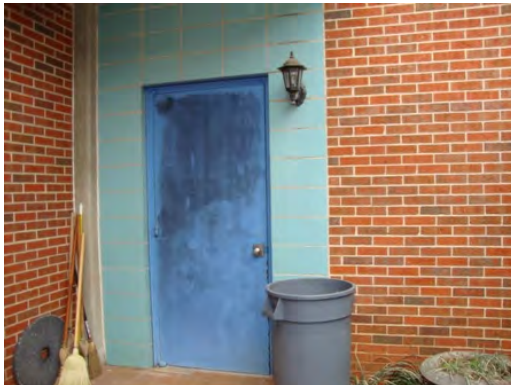
Assembly: **B2030**
System: **Exterior Doors**
Material: **System**
Distress: **Beyond Service Life**
Category: **Deferred Maintenance**
Correction: **Renew System**
Note: **The exterior doors and hardware are original and worn and should be replaced.**

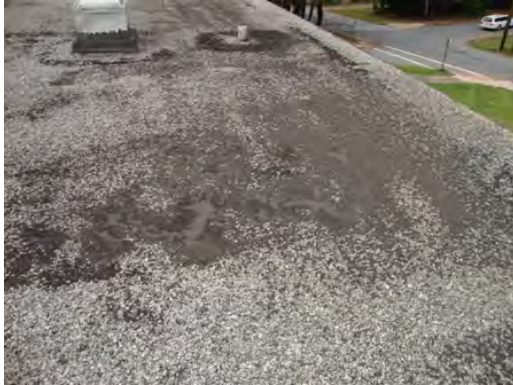
Note: **The roof covering is aged, has standing water, and should be scheduled for replacement.**

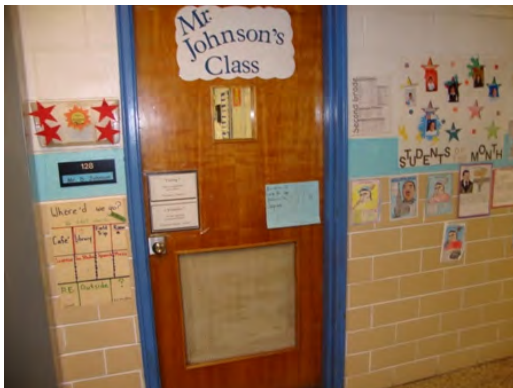
Note: **The original interior doors and hardware are aged and damaged and should be replaced.**

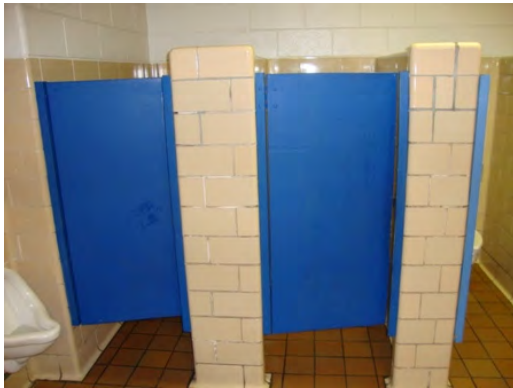
Note: **Fittings, such as chalk and tack boards, toilet and bath accessories, toilet partitions, and directional signage, are aged, worn, and damaged, and should be replaced.**

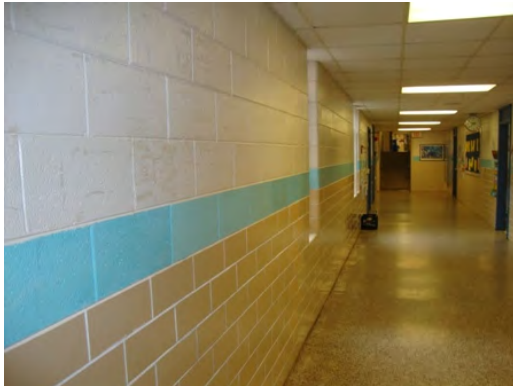
Note: **The painted wall finishes are aged and scuffed and should be repainted.**

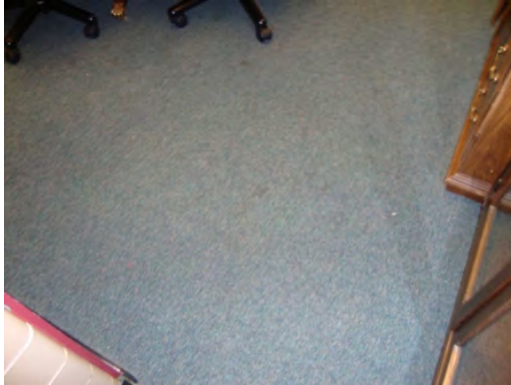
Assembly: **C3020**
System: **Floor Finishes - Carpet System**
Material: **Beyond Service Life**
Distress: **Beyond Service Life**
Category: **Deferred Maintenance**
Correction: **Renew System**
Note: **The carpet is aged, worn, and stained, and should be replaced.**

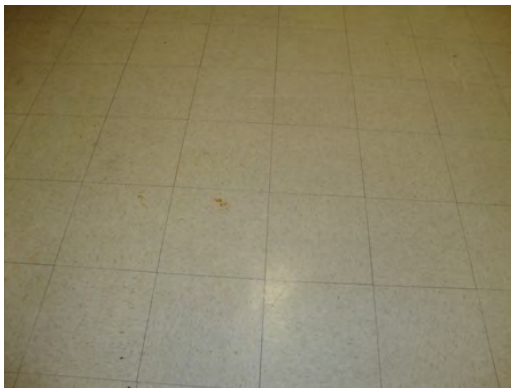
Assembly: **C3020**
System: **Floor Finishes - VCT System**
Material: **Beyond Service Life**
Distress: **Beyond Service Life**
Category: **Deferred Maintenance**
Correction: **Renew System**
Note: **The VCT is worn, scuffed, and separating, and should be replaced.**

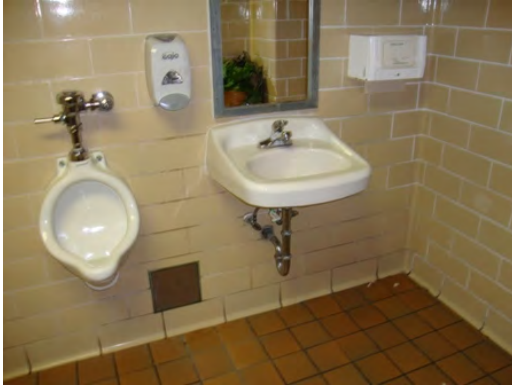
Note: **The original plumbing fixtures are aged and inefficient and should be replaced with low flow fixtures.**

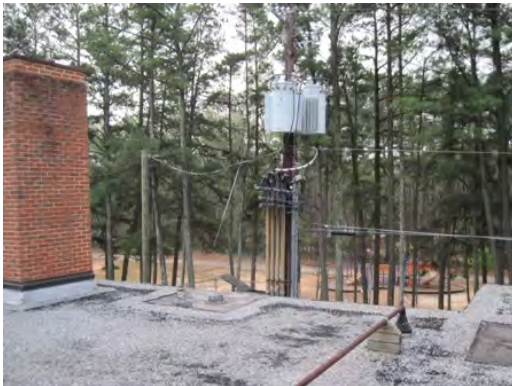
Note: **The rain water drainage system is aged and should be replaced in conjunction with the roof covering.**

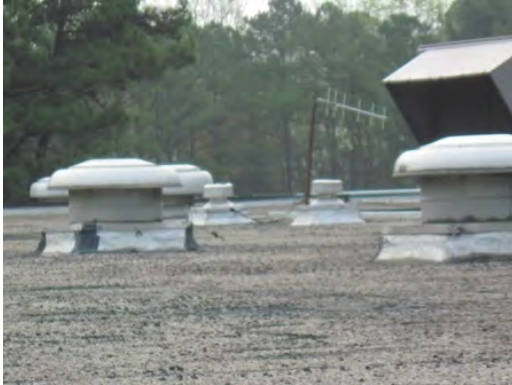
Note: The exhaust system is aged and ineffective and should be replaced.

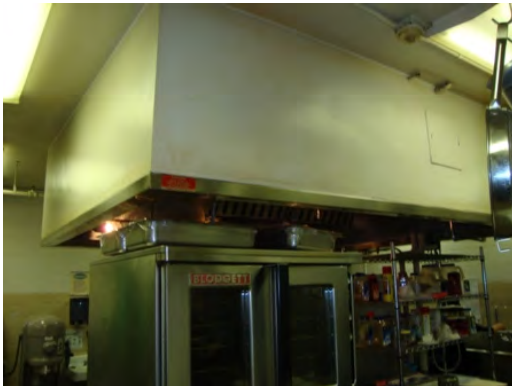
Note: The original kitchen hood system is aged and inefficient and should be replaced.

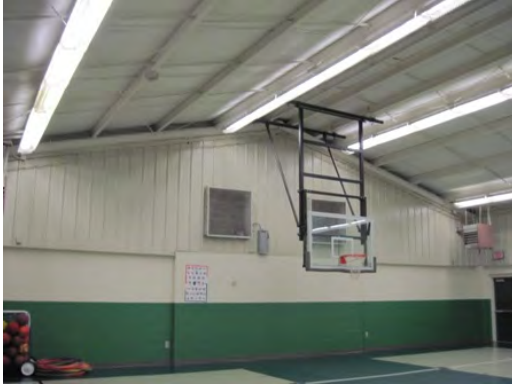
Assembly: **D3050**
System: **Terminal & Package Units**
Material: **Packaged A/C, Elec. Ht., Const. Volume**
Distress: **Missing**
Category: **Capital Improvement**
Correction: **Install Package A/C - 20 ton**
Note: **An air conditioning system is missing in the gymnasium and should be installed.**

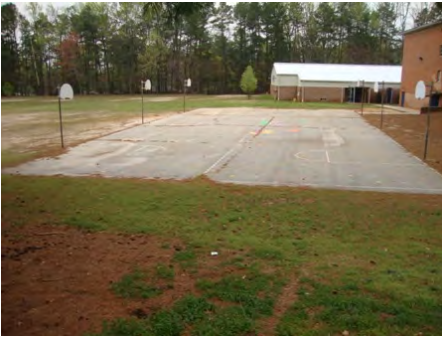
21-Mar-2011
Hard Surface Play Area at Oakcliff
Elementary School

| Facility Name | Assembly | System | Material | Distress | Correction | Qty | Unit | Raw Cost | Additional Cost | Total Cost | Priority | Def. Cat. | Location / Note |
|---|--|---|---|---|---|---|---|---|---|---|---|---|---|
| F1040 | Special Facilities - Basketball Court Hard Surface | System | | Beyond Service Life | Renew System | 1 | Ea. | \$79,797 | \$20,747 | \$100,544 | Necessary | Deferred Maintenance | The hard surface play area is aged and cracked and should be resurfaced and repainted |

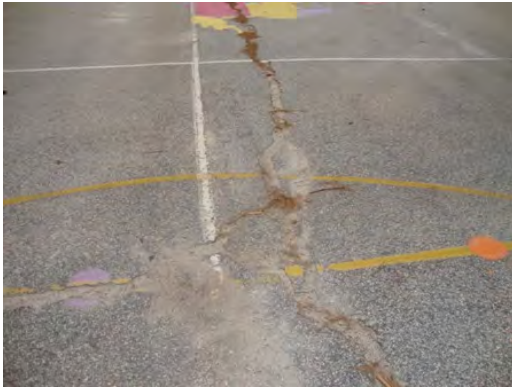
Note: **The hard surface play area is aged and cracked and should be resurfaced and repainted**

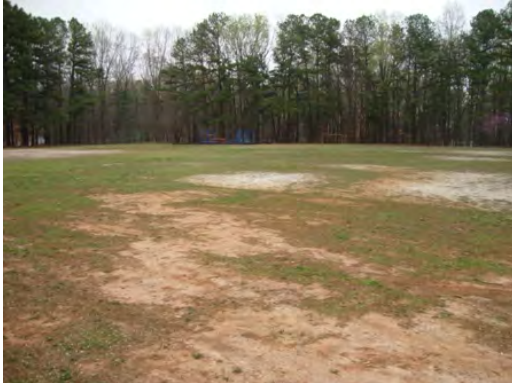
Assembly: **F1040**
System: **Special Facilities - Sports Field - Natural Turf System**
Material: **System**
Distress: **Beyond Service Life**
Category: **Deferred Maintenance**
Correction: **Renew System**
Note: **The playfield turf is worn and damaged and should be reseeded.**

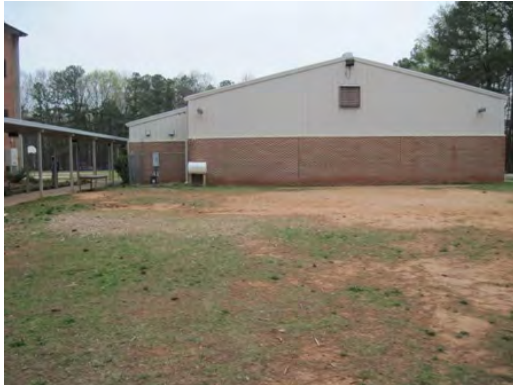
Assembly: **F1040**
System: **Special Facilities - Sports Field - Natural Turf System**
Material:
Distress: **Beyond Service Life**
Category: **Deferred Maintenance**
Correction: **Renew System**
Note: **The playfield turf is worn and should be reseeded.**

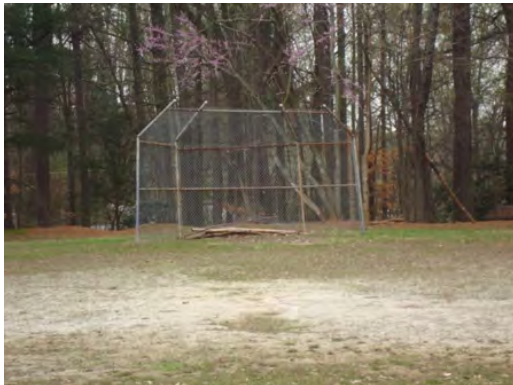
Assembly: **G2040**
System: **Site Development - Fencing System**
Material:
Distress: **Beyond Service Life**
Category: **Deferred Maintenance**
Correction: **Renew System**
Note: **The backstop is rusted and should be replaced.**

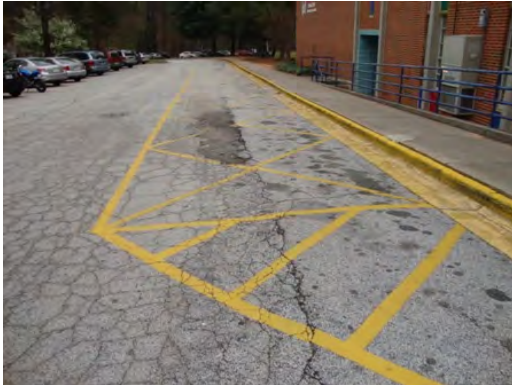
Assembly: **G2010**
System: **Roadways**
Material: **System**
Distress: **Beyond Service Life**
Category: **Deferred Maintenance**
Correction: **Renew System**
Note: **The roadways are aged and cracked, have many road cuts and repairs, and should be resurfaced and restriped.**

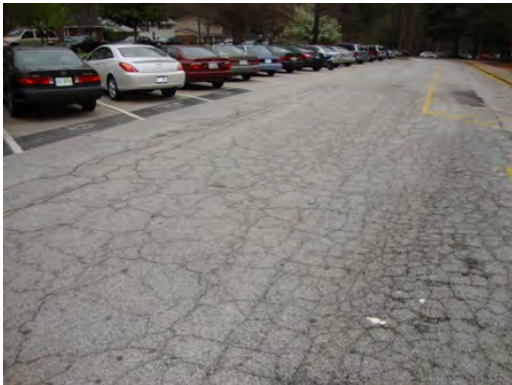
Assembly: **G2020**
System: **Parking Lots**
Material: **System**
Distress: **Beyond Service Life**
Category: **Deferred Maintenance**
Correction: **Renew System**
Note: **The parking lots are aged and cracked and should be resurfaced and restriped.**

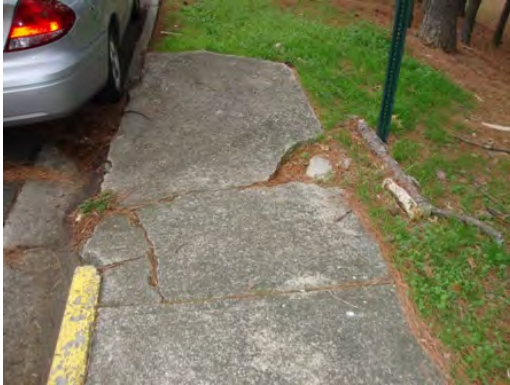
Note: **The pedestrian paving and walkways are aged and damaged and should be replaced.**

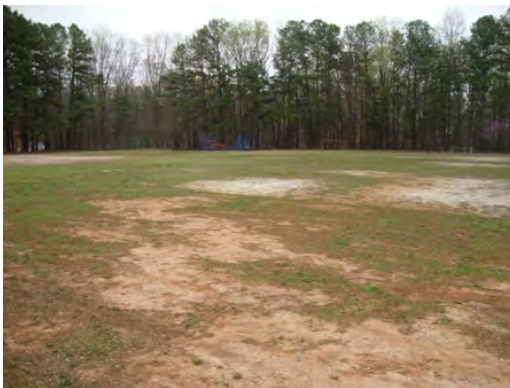
Assembly: **G2040**
System: **Site Development System**
Material: **Beyond Service Life**
Distress: **Deferred Maintenance**
Category: **Renew System**
Correction: **Renew System**
Note: **The site turf is worn and should be reseeded.**
