Facility Condition Assessment Report

DeKalb County School System1701 Mountain Industrial Blvd
Stone Mountain, GA 30083COMET4 Facility Report
Old Briarcliff Open Campus (Closed) Facility Executive Summary ReportReport Date: 25 Jun 2011

As part of the Facility Condition Assessment, the DeKalb County School System facilities staff asked Parsons to conduct a visual condition assessment of the buildings and sites, determine their physical condition, and make recommendations on either renovating or demolishing the schools. This report provides a description of the building and site systems, summarizes their physical condition, and includes Parsons' recommendation for future actions.

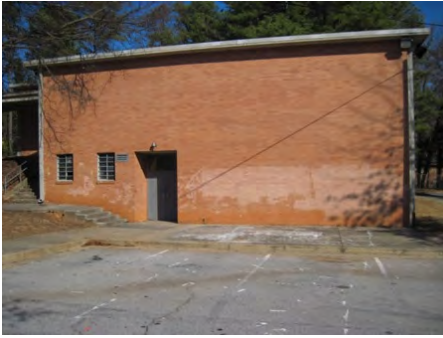
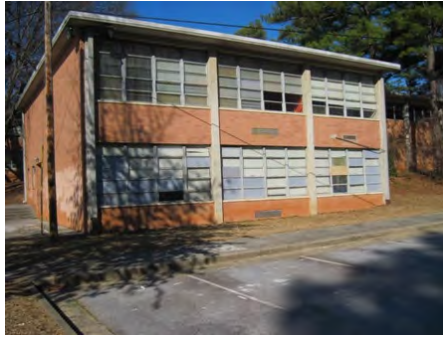
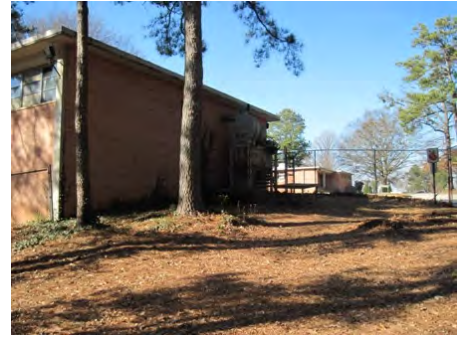
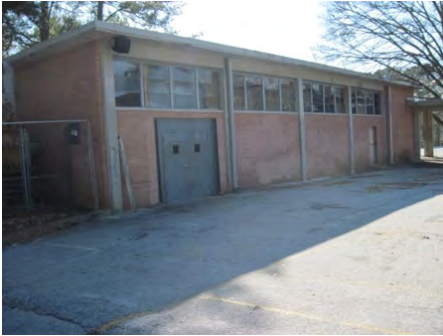
The 1958 Arts Building is a two-story masonry building and is set on standard concrete foundations and slab on grade. Visible sections of the foundation and concrete slab were found to be in fair condition. The exterior walls are constructed of concrete masonry unit blocks with a brick veneer. Visible sections of the exterior walls were found to be in fair condition. The exterior windows are original, fixed and operating steel units. Some of the exterior windows are broken or missing and the remaining components have deteriorated beyond repair and are in poor condition. The exterior doors are steel units set on steel frames with all but one set of exterior doors welded shut. Like the exterior windows, the exterior doors are broken, rusted, and are beyond repair. The roof is constructed of steel joists with a concrete deck and is covered with a built-up roof covering. The visible sections of the steel roof joists were found to be in fair condition. The roof covering was found to be aged, but without leaks and in fair condition. The roof structure and covering are in fair condition. While the concrete foundation and slab, exterior walls, and roof structure and coverings are in fair condition, the exterior windows and doors are beyond repair. Overall the exterior envelope and roof of the building are beyond economic repair or renovation. Demolition and removal of the building are needed and recommended.

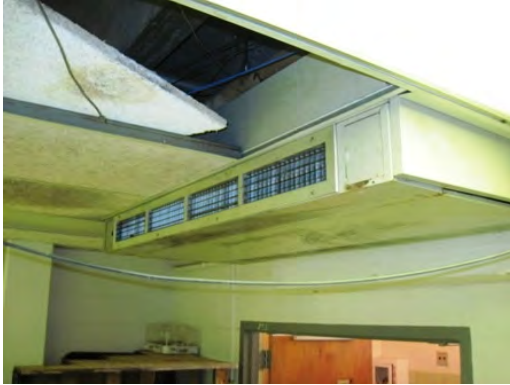
Assembly: **G10**
System: **Site Preparation**
Material: **Demo Site and Buildings**
Distress: **Damaged**
Category: **Safety**
Correction: **Demo Building**
Note: **The arts building is abandoned, damaged, and beyond economical repair, and should be demolished.**

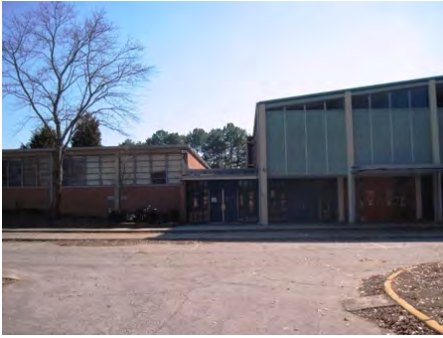
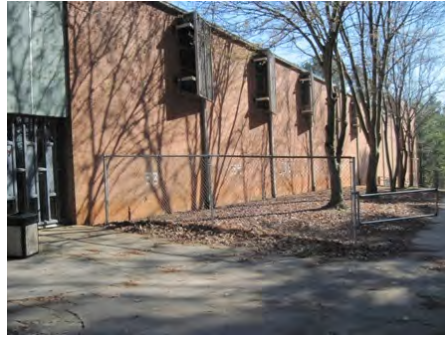
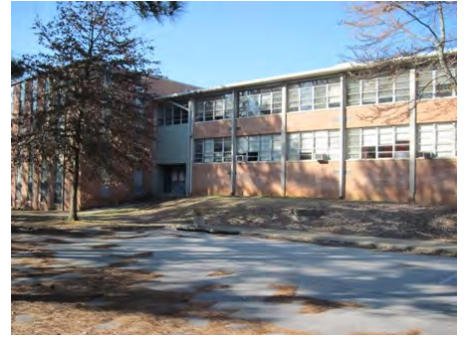
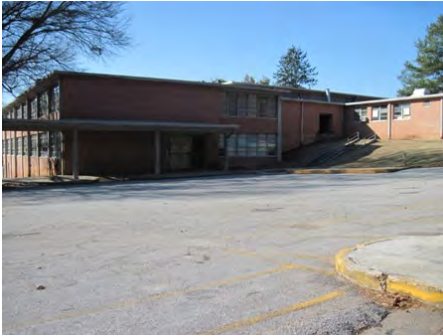
The main classroom building is a two-story masonry building and is set on standard concrete foundations and slab on grade. Visible sections of the foundation and concrete slab were found to be in fair condition. The exterior walls are constructed of concrete masonry unit blocks with a brick veneer. Visible sections of the exterior walls were found to be in fair condition. The exterior windows are original with fixed and operating steel units. Some of the exterior windows are broken or missing and the remaining components have deteriorated beyond repair and are in poor condition. The exterior doors are steel units set on steel frames with all but one set of exterior doors welded shut. Like the exterior windows, the exterior doors are broken, rusted, and are beyond repair. The roof is constructed of steel joists with a concrete deck and is covered with a built-up roof covering. The visible sections of the steel roof joists were found to be in fair condition. The roof covering was found to be aged, but without leaks and in fair condition. The roof structure and covering are in fair condition. While the concrete foundation and slab, exterior walls, and roof structure and coverings are in fair condition, the exterior windows and doors are beyond repair. Overall the exterior envelope and roof of the building are beyond economic repair or renovation. Demolition and removal of the building are needed and recommended.

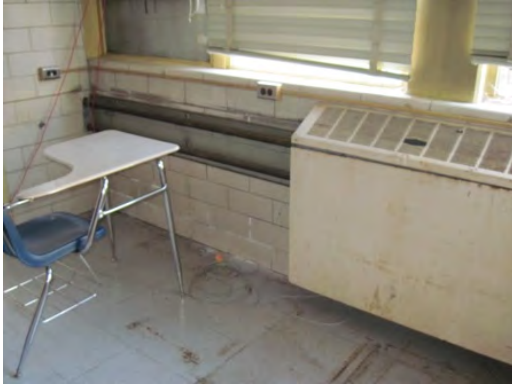
Assembly: **G10**
System: **Site Preparation**
Material: **Demo Site and Buildings**
Distress: **Damaged**
Category: **Safety**
Correction: **Demo Building**
Note: **The main classroom building is abandoned and damaged and should be demolished.**

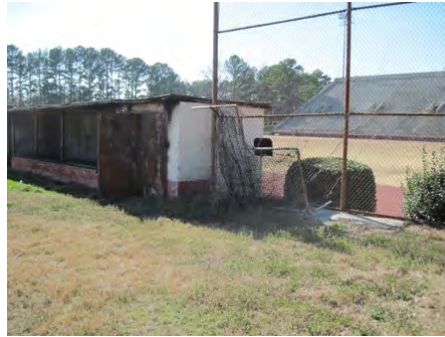
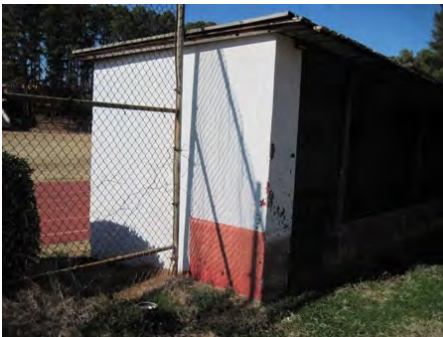
Baseball Dugout 1 at Old Briarcliff Open Campus is constructed of concrete block exterior walls, a structural slab on grade, and a concrete filled metal roof deck. The dugout is abandoned and is in poor, unsalvageable condition and should be demolished and removed.

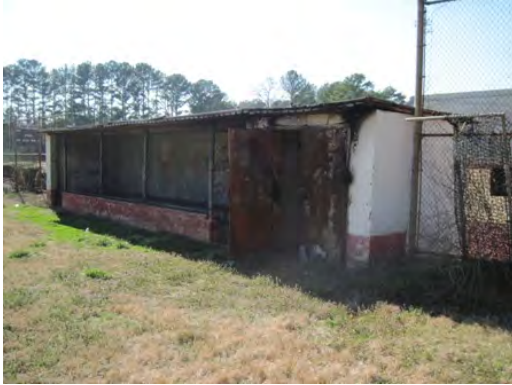
Assembly: **G10**
System: **Site Preparation**
Material: **Demo Site and Buildings**
Distress: **Damaged**
Category: **Safety**
Correction: **Demo Building**
Note: **The baseball dugout is abandoned and damaged and should be demolished.**

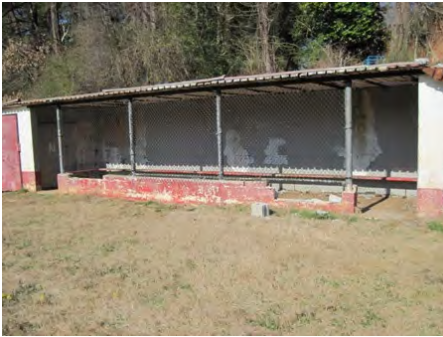
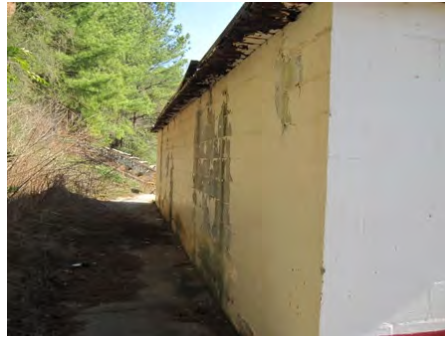
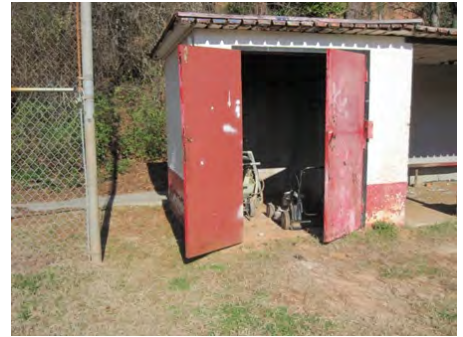
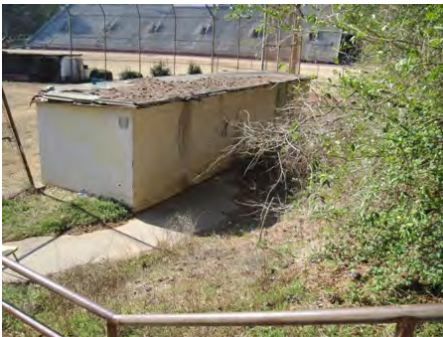
Baseball Dugout 2 at Old Briarcliff Open Campus is constructed of concrete block exterior walls, a structural slab on grade, and a concrete filled metal roof deck. The dugout is abandoned and is in poor, unsalvageable condition and should be demolished and removed.

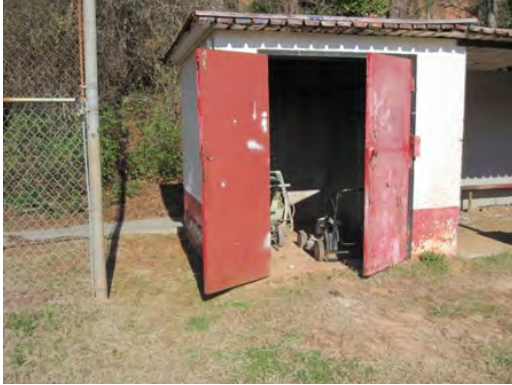
Assembly: **G10**
System: **Site Preparation**
Material: **Demo Site and Buildings**
Distress: **Damaged**
Category: **Safety**
Correction: **Demo Building**
Note: **The baseball dugout is abandoned and damaged and should be demolished.**

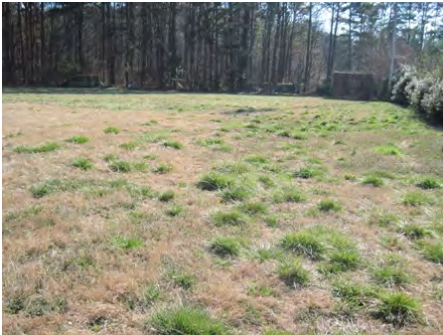
23-Feb-2011
Baseball Field at Old Briarcliff Open
Campus

The Baseball Field at Old Briarcliff Open Campus is located on the campus grounds and is no longer in use. The baseball field is abandoned and is in poor, unsalvageable condition and should be demolished.

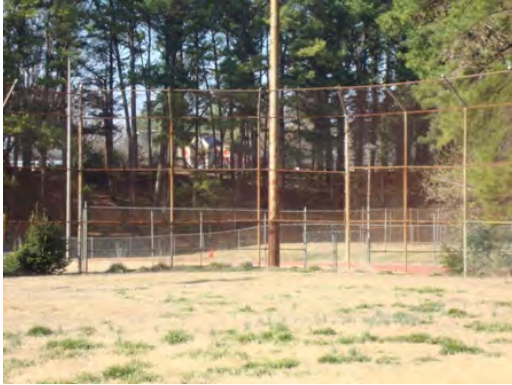
Assembly: **G10**
System: **Site Preparation**
Material: **Demo Site and Buildings**
Distress: **Damaged**
Category: **Safety**
Correction: **Demo Site**
Note: **The baseball field is abandoned and damaged and should be demolished.**

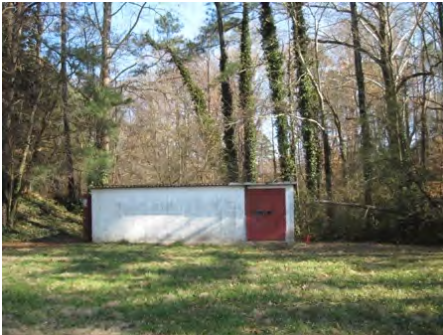
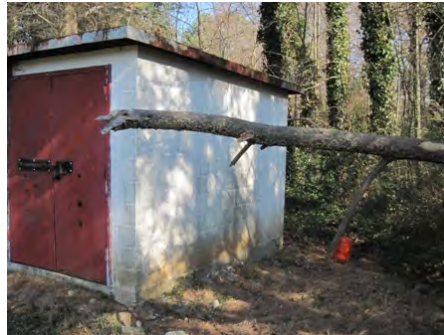
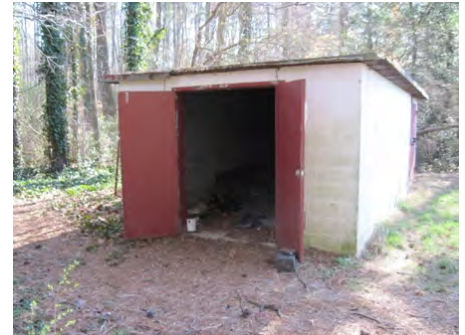
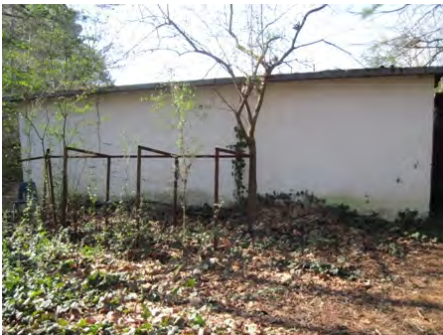
The Baseball Storage Building at Old Briarcliff Open Campus is constructed of concrete blocks exterior walls, a structural slab on grade, and a concrete filled metal roof deck. The building is abandoned and is in poor, unsalvageable condition and should be demolished and removed.

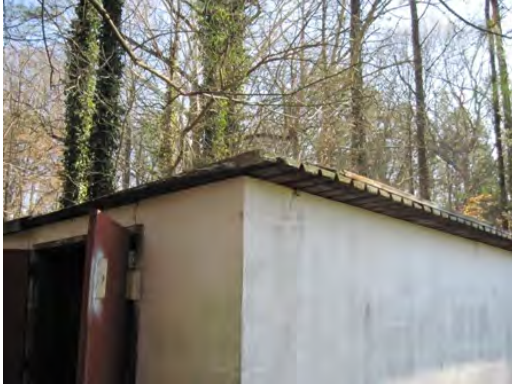
Assembly: **G10**
System: **Site Preparation**
Material: **Demo Site and Buildings**
Distress: **Damaged**
Category: **Safety**
Correction: **Demo Building**
Note: **The baseball storage shed is abandoned and damaged and should be demolished.**

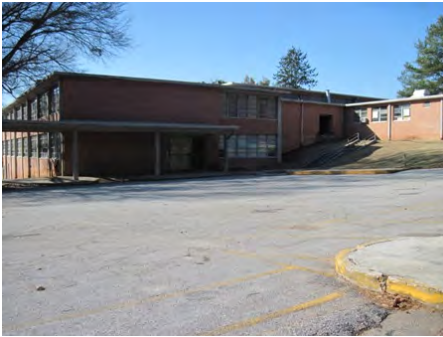
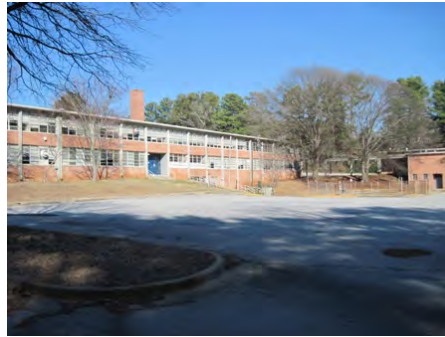
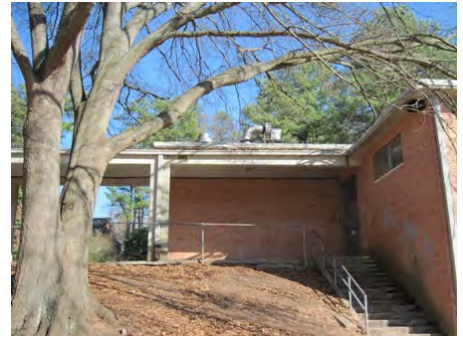
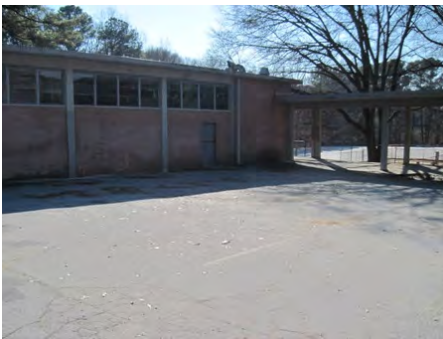
An engineered metal covered walkway connects the main classroom building with the 1958 arts building. The covered walkway is in poor condition and should be demolished and removed in conjunction with the main building, arts building, and site demolition.

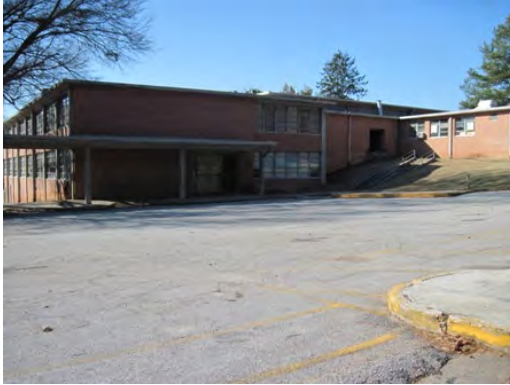
Assembly: **G10**
System: **Site Preparation**
Material: **Demo Site and Buildings**
Distress: **Damaged**
Category: **Safety**
Correction: **Demo Building**
Note: **The covered walkways are aged, abandoned, and damaged, and should be demolished.**

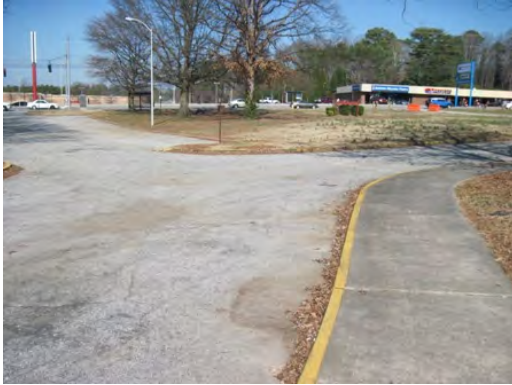
The Old Briarcliff Open Campus site was originally constructed in 1958, has a total area of 15.6 acres, and is occupied by approximately 154,855 square feet of permanent building space. The site includes concrete and asphalt paved roads and parking, concrete sidewalks, metal fencing, retaining walls, and landscaping. It also includes water, sanitary, and electrical utilities. Paved surfaces are cracked and damaged with large areas of heaving, settling and potholes, and some hard surface sections have reverted to their natural aggregate material. Fencing and retaining walls are damaged and deteriorated. Water, sanitary, and electrical systems are inoperable and unsafe. All paved surfaces, fencing, retaining walls, landscaping, as well as water, sanitary, and electrical systems throughout the site are damaged and deteriorated beyond economical repair. Demolition and removal is recommended.

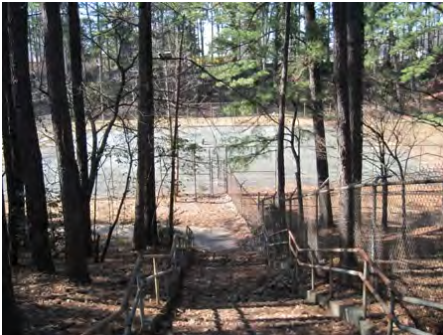
The Tennis Courts at Old Briarcliff Open Campus are located on the campus grounds, are in poor condition, and should be demolished and removed in conjunction with the main building, arts building, and site demolition.

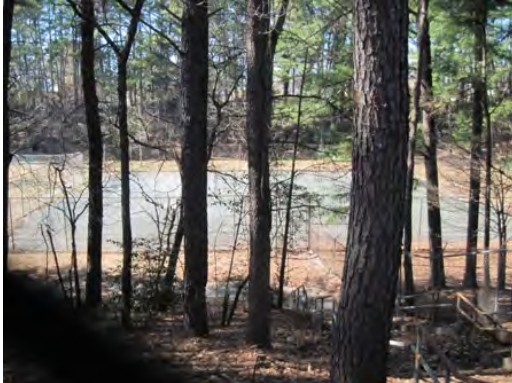
Facility Name	Assembly	System	Material	Distress	Correction	Qty	Unit	Raw Cost	Additional Cost	Total Cost	Priority	Def. Cat.	Location / Note
Tennis Courts								\$1,710	\$445	\$2,155			
Building Systems								\$1,710	\$445	\$2,155			
G10		Site Preparation	Demo Site and Buildings	Needs Remediation	Demo Site	22,440	S.F.	\$1,710	\$445	\$2,155	Necessary	Safety	The tennis courts are abandoned and damaged and should be demolished.
