Facility Condition Assessment Report

DeKalb County School System1701 Mountain Industrial Blvd
Stone Mountain, GA 30083

Panola Way Elementary Facility Executive Summary ReportReport Date: 05 Jul 2011

Facility: \Elementary Schools\Panola Way Elementary**Address:** 2170 Panola Way Court, Lithonia, GA 30058**Attributes:****Facility Code** 0188
Super Cluster 4**General Information:****Function:** Elementary School
Gross Area: 86,443 S.F.**Year Built:**
Last Renovation:**Facility Description:**

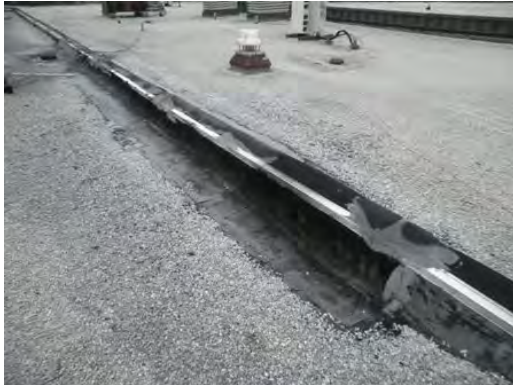
Note: **The built-up roofing is aged, has reported leaks, and should be replaced.**

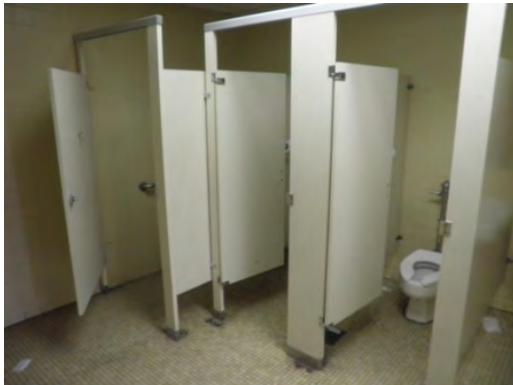
Note: **The bathroom fittings and partitions are aged and worn and should be replaced.**

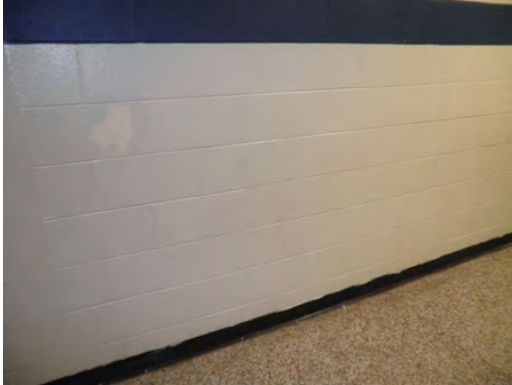
Note: **The wall paint is aged and scuffed and should be repainted.**

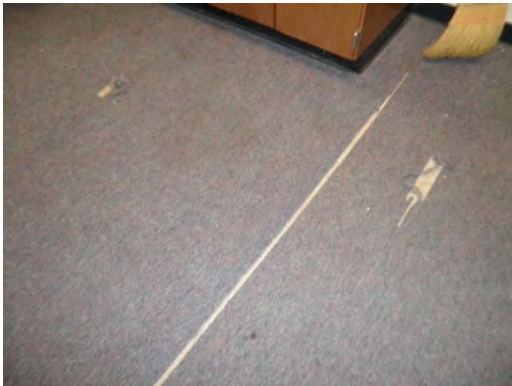
Note: **The carpet is aged, worn, stained, and frayed, and should be replaced.**

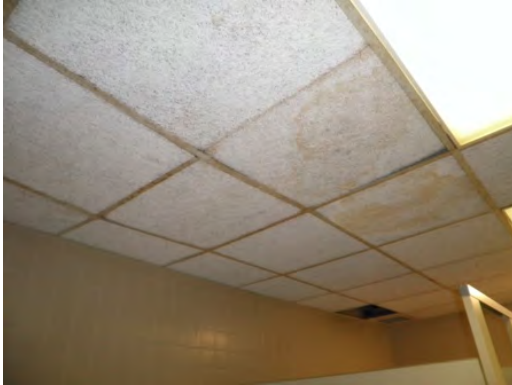
Assembly: **C3030**
 System: **Ceiling Finishes**
 Material: **System**
 Distress: **Beyond Service Life**
 Category: **Deferred Maintenance**
 Correction: **Renew System**
 Note: **The acoustical ceiling tile and grid system is rusted, stained, and damaged, and should be replaced.**

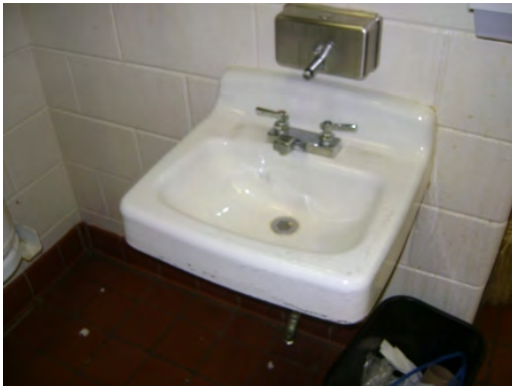
Assembly: **D2010**
 System: **Plumbing Fixtures**
 Material: **System**
 Distress: **Beyond Service Life**
 Category: **Deferred Maintenance**
 Correction: **Renew System**
 Note: **The plumbing fixtures are aged, chipped, stained, and showing signs of excessive wear, and should be replaced.**

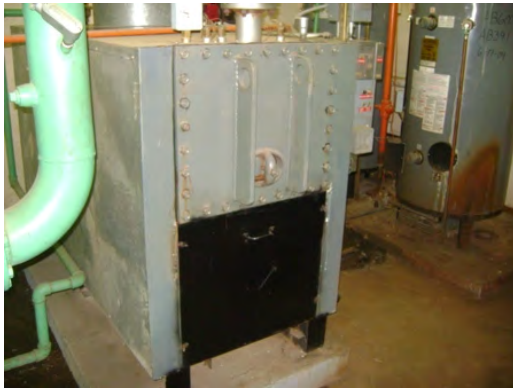
Note: **The heating system, including gas fired boiler, pumps, piping, and valves are aged, rusted, inefficient, and becoming logistically unsupportable, and should be replaced with an energy efficient equipment.**

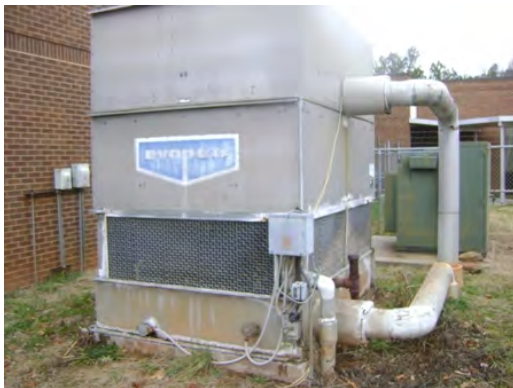
Note: **The cooling system, including cooling tower, pumps, piping, and valves, are aged, rusted, inefficient, and becoming logistically unsupportable, and should be replaced with energy efficient equipment.**

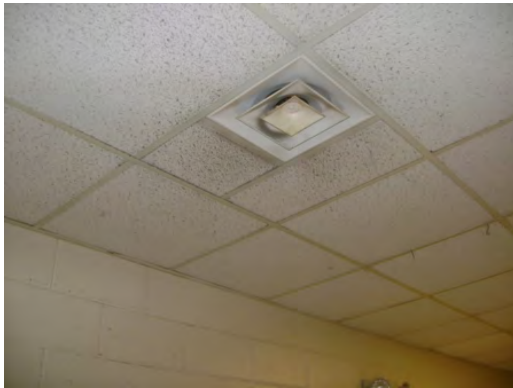
Note: **The exhaust fans and duct systems are inadequate, dirty, and damaged; they do not ventilate restrooms and other spaces properly; and should be replaced.**

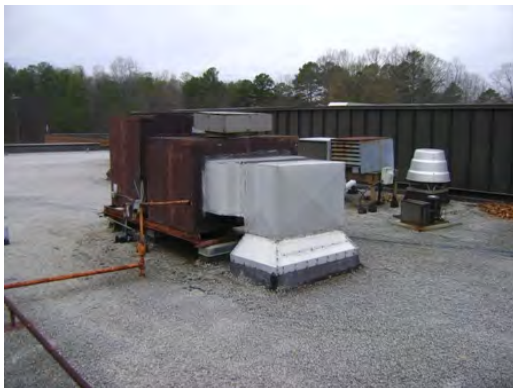
Note: **The roof top package units, water source heat pumps, and fan coil units are aged, worn, rusted, inefficient, and becoming logistically unsupportable, and should be replaced with energy efficient models.**

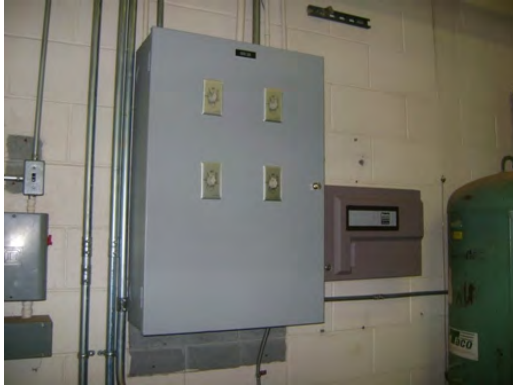
Note: **The HVAC controls are inadequate with obsolete parts and equipment and should be replaced.**

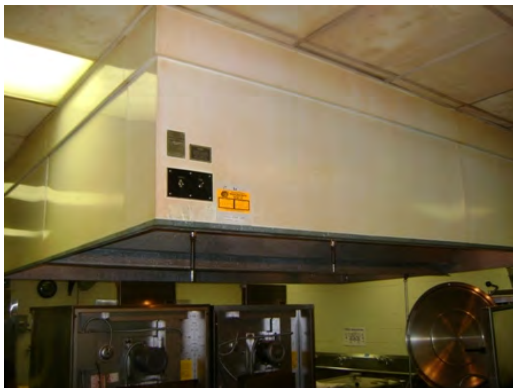
Note: **The kitchen hood and exhaust system is aged and worn and should be replaced.**

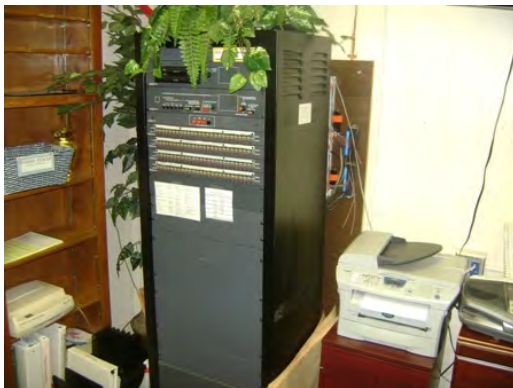
Note: **The clock and PA systems are aged, have reported outages, and should be replaced.**

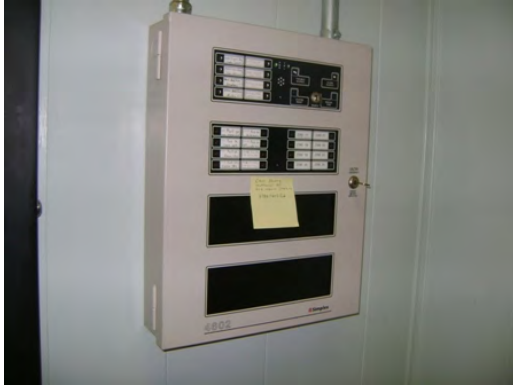
Assembly: **D5030**
System: **Communications and Security - Fire Alarm System**
Material: **Beyond Service Life**
Distress: **Beyond Service Life**
Category: **Deferred Maintenance**
Correction: **Renew System**
Note: **The fire alarm system is aged, has reported outages, and should be replaced.**

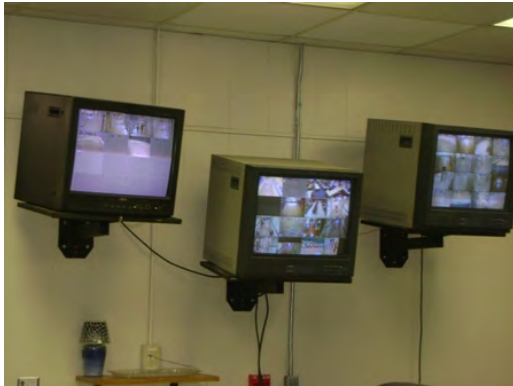
Assembly: **D5030**
System: **Communications and Security - Security & CCTV System**
Material: **Beyond Service Life**
Distress: **Beyond Service Life**
Category: **Deferred Maintenance**
Correction: **Renew System**
Note: **The security system has reported outages and inadequate coverage and should be replaced.**

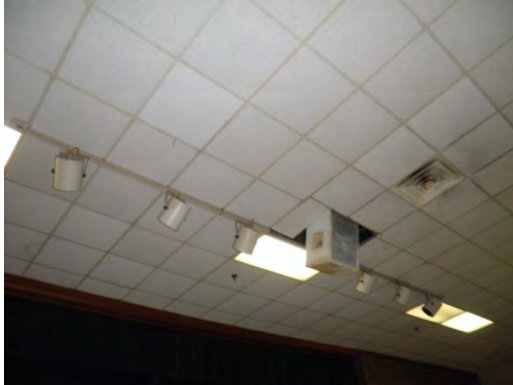
Assembly: **E1020**
System: **Institutional Equipment System**
Material: **Beyond Service Life**
Distress: **Beyond Service Life**
Category: **Deferred Maintenance**
Correction: **Renew System**
Note: **Stage lighting and curtains are aged and should be replaced.**

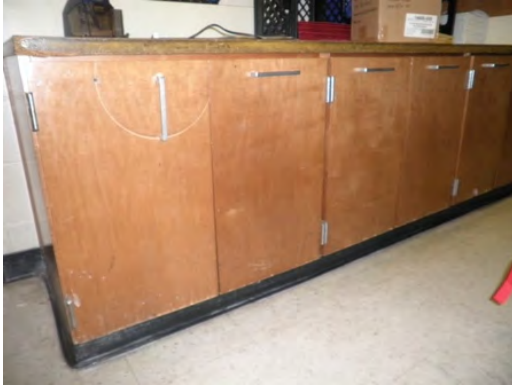
Note: **Fittings, such as chalk and tack boards, toilet and bath accessories, toilet partitions, and shelving, are aged, worn, and damaged, and should be replaced.**

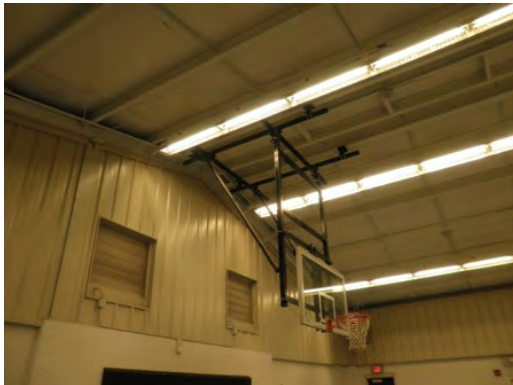
Assembly: **D3050**
System: **Terminal & Package Units**
Material: **Packaged A/C, Elec. Ht., Const. Volume**
Distress: **Missing**
Category: **Capital Improvement**
Correction: **Install Package A/C - 20 ton**
Note: **An air conditioning system is missing in the gymnasium and should be installed.**

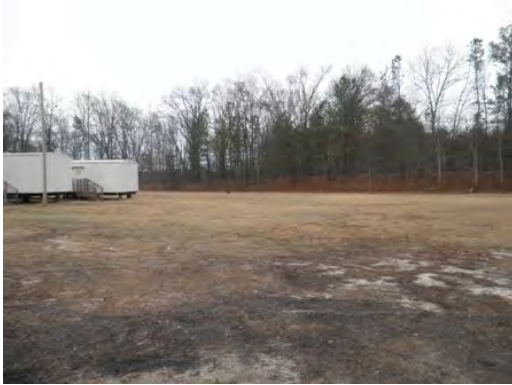
Assembly: **F1040**
 System: **Special Facilities - Sports Field - Natural Turf System**
 Material: **Inadequate**
 Distress: **Inadequate**
 Category: **Deferred Maintenance**
 Correction: **Renew System**
 Note: **The play field turf is worn and should be reseeded.**

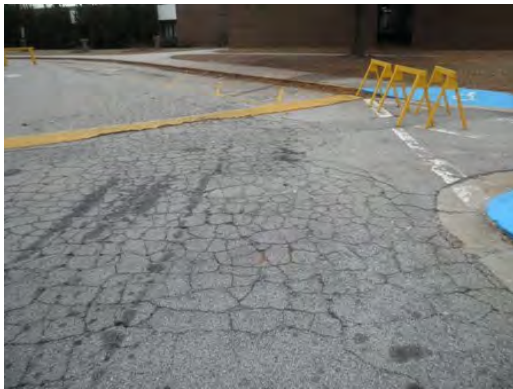
Assembly: **G2010**
System: **Roadways**
Material: **System**
Distress: **Damaged**
Category: **Deferred Maintenance**
Correction: **Renew System**
Note: **The roadways are aged and cracked, have many road cuts and repairs, and should be resurfaced.**

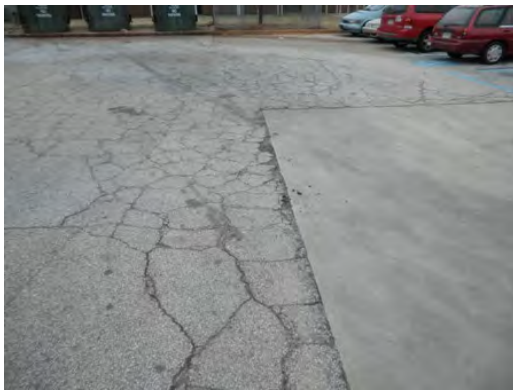
Assembly: **G2020**
System: **Parking Lots**
Material: **System**
Distress: **Damaged**
Category: **Deferred Maintenance**
Correction: **Renew System**
Note: **The asphaltic parking lot is aged and craked and should be resurfaced and restriped. The parking lot also needs to be expanded, as staff and visitors currently park on the playfield.**

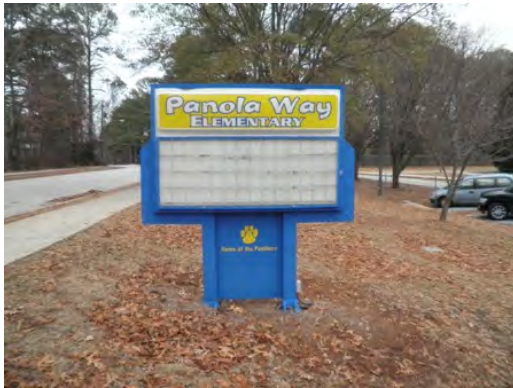
Assembly: **G2040**
 System: **Site Development**
 Material: **System**
 Distress: **Beyond Service Life**
 Category: **Deferred Maintenance**
 Correction: **Renew System**
 Note: **Site development features, such as site furnishings, playgrounds, retaining walls, signage, etc., are beyond their service life and should be replaced.**

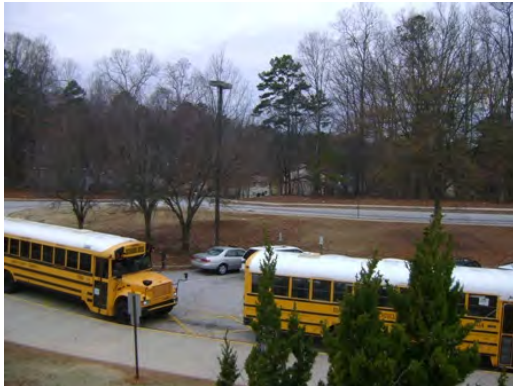
Assembly: **G4020**
 System: **Site Lighting**
 Material: **System**
 Distress: **Beyond Service Life**
 Category: **Deferred Maintenance**
 Correction: **Renew System**
 Note: **The site lighting system is aged, worn, and inadequate, and should be replaced.**
