Facility Condition Assessment Report

Panthersville Stadium Facility Executive Summary ReportReport Date: 24 Jun 2011

Facility: \Non School Sites\Panthersville Stadium
Address: 2817 Clifton Springs Road, Decatur, GA 30034**Attributes:****Facility Code** 9005
Super Cluster 0**General Information:****Function:** Non School Sites
Gross Area: 24,873 S.F.
Year Built:
Last Renovation:**Facility Description:**

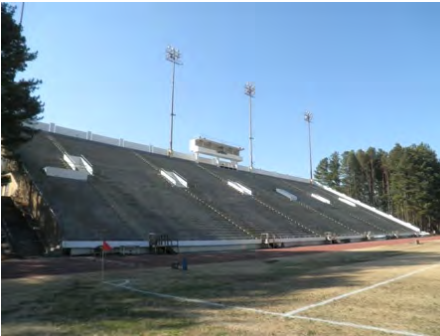
23-Feb-2011
Panthersville Stadium

Panthersville Stadium campus is located at 2817 Clifton Springs Road in Decatur, Georgia. The original campus was constructed in 1968 and consists of the stadium seating structure and a separate concessions/restroom building constructed beneath the stadium. In addition to these buildings, the campus contains a football field and track. This report contains condition and adequacy data collected during the 2010/2011 Facility Condition Assessment (FCA). The detailed condition and deficiency statements are contained in this report for each building and other facilities on the campus.

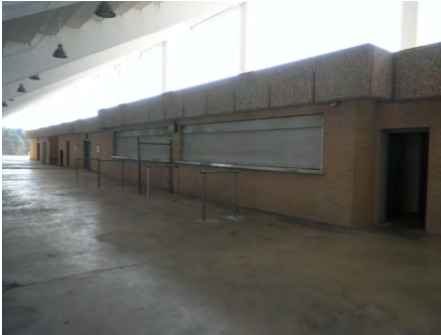
23-Feb-2011
East Elevation

The Concession/Restroom Building at Panthersville Stadium is a one-story building with a full basement located at 2817 Clifton Springs Road in Decatur, Georgia. There have been no additions and no major renovations. This report contains condition and adequacy data collected during the 2010/2011 Facility Condition Assessment (FCA). The detailed condition and deficiency statements are contained in this report.

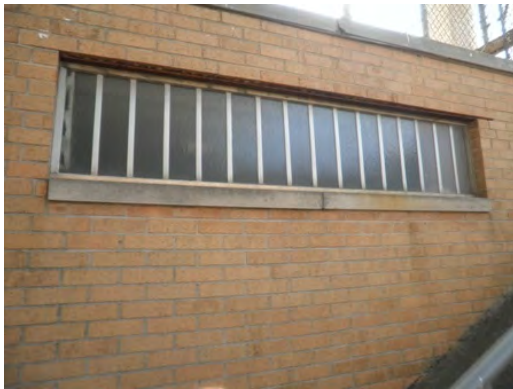
Assembly: **B2020**
System: **Exterior Windows**
Material: **System**
Distress: **Beyond Service Life**
Category: **Deferred Maintenance**
Correction: **Renew System**
Note: **The original metal frame, single pane windows are aged, worn, and inefficient, and should be replaced.**

Raw Cost	\$53,011.99
Plus or (Minus) Additional Cost	\$20,144.56
Total Estimated Amount	\$73,156.55

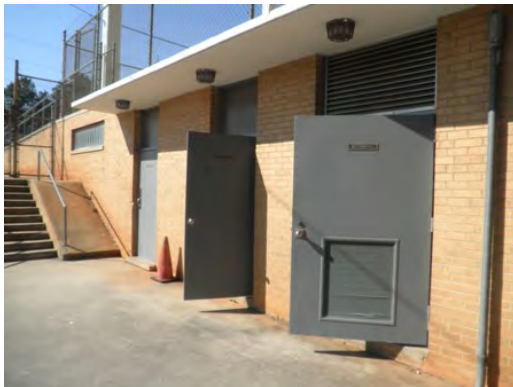
Assembly: **B2030**
System: **Exterior Doors**
Material: **System**
Distress: **Beyond Service Life**
Category: **Deferred Maintenance**
Correction: **Renew System**
Note: **The original metal exterior doors are aged, rusted, and damaged, and should be replaced.**

Raw Cost	\$8,441.40
Plus or (Minus) Additional Cost	\$3,207.73
Total Estimated Amount	\$11,649.13

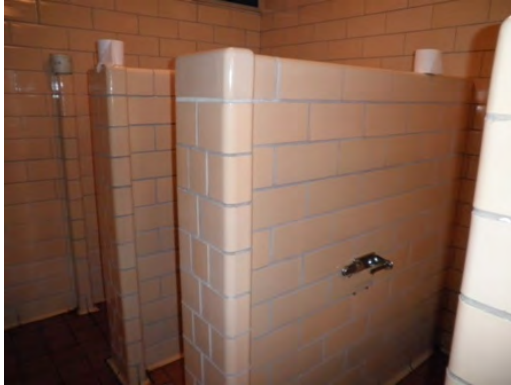
Assembly: **C1030**
 System: **Fittings**
 Material: **System**
 Distress: **Beyond Service Life**
 Category: **Deferred Maintenance**
 Correction: **Renew System**
 Note: **The metal bathroom fittings and partitions are aged, worn, and damaged, and should be replaced.**

Raw Cost	\$32,414.98
Plus or (Minus) Additional Cost	\$12,317.69
Total Estimated Amount	\$44,732.67

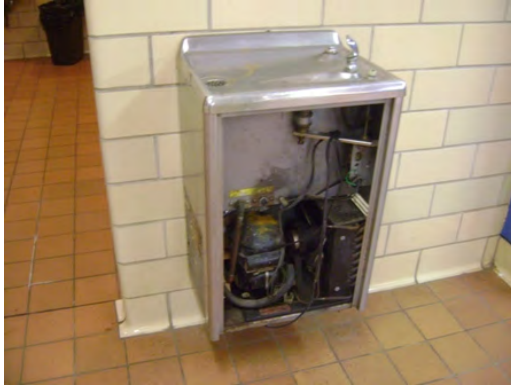
Assembly: **D2010**
System: **Plumbing Fixtures**
Material: **Drinking Fountain Systems**
Distress: **Needs Remediation**
Category: **Deferred Maintenance**
Correction: **Replace Drinking Fountain Systems**
Note: **The drinking fountains in the restrooms and locker rooms are inoperable and should be replaced.**

Raw Cost	\$6,052.00
Plus or (Minus) Additional Cost	\$2,299.76
Total Estimated Amount	\$8,351.76

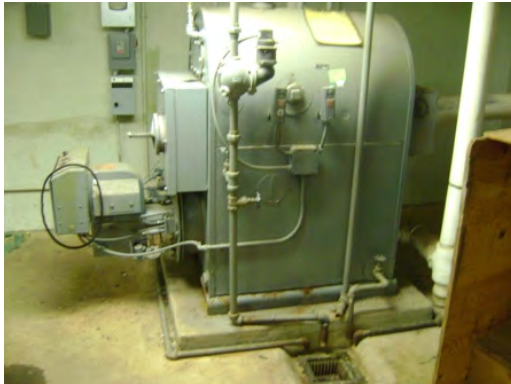
Assembly: **D3020**
System: **Heat Generating Systems**
Material: **System**
Distress: **Beyond Service Life**
Category: **Deferred Maintenance**
Correction: **Renew System**
Note: **The heating system, including gas fired boiler, pumps, piping, and valves are aged, rusted, inefficient, and becoming logistically unsupportable, and should be replaced with energy efficient equipment.**

Raw Cost	\$33,878.15
Plus or (Minus) Additional Cost	\$12,873.70
Total Estimated Amount	\$46,751.85

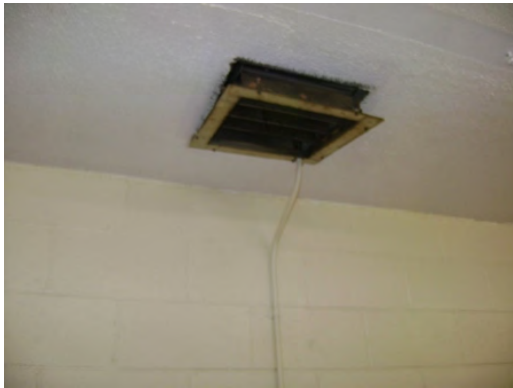
Assembly: **D3040**
System: **Distribution System**
Material: **System**
Distress: **Beyond Service Life**
Category: **Deferred Maintenance**
Correction: **Renew System**

Note: **The exhaust fans and duct systems are inadequate, dirty, and damaged; they do not ventilate restrooms and other spaces properly; and should be replaced.**

Raw Cost	\$40,631.27
Plus or (Minus) Additional Cost	\$15,439.88
Total Estimated Amount	\$56,071.15

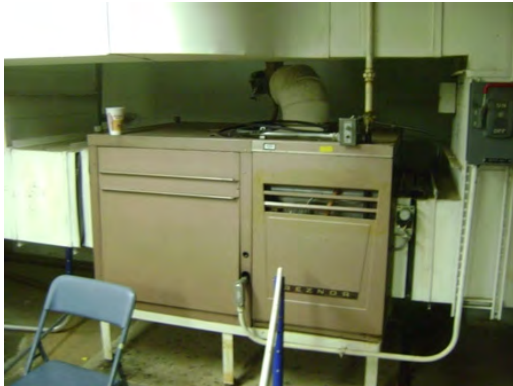
Assembly: **D3050**
System: **Terminal & Package Units**
Material: **System**
Distress: **Beyond Service Life**
Category: **Deferred Maintenance**
Correction: **Renew System**

Note: **The gas furnances and the electric unit heaters are aged, worn, and outdated, and should be replaced.**

Raw Cost	\$141,027.66
Plus or (Minus) Additional Cost	\$53,590.51
Total Estimated Amount	\$194,618.17

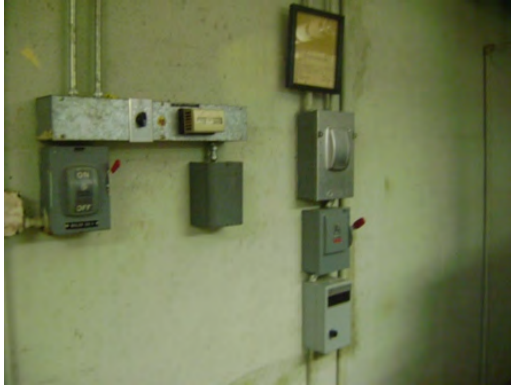
Assembly: **D3060**
System: **Controls & Instrumentation System**
Material: **Beyond Service Life**
Distress: **Beyond Service Life**
Category: **Deferred Maintenance**
Correction: **Renew System**

Note: **The control system is aged, worn, outdated, and inadequate, and should be replaced.**

Raw Cost	\$23,298.26
Plus or (Minus) Additional Cost	\$8,853.34
Total Estimated Amount	\$32,151.60

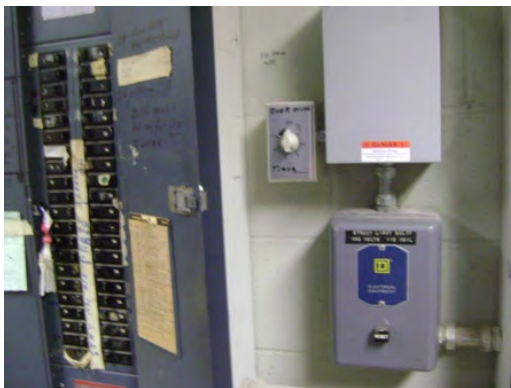
Assembly: **D5010**
System: **Electrical Service/Distribution System**
Material: **Beyond Service Life**
Distress: **Beyond Service Life**
Category: **Deferred Maintenance**
Correction: **Renew System**

Note: **The original electric service switch boards, distribution panel board, motor control center, and branch circuit panel boards are aged, worn, and outdated, and should be replaced.**

Raw Cost	\$26,899.93
Plus or (Minus) Additional Cost	\$10,221.97
Total Estimated Amount	\$37,121.90

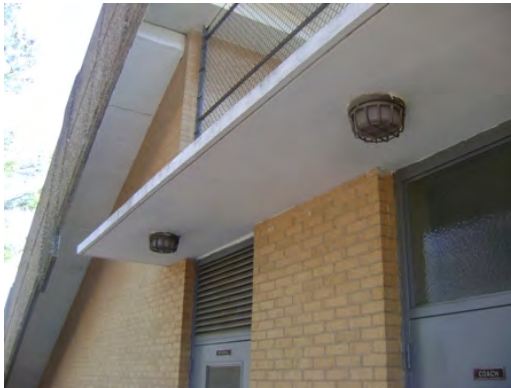
Assembly: **D5020**
 System: **Lighting and Branch Wiring System**
 Material: **Beyond Service Life**
 Distress: **Beyond Service Life**
 Category: **Deferred Maintenance**
 Correction: **Renew System**

Note: **With the exception of the restroom light fixtures, the fixtures in the other rooms, on the exterior of the building, and the concourse pendant lighting are aged, worn, and outdated, and should be replaced.**

Raw Cost	\$98,820.66
Plus or (Minus) Additional Cost	\$37,551.85
Total Estimated Amount	\$136,372.51

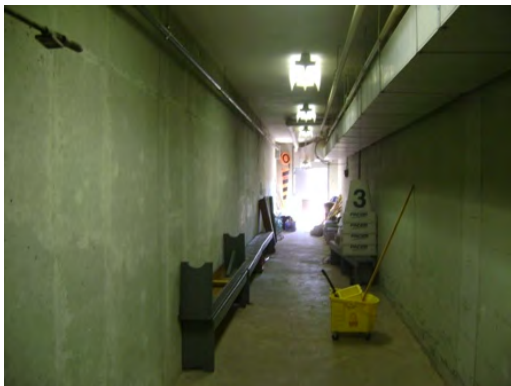
Assembly: **D5030**
 System: **Communications and Security - Fire Alarm System**
 Material: **System**
 Distress: **Missing**
 Category: **Deferred Maintenance**
 Correction: **Renew System**

Note: **A fire alarm system needs to be installed.**

Raw Cost	\$6,190.36
Plus or (Minus) Additional Cost	\$2,352.34
Total Estimated Amount	\$8,542.70

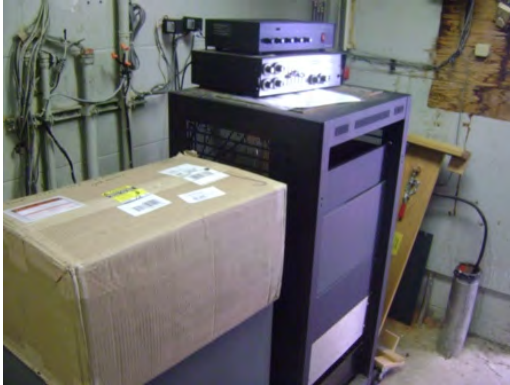
Assembly: **D5030**
System: **Communications and Security - PA System**
Material: **System**
Distress: **Beyond Service Life**
Category: **Deferred Maintenance**
Correction: **Renew System**

Note: **The PA system is aged, worn, outdated, and inadequate, and should be replaced.**

Raw Cost	\$38,380.23
Plus or (Minus) Additional Cost	\$14,584.49
Total Estimated Amount	\$52,964.72

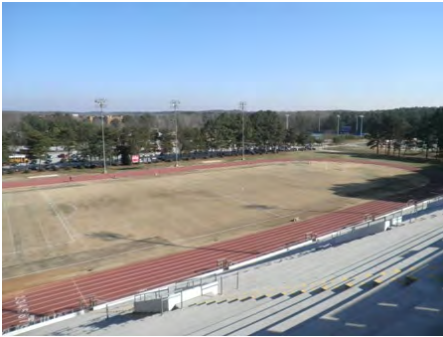
23-Feb-2011

The Football Field at Panthersville Stadium is located at 2817 Clifton Springs Road, Decatur, Georgia. There have been no additions and no major renovations. This report contains condition and adequacy data collected during the 2010/2011 Facility Condition Assessment (FCA). The detailed condition and deficiency statements are contained in this report.

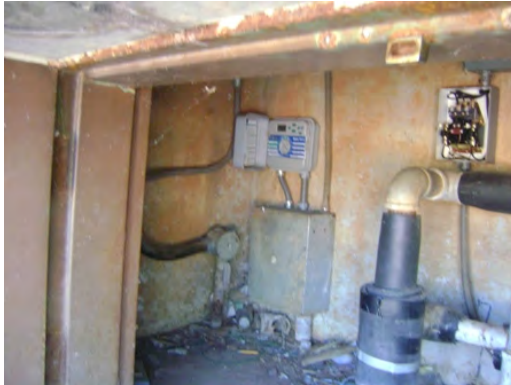
Assembly: **G2050**
System: **Landscaping - Irrigation System**
Material: **Beyond Service Life**
Distress: **Deferred Maintenance**
Category: **Renew System**
Correction: **The irrigation system is operational, but is aged and worn and should be replaced.**
Note:

Raw Cost	\$8,316.00
Plus or (Minus) Additional Cost	\$2,162.16
Total Estimated Amount	\$10,478.16

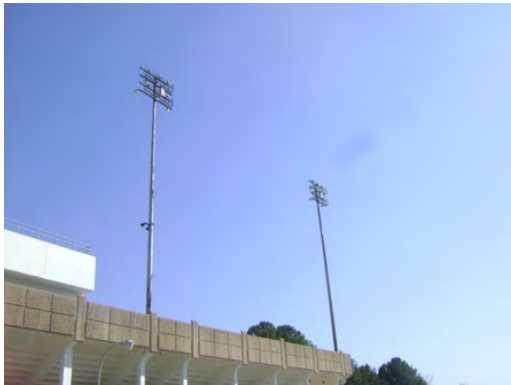
Assembly: **G4020**
System: **Site Lighting System**
Material: **Beyond Service Life**
Distress: **Deferred Maintenance**
Category: **Renew System**
Correction: **The stadium lighting for the football field is operational, but is worn and outdated and should be replaced.**
Note:

Raw Cost	\$686,664.00
Plus or (Minus) Additional Cost	\$178,532.64
Total Estimated Amount	\$865,196.64

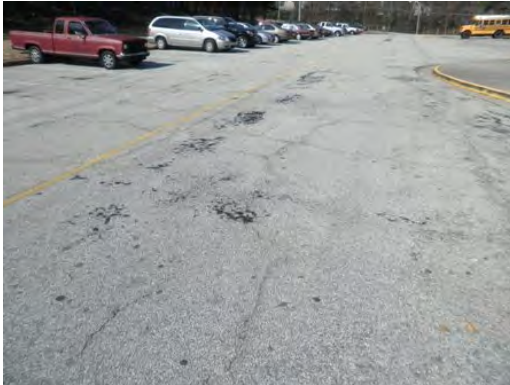
Assembly: **G2010**
 System: **Roadways**
 Material: **System**
 Distress: **Beyond Service Life**
 Category: **Deferred Maintenance**
 Correction: **Renew System**
 Note: **The roadways are aged and cracked, have many road cuts and repairs, and should be resurfaced.**

Raw Cost	\$21,614.64
Plus or (Minus) Additional Cost	\$5,619.81
Total Estimated Amount	\$27,234.45

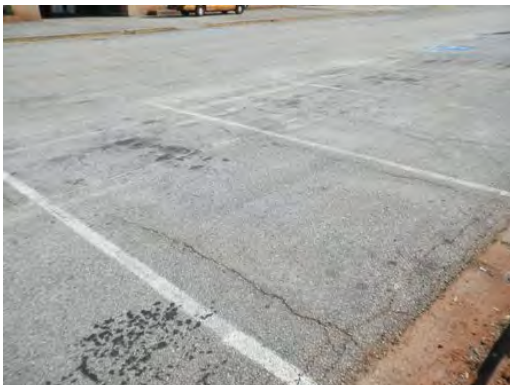
Assembly: **G2020**
 System: **Parking Lots**
 Material: **System**
 Distress: **Beyond Service Life**
 Category: **Deferred Maintenance**
 Correction: **Renew System**
 Note: **The parking lots are aged and cracked and should be resurfaced and restriped.**

Raw Cost	\$20,793.83
Plus or (Minus) Additional Cost	\$5,406.40
Total Estimated Amount	\$26,200.23

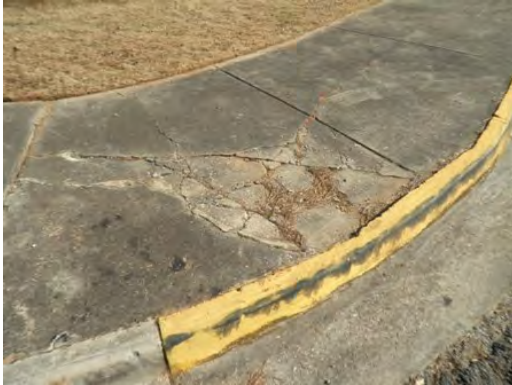
Note: **The sidewalks are aged, cracked, and damaged, and should be replaced.**

Raw Cost	\$41,040.45
Plus or (Minus) Additional Cost	\$10,670.52
Total Estimated Amount	\$51,710.97

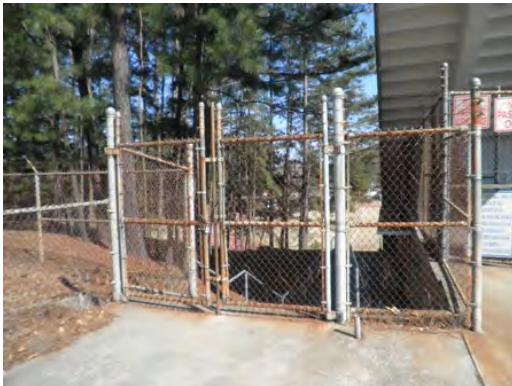
Note: **The fencing is aged, rusted, and damaged, and should be replaced.**

Raw Cost	\$42,035.37
Plus or (Minus) Additional Cost	\$10,929.20
Total Estimated Amount	\$52,964.57

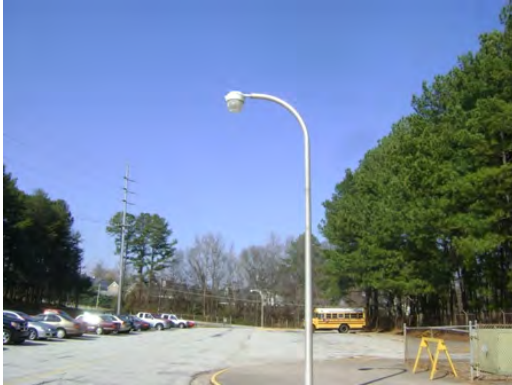
Note: **The site lighting for the parking lot is aged, worn, and outdated, and should be replaced.**

Raw Cost	\$15,048.17
Plus or (Minus) Additional Cost	\$3,912.52
Total Estimated Amount	\$18,960.69

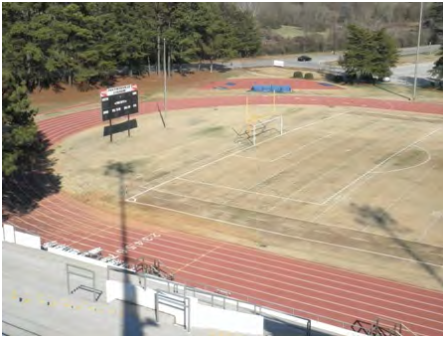
23-Feb-2011
Track at Panthersville Stadium

The Track at Panthersville Stadium is located at 2817 Clifton Springs Road, Decatur, Georgia. There have been no additions and no major renovations. This report contains condition and adequacy data collected during the 2010/2011 Facility Condition Assessment (FCA). The detailed condition and deficiency statements are contained in this report.

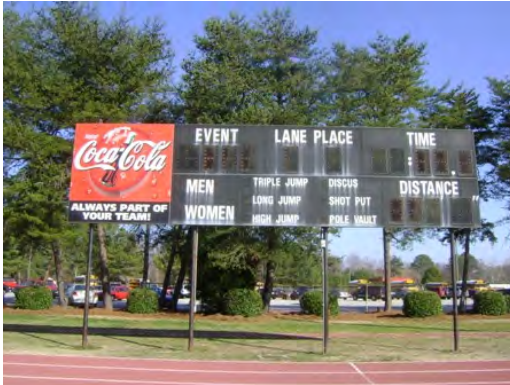
Assembly: **F10**
 System: **Special Construction - Track Score Board**
 Material: **System**
 Distress: **Beyond Service Life**
 Category: **Deferred Maintenance**
 Correction: **Renew System**
 Note: **The score board for the track is aged, worn, and weathered, and should be replaced.**

Raw Cost	\$22,048.16
Plus or (Minus) Additional Cost	\$5,732.52
Total Estimated Amount	\$27,780.68
