# **Facility Condition Assessment Report**

**Sagamore Hills Elementary Facility Executive Summary Report**Report Date: 05 Jul 2011

**Facility:** \Elementary Schools\Sagamore Hills Elementary**Address:** 1865 Alderbrook Road N.E., Atlanta, GA 30345**Attributes:**

## COMET4 Survey Report Sagamore Hills Elementary Detailed Facility Needs Assessment Report

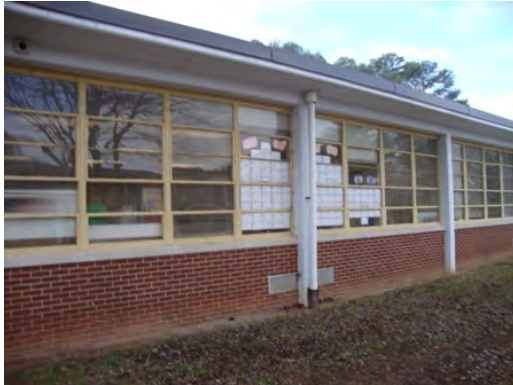
Assembly: **B2020**  
System: **Exterior Windows**  
Material: **System**  
Distress: **Beyond Service Life**  
Category: **Deferred Maintenance**  
Correction: **Renew System**  
Note: **The original metal frame, single pane, operable windows are aged, worn, and inefficient, and should be replaced.**

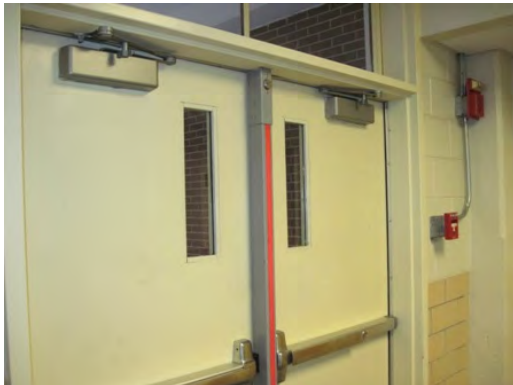
Assembly: **B2030**  
System: **Exterior Doors**  
Material: **System**  
Distress: **Beyond Service Life**  
Category: **Deferred Maintenance**  
Correction: **Renew System**  
Note: **The original exterior doors are aged and should be replaced with efficient doors.**

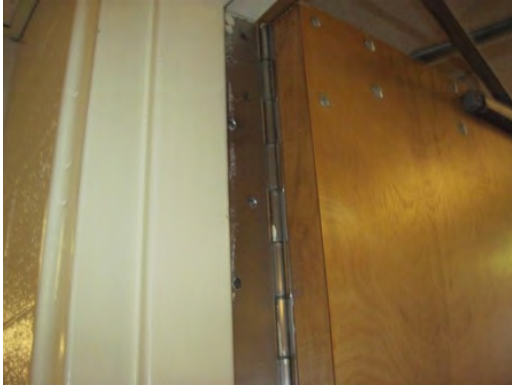
Assembly: **C1020**  
 System: **Interior Doors**  
 Material: **System**  
 Distress: **Needs Remediation**  
 Category: **Deferred Maintenance**  
 Correction: **Renew System**  
 Note: **The original interior doors are aged, require frequent repairs, and should be replaced.**

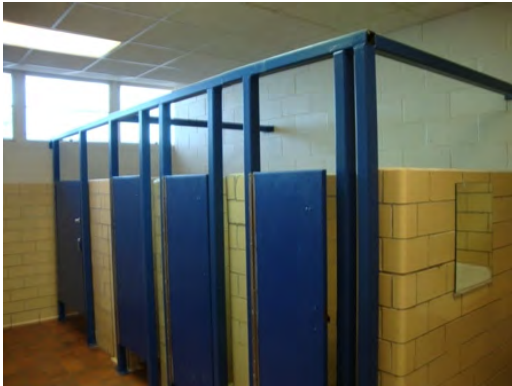
Assembly: **C1030**  
 System: **Fittings**  
 Material: **System**  
 Distress: **Beyond Service Life**  
 Category: **Deferred Maintenance**  
 Correction: **Renew System**  
 Note: **Fittings, such as chalk and tack boards, toilet and bath accessories, toilet partitions, and shelving, are aged, worn, and damaged, and should be replaced.**

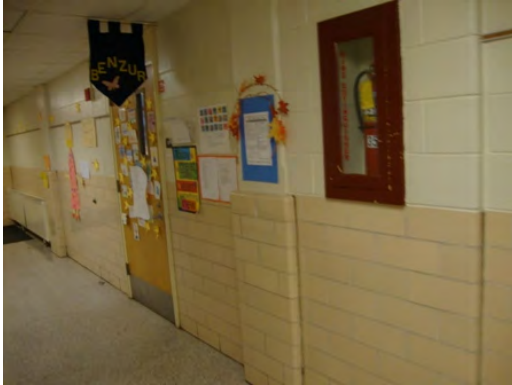
**Note:** The wall paint is aged and scuffed and should be repainted.

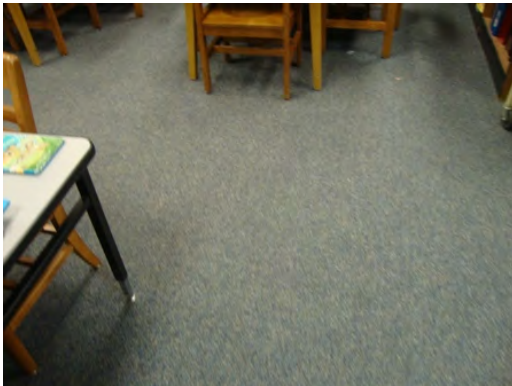
**Note:** The carpet is aged, worn, and stained, and should be replaced.

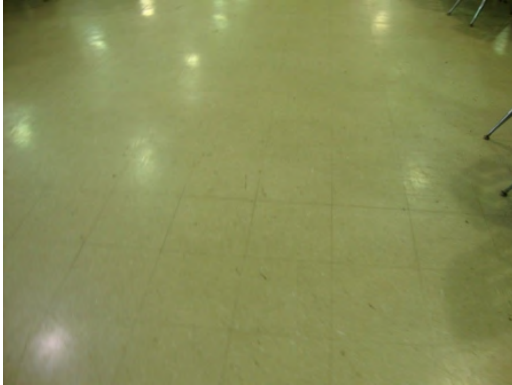
**Note:** The VCT is beyond its service life and should be replaced.

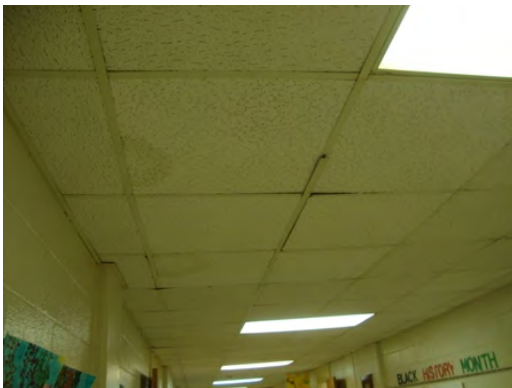
**Note:** The acoustical ceiling tile and grid system is aged, stained, and damaged, and should be replaced.

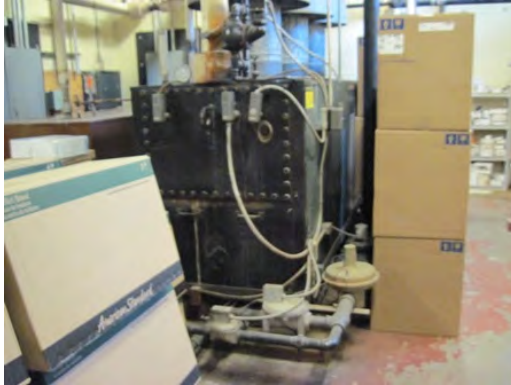
Note: **The original boiler is aged and inefficient and should be replaced.**

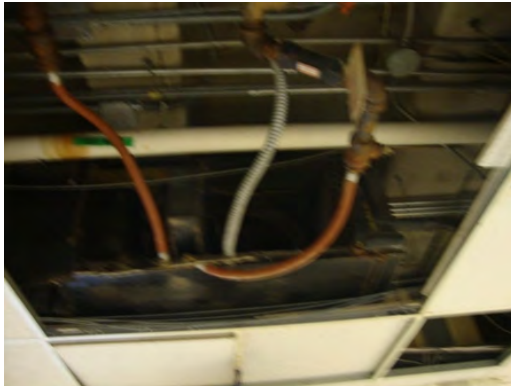
Note: **The water source heat pumps and fan coil units are aged, worn, rusted, inefficient, and becoming logistically unsupportable, and should be replaced with energy efficient models.**

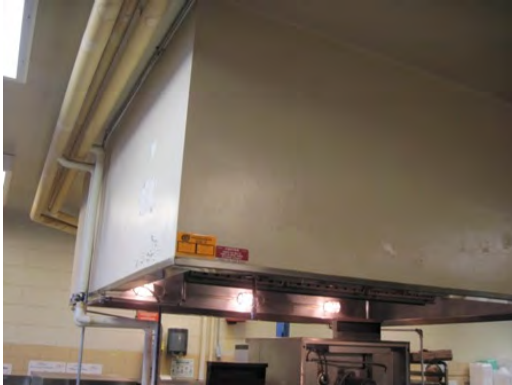
**Note:** The kitchen hood is aged and inefficient and should be replaced.

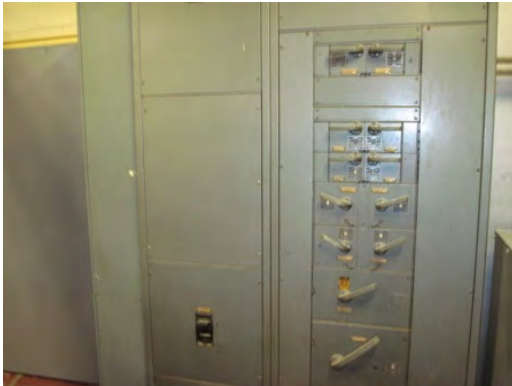
**Note:** The original electrical service and distribution is operable, but inadequate for modern technology loads and should be scheduled for replacement.

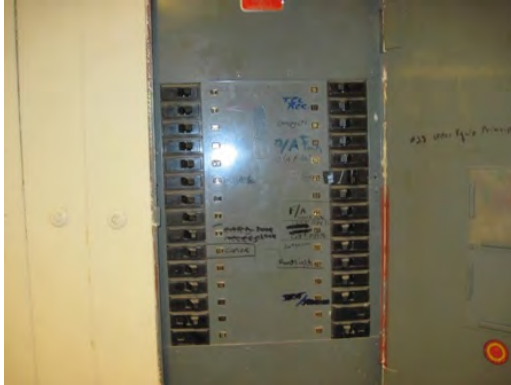
Assembly: **D5020**  
 System: **Branch Wiring**  
 Material: **System**  
 Distress: **Beyond Service Life**  
 Category: **Deferred Maintenance**  
 Correction: **Renew System**  
 Note: **The original branch wiring is aged and inadequate for modern computer loads.**

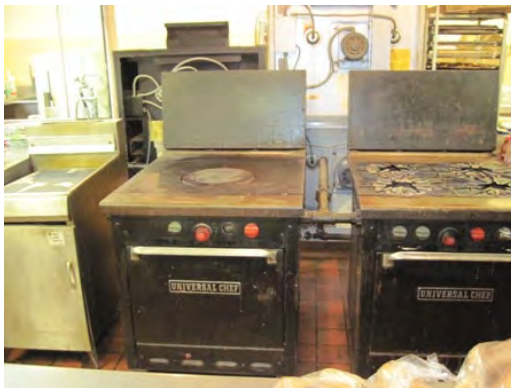
Assembly: **E1090**  
 System: **Other Equipment**  
 Material: **System**  
 Distress: **Beyond Service Life**  
 Category: **Deferred Maintenance**  
 Correction: **Renew System**  
 Note: **The original kitchen equipment is aged and should be replaced.**

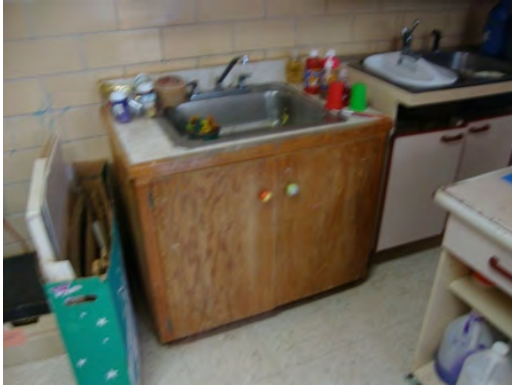
Note: **Fixed furnishings, such as the base/wall cabinets, counter tops, window shades, and fixed seating, are worn, beyond their service life, and should be replaced.**

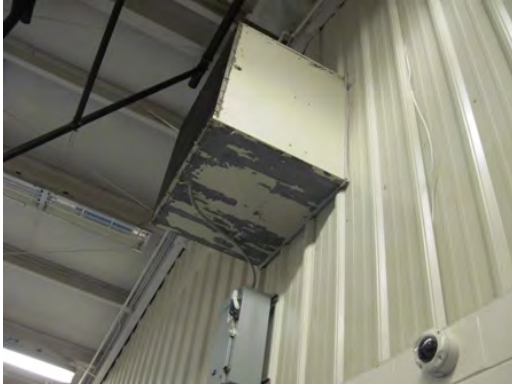
Assembly: **D3050**  
System: **Terminal & Package Units**  
Material: **Packaged A/C, Elec. Ht., Const. Volume**  
Distress: **Missing**  
Category: **Capital Improvement**  
Correction: **Install Package A/C - 20 ton**  
Note: **An air conditioning system is missing in the gymnasium and should be installed.**

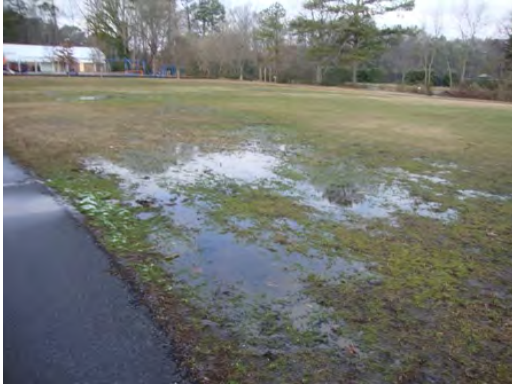
Assembly: **F1040**  
System: **Special Facilities - Sports Field - Natural Turf System**  
Material: **Beyond Service Life**  
Distress: **Beyond Service Life**  
Category: **Deferred Maintenance**  
Correction: **Renew System**  
Note: **The turf is aged and worn and should be reseeded.**

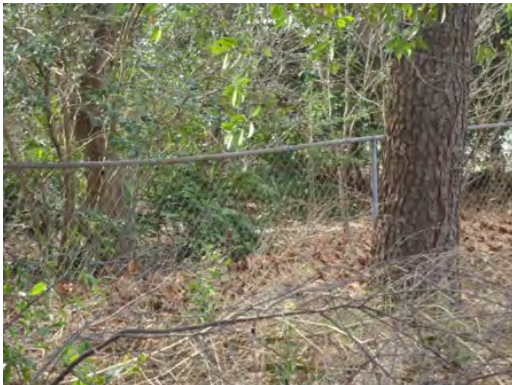
Assembly: **G2040**  
System: **Site Development - Fencing System**  
Material: **Beyond Service Life**  
Distress: **Beyond Service Life**  
Category: **Deferred Maintenance**  
Correction: **Renew System**  
Note: **The fencing is aged and rusted and should be replaced.**

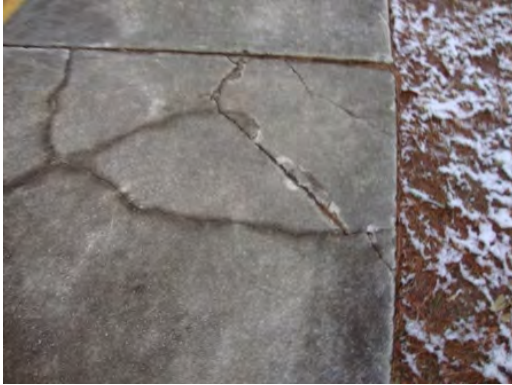
Assembly: **G2030**  
System: **Pedestrian Paving**  
Material: **System**  
Distress: **Beyond Service Life**  
Category: **Deferred Maintenance**  
Correction: **Renew System**  
Note: **The pedestrian paving and walkways are aged and damaged and should be replaced.**

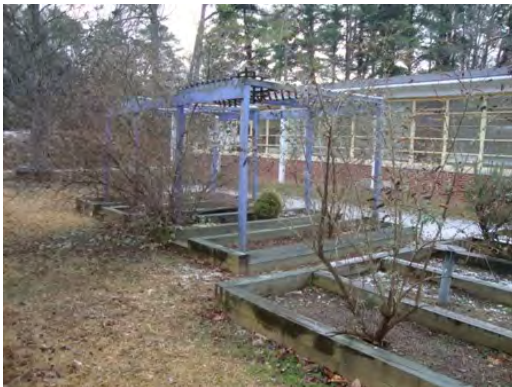
Assembly: **G2040**  
System: **Site Development**  
Material: **System**  
Distress: **Beyond Service Life**  
Category: **Deferred Maintenance**  
Correction: **Renew System**  
Note: **Site development features, such as site furnishings, playgrounds, and signage, are beyond their service life and should be replaced.**

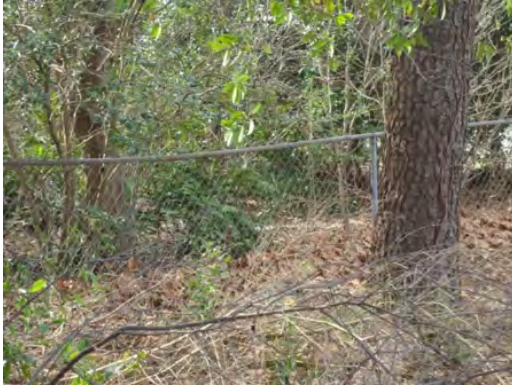
Note: **The fencing is aged, rusted, and damaged, and should be replaced.**
