Facility Condition Assessment Report

DeKalb County School System1701 Mountain Industrial Blvd
Stone Mountain, GA 30083COMET4 Facility Report
Salem Middle Facility Executive Summary ReportReport Date: 24 Jun 2011

Facility: \Middle Schools\Salem Middle
Address: 5333 Salem Road, Lithonia, GA 30058**Attributes:****Facility Code** 0291
Super Cluster 4**General Information:****Function:** Middle School
Gross Area: 138,469 S.F.
Year Built:
Last Renovation:**Facility Description:**

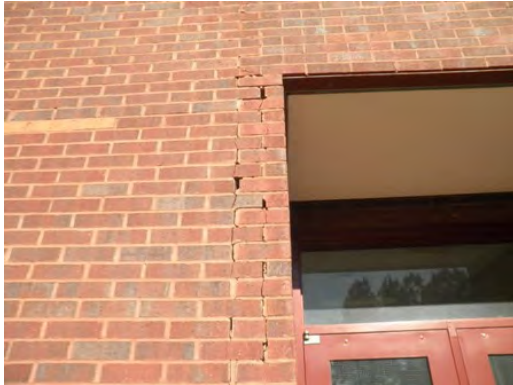
Assembly: **B2010**
System: **Exterior Walls**
Material: **Brick Veneer w/Stud Backup**
Distress: **Needs Remediation**
Category: **Deferred Maintenance**
Correction: **Repair Brick Veneer w/Stud Backup**
Note: **The brick veneer around the entrances at the rear of the building is cracking and should be repaired.**

Raw Cost	\$33,750.00
	Plus or (Minus) Additional Cost	\$12,825.00
	Total Estimated Amount	\$46,575.00

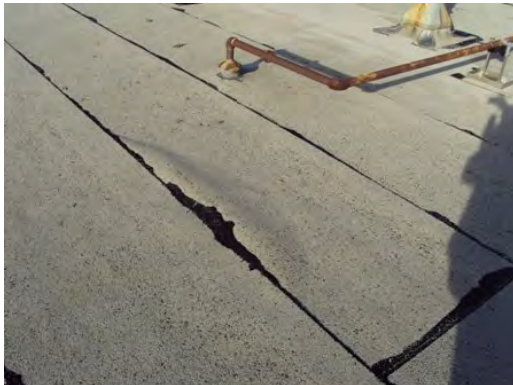
Assembly: **B3010**
System: **Roof Coverings - BUR System**
Material: **System**
Distress: **Needs Remediation**
Category: **Deferred Maintenance**
Correction: **Renew System**
Note: **The built up roofing is reported to have leaks, is aged, and should be replaced.**

Raw Cost	\$517,648.16
	Plus or (Minus) Additional Cost	\$196,706.30
	Total Estimated Amount	\$714,354.46

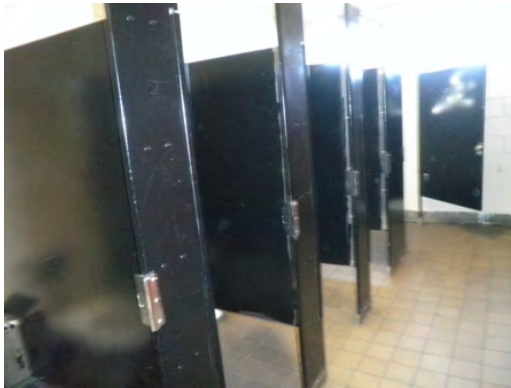
Assembly: **C1030**
 System: **Fittings**
 Material: **System**
 Distress: **Damaged**
 Category: **Deferred Maintenance**
 Correction: **Renew System**
 Note: **Fittings, such as chalk and tack boards, toilet and bath accessories, toilet partitions, and shelving, are worn and damaged and should be replaced.**

Raw Cost	\$176,412.43
Plus or (Minus) Additional Cost	\$67,036.72
Total Estimated Amount	\$243,449.15

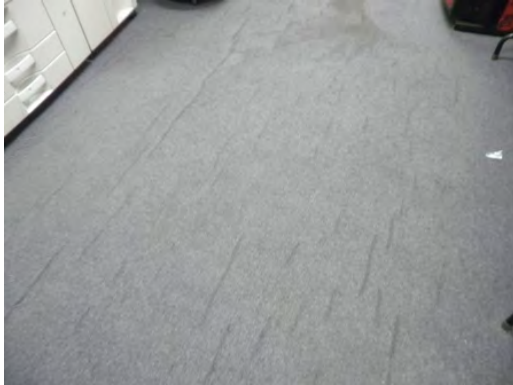
Assembly: **C3020**
System: **Floor Finishes - Carpet**
Material: **System**
Distress: **Needs Remediation**
Category: **Safety**
Correction: **Renew System**
Note: **The carpet is a tripping hazard, stained, and worn, and should be replaced.**

Raw Cost	\$73,396.62
Plus or (Minus) Additional Cost	\$27,890.72
Total Estimated Amount	\$101,287.34

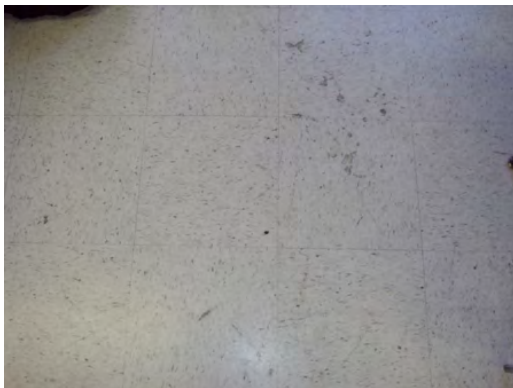
Assembly: **C3020**
System: **Floor Finishes - VCT**
Material: **System**
Distress: **Needs Remediation**
Category: **Deferred Maintenance**
Correction: **Renew System**
Note: **The VCT flooring is scuffed, stained, and worn, and should be replaced.**

Raw Cost	\$478,515.04
Plus or (Minus) Additional Cost	\$181,835.71
Total Estimated Amount	\$660,350.75

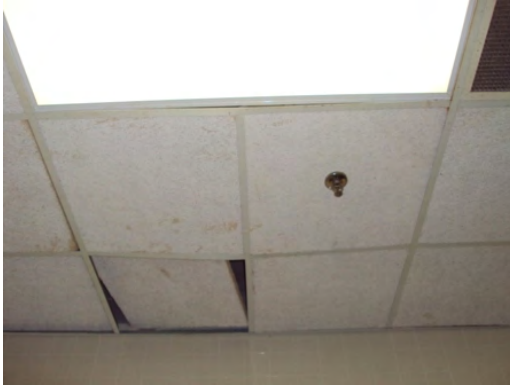
Note: The suspended ceiling tile and grid system is stained and damaged and should be replaced.

Raw Cost	\$507,346.71
Plus or (Minus) Additional Cost	\$192,791.75
Total Estimated Amount	\$700,138.46

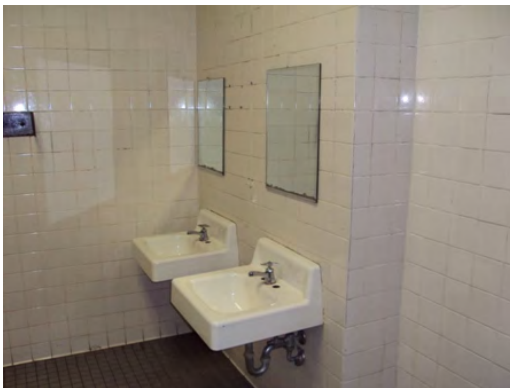
Note: The original plumbing fixtures are operable, but aged and should be scheduled for replacement.

Raw Cost	\$690,197.55
Plus or (Minus) Additional Cost	\$262,275.07
Total Estimated Amount	\$952,472.62

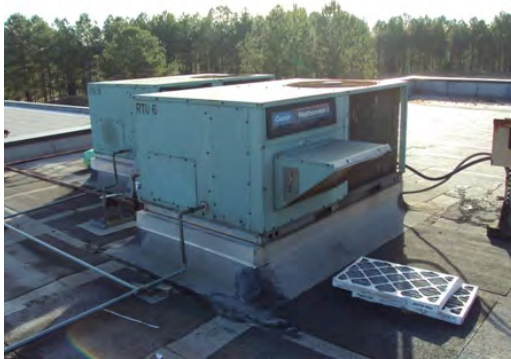
Note: **The original package units are reported to be malfunctioning and should be replaced.**

Raw Cost	\$1,613,465.55
Plus or (Minus) Additional Cost	\$613,116.91
Total Estimated Amount	\$2,226,582.46

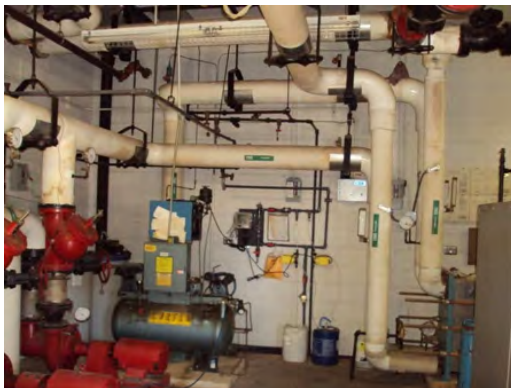
Assembly: **D3060**
System: **Controls & Instrumentation**
Material: **System**
Distress: **Inadequate**
Category: **Deferred Maintenance**
Correction: **Renew System**

Note: **The pneumatic HVAC control system is inadequate and should be replaced with an energy management system.**

Raw Cost	\$298,742.22
Plus or (Minus) Additional Cost	\$113,522.05
Total Estimated Amount	\$412,264.27

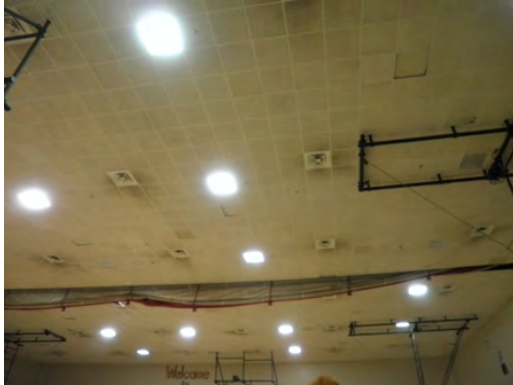
Assembly: **D5020**
System: **Lighting**
Material: **Lighting**
Distress: **Inadequate**
Category: **Deferred Maintenance**
Correction: **Replace the lighting system**
Note: **The gym and hallway lighting is too dim and inadequate for its use. It is suggested that the lighting be replaced.**

Raw Cost	\$193,230.00
Plus or (Minus) Additional Cost	\$73,427.40
Total Estimated Amount	\$266,657.40

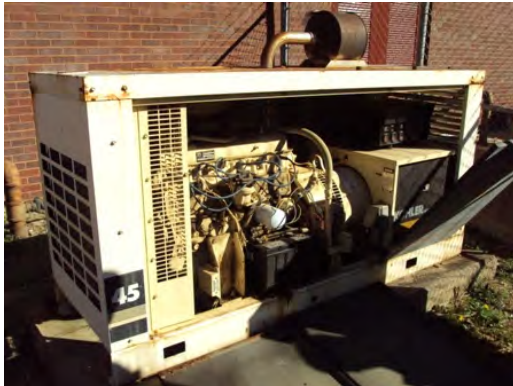
Assembly: **D5090**
System: **Other Electrical Systems - Emergency Generator**
Material: **System**
Distress: **Beyond Service Life**
Category: **Deferred Maintenance**
Correction: **Renew System**
Note: **The original emergency generator is aged, inefficient, and should be replaced with an energy efficient model.**

Raw Cost	\$87,562.38
Plus or (Minus) Additional Cost	\$33,273.70
Total Estimated Amount	\$120,836.08

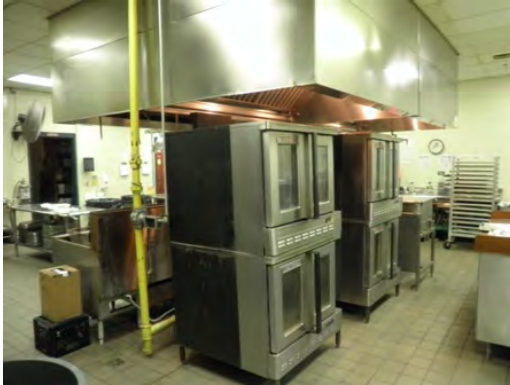
Note: The original food service equipment is aged and should be scheduled for replacement.

Raw Cost	\$315,482.09
Plus or (Minus) Additional Cost	\$119,883.19
Total Estimated Amount	\$435,365.28

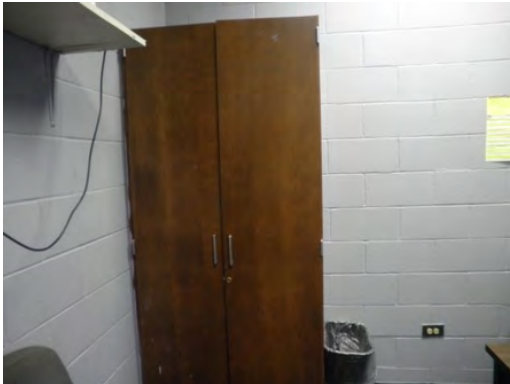
Note: Fixed furnishings, such as the base/wall cabinets, counter tops, window shades, and fixed seating, are worn, beyond their service life, and should be replaced.

Raw Cost	\$481,593.07
Plus or (Minus) Additional Cost	\$183,005.37
Total Estimated Amount	\$664,598.44

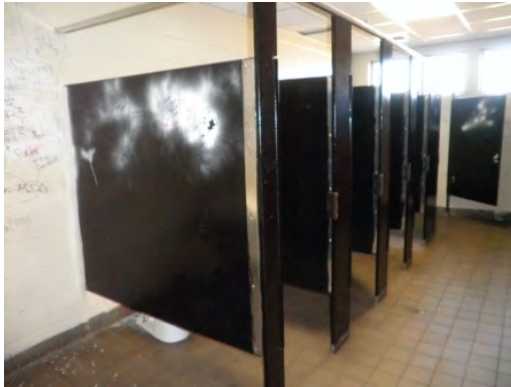
Assembly: **C1030**
 System: **Fittings**
 Material: **System**
 Distress: **Beyond Service Life**
 Category: **Deferred Maintenance**
 Correction: **Renew System**
 Note: **Fittings, such as chalk and tack boards, lockers, toilet and bath accessories, toilet partitions, and shelving, are beyond their service life and should be replaced.**

Raw Cost	\$31,717.83
Plus or (Minus) Additional Cost	\$12,052.78
Total Estimated Amount	\$43,770.61

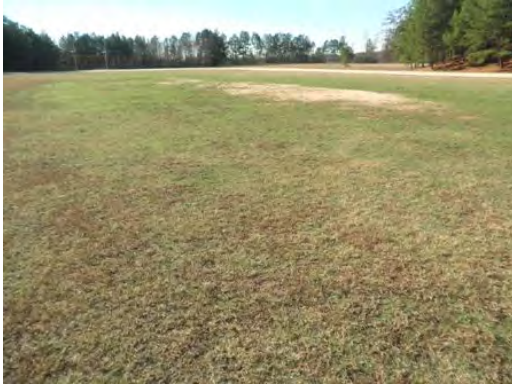
Assembly: **F1040**
System: **Special Facilities - Footbal Field - Natural Turf System**
Material: **System**
Distress: **Needs Remediation**
Category: **Deferred Maintenance**
Correction: **Renew System**
Note: **The football field turf is worn and should be reseeded.**

Raw Cost	\$11,880.00
Plus or (Minus) Additional Cost	\$3,088.80
Total Estimated Amount	\$14,968.80

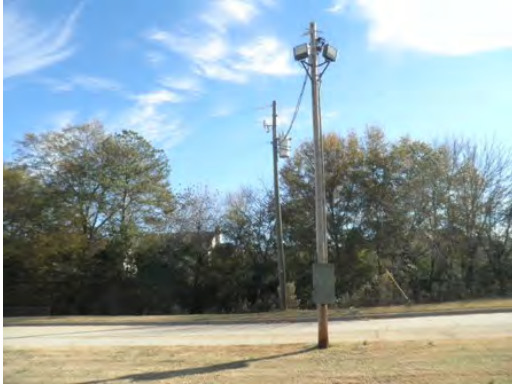
Assembly: **G4020**
System: **Site Lighting**
Material: **System**
Distress: **Inadequate**
Category: **Deferred Maintenance**
Correction: **Renew System**
Note: **The site lighting is reported and assessed to be inadequate and should be replaced.**

Raw Cost	\$83,773.75
Plus or (Minus) Additional Cost	\$21,781.17
Total Estimated Amount	\$105,554.92

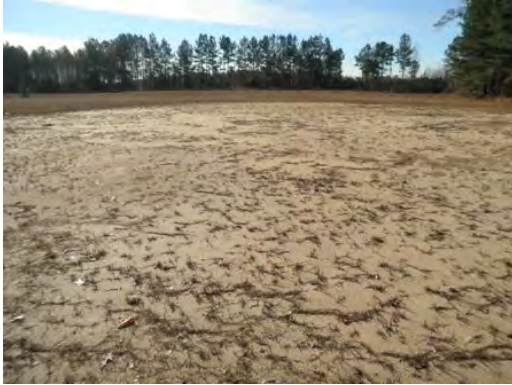
Assembly: **F1040**
System: **Special Facilities - Sports Field - Natural Turf System**
Material: **Needs Remediation**
Distress: **Needs Remediation**
Category: **Deferred Maintenance**
Correction: **Renew System**
Note: **The softball field turf is worn and should be reseeded.**

Raw Cost	\$4,642.00
Plus or (Minus) Additional Cost	\$1,206.92
Total Estimated Amount	\$5,848.92

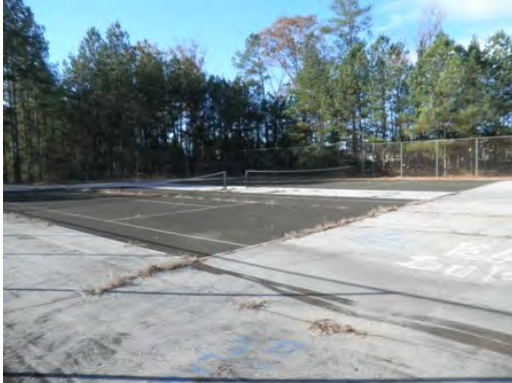
Assembly: **F1040**
System: **Special Facilities - Tennis Court Hard Surface System**
Material: **Damaged**
Distress: **Damaged**
Category: **Deferred Maintenance**
Correction: **Renew System**
Note: **The tennis court surface is damaged and should be replaced.**

Raw Cost	\$33,158.40
Plus or (Minus) Additional Cost	\$8,621.18
Total Estimated Amount	\$41,779.58

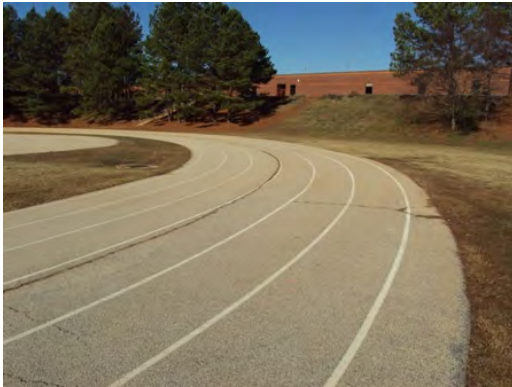
Correction: **Renew System**
Note: **The track surface is cracked and damaged and should be resurfaced.**

Raw Cost	\$116,049.65
Plus or (Minus) Additional Cost	\$30,172.91
Total Estimated Amount	\$146,222.56
