# **Facility Condition Assessment Report**

**Snapfinger Elementary Facility Executive Summary Report**Report Date: 05 Jul 2011

**Facility:** \Elementary Schools\Snapfinger Elementary**Address:** 1365 Snapfinger Road, Decatur, GA 30032**Attributes:****Facility Code** 4067  
**Super Cluster** 5**General Information:****Function:** Elementary School  
**Gross Area:** 87,316 S.F.**Year Built:**  
**Last Renovation:****Facility Description:**

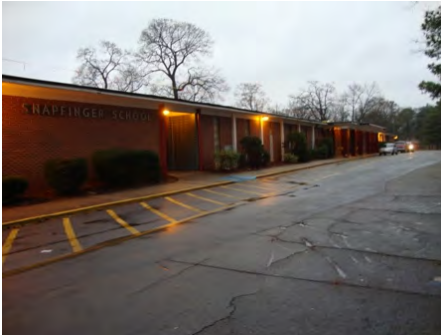
09-Mar-2011  
North Elevation

The Snapfinger Elementary School main building is a two-story building located at 1365 Snapfinger Road in Decatur, Georgia. Originally built in 1964, there have been three additions in 1966, 1969, and 1994, and significant renovations since 2006. This report contains condition and adequacy data collected during the 2010/2011 Facility Condition Assessment (FCA). The detailed condition and deficiency statements are contained in this report.

Energy conservation opportunities for this building include: 1) Replacing the single pane, operable windows with double pane, energy efficient windows; 2) Replacing the plumbing fixtures with low flow fixtures; and 3) Replacing the building automation system with an effective energy management system that completely controls HVAC and lighting.

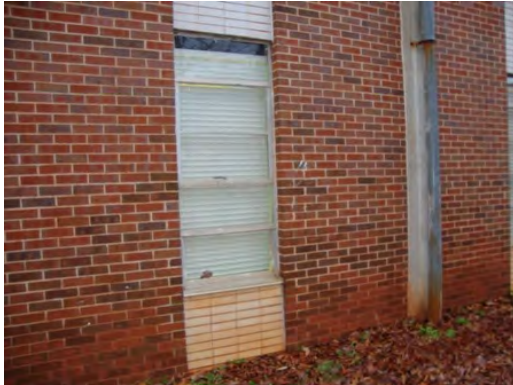
Assembly: **B2020**  
 System: **Exterior Windows**  
 Material: **System**  
 Distress: **Beyond Service Life**  
 Category: **Deferred Maintenance**  
 Correction: **Renew System**  
 Note: **The original metal frame, single pane, operable windows are aged, worn, and inefficient, and should be replaced.**

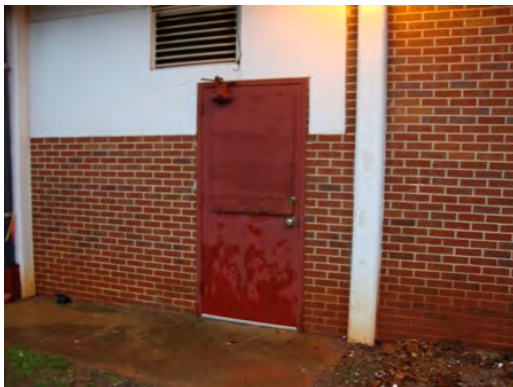
Assembly: **B2030**  
 System: **Exterior Doors**  
 Material: **System**  
 Distress: **Beyond Service Life**  
 Category: **Deferred Maintenance**  
 Correction: **Renew System**  
 Note: **The original metal exterior doors are aged, rusted, and damaged, and should be replaced.**

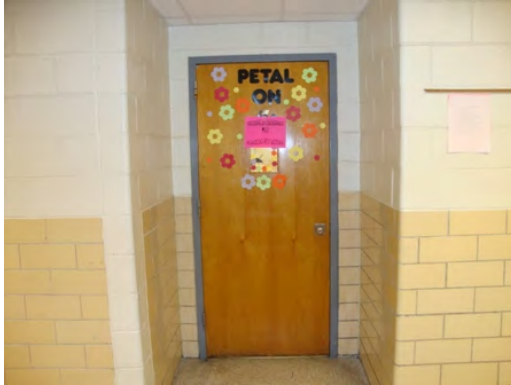
Note: **The doors and hardware are original and worn and should be replaced.**

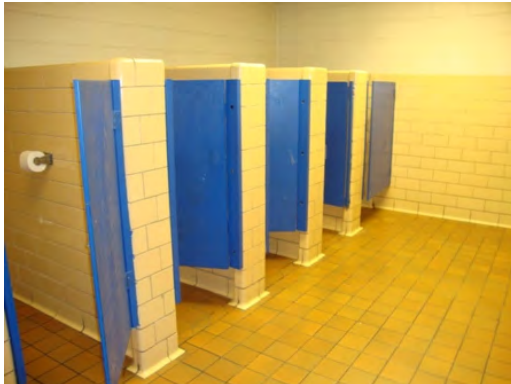
Note: **Fittings, such as chalk and tack boards, toilet and bath accessories, toilet partitions, and signage, are aged, worn, and damaged, and should be replaced.**

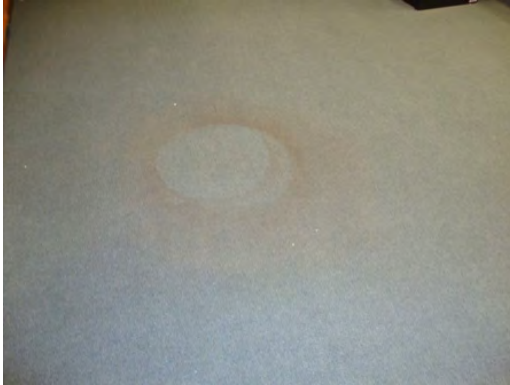
Assembly: **C3020**  
 System: **Floor Finishes - Carpet**  
 Material: **System**  
 Distress: **Beyond Service Life**  
 Category: **Deferred Maintenance**  
 Correction: **Renew System**  
 Note: **The carpet is aged, worn, and stained, and should be replaced.**

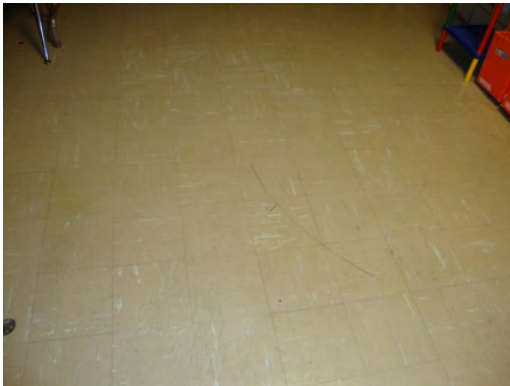
Assembly: **C3020**  
 System: **Floor Finishes - VCT**  
 Material: **System**  
 Distress: **Beyond Service Life**  
 Category: **Deferred Maintenance**  
 Correction: **Renew System**  
 Note: **The VCT and VAT are beyond their service life and should be replaced.**

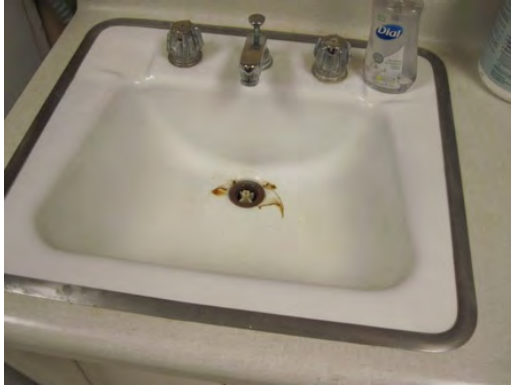
Note: **The plumbing fixtures are aged and worn and should be replaced.**

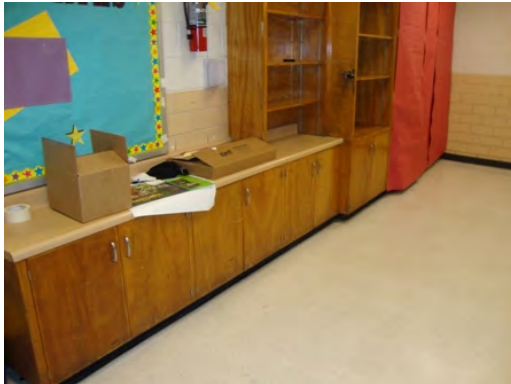
Note: **Fittings, such as chalk and tack boards, toilet and bath accessories, toilet partitions, and shelving, are aged, worn, and damaged, and should be replaced.**

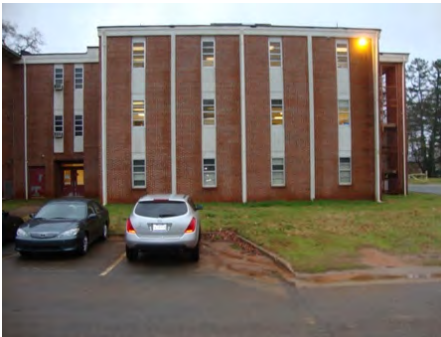
09-Mar-2011  
West Elevation

The 1994 Classroom Addition at Snapfinger Elementary School is a three-story building located at 1365 Snapfinger Road in Decatur, Georgia. There have been no additions, but there has been significant renovations in 2009. This report contains condition and adequacy data collected during the 2010/2011 Facility Condition Assessment (FCA). The detailed condition and deficiency statements are contained in this report.

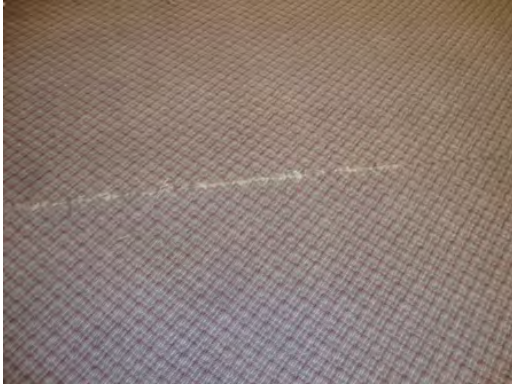
Assembly: **C3020**  
System: **Floor Finishes - Carpet**  
Material: **System**  
Distress: **Beyond Service Life**  
Category: **Deferred Maintenance**  
Correction: **Renew System**  
Note: **The carpet is aged, worn, and stained, and should be replaced.**

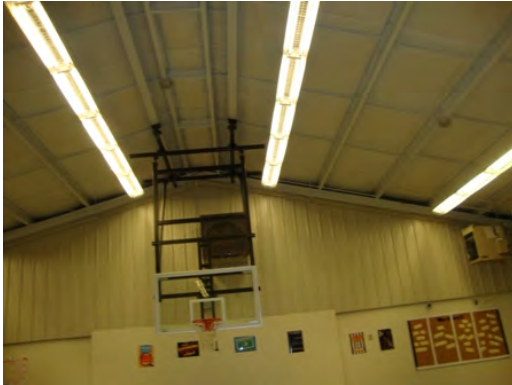
Assembly: **D3050**  
System: **Terminal & Package Units**  
Material: **Packaged A/C, Elec. Ht., Const. Volume**  
Distress: **Missing**  
Category: **Capital Improvement**  
Correction: **Install Package A/C - 20 ton**  
Note: **An air conditioning system is missing in the gymnasium and should be installed.**

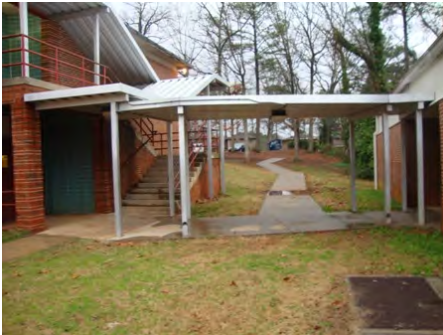
09-Mar-2011  
East Elevation

An engineered metal covered walkway connects the classrooms with the gymnasium and provides some weather protection for the students.

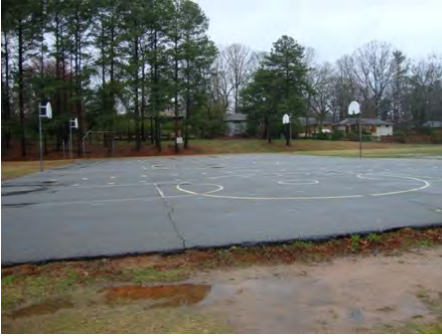
Hard Surface Play Area 1 at Snapfinger Elementary School is located on the campus grounds, west of the 1994 Classroom Addition, and features basketball courts. There have been no additions and no major renovations. This report contains condition and adequacy data collected during the 2010/2011 Facility Condition Assessment (FCA). The detailed condition and deficiency statements are contained in this report.

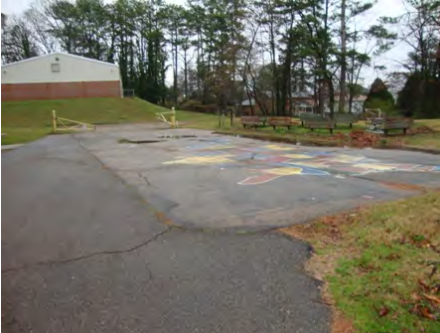
Hard Surface Play Area 2 at Snapfinger Elementary School is located on the campus grounds, south of the 1994 Classroom Addition. There have been no additions and no major renovations. This report contains condition and adequacy data collected during the 2010/2011 Facility Condition Assessment (FCA). The detailed condition and deficiency statements are contained in this report.

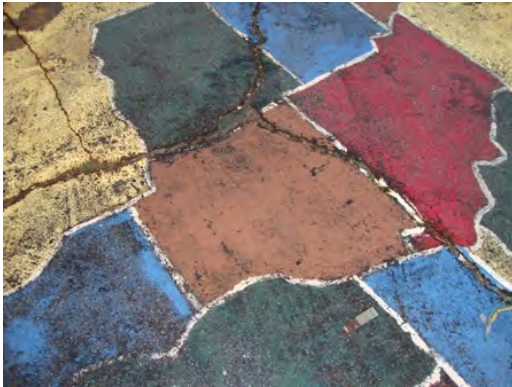
Correction: **The hard surface play area is aged and cracked and should be resurfaced and repainted.**

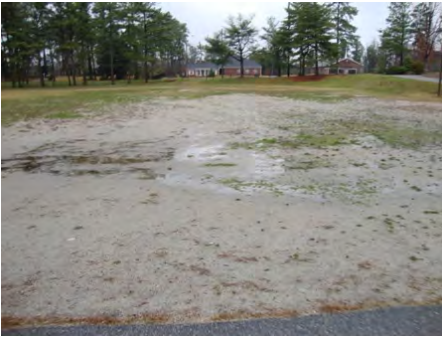
The Playfield at Snapfinger Elementary School is located on the campus grounds. There have been no additions and no major renovations. This report contains condition and adequacy data collected during the 2010/2011 Facility Condition Assessment (FCA). The detailed condition and deficiency statements are contained in this report.

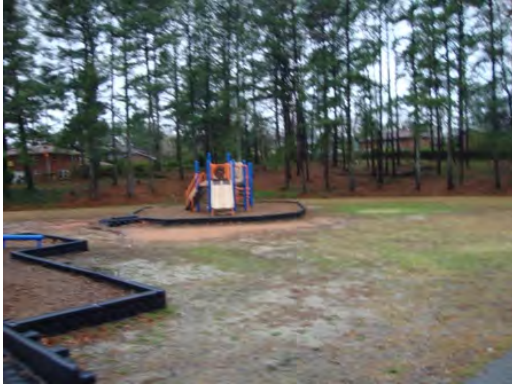
Assembly: **F1040**  
 System: **Special Facilities - Sports Field - Natural Turf System**  
 Material: **System**  
 Distress: **Beyond Service Life**  
 Category: **Deferred Maintenance**  
 Correction: **Renew System**  
 Note: **The playfield turf is worn and damaged and should be seeded.**

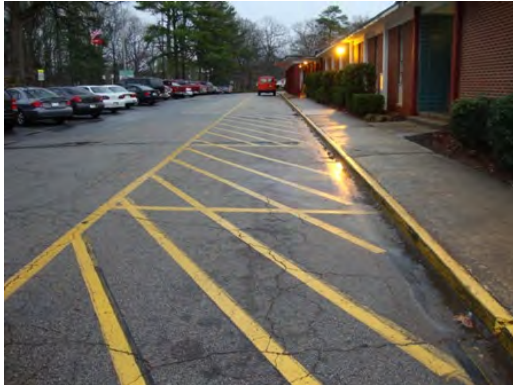
Assembly: **G2010**  
 System: **Roadways**  
 Material: **System**  
 Distress: **Beyond Service Life**  
 Category: **Deferred Maintenance**  
 Correction: **Renew System**  
 Note: **The roadways are aged and cracked, have many road cuts and repairs, and should be resurfaced and restriped.**

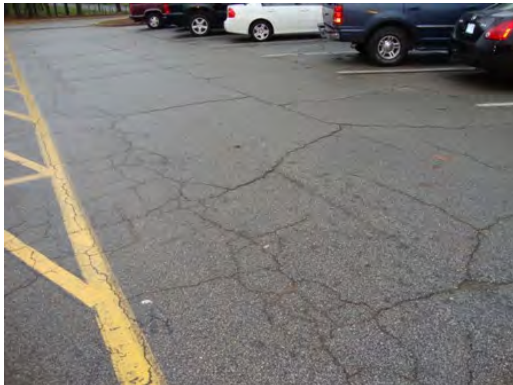
Assembly: **G2020**  
 System: **Parking Lots**  
 Material: **System**  
 Distress: **Beyond Service Life**  
 Category: **Deferred Maintenance**  
 Correction: **Renew System**  
 Note: **The parking lots are aged and cracked and should be resurfaced and restriped.**

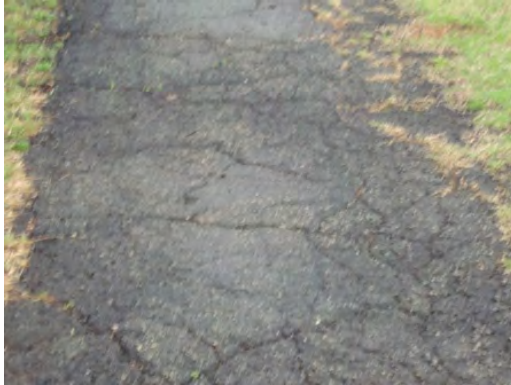
Note: **The pedestrian paving and walkways are aged and damaged and should be replaced.**

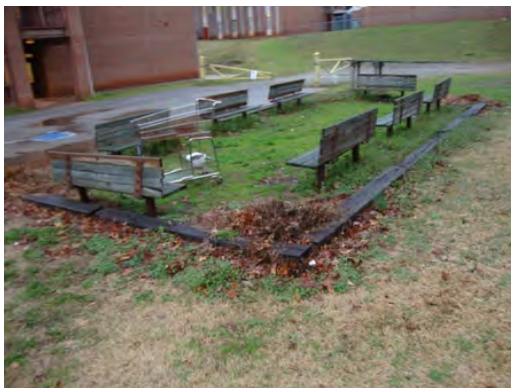
Note: **Site development features, such as the flagpole, site furnishings, and signage, are beyond their service life and should be replaced.**
