Facility Condition Assessment Report

DeKalb County School System1701 Mountain Industrial Blvd
Stone Mountain, GA 30083

Stone Mountain Middle Facility Executive Summary ReportReport Date: 24 Jun 2011

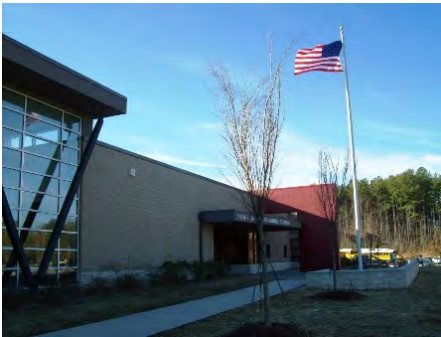
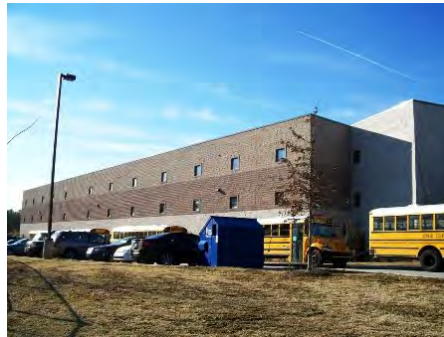
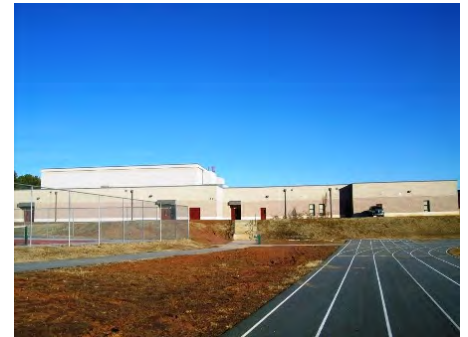
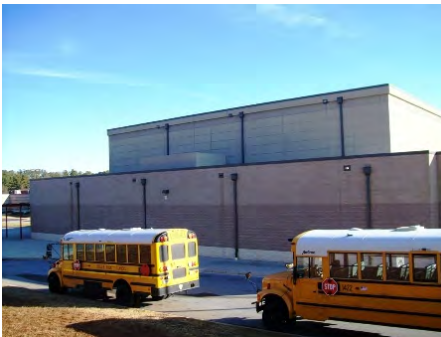
The Stone Mountain Middle School main building is a three-story building located at 4301 Sarr Parkway in Stone Mountain, Georgia. There have been no additions or renovations to the main building. This report contains condition and adequacy data collected during the 2010/2011 Facility Condition Assessment (FCA). The detailed condition and deficiency statements are contained in this report.

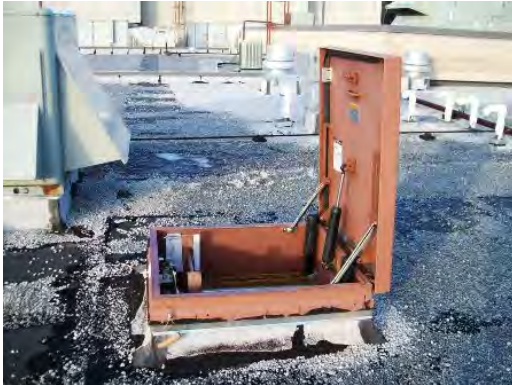
Assembly: **B3020**
System: **Roof Openings**
Material: **Roof Hatches, Skylights**
Distress: **Inadequate**
Category: **Safety**
Correction: **Replace Roof Hatches, Skylights**
Note: **The roof opening does not follow OSHA safety guidelines and should be replaced.**

Raw Cost	\$2,960.76
	Plus or (Minus) Additional Cost	\$1,125.09
	Total Estimated Amount	\$4,085.85

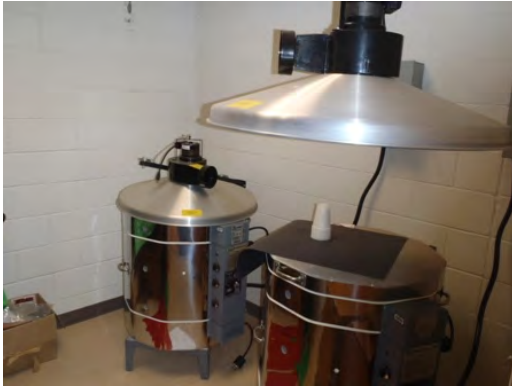
Assembly: **D3040**
System: **Distribution Systems & Exhaust Systems**
Material: **Roof Exhaust Fan Systems**
Distress: **Inadequate**
Category: **Code Compliance**
Correction: **KILN Exhaust System incl fixed hood roof exhaust**

Note: **Kiln exhaust system is inadequate and has no outside air available. Replace with code compliant system with run time delay.**

Raw Cost	\$12,006.15
Plus or (Minus) Additional Cost	\$4,562.34
Total Estimated Amount	\$16,568.49

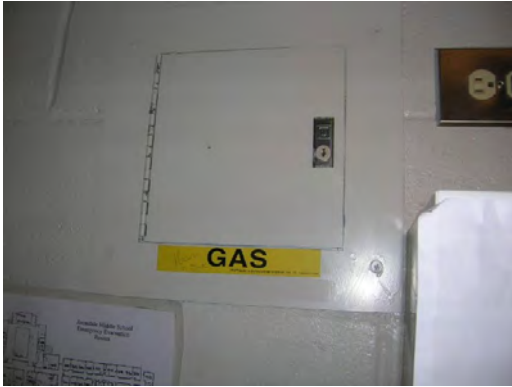
Assembly: **D5020**
System: **Branch Wiring**
Material: **Safety Switich**
Distress: **Inadequate**
Category: **Code Compliance**
Correction: **Install Classroom Emergency Utility Safety S.O.**

Note: **Lab emergency utility shutoffs are inaccessible or inadequate (locked or in another room) and should be moved to the hallway exit in each room.**

Raw Cost	\$24,921.00
Plus or (Minus) Additional Cost	\$9,469.98
Total Estimated Amount	\$34,390.98

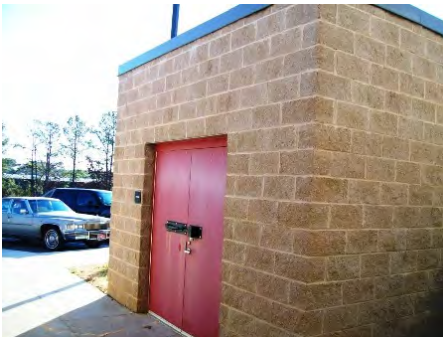
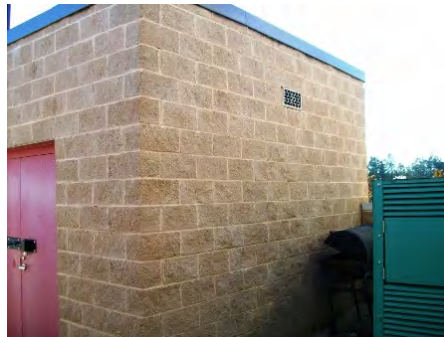
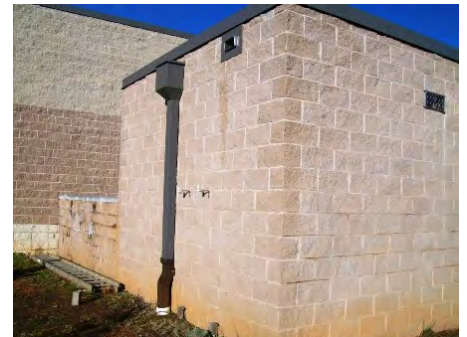
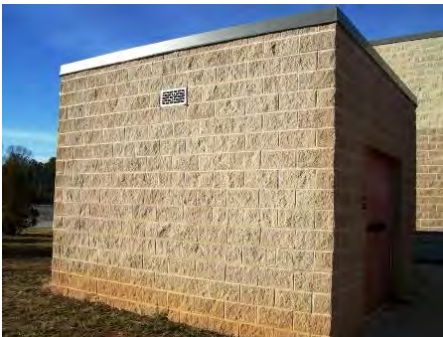
The Storage Building at Stone Mountain Middle School is located at 4301 Sarr Parkway in Stone Mountain, Georgia. There have been no additions and no major renovations. This report contains condition and adequacy data collected during the 2010/2011 Facility Condition Assessment (FCA). The detailed condition and deficiency statements are contained in this report.

*** No Deficiencies Found ***

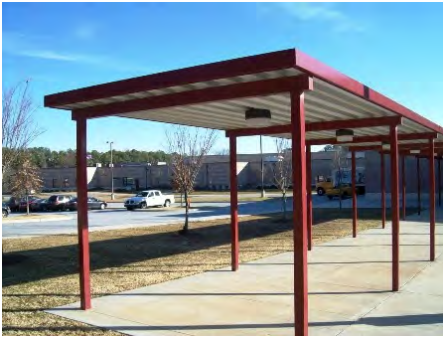
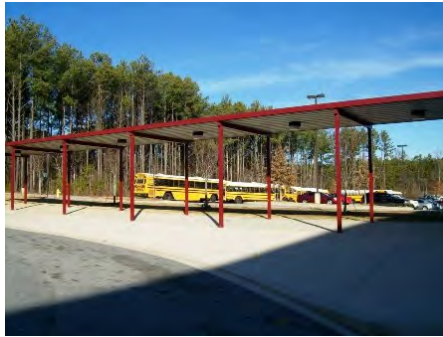
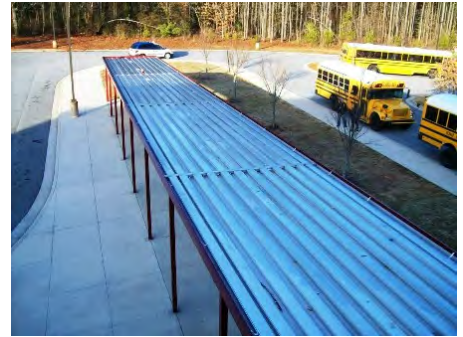
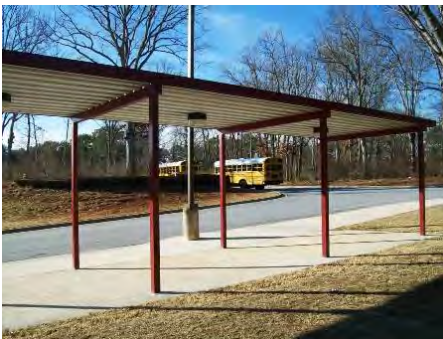
An engineered covered walkway connects the student drop off/pick up area and the main building and provides some weather protection for the students.

*** No Deficiencies Found ***

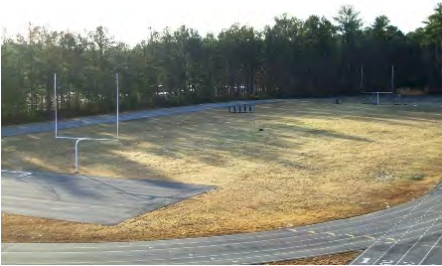
The Football Field at Stone Mountain Middle School is located on the campus grounds. There have been no additions and no major renovations. This report contains condition and adequacy data collected during the 2010/2011 Facility Condition Assessment (FCA). The detailed condition and deficiency statements are contained in this report.

*** No Deficiencies Found ***

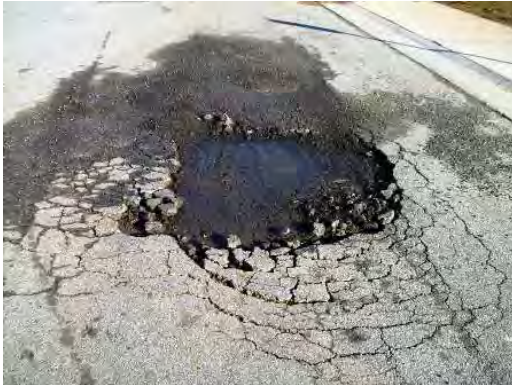
Assembly: **G2010**
System: **Roadways**
Material: **Paving**
Distress: **Damaged**
Category: **Safety**
Correction: **Re-pave parking lot / roadways**
Note: **The asphaltic roadway is damaged with large potholes that should be repaired.**

Raw Cost	\$9,615.00
Plus or (Minus) Additional Cost	\$2,499.90
Total Estimated Amount	\$12,114.90

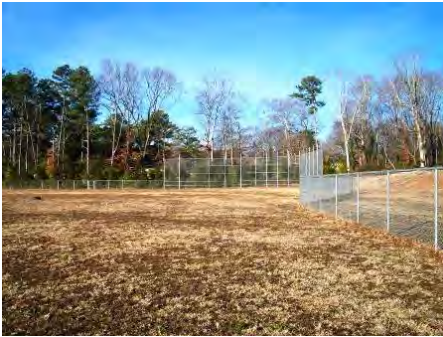
The Softball Field at Stone Mountain Middle School is located on the campus grounds. There have been no additions and no major renovations. This report contains condition and adequacy data collected during the 2010/2011 Facility Condition Assessment (FCA). The detailed condition and deficiency statements are contained in this report.

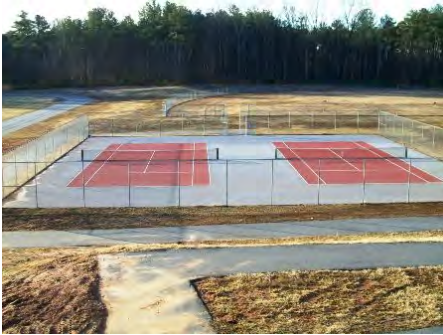
The Tennis Courts at Stone Mountain Middle School is located on the campus grounds. There have been no additions or renovations. This report contains condition and adequacy data collected during the 2010/2011 Facility Condition Assessment (FCA). The detailed condition and deficiency statements are contained in this report.

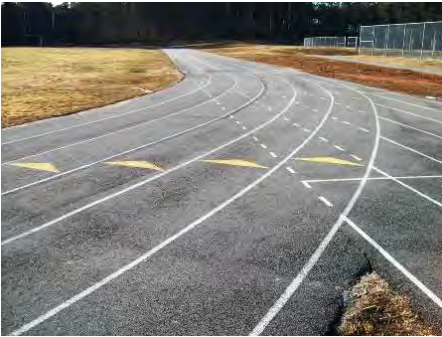
28-Jan-2011
Track at Stone Mountain Middle School

The Track at Stone Mountain Middle School is located on the campus grounds. There have been no additions or renovations. This report contains condition and adequacy data collected during the 2010/2011 Facility Condition Assessment (FCA). The detailed condition and deficiency statements are contained in this report.
