Facility Condition Assessment Report

Woodridge Elementary Facility Executive Summary ReportReport Date: 05 Jul 2011

Facility: \Elementary Schools\Woodridge Elementary**Address:** 4120 Cedar Ridge Trail, Stone Mountain, GA 30083**Attributes:****Facility Code** 0675
Super Cluster 4**General Information:****Function:** Elementary School
Gross Area: 58,418 S.F.**Year Built:**
Last Renovation:**Facility Description:**

COMET4 Survey Report
Woodridge Elementary Detailed Facility Needs Assessment Report

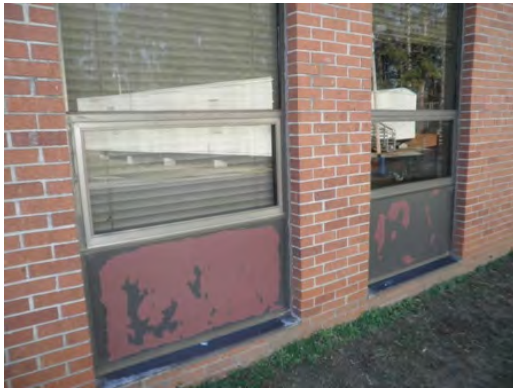
Assembly: **B2020**
System: **Exterior Windows**
Material: **System**
Distress: **Beyond Service Life**
Category: **Deferred Maintenance**
Correction: **Renew System**
Note: **The original metal frame, single pane windows are aged, worn, and inefficient, and should be replaced.**

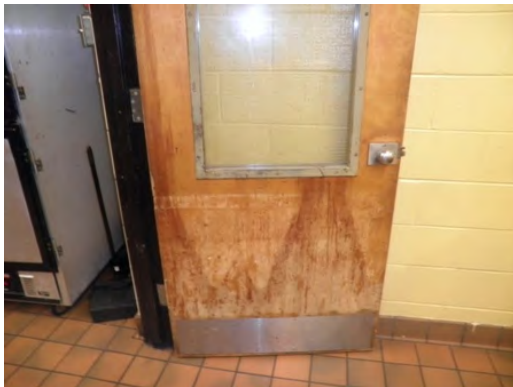
Assembly: **C1020**
System: **Interior Doors**
Material: **System**
Distress: **Beyond Service Life**
Category: **Deferred Maintenance**
Correction: **Renew System**
Note: **The original wood interior doors are aged and worn and should be scheduled for replacement, including door frame and hardware.**

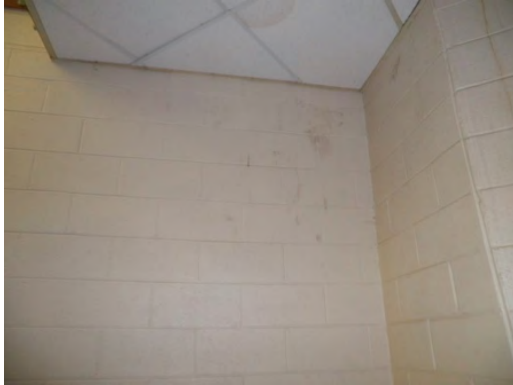
Note: **The wall paint is aged and scuffed and should be repainted.**

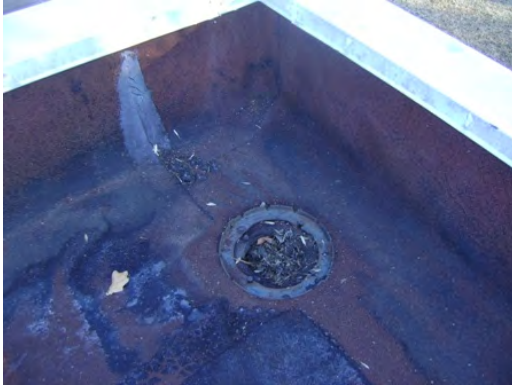
Note: **The roof drains are aged, damaged, and missing parts, and should be replaced.**

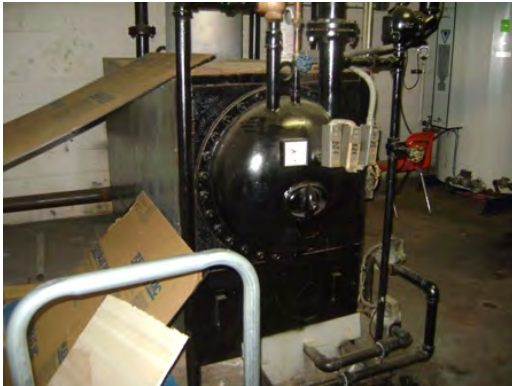
Note: **The heating system, including gas fired boiler, pumps, piping, and valves are aged, rusted, inefficient, and becoming logistically unsupportable, and should be replaced with an energy efficient equipment.**

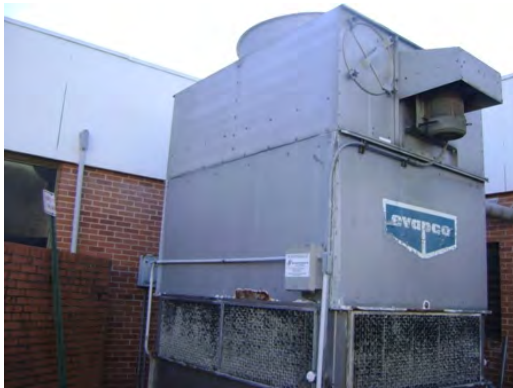
Note: **The cooling system, including cooling tower, pumps, piping, and valves are aged, rusted, inefficient, and becoming logistically unsupportable, and should be replaced with energy efficient equipment.**

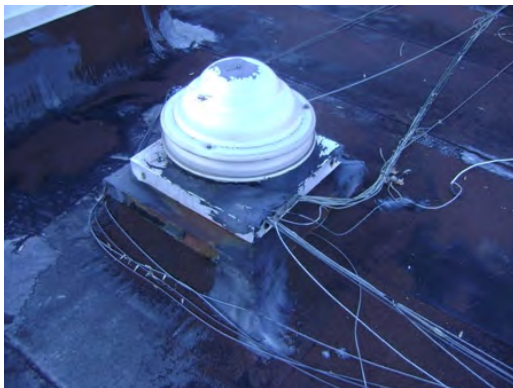
Note: **The exhaust fans and duct systems are inadequate, dirty, and damaged; they do not ventilate restrooms and other spaces properly; and should be replaced.**

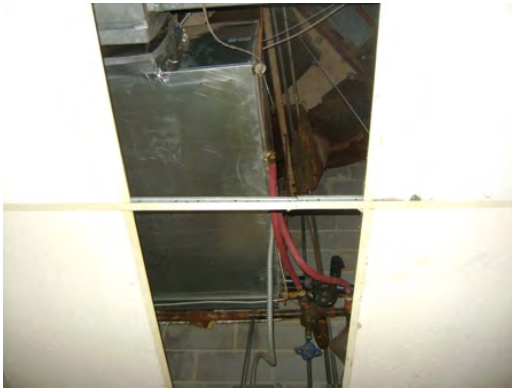
Note: **The roof top package units, water source heat pumps, and fan coil units are aged, worn, rusted, inefficient, and becoming logistically unsupportable, and should be replaced with energy efficient models.**

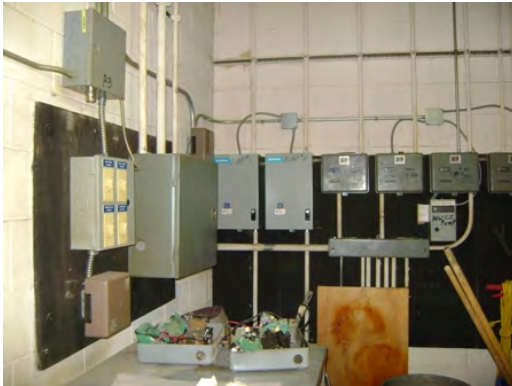
Note: **The HVAC controls are inadequate with obsolete parts and equipment and should be replaced.**

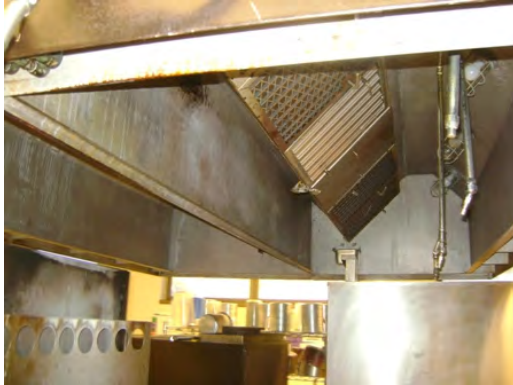
Assembly: **D3090**
System: **Other HVAC Systems/Equip - Kitchen Hood System**
Material: **Beyond Service Life**
Distress: **Beyond Service Life**
Category: **Deferred Maintenance**
Correction: **Renew System**
Note: **The kitchen hood and exhaust system is aged and worn and should be replaced.**

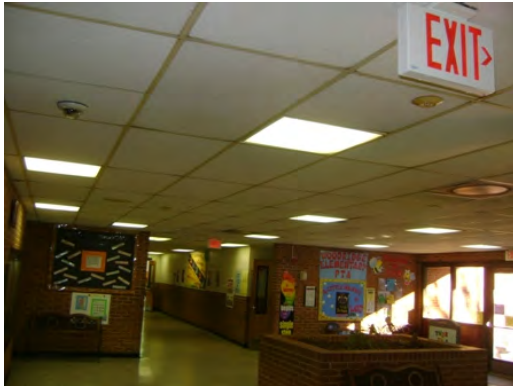
Assembly: **D5020**
System: **Lighting System**
Material: **Beyond Service Life**
Distress: **Beyond Service Life**
Category: **Deferred Maintenance**
Correction: **Renew System**
Note: **The lighting system is is aged, inefficient, in poor condition, and should be replaced with an energy efficient system.**

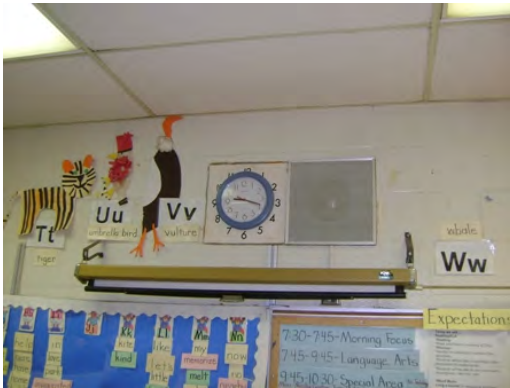
Note: **The clock and PA systems are aged, have reported outages, and should be replaced.**

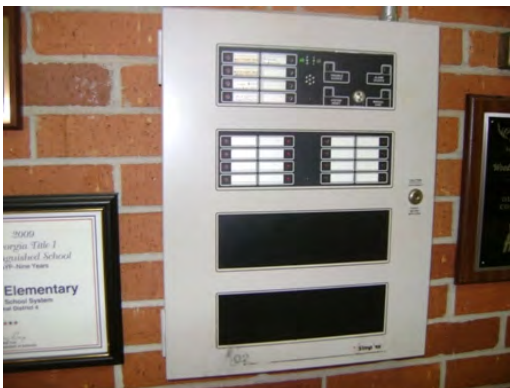
Note: **The fire alarm system is aged, has reported outages, and should be replaced.**

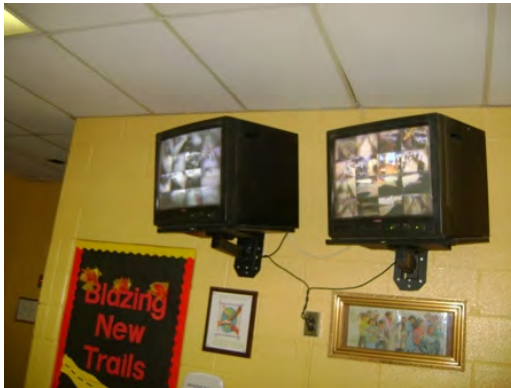
Note: **The security system has reported outages and inadequate coverage and should be replaced.**

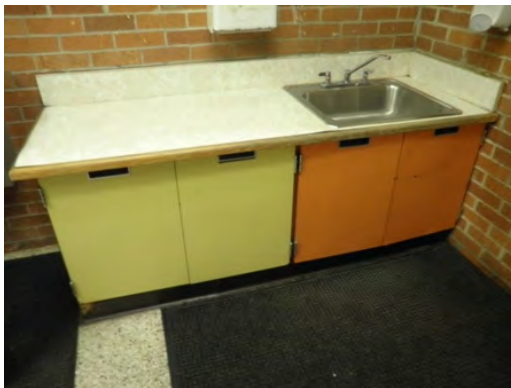
Note: **Fixed furnishings, such as the base/wall cabinets, counter tops, window shades, and fixed seating, are aged, worn, and damaged, and should be replaced.**

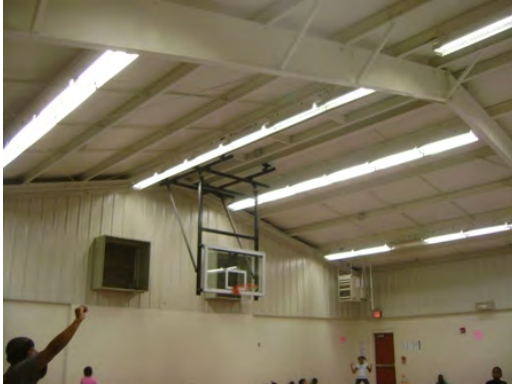
Assembly: **D3050**
System: **Terminal & Package Units**
Material: **Packaged A/C, Elec. Ht., Const. Volume**
Distress: **Missing**
Category: **Capital Improvement**
Correction: **Install Package A/C - 20 ton**
Note: **An air conditioning system is missing in the gymnasium and should be installed.**

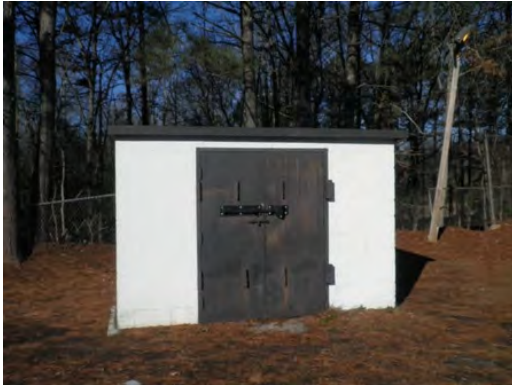
Assembly: **B2030**
System: **Exterior Doors**
Material: **System**
Distress: **Beyond Service Life**
Category: **Deferred Maintenance**
Correction: **Renew System**
Note: **The exterior doors are aged beyond their service life and should be replaced.**

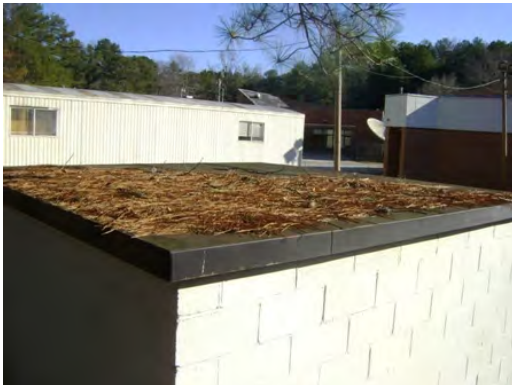
Assembly: **B3010**
System: **Roof Coverings**
Material: **System**
Distress: **Beyond Service Life**
Category: **Deferred Maintenance**
Correction: **Renew System**
Note: **The original metal roof covering is rusted and damaged and should be replaced.**

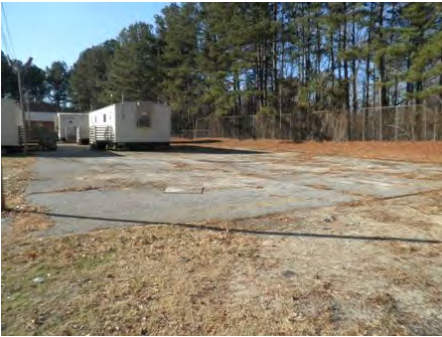
08-Feb-2011

B3010	Roof Coverings	System	Beyond Service Life	Renew System	1	Ea.	\$559	\$212	\$772	Necessary	Deferred Maintenance	The original metal roof covering is rusted and damaged and should be replaced.
Hard Surface Play Area Building Systems	F1040	Special Facilities - Basketball Court Hard Surface	System	Beyond Service Life	Renew System	1	Ea.	\$73,098	\$19,005	\$92,104	Recommended	Deferred Maintenance	The hard surface play area is aged and cracked and should be resurfaced.

Hard Surface Play Area at Woodridge
Elementary School

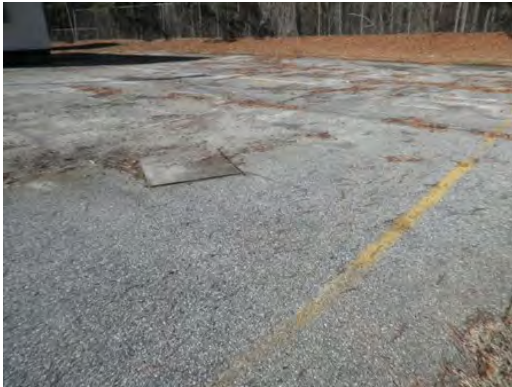
Correction: **The hard surface play area is aged and cracked and should be resurfaced.**

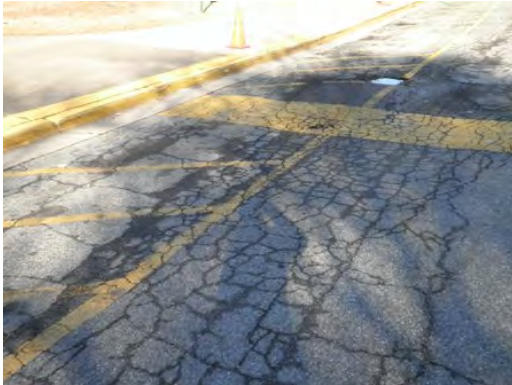
Deficiency: Surveyor/Update: Troy Weeks Fri, 24-Jun-2011
 Assembly: **G2010** Priority: 3
 System: **Roadways** Quantity: 1
 Material: **System**
 Distress: **Beyond Service Life**
 Category: **Deferred Maintenance**
 Correction: **Renew System**
 Note: **The roadways are aged and cracked, have many road cuts and repairs, and should be resurfaced.**

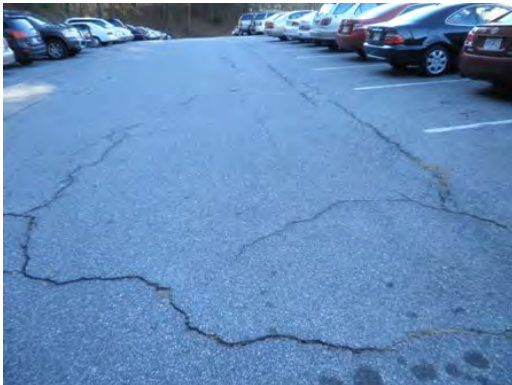
Deficiency: Surveyor/Update: Troy Weeks Fri, 24-Jun-2011
 Assembly: **G2020** Priority: 3
 System: **Parking Lots** Quantity: 1
 Material: **System**
 Distress: **Beyond Service Life**
 Category: **Deferred Maintenance**
 Correction: **Renew System**
 Note: **The parking lots are aged and cracked and should be resurfaced and restriped.**

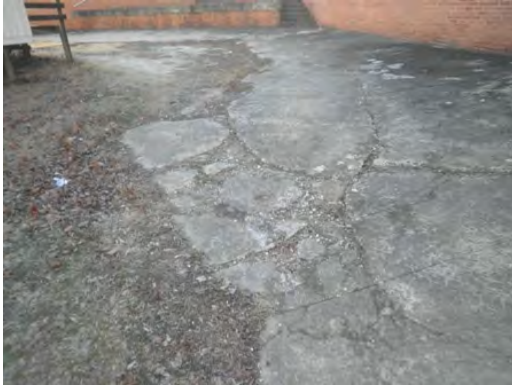
Note: **The sidewalks are aged, cracked, and damaged, and should be replaced.**

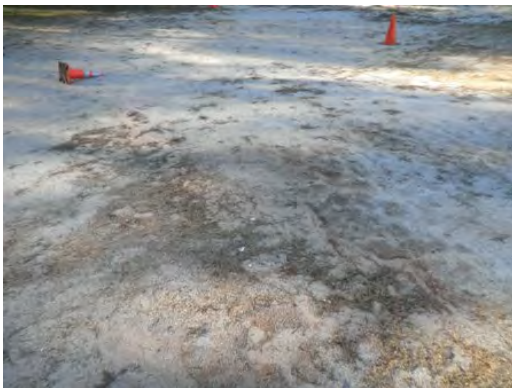
Assembly: **G2050**
System: **Landscaping System**
Material: **Beyond Service Life**
Distress: **Beyond Service Life**
Category: **Deferred Maintenance**
Correction: **Renew System**
Note: **The grass is worn and should be reseeded.**

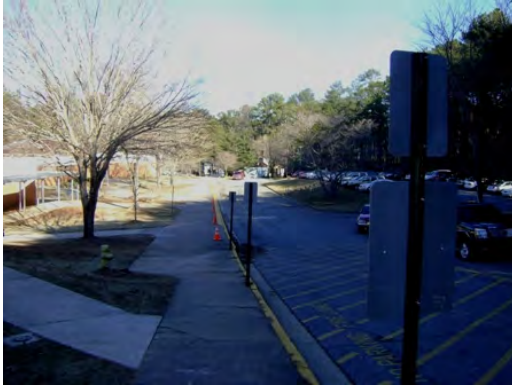
Assembly: **G4020**
System: **Site Lighting**
Material: **System**
Distress: **Beyond Service Life**
Category: **Deferred Maintenance**
Correction: **Renew System**
Note: **Site lighting for the parking areas is aged and inadequate and should be replaced.**
