Facility Condition Assessment Report

Woodward Elementary Facility Executive Summary ReportReport Date: 05 Jul 2011

COMET4 Survey Report Woodward Elementary Detailed Facility Needs Assessment Report

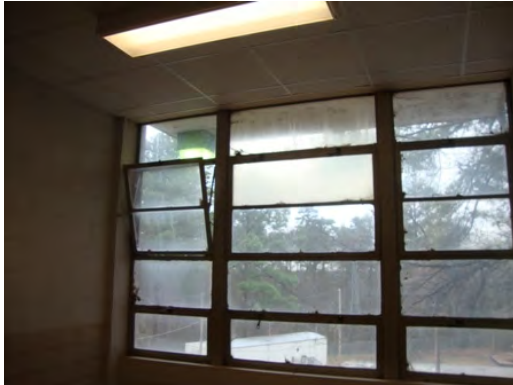
Assembly: **B2020**
System: **Exterior Windows**
Material: **System**
Distress: **Beyond Service Life**
Category: **Deferred Maintenance**
Correction: **Renew System**
Note: **The original metal frame, single pane, operable windows are aged, worn, and inefficient, and should be replaced.**

Raw Cost	\$249,995.64
Plus or (Minus) Additional Cost	\$94,998.34
Total Estimated Amount	\$344,993.98

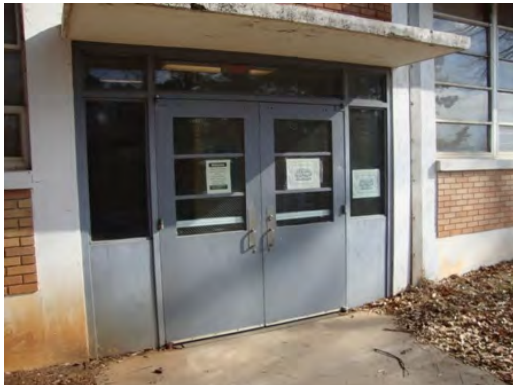
Assembly: **B2030**
System: **Exterior Doors**
Material: **System**
Distress: **Beyond Service Life**
Category: **Deferred Maintenance**
Correction: **Renew System**
Note: **The doors are original, rusted, and worn, and should be replaced.**

Raw Cost	\$34,388.05
Plus or (Minus) Additional Cost	\$13,067.46
Total Estimated Amount	\$47,455.51

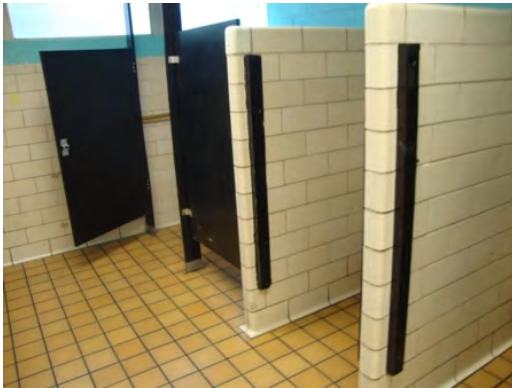
Note: **Fittings, such as chalk and tack boards, toilet and bath accessories, toilet partitions, and shelving, are aged, worn, and damaged, and should be replaced.**

Raw Cost	\$100,980.77
Plus or (Minus) Additional Cost	\$38,372.69
Total Estimated Amount	\$139,353.46

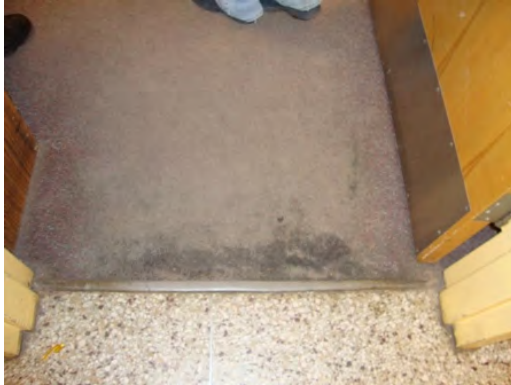
Assembly: **C3020**
System: **Floor Finishes - Carpet**
Material: **System**
Distress: **Beyond Service Life**
Category: **Deferred Maintenance**
Correction: **Renew System**
Note: **The carpet is aged, worn, and stained, and should be replaced.**

Raw Cost	\$311,129.94
Plus or (Minus) Additional Cost	\$118,229.38
Total Estimated Amount	\$429,359.32

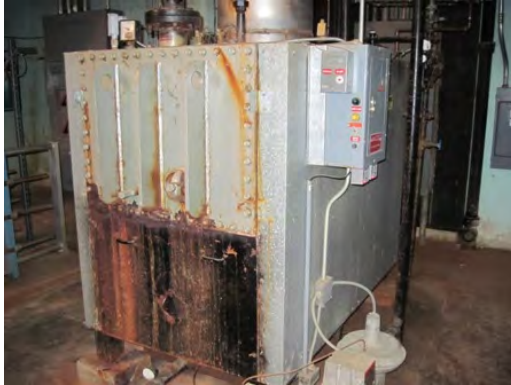
Note: **The original boiler is aged and should be replaced.**

Raw Cost	\$164,298.44
Plus or (Minus) Additional Cost	\$62,433.41
Total Estimated Amount	\$226,731.85

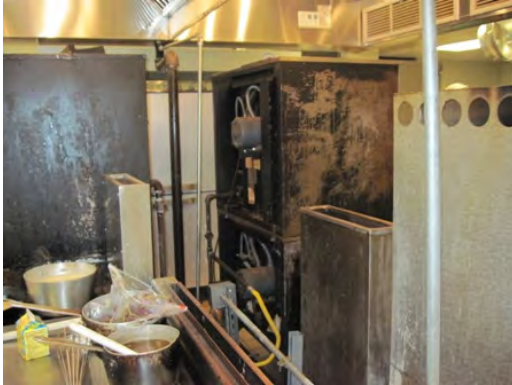
Assembly: **E1090**
 System: **Other Equipment**
 Material: **System**
 Distress: **Beyond Service Life**
 Category: **Deferred Maintenance**
 Correction: **Renew System**
 Note: **The kitchen equipment is aged and should be replaced.**

Raw Cost	\$320,955.10
Plus or (Minus) Additional Cost	\$121,962.94
Total Estimated Amount	\$442,918.04

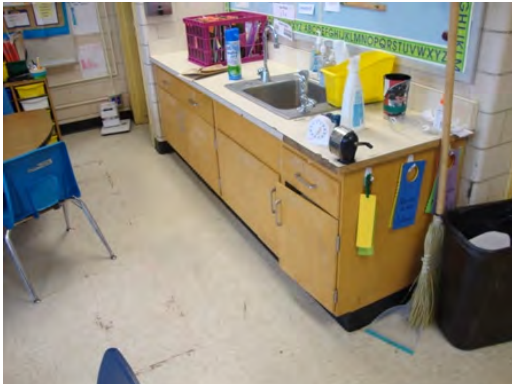
Assembly: **E2010**
 System: **Fixed Furnishings**
 Material: **System**
 Distress: **Beyond Service Life**
 Category: **Deferred Maintenance**
 Correction: **Renew System**
 Note: **Fixed furnishings, such as the base/wall cabinets, counter tops, window shades, and fixed seating, are worn, beyond their service life, and should be replaced.**

Raw Cost	\$167,027.65
Plus or (Minus) Additional Cost	\$63,470.51
Total Estimated Amount	\$230,498.16

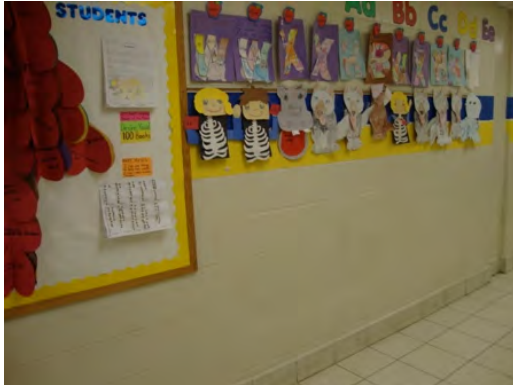
Assembly: **C3010**
 System: **Wall Finishes - Paint**
 Material: **System**
 Distress: **Beyond Service Life**
 Category: **Deferred Maintenance**
 Correction: **Renew System**
 Note: **The wall paint is aged and scuffed and should be repainted.**

Raw Cost	\$13,734.17
Plus or (Minus) Additional Cost	\$5,218.98
Total Estimated Amount	\$18,953.15

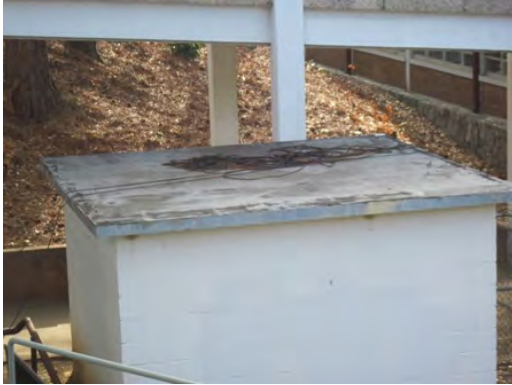
Assembly: **B3010**
System: **Roof Coverings**
Material: **System**
Distress: **Beyond Service Life**
Category: **Deferred Maintenance**
Correction: **Renew System**
Note: **The roof openings are aged and worn and should be replaced in conjunction with the roof.**

Raw Cost	\$1,374.12
Plus or (Minus) Additional Cost	\$522.17
Total Estimated Amount	\$1,896.29

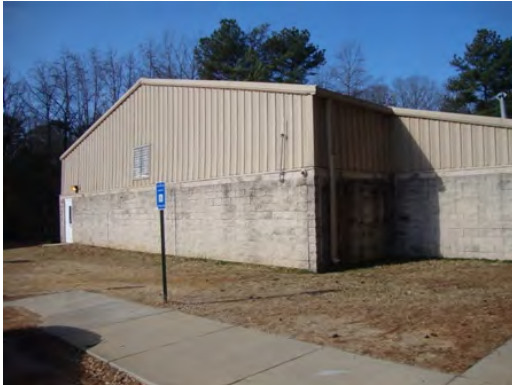
Assembly: **B2010**
System: **Exterior Walls**
Material: **Brick Face Cavity Wall**
Distress: **Damaged**
Category: **Deferred Maintenance**
Correction: **Power wash brick face cavity wall**
Note: **The exterior walls are stained and should be pressure washed.**

Raw Cost	\$3,066.56
	Plus or (Minus) Additional Cost	\$1,165.29
	Total Estimated Amount	\$4,231.85

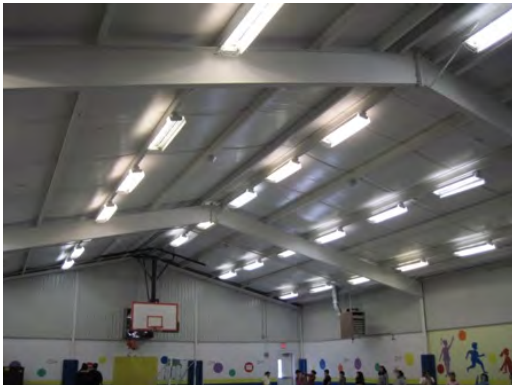
Assembly: **D3050**
System: **Terminal & Package Units**
Material: **Packaged A/C, Elec. Ht., Const. Volume**
Distress: **Missing**
Category: **Capital Improvement**
Correction: **Install Package A/C - 20 ton**
Note: **An air conditioning system is missing in the gymnasium and should be installed.**

Raw Cost	\$40,691.00
	Plus or (Minus) Additional Cost	\$15,462.58
	Total Estimated Amount	\$56,153.58

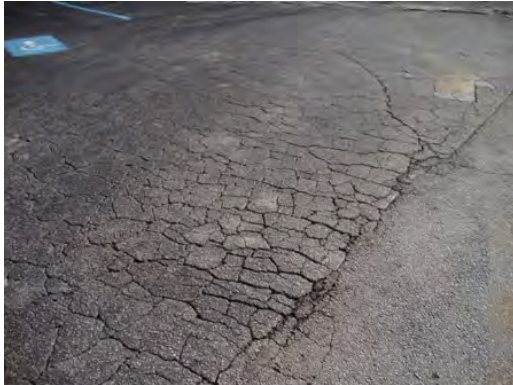
Assembly: **G2010**
System: **Roadways**
Material: **System**
Distress: **Beyond Service Life**
Category: **Deferred Maintenance**
Correction: **Renew System**
Note: **The roadways are aged and cracked, have many road cuts and repairs, and should be resurfaced.**

Raw Cost	\$210,468.92
Plus or (Minus) Additional Cost	\$54,721.92
Total Estimated Amount	\$265,190.84

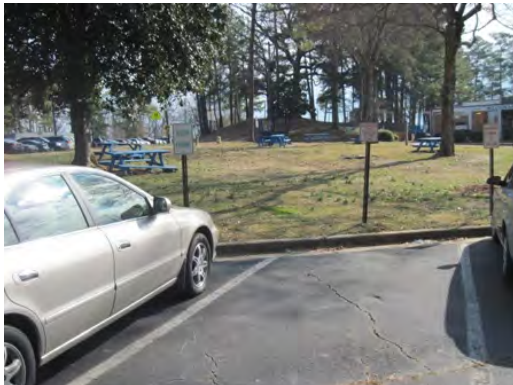
Assembly: **G2020**
System: **Parking Lots**
Material: **System**
Distress: **Beyond Service Life**
Category: **Deferred Maintenance**
Correction: **Renew System**
Note: **The parking lots are aged and cracked and should be resurfaced.**

Raw Cost	\$95,445.21
Plus or (Minus) Additional Cost	\$24,815.75
Total Estimated Amount	\$120,260.96

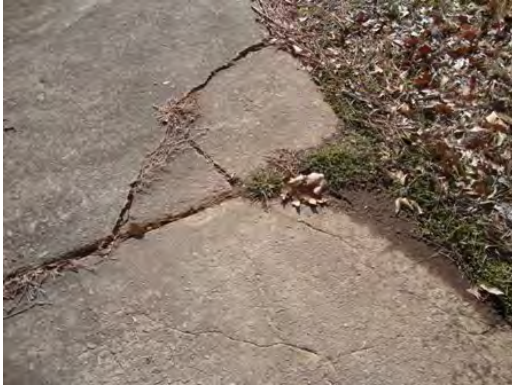
Assembly: **G2030**
System: **Pedestrian Paving**
Material: **System**
Distress: **Beyond Service Life**
Category: **Deferred Maintenance**
Correction: **Renew System**
Note: **The pedestrian paving is damaged and should be replaced.**

Raw Cost	\$106,866.00
Plus or (Minus) Additional Cost	\$27,785.16
Total Estimated Amount	\$134,651.16

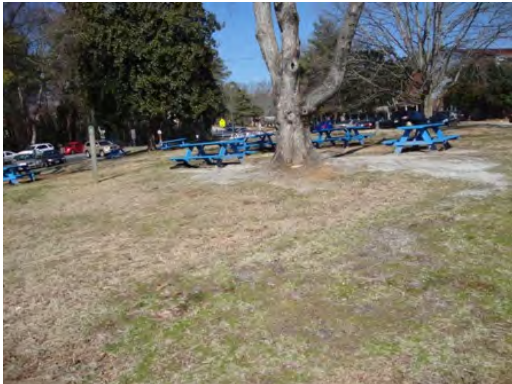
Assembly: **G2040**
System: **Site Development**
Material: **System**
Distress: **Beyond Service Life**
Category: **Deferred Maintenance**
Correction: **Renew System**
Note: **Site development features, such as site furnishings, playgrounds, and signage, are beyond their service life and should be scheduled for replacement.**

Raw Cost	\$17,131.19
Plus or (Minus) Additional Cost	\$4,454.11
Total Estimated Amount	\$21,585.30

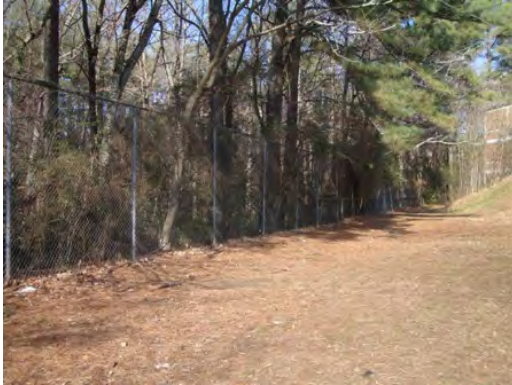
Assembly: **G2040105**
 System: **Fence & Guardrails System**
 Material: **System**
 Distress: **Beyond Service Life**
 Category: **Deferred Maintenance**
 Correction: **Renew System**
 Note: **The fence is rusting and damaged and should be replaced.**

Raw Cost	\$116,432.77
Plus or (Minus) Additional Cost	\$30,272.52
Total Estimated Amount	\$146,705.29

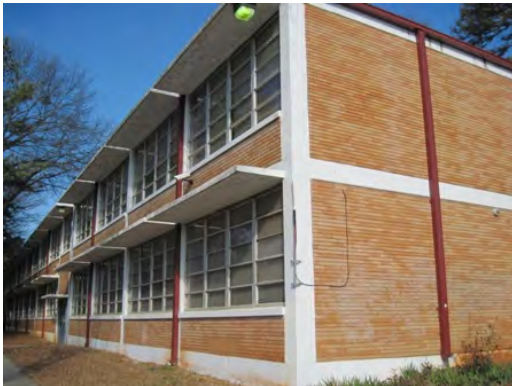
Assembly: **G4020**
 System: **Site Lighting System**
 Material: **System**
 Distress: **Inadequate**
 Category: **Deferred Maintenance**
 Correction: **Renew System**
 Note: **The site lighting is inadequate and should be replaced.**

Raw Cost	\$44,867.41
Plus or (Minus) Additional Cost	\$11,665.53
Total Estimated Amount	\$56,532.94
