DeKalb County School District/Elementary Schools

Allgood Elementary

School Assessment Report

May 19, 2016

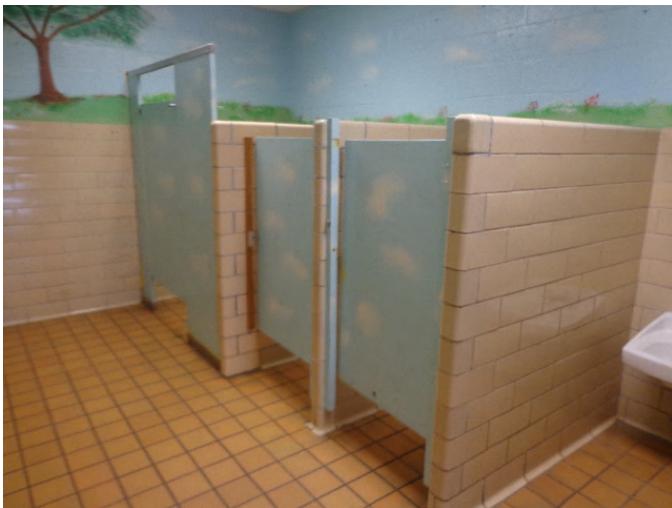
System: C1030 - Fittings

Location: Throughout Building

Distress: Beyond Service Life

Notes: Fittings, such as toilet partitions, handrails and signage, are beyond their expected service life, not ADA compliant, and should be replaced. Interior signage is inadequate.

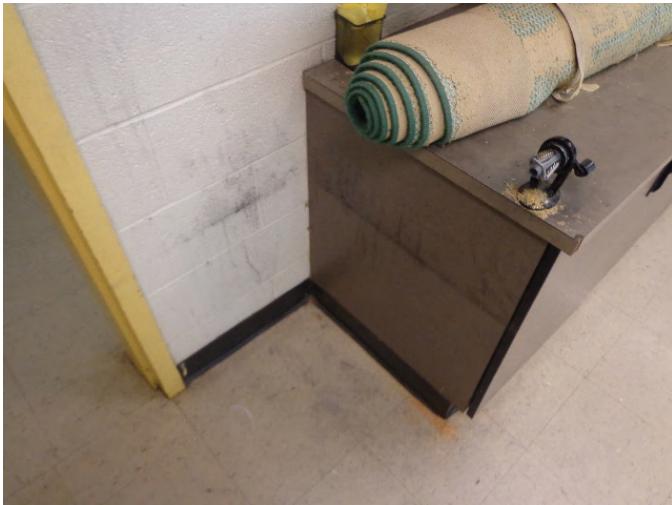
System: C3010 - Wall Finishes - Paint

Location: Throughout Building

Distress: Beyond Service Life

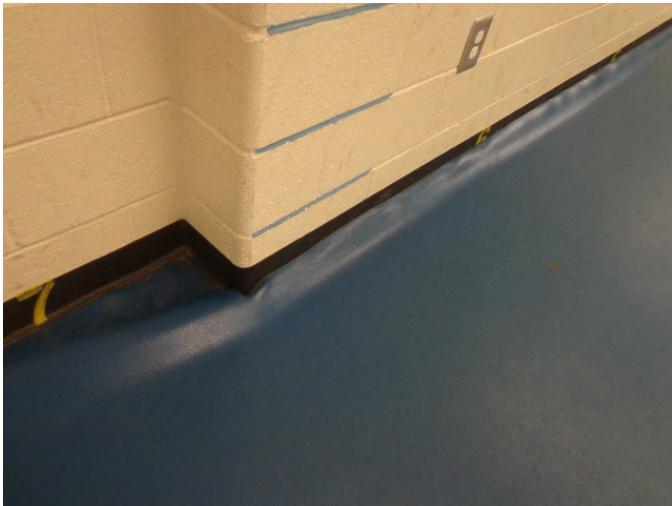
System: C3020 - Floor Finishes - Neoprene

Location: Basketball Court

Distress: Beyond Service Life

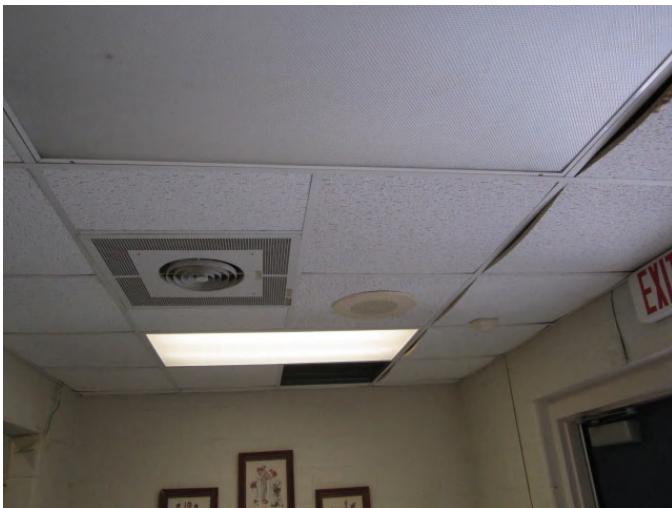
System: D5030 - Communications and Security - Public Address & Clock System

Location: Throughout Building

Distress: Beyond Service Life

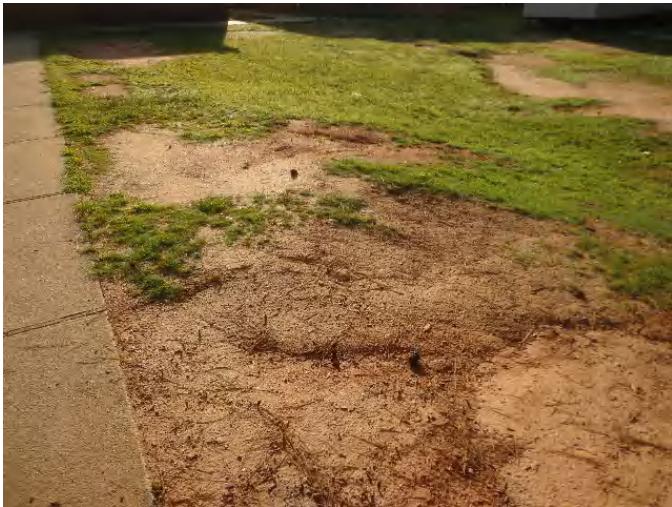
System: G2050 - Landscaping

Location: Site

Distress: Beyond Service Life

Notes: Landscaping is in poor condition, with many areas completely eroded away, and should be replaced. There is a severe problem with flooding of the site during rain storms, especially at the older building.

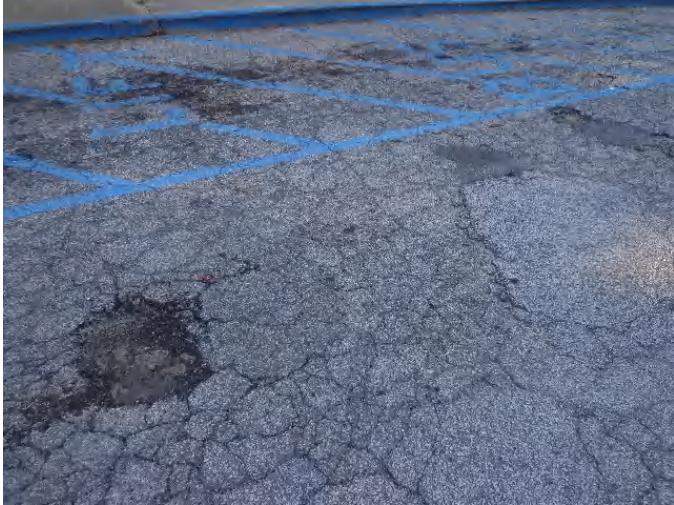
System: G2010 - Roadways

Location: Site

Distress: Beyond Service Life

Notes: Roadways are beyond their expected service life, damaged with many cracks and potholes, worn, and should be replaced.

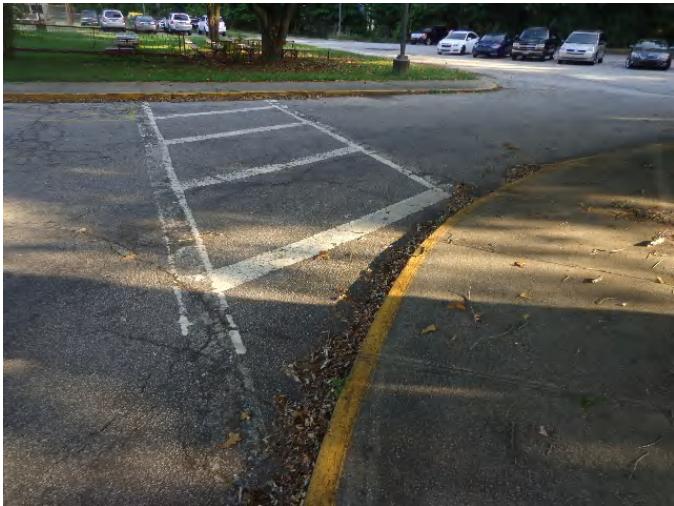
System: G2030 - Pedestrian Paving

Location: Site

Distress: Beyond Service Life

Notes: Pedestrian paving is beyond its expected service life, damaged, and should be replaced to include missing ramps from street access per ADA standards. SPLOST project 300-422 to upgrade the sidewalks.

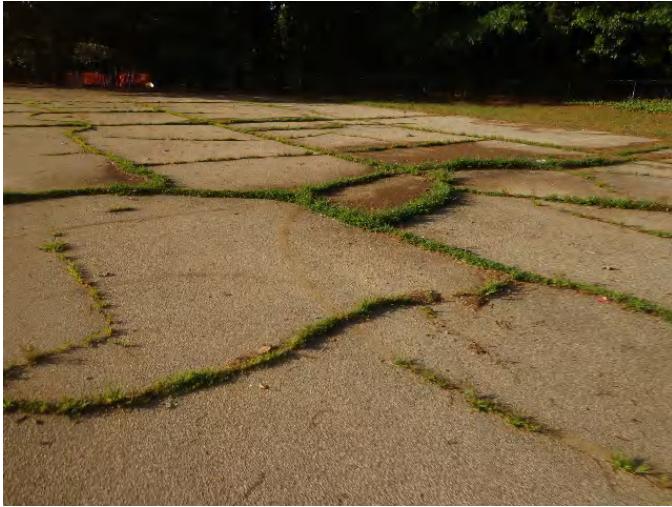
System: G2040 - Hard Surface Play Area

Location: Site

Distress: Beyond Service Life

Notes: The hard surface play area is beyond its expected service life, badly damaged with cracks, and should be replaced.

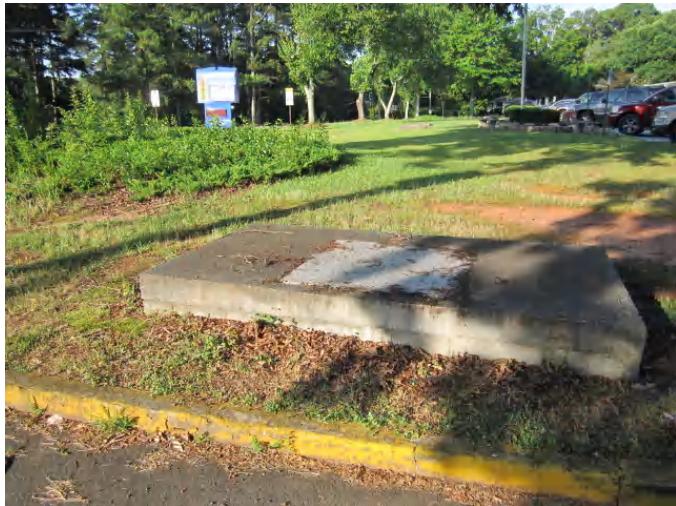
System: G3010 - Water Supply

Location: Site

Distress: Beyond Service Life

Notes: The site water supply system is beyond its expected service life and should be scheduled for replacement. SPLOST project 300-422 to replace water storage tanks with gas fired water heater.
