DeKalb County School District/Elementary Schools

Briar Vista Elementary

School Assessment Report

May 19, 2016

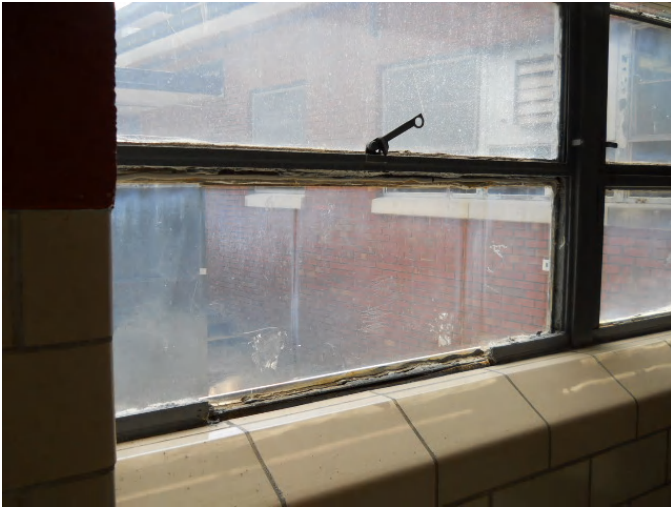
System: B2020 - Exterior Windows

Location: Throughout Building

Distress: Beyond Service Life

Notes: The exterior window system is original construction, beyond its expected service life, damaged, and should be replaced.

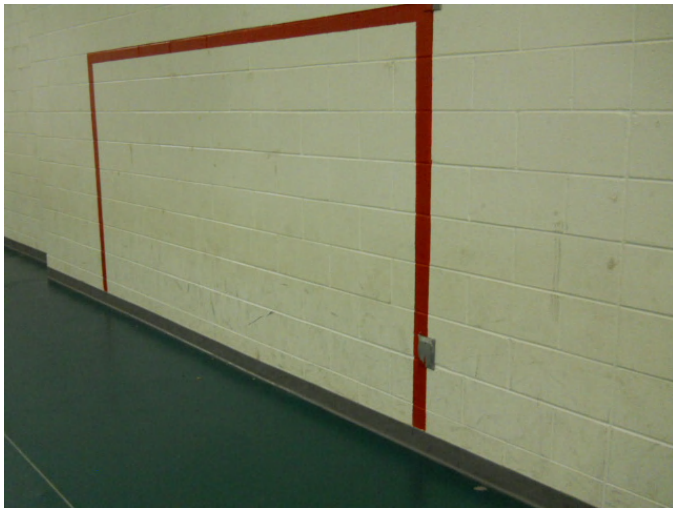
System: C3010 - Wall Finishes - Paint

Location: Throughout Building

Distress: Beyond Service Life

Notes: The painted wall finishes are beyond their expected service life, dirty, and should be replaced. SPLOST IV project 101-422 to paint interior walls.

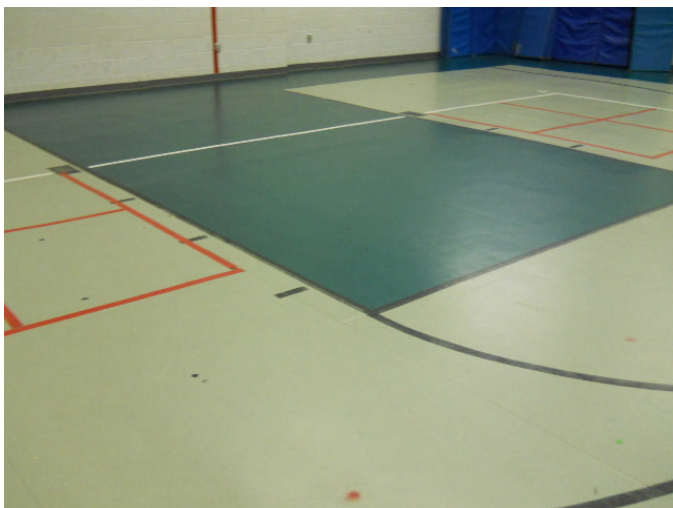
System: C3020 - Floor Finishes - Neoprene

Location: Gym

Distress: Beyond Service Life

Notes: The flooring is stained, showing signs of early failure and should be replaced.

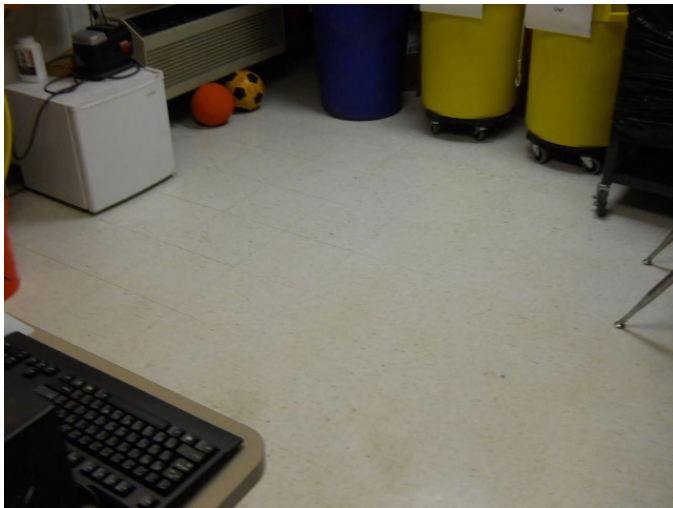
System: C3020 - Floor Finishes - VCT

Location: Office and Main Entrance

Distress: Beyond Service Life

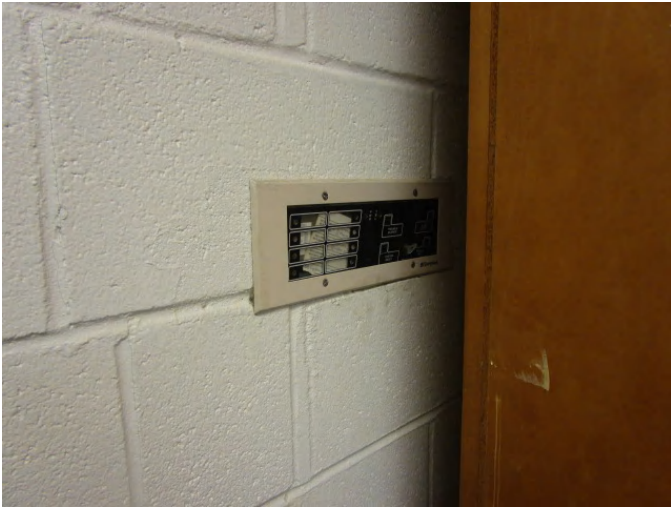
System: D5030 - Communications and Security - Fire Alarm

Location: Throughout Building

Distress: Beyond Service Life

Notes: The fire alarm system is beyond its expected service life and should be scheduled for replacement.

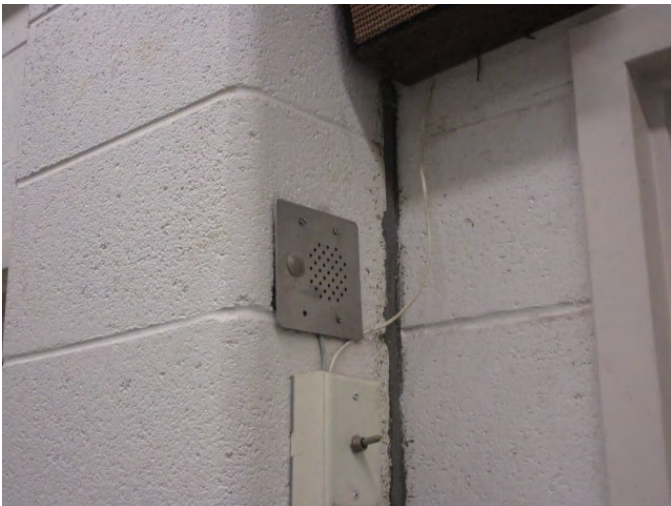
System: D5030 - Communications and Security - Public Address & Clock System

Location: Throughout Building

Distress: Beyond Service Life

Notes: The public address and clock system is beyond its expected service life and should be scheduled for replacement.

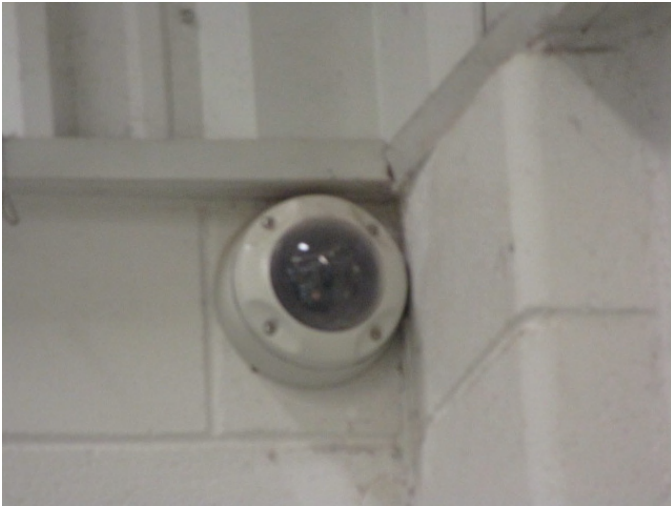
System: D5030 - Communications and Security - Security & CCTV

Location: Throughout Building

Distress: Beyond Service Life

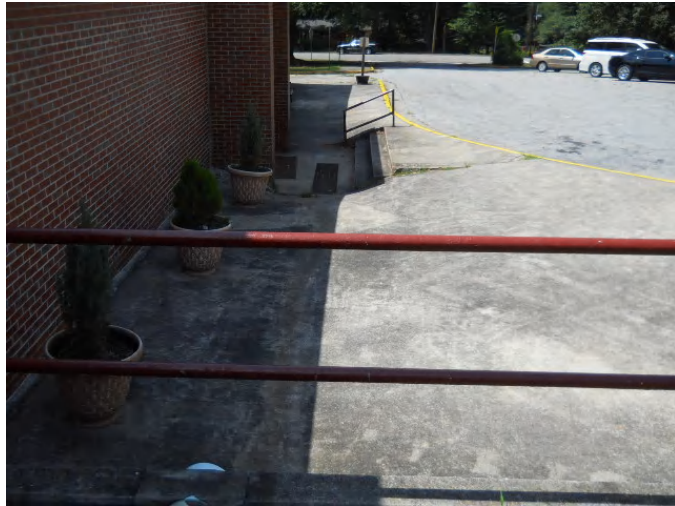
System: G3030 - Storm Sewer

Location: Site

Distress: Beyond Service Life

Notes: The storm sewer system is beyond its expected service life and should be scheduled for replacement. Storm water runoff funnels into a depression in front of the 1979 addition, causing flooding of the building's classrooms.

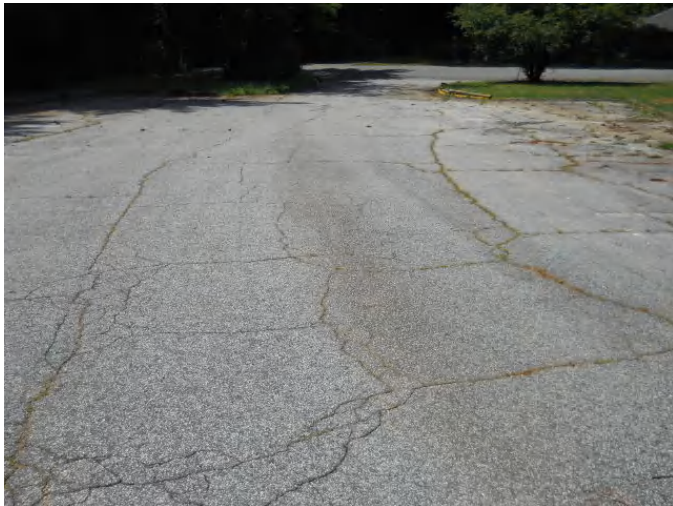
System: G2010 - Roadways

Location: Site

Distress: Beyond Service Life

Notes: Roadways are beyond their expected service life, damaged with many cracks and potholes, worn, and should be replaced.

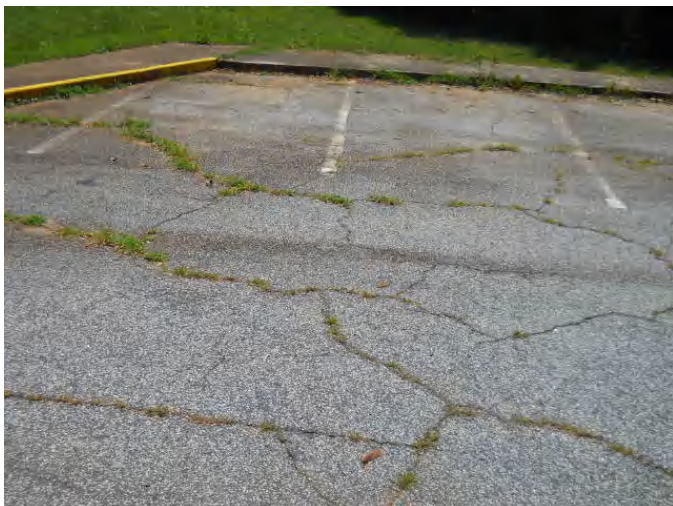
System: G2020 - Parking Lots

Location: Site

Distress: Beyond Service Life

Notes: The parking lot is beyond its expected service life, inadequate, deteriorating, not fully ADA compliant, and should be replaced.

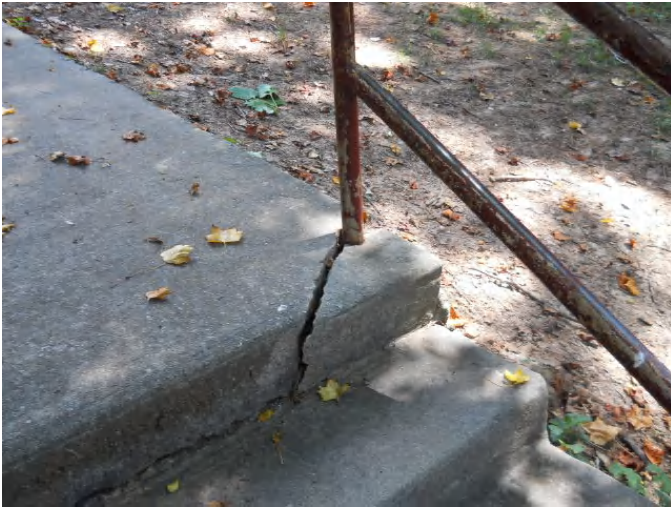
System: G2030 - Pedestrian Paving

Location: Site

Distress: Beyond Service Life

Notes: Pedestrian paving is beyond its expected service life, damaged, not fully ADA compliant, and should be replaced.

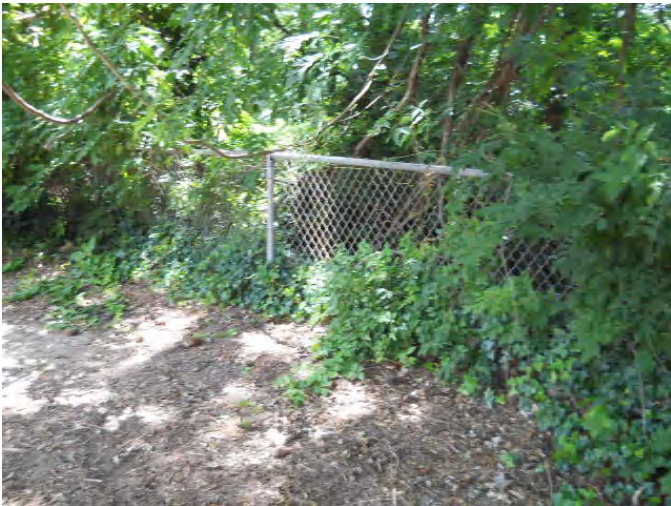
System: G2040 - Fencing & Guardrails

Location: Site

Distress: Beyond Service Life

Notes: Fencing is damaged from overgrown vines and brush, and should be replaced. Handrails in front of campus and at lower field are damaged and in need of repair.

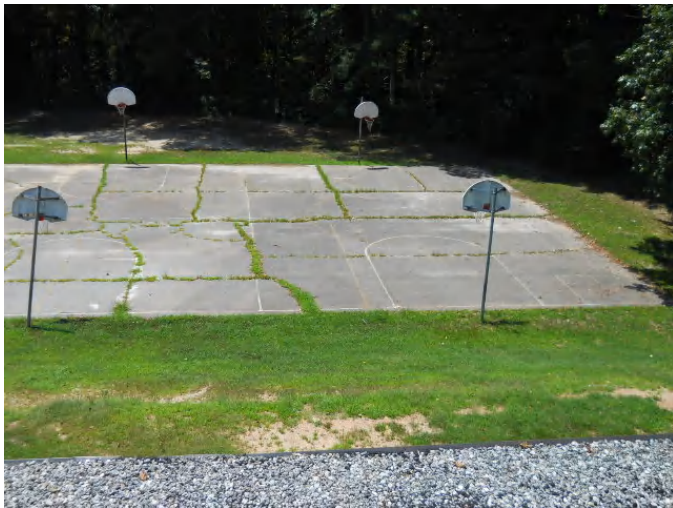
System: G2040 - Hard Surface Play Area

Location: Site

Distress: Beyond Service Life

Notes: The hard surface play area is beyond its expected service life, damaged with cracks, and should be replaced. Basketball goals are also damaged and should be replaced.

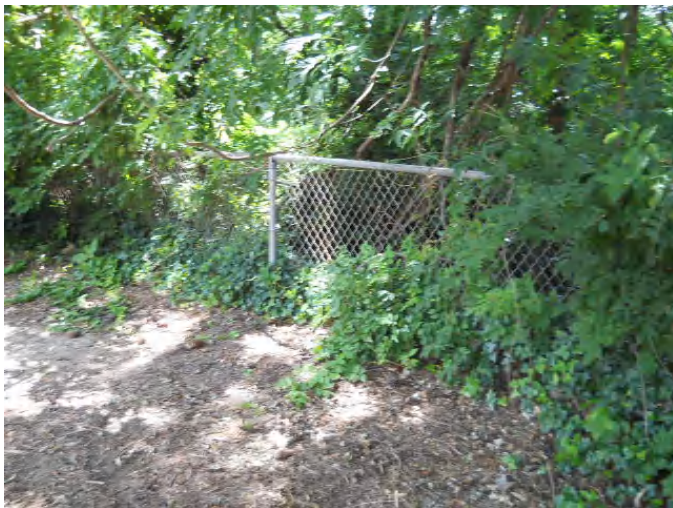
System: G2050 - Landscaping

Location: Site

Distress: Beyond Service Life

Notes: Landscaping is beyond its expected service life, overgrown, and should be replaced.

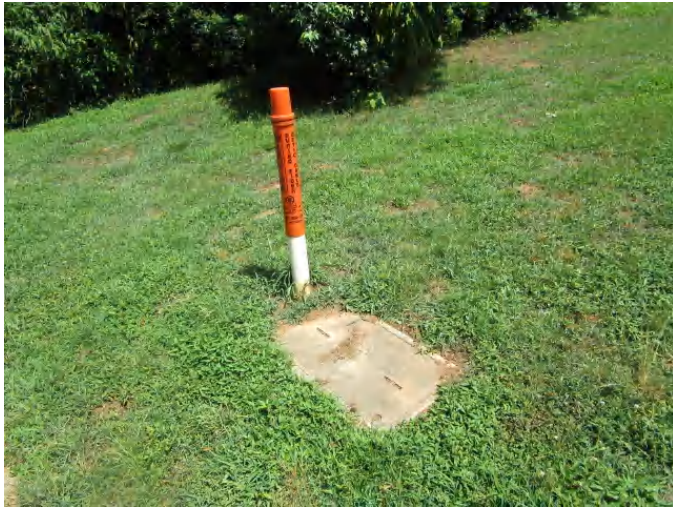
System: G4030 - Site Communications & Security

Location: Site

Distress: Beyond Service Life

Notes: The site communications and security systems are beyond their expected service life and should be scheduled for replacement.
