DeKalb County School District/Elementary Schools

Brockett Elementary

School Assessment Report

May 19, 2016

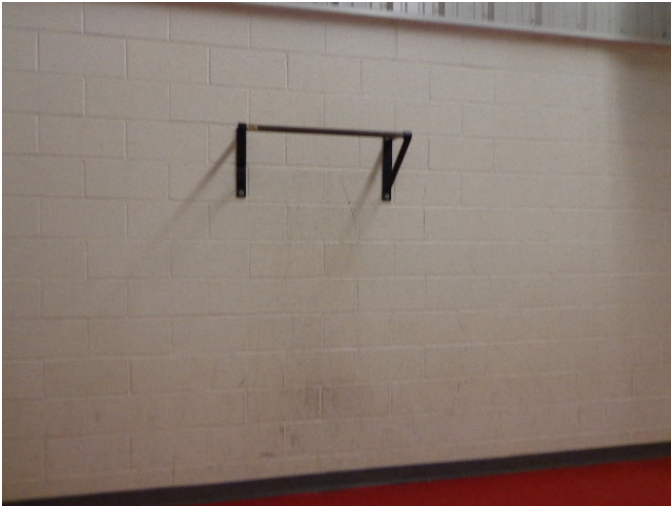
System: C3010 - Wall Finishes - Paint

Location: Throughout Building

Distress: Beyond Service Life

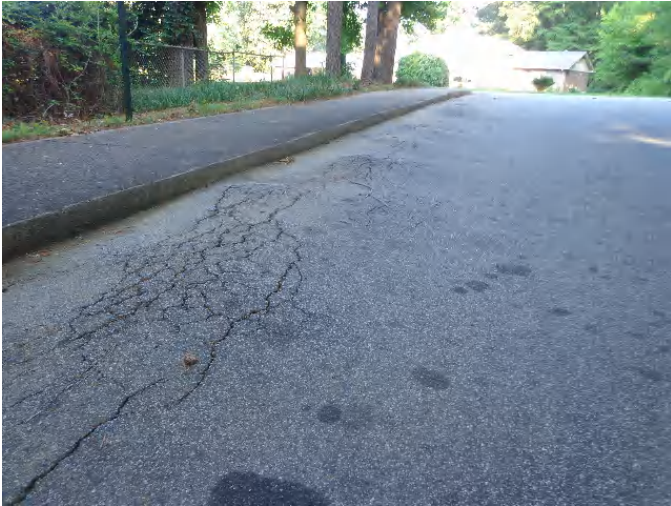
System: G2010 - Roadways

Location: Site

Distress: Beyond Service Life

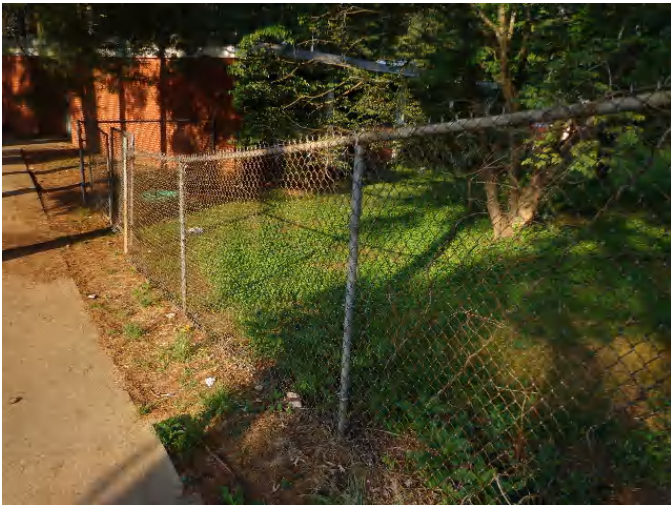
System: G2040 - Fencing & Guardrails

Location: Site

Distress: Beyond Service Life

Notes: Fencing and gates are beyond their expected service life, rusted and falling, and should be scheduled for replacement.

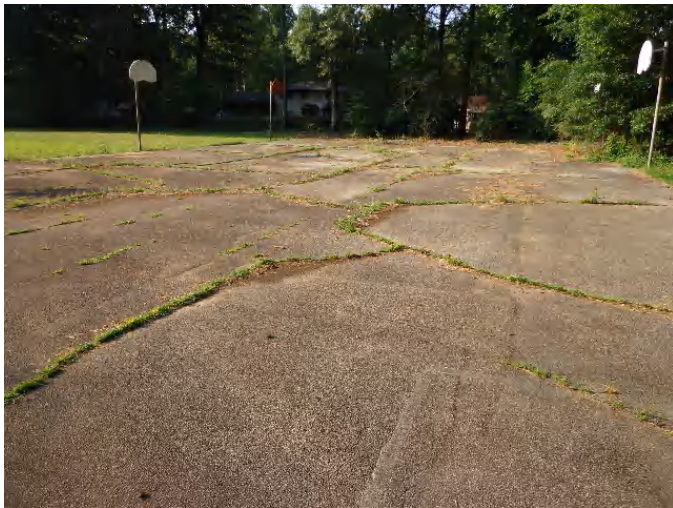
System: G2040 - Hard Surface Play Area

Location: Site

Distress: Beyond Service Life

Notes: The hard surface play area is beyond its expected service life, badly damaged with cracks, and should be replaced. Basketball goals are also damaged and should be replaced.

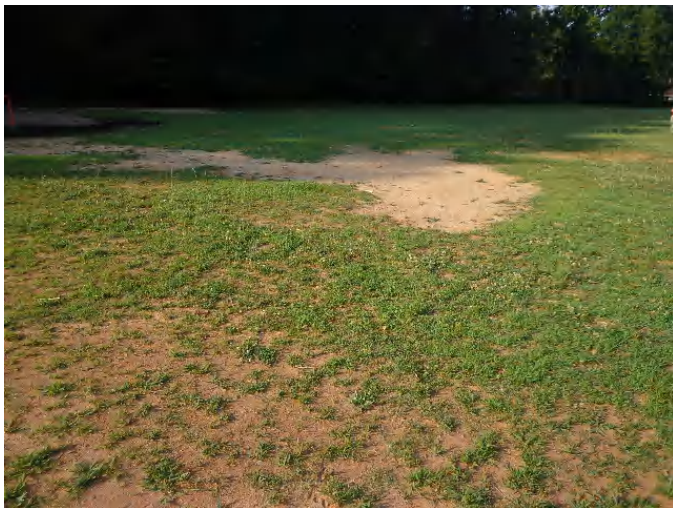
System: G2040 - Playing Field

Location: Site

Distress: Beyond Service Life

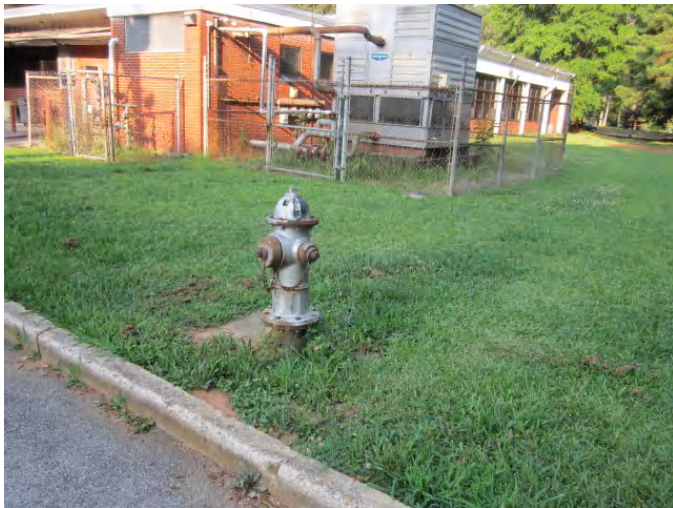
System: G3010 - Water Supply

Location: Site

Distress: Beyond Service Life

Notes: The site water supply system is beyond its expected service life and should be scheduled for replacement.

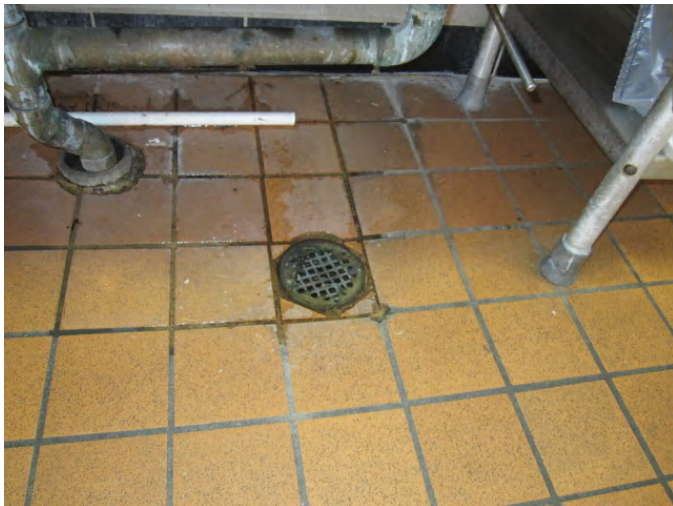
System: G3020 - Sanitary Sewer

Location: Site

Distress: Beyond Service Life

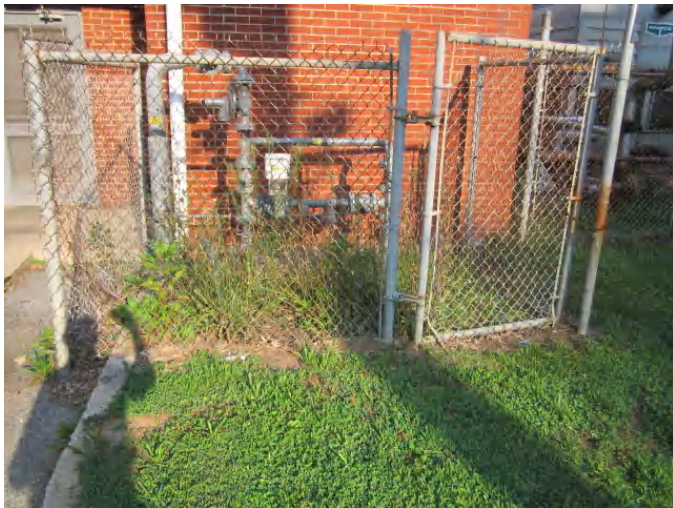
System: G3060 - Fuel Distribution

Location: Site

Distress: Beyond Service Life

Notes: The site fuel distribution system is beyond its expected service life and should be scheduled for replacement.

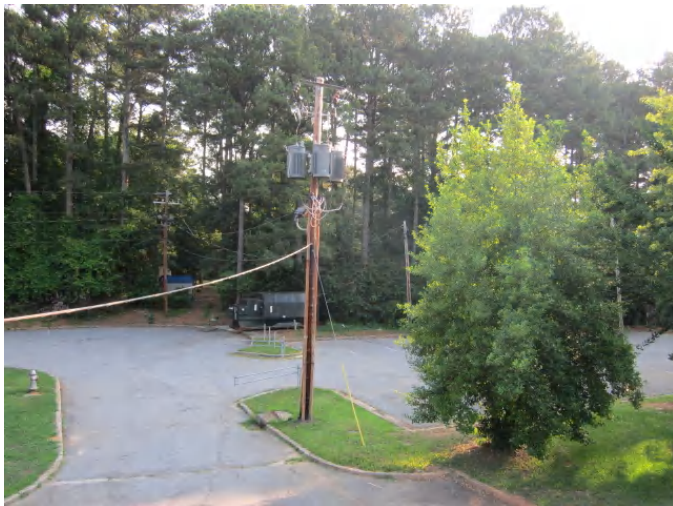
System: G4010 - Electrical Distribution

Location: Site

Distress: Beyond Service Life

Notes: The site electrical distribution system is beyond its expected service life and should be scheduled for replacement.

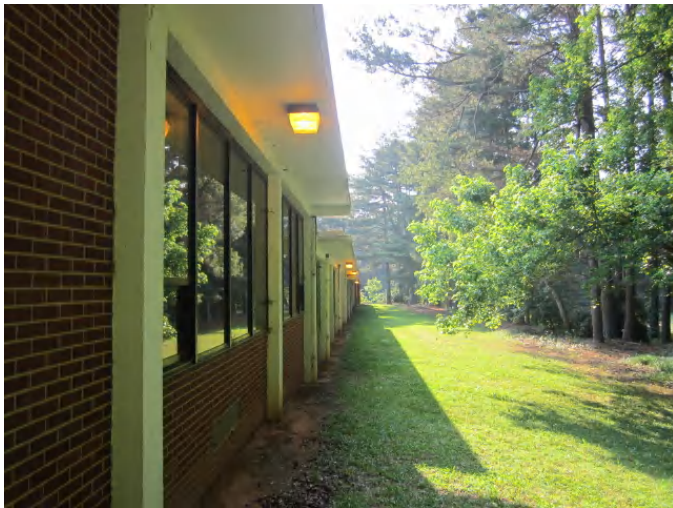
System: G4020 - Site Lighting

Location: Site

Distress: Beyond Service Life

Notes: Site lighting is beyond its expected service life, inadequate with dark areas, and should be scheduled for replacement and improvement.

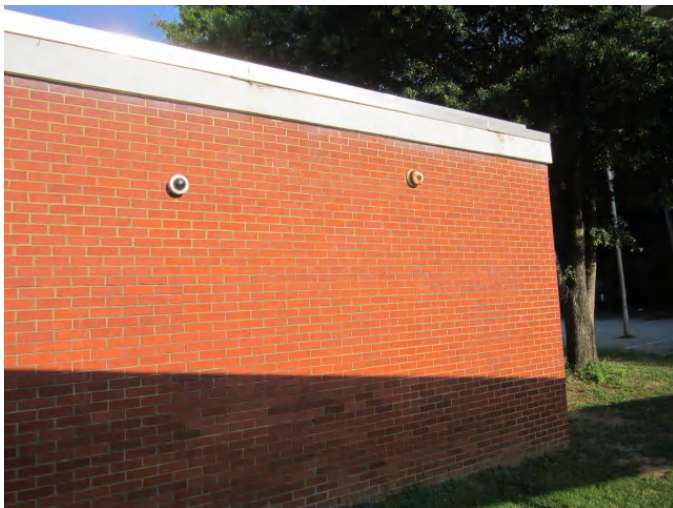
System: G4030 - Site Communications & Security

Location: Site

Distress: Beyond Service Life

Notes: The site communications and security systems are beyond their expected service life and should be scheduled for replacement.
