**DeKalb County School District/Elementary Schools**

# **Canby Lane Elementary**

School Assessment Report
May 19, 2016

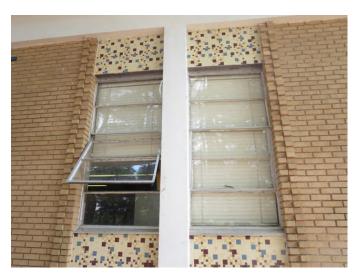
#### **System: B2020 - Exterior Windows**

**Location:** Throughout Building

**Distress:** Beyond Service Life

**Notes:** The exterior window system is beyond its expected service life, not energy efficient, and should be replaced.

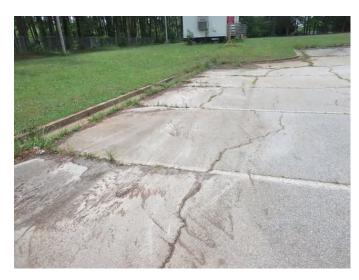
#### System: G2010 - Roadways

Location: Site

**Distress:** Beyond Service Life

Notes: Roadways are beyond their expected service life, damaged with many cracks and road cuts, and should be replaced.

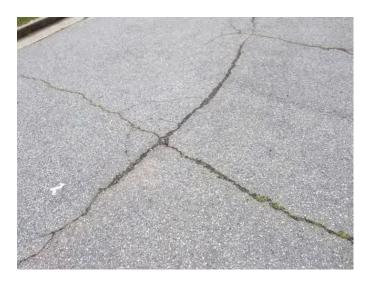
#### System: G2020 - Parking Lots

Location: Site

**Distress:** Beyond Service Life

**Notes:** The parking lot is deteriorating, inadequate, not ADA compliant, and should be replaced. The back parking lot near the gym/trailer floods when it rains. SPLOST project 102-422 to provide three additional disabled parking spaces and an accessible route to the building.

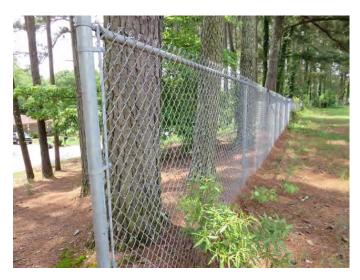
### System: G2040 - Fencing & Guardrails

Location: Site

**Distress:** Beyond Service Life

**Notes:** Fencing is beyond its expected service life, has some deterioration due to age, weather and use, and should be replaced.

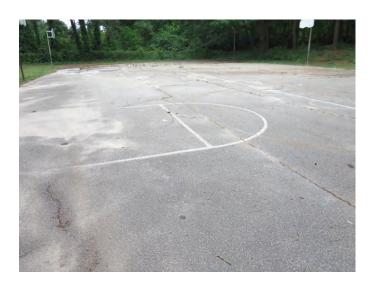
#### System: G2040 - Hard Surface Play Area

Location: Site

**Distress:** Beyond Service Life

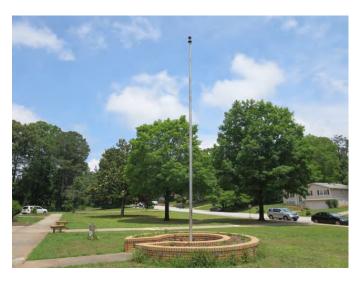
#### System: G2050 - Landscaping

Location: Site

**Distress:** Beyond Service Life

**Notes:** Landscaping is beyond its expected service life, deteriorated, inadequate, and should be replaced.

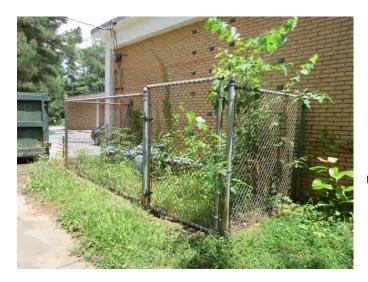
#### System: G3060 - Fuel Distribution

**Location:** Site

**Distress:** Beyond Service Life

**Notes:** Fuel distribution system is beyond its expected service life and should be replaced.

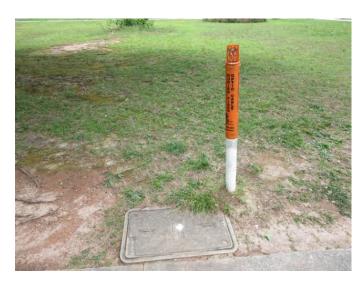
#### System: G4030 - Site Communications & Security

Location: Site

**Distress:** Beyond Service Life
