DeKalb County School District/Elementary Schools

Cary Reynolds Elementary

School Assessment Report
May 19, 2016

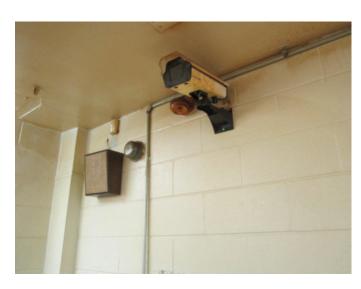
System: D5030 - Communications and Security - Security & CCTV

Location: Throughout Building

Distress: Beyond Service Life

Notes: The security and CCTV systems are beyond their expected service life, inadequate, and should be scheduled for replacement/upgraded to provide full coverage.

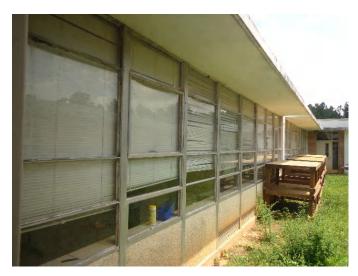
System: B2020 - Exterior Windows

Location: Throughout Building

Distress: Beyond Service Life

Notes: The original aluminum windows are aged, inoperable and not energy efficient, and should be replaced.

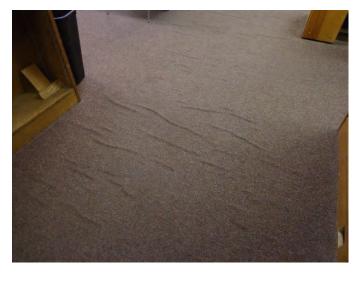
System: C3020 - Floor Finishes - Carpet

Location: Throughout Building

Distress: Beyond Service Life

Notes: The carpet in the principal's office has been replaced, however, the carpet in the media center is aged, stained and frayed, and should be replaced.

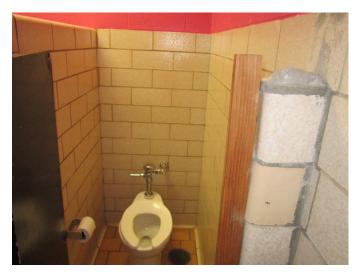
System: D2010 - Plumbing Fixtures

Location: Throughout Building

Distress: Beyond Service Life

Notes: The plumbing fixtures are beyond their expected service life and should be scheduled for replacement. SPLOST project 103-422 to provide hall restroom renovations.

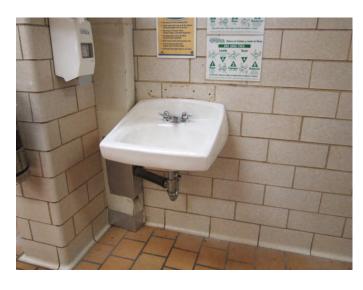
System: D2020 - Domestic Water Distribution

Location: Throughout Building

Distress: Beyond Service Life

Notes: The domestic water distribution system is beyond its expected service life, not code compliant, and should be scheduled for replacement. Domestic water heaters or converters are not equipped with adequate expansion compensation. SPLOST project 103-422 to replace the backflow preventer.

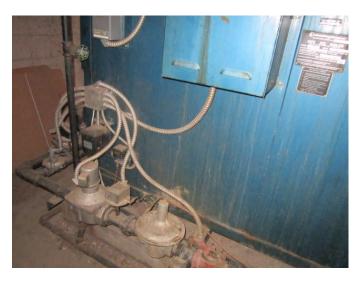
System: D2090 - Other Plumbing Systems - Natural Gas

Location: Throughout Building

Distress: Beyond Service Life

Notes: The natural gas system is beyond its expected service life and should be scheduled for replacement. SPLOST project 103-422 to replace the grease trap.

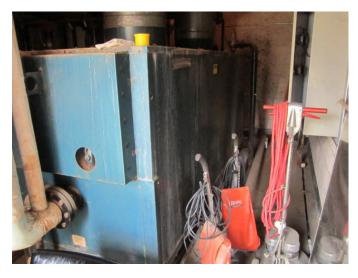
System: D3020 - Heat Generating Systems

Location: Mechanical Room

Distress: Beyond Service Life

Notes: The heat generating system is beyond its expected service life and should be scheduled for replacement.

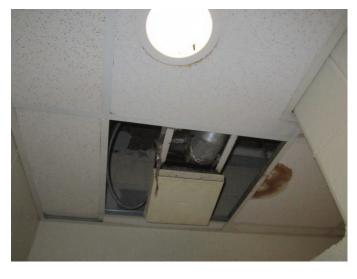
System: D5020 - Lighting

Location: Throughout Building

Distress: Beyond Service Life

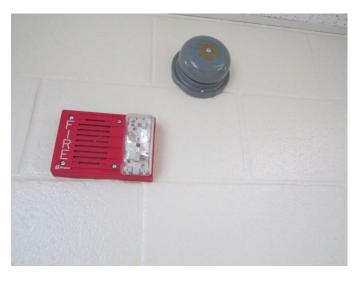
System: D5030 - Communications and Security - Fire Alarm

Location: Throughout Building

Distress: Beyond Service Life

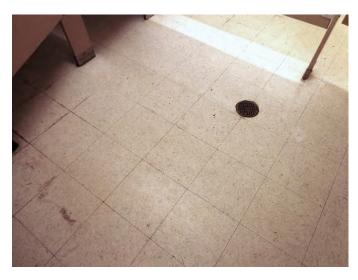
System: C3020 - Floor Finishes - VCT

Location: Entrance Area and Offices

Distress: Beyond Service Life

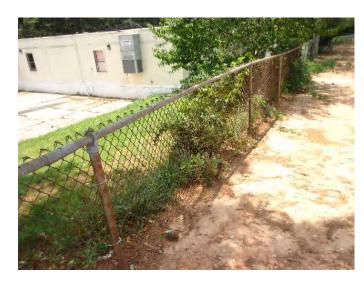
System: G2040 - Fencing & Guardrails

Location: Site

Distress: Beyond Service Life

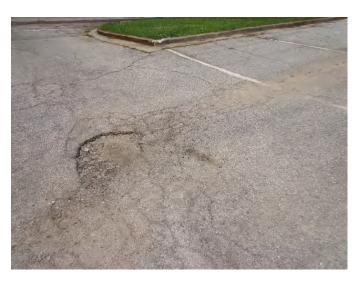
System: G2010 - Roadways

Location: Site

Distress: Beyond Service Life

Notes: The parking lot is beyond its expected service life, has many repairs and potholes, and should be replaced and expanded. Directional signage and markings between accessible parking and accessible building entrance is missing. Sign heights need to be adjusted per minimum ADA standards. SPLOST project 103-422 to provide parking renovations.

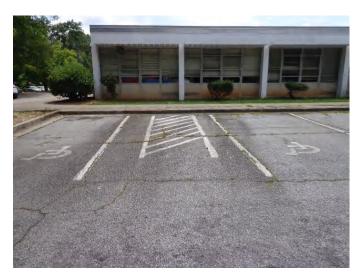
System: G2030 - Pedestrian Paving

Location: Site

Distress: Beyond Service Life
