DeKalb County School District/Middle Schools

# Champion Theme Middle

## School Assessment Report

May 20, 2016

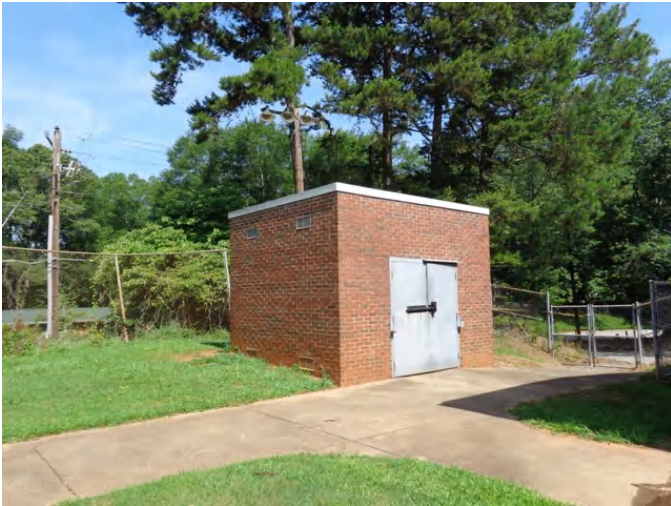
#### System: B2030 - Exterior Doors

**Location:** Exterior Wall

**Distress:** Beyond Service Life

**Notes:** The exterior doors are beyond their expected service life and should be replaced.

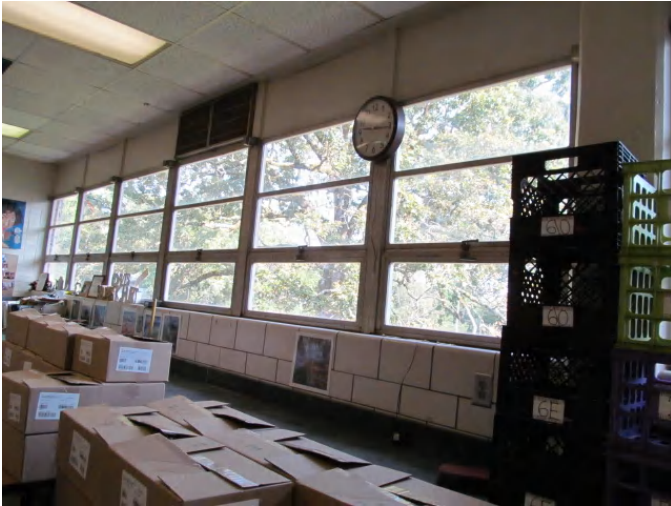
**System: B2020 - Exterior Windows**

**Location:** Throughout Building

**Distress:** Beyond Service Life

**Notes:** The original windows are beyond their expected service life, not energy efficient, and should be replaced. Many window seals are damaged and should be repaired or replaced in conjunction with window replacement.

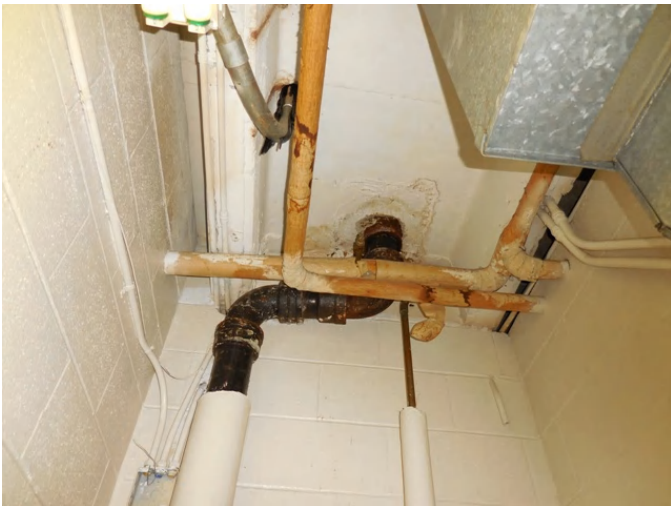
**System: D2020 - Domestic Water Distribution**

**Location:** Throughout Building

**Distress:** Beyond Service Life

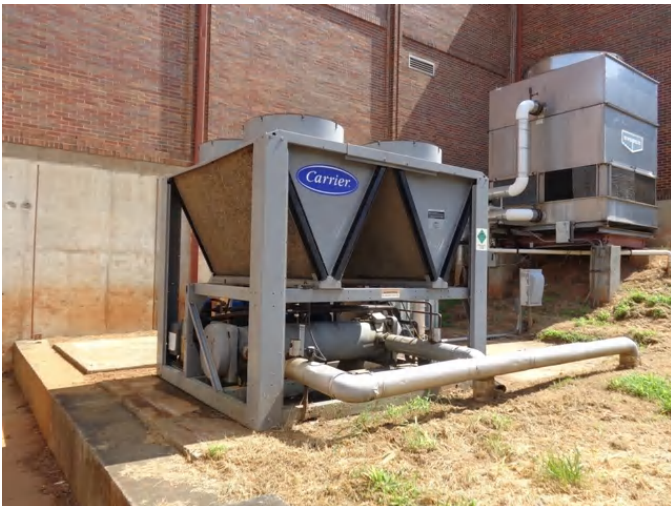
**System: D3030 - Cooling Generating Systems**

**Location:** Site

**Distress:** Beyond Service Life

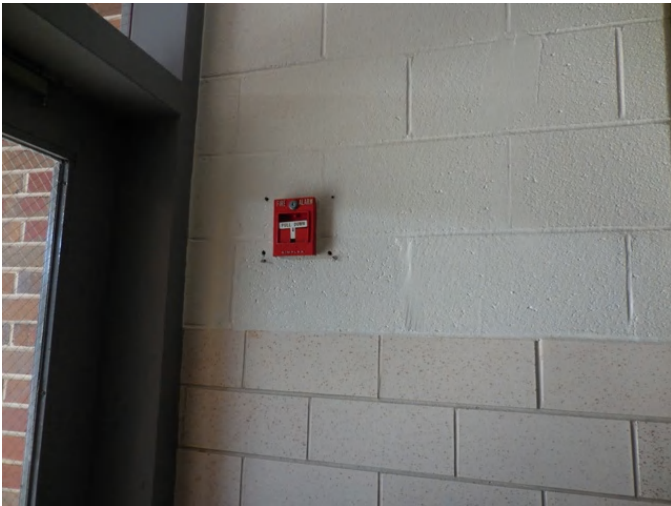
**System: D5030 - Communications and Security - Fire Alarm**

**Location:** Throughout Building

**Distress:** Beyond Service Life

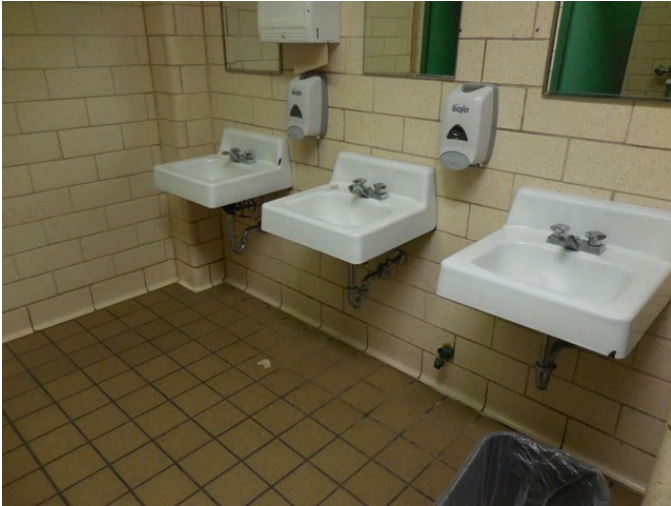
**System: D2010 - Plumbing Fixtures**

**Location:** Throughout Building

**Distress:** Beyond Service Life

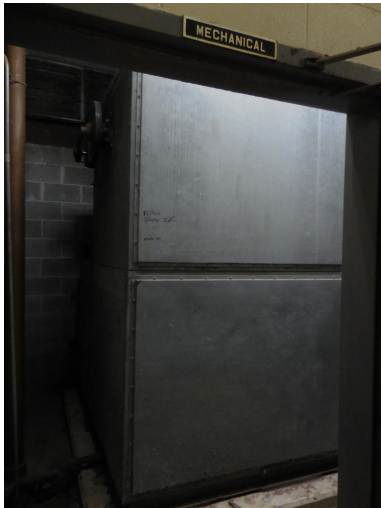
**System: D3040 - Distribution Systems & Exhaust Systems**

**Location:** Throughout Building

**Distress:** Beyond Service Life

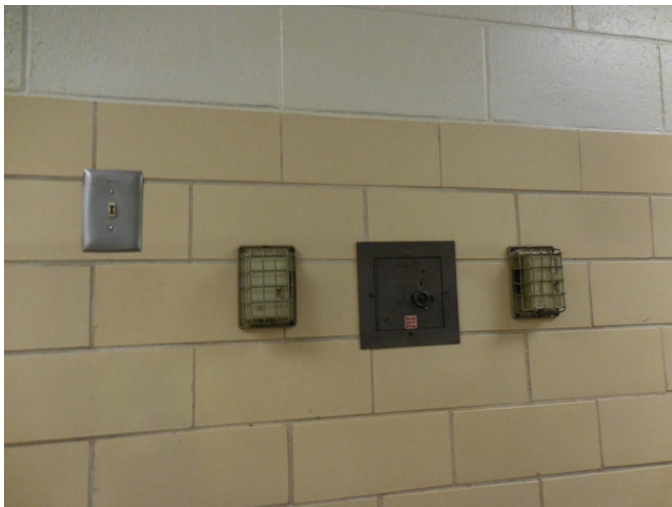
**System: D3060 - Controls & Instrumentation**

**Location:** Throughout Building

**Distress:** Beyond Service Life

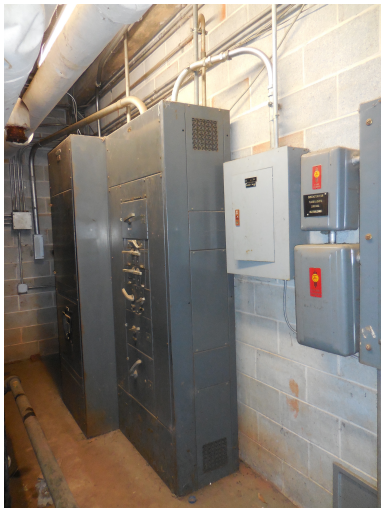
**System: D5010 - Electrical Service/Distribution**

**Location:** Throughout Building

**Distress:** Beyond Service Life

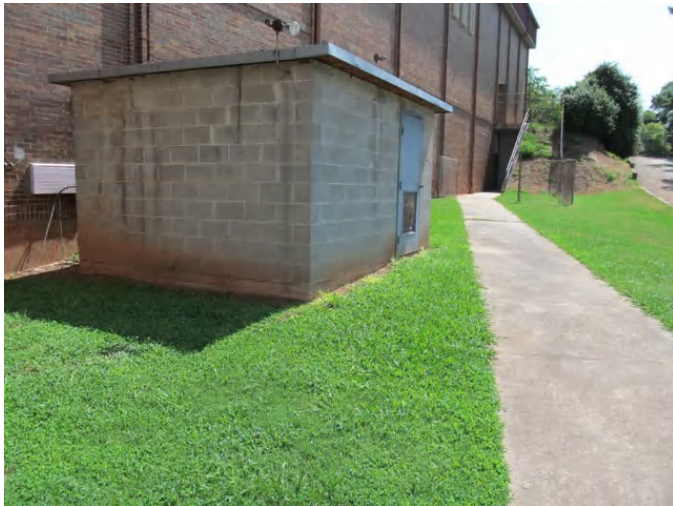
#### System: B2030 - Exterior Doors

**Location:** Exterior Wall

**Distress:** Beyond Service Life

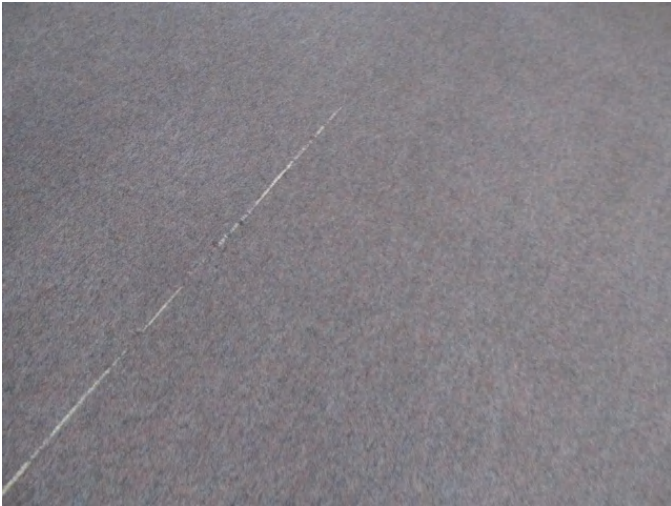
#### System: C3020 - Floor Finishes - Carpet

**Location:** Media Center

**Distress:** Beyond Service Life

**Notes:** The carpet is damaged, has tripping hazards, and should be replaced.

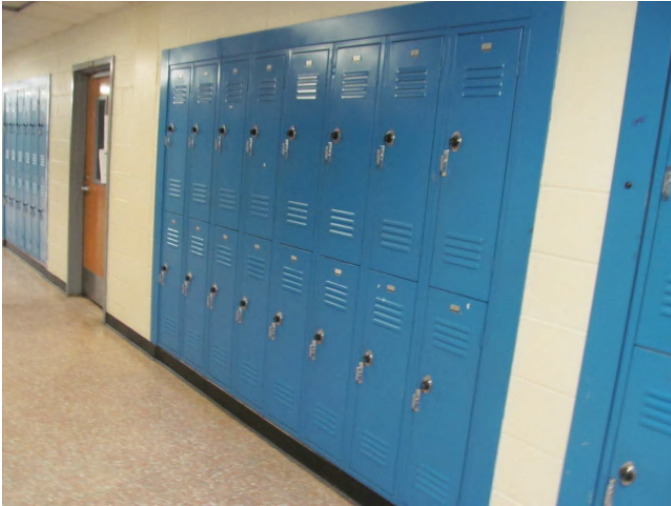
**System: C1030 - Fittings**

**Location:** Throughout Building

**Distress:** Beyond Service Life

**Notes:** Fittings, such as toilet partitions, lockers and signage, are beyond their expected service life, not ADA compliant, and should be scheduled for replacement.

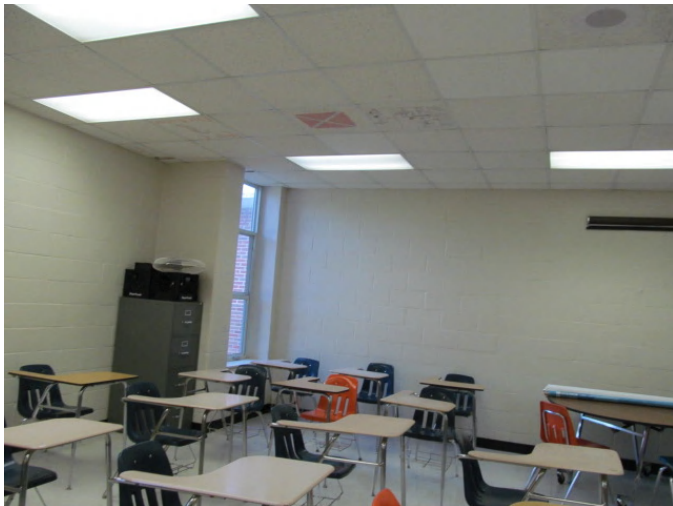
**System: C3030 - Ceiling Finishes**

**Location:** Throughout Building

**Distress:** Beyond Service Life

**Notes:** The acoustical ceiling finishes are beyond their expected service life and should be scheduled for replacement.

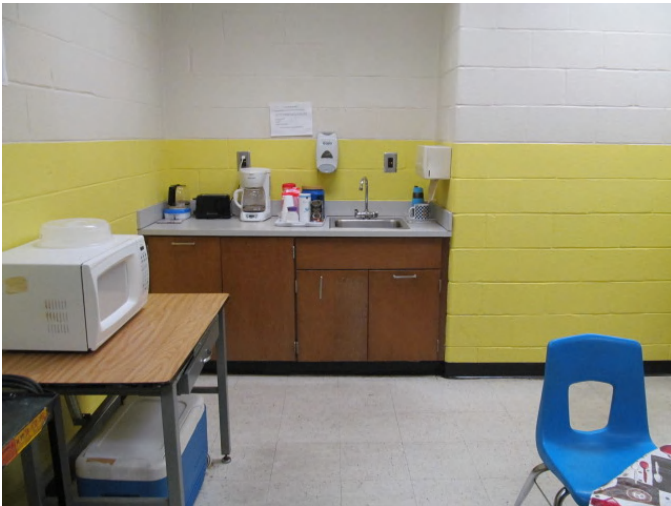
**System: E2010 - Fixed Furnishings**

**Location:** Throughout Building

**Distress:** Beyond Service Life

**Notes:** The fixed furnishings are beyond their expected service life and should be replaced.

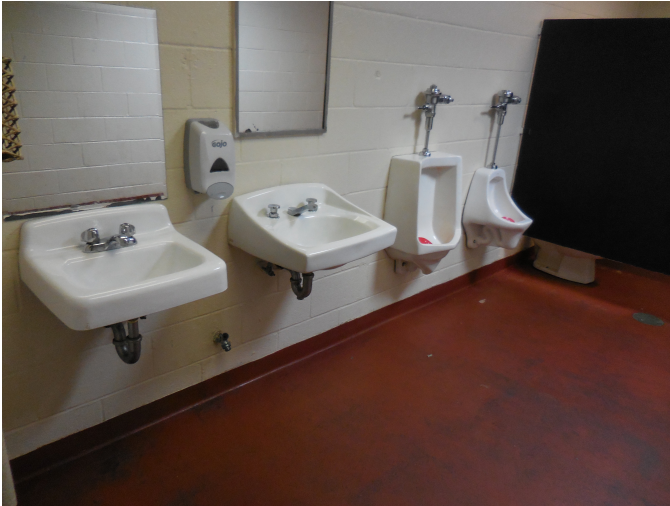
**System: D2010 - Plumbing Fixtures**

**Location:** Throughout Building

**Distress:** Beyond Service Life

**Notes:** Some fixtures have been replaced as needed but the majority are original, not fully ADA compliant, and should be scheduled for replacement.

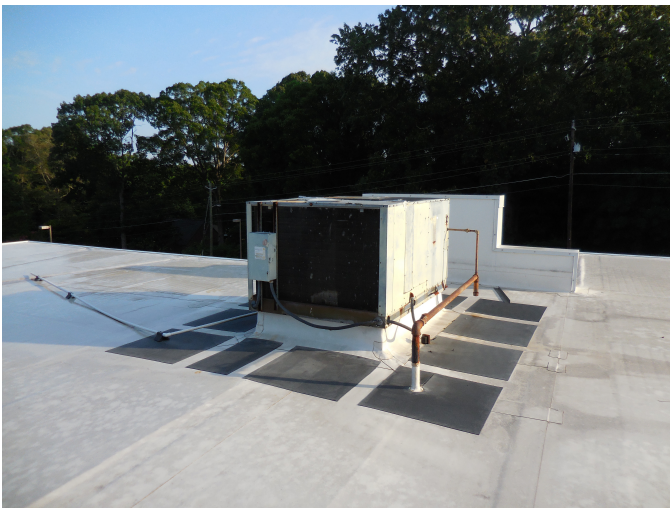
**System: D3050 - Terminal & Package Units**

**Location:** Throughout Building

**Distress:** Beyond Service Life

**Notes:** A couple of units were replaced, but the majority of the units are original. Terminal and package unit systems are beyond its expected service life and should be scheduled for replacement.

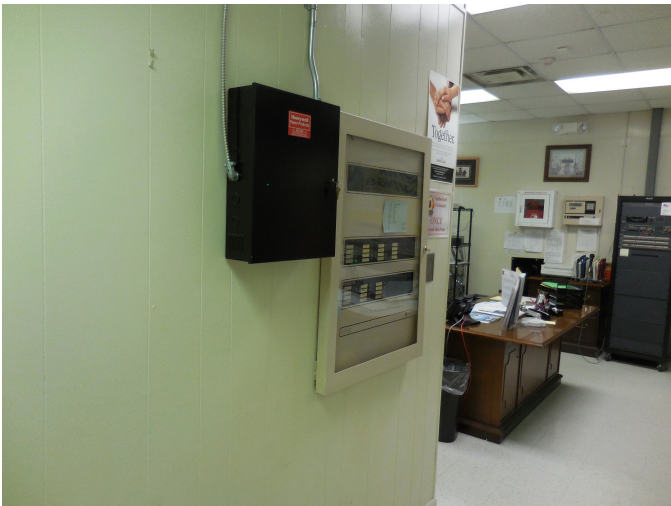
**System: D5030 - Communications and Security - Fire Alarm**

**Location:** Office/Throughout Building

**Distress:** Beyond Service Life

**Notes:** Fire alarm system is beyond its expected service life and should be scheduled for replacement.

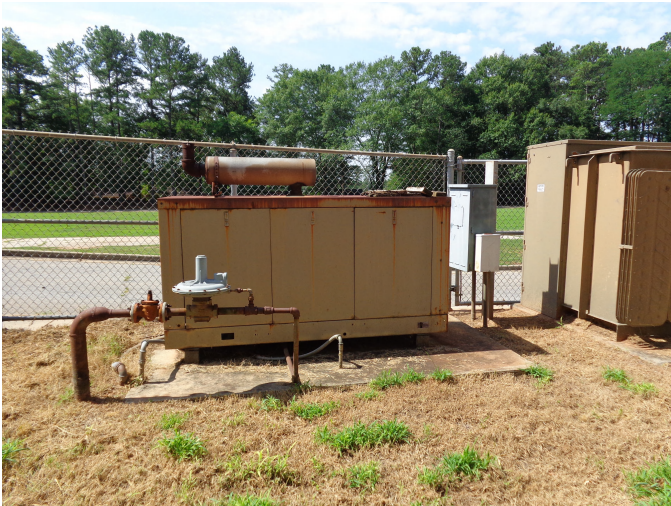
**System: D5090 - Other Electrical Systems - Emergency Generator**

**Location:** Outside Mechanical Room

**Distress:** Beyond Service Life

**Notes:** Generator is beyond its expected service life and should be scheduled for replacement. Casing shows severe signs of rust, however, the generator is still functional.

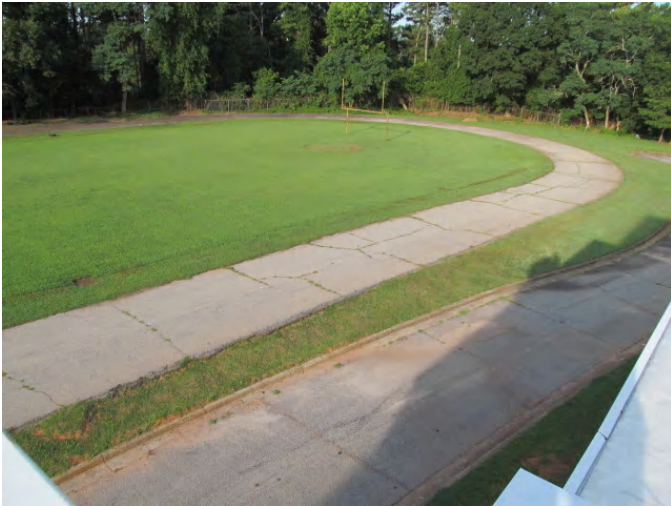
#### System: G2040 - Track

**Location:** Site

**Distress:** Beyond Service Life

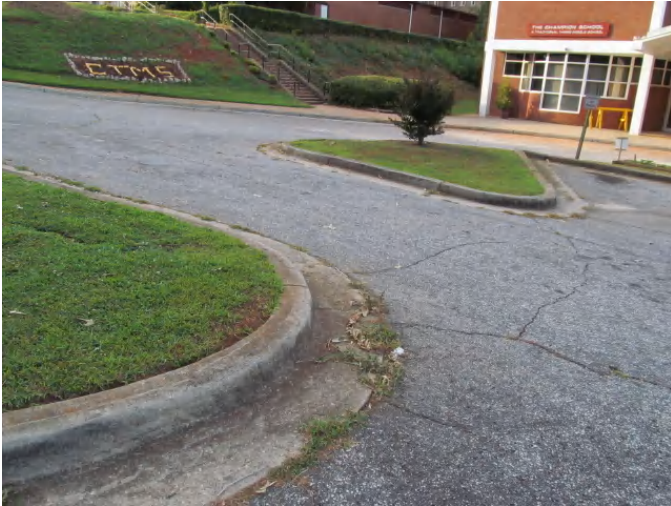
**System: G2010 - Roadways**

**Location:** Site

**Distress:** Beyond Service Life

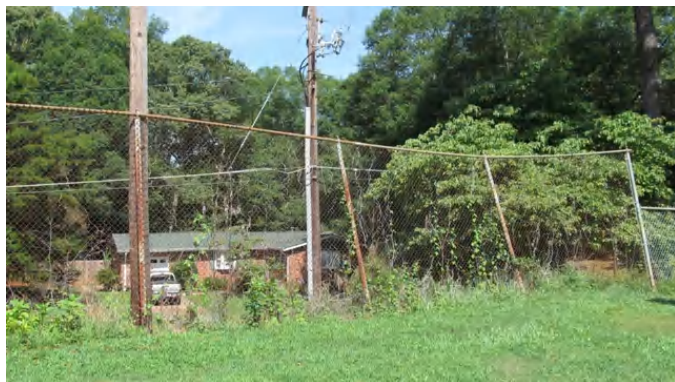
**System: G2040 - Fencing & Guardrails**

**Location:** Site

**Distress:** Beyond Service Life

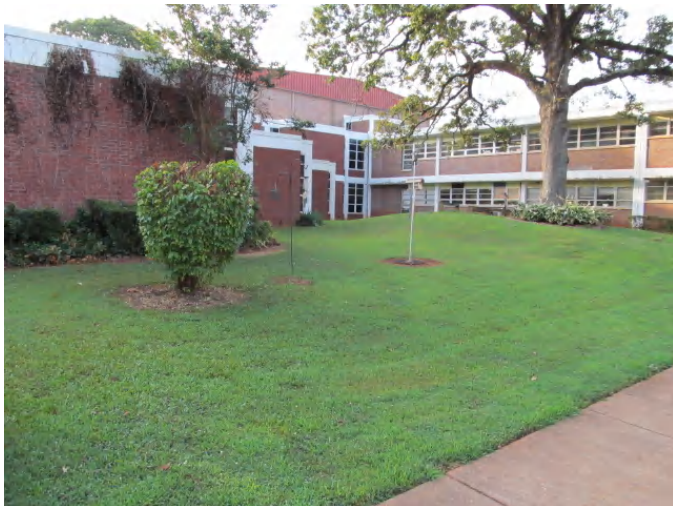
**System: G2050 - Landscaping**

**Location:** Site

**Distress:** Beyond Service Life

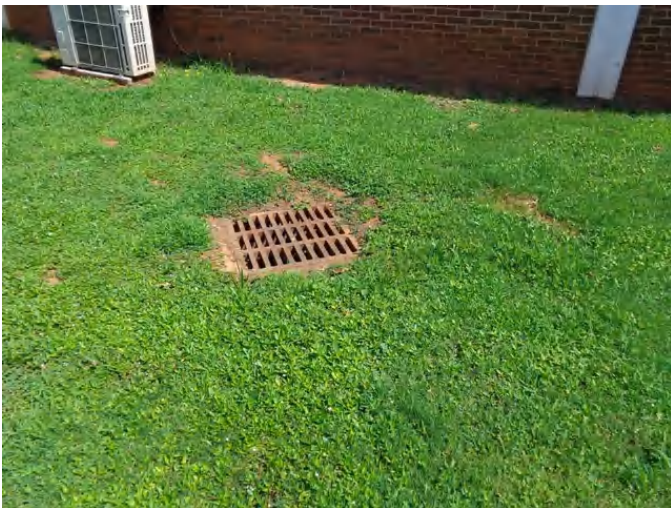
**System: G3030 - Storm Sewer**

**Location:** Site

**Distress:** Beyond Service Life
