DeKalb County School District/High Schools

Clarkston High

School Assessment Report

May 19, 2016

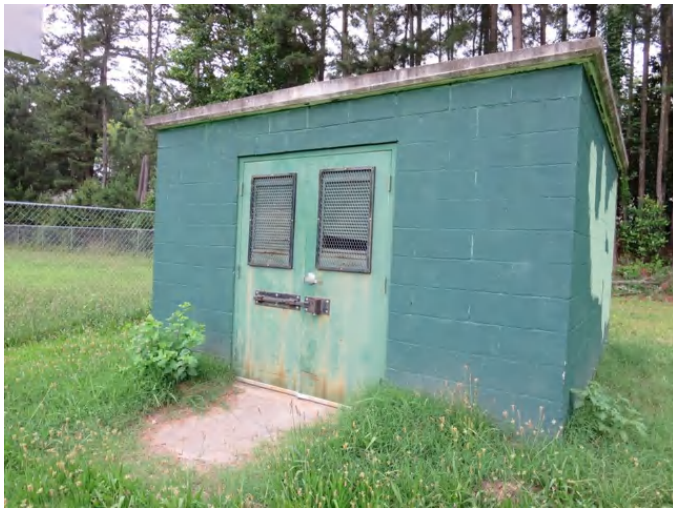
System: B2030 - Exterior Doors

Location: Exterior Wall

Distress: Beyond Service Life

Notes: The original exterior doors are aged, rusted, and should be replaced.

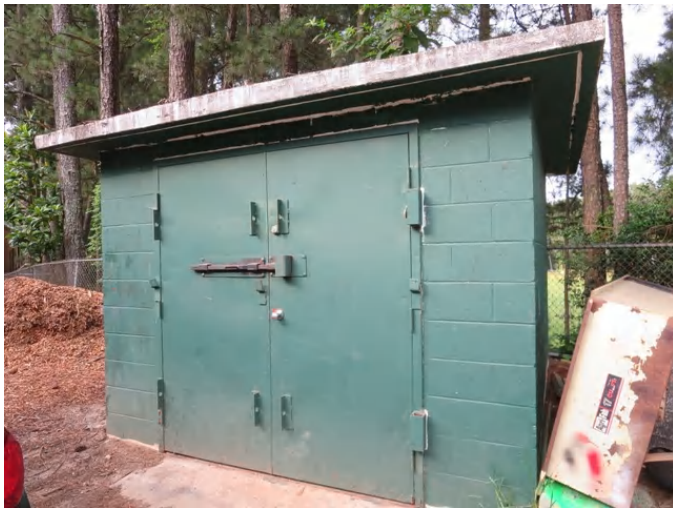
System: B2030 - Exterior Doors

Location: Exterior Wall

Distress: Beyond Service Life

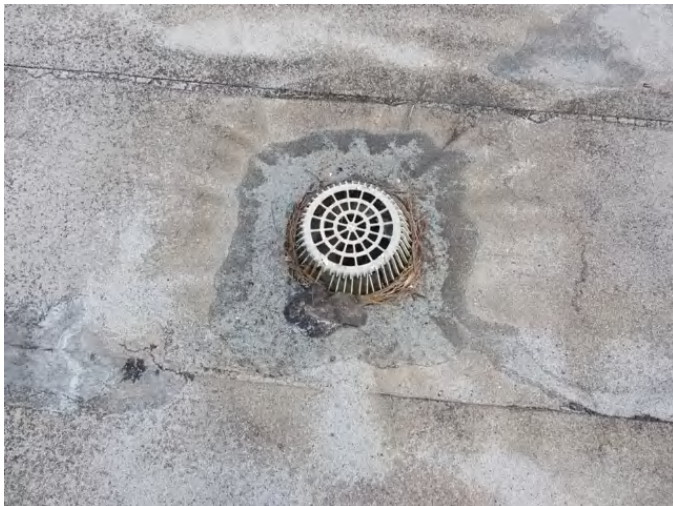
System: D2040 - Rain Water Drainage

Location: Throughout Building

Distress: Beyond Service Life

Notes: The rainwater drainage system is beyond its expected service life and should be scheduled for replacement.

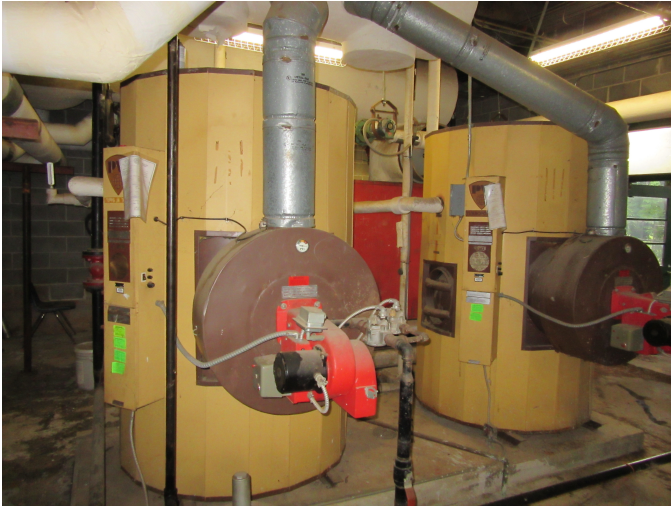
System: D2020 - Domestic Water Distribution

Location: Mechanical Room

Distress: Beyond Service Life

Notes: The domestic water distribution system is beyond its expected service life, has water quality issues, and should be scheduled for replacement. Hot water distribution system has non-functional pressure relief valves.

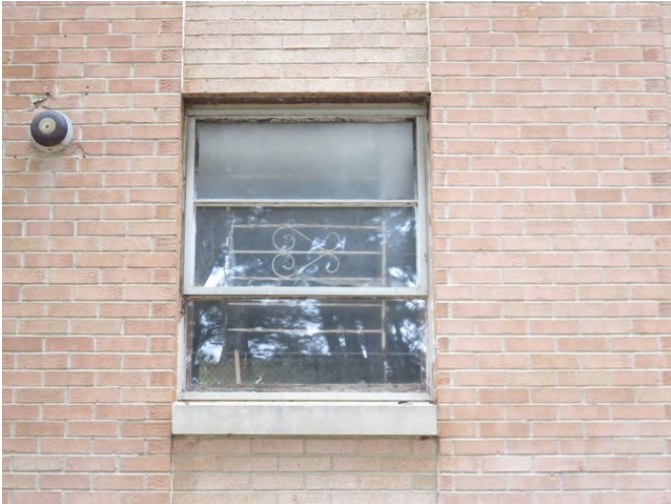
System: B2020 - Exterior Windows

Location: Throughout Building

Distress: Beyond Service Life

Notes: The aluminum frame, operable, single pane windows are aged, not energy efficient, and should be replaced.

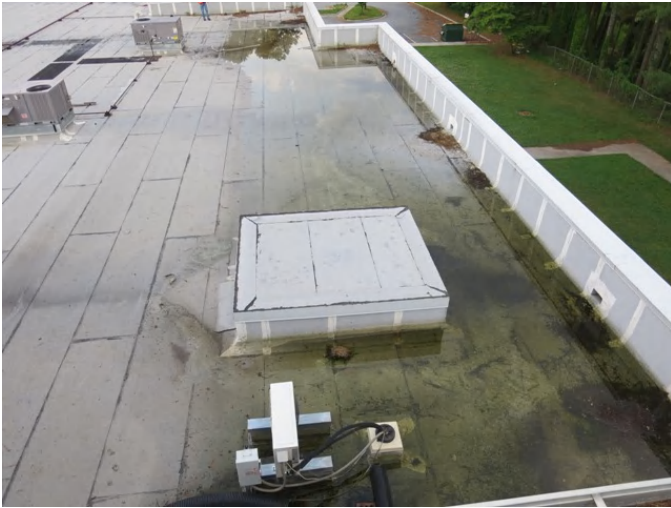
System: B3010 - Roof Coverings - BUR

Location: Roof

Distress: Beyond Service Life

Notes: The built-up roof covering is aged, showing signs of failure, and should be replaced. SPLOST project 406-422 to replace the roof on the buildings.

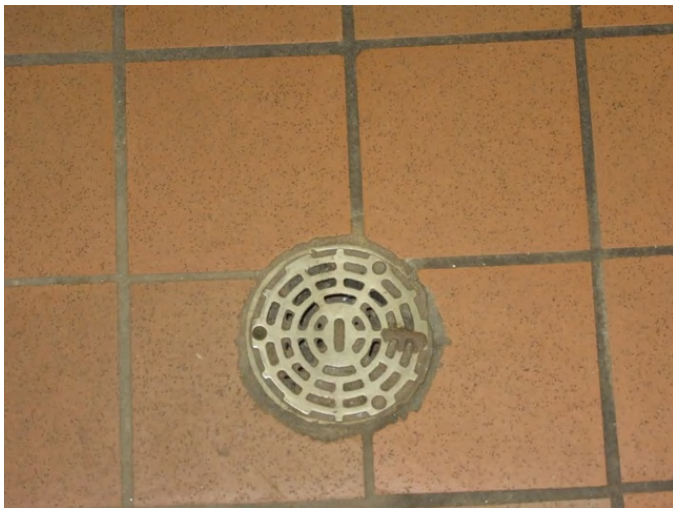
System: D2030 - Sanitary Waste

Location: Throughout Building

Distress: Beyond Service Life

Notes: The sanitary waste system is beyond its expected service life and should be scheduled for replacement. SPLOST project 406-422 to replace grease trap and backflow preventer.

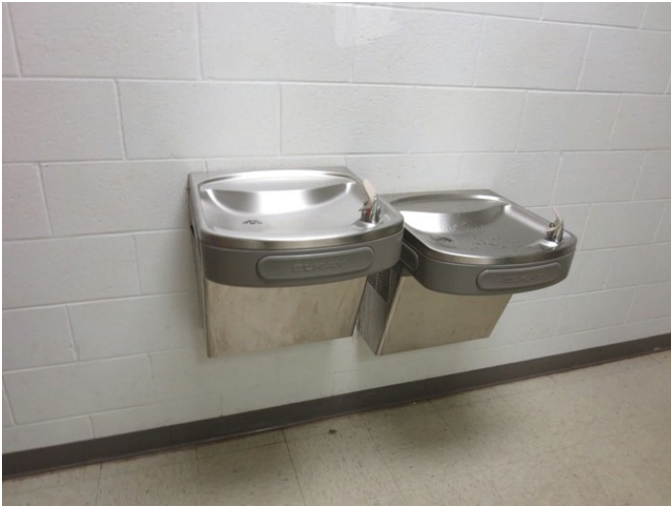
System: D2010 - Plumbing Fixtures

Location: Hallway

Distress: Needs Remediation

Correction: Remove/replace drinking fountain w/recessed ADA compliant drinking fountain

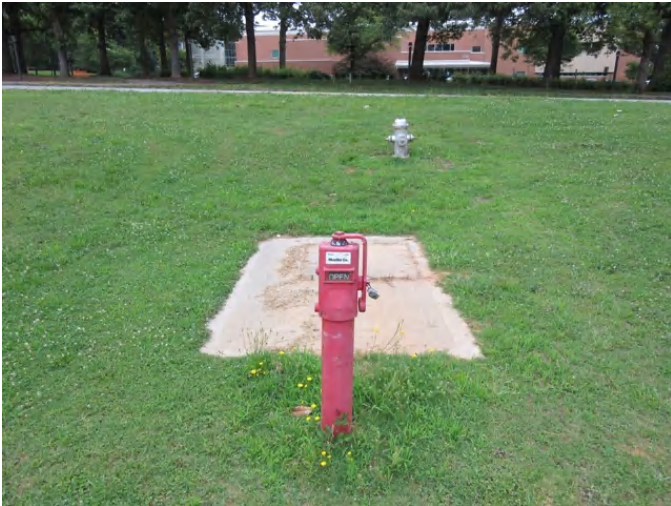
System: G3010 - Water Supply

Location: Site

Distress: Beyond Service Life

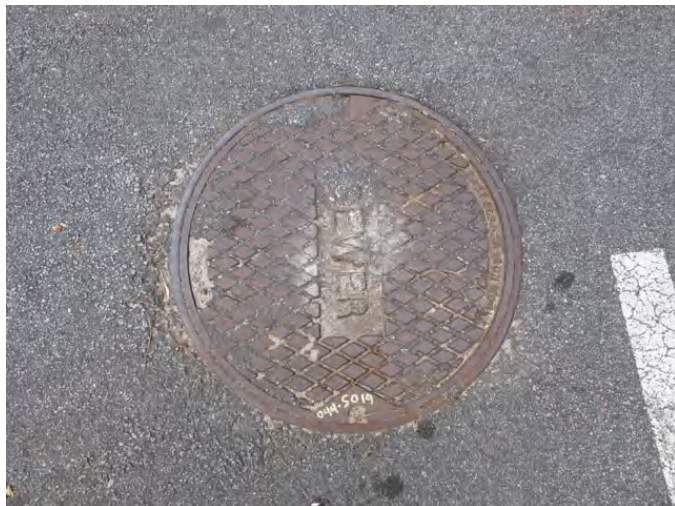
System: G3020 - Sanitary Sewer

Location: Site

Distress: Beyond Service Life

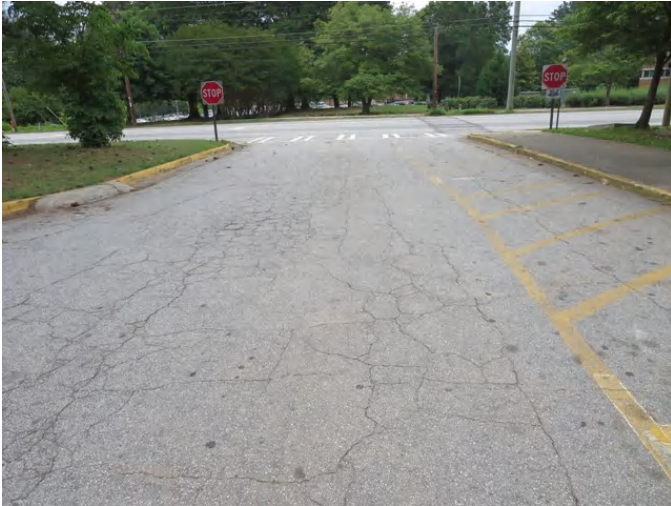
System: G2010 - Roadways

Location: Site

Distress: Beyond Service Life
