DeKalb County School District/High Schools

Dunwoody High

School Assessment Report

May 19, 2016

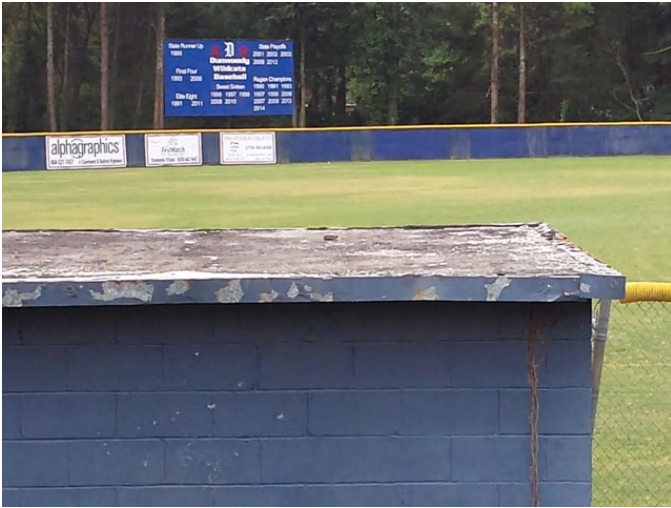
System: B3010 - Roof Coverings -BUR

Location: Roof

Distress: Beyond Service Life

Notes: Built-up roof covering is in deteriorating condition, with cracks and loss of surface, and should be replaced.

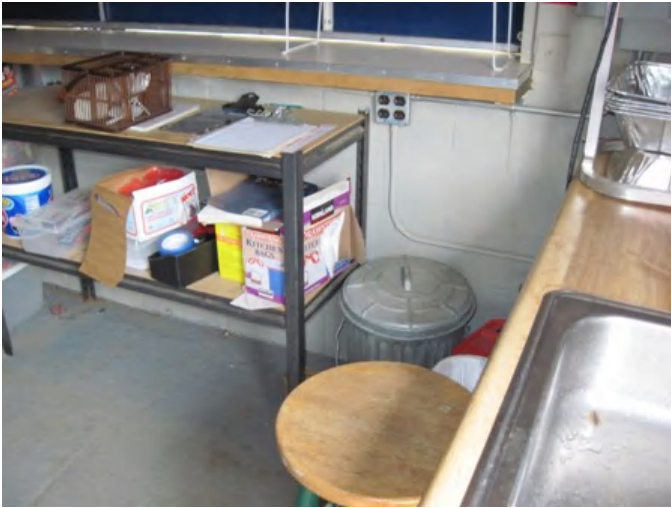
System: C3010 - Wall Finishes

Location: Throughout Building

Distress: Beyond Service Life

Notes: The painted wall finishes are beyond their expected service life, stained, and should be replaced.

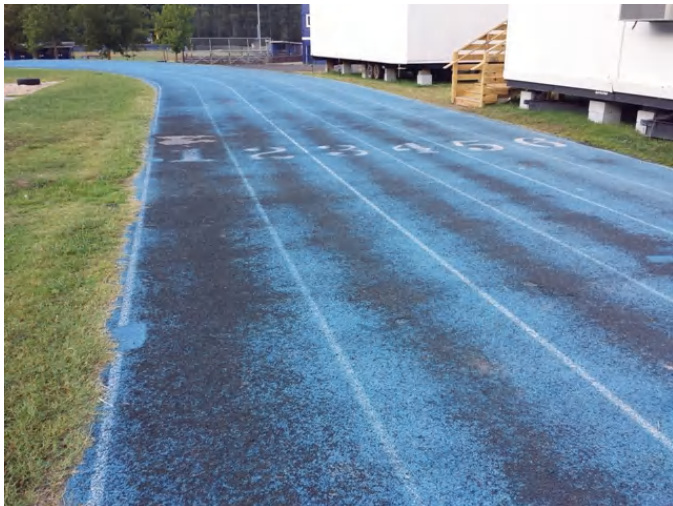
System: G2040 - Track

Location: Site

Distress: Beyond Service Life
