DeKalb County School District/Elementary Schools

Flat Shoals Elementary

School Assessment Report

May 19, 2016

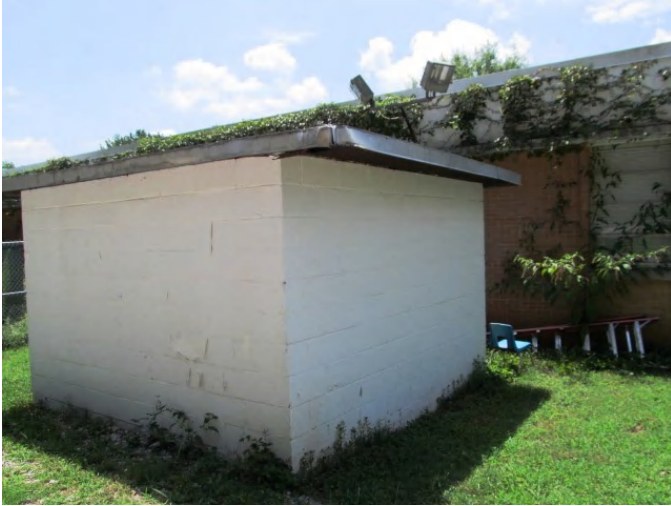
System: B2010 - Exterior Walls

Location: Exterior Walls

Distress: Damaged

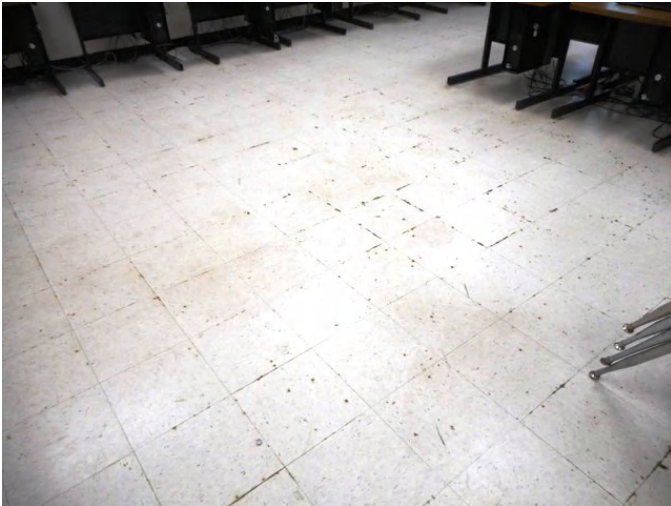
System: C3020 - Floor Finishes - VCT

Location: Throughout Building

Distress: Beyond Service Life

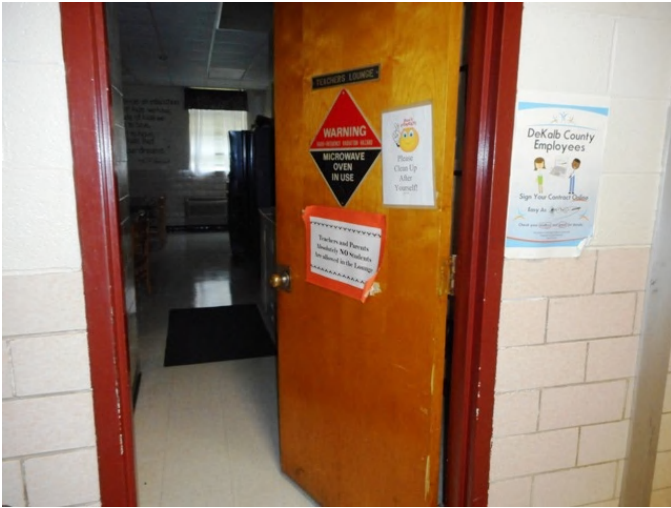
System: C1020 - Interior Doors

Location: Throughout Building

Distress: Beyond Service Life

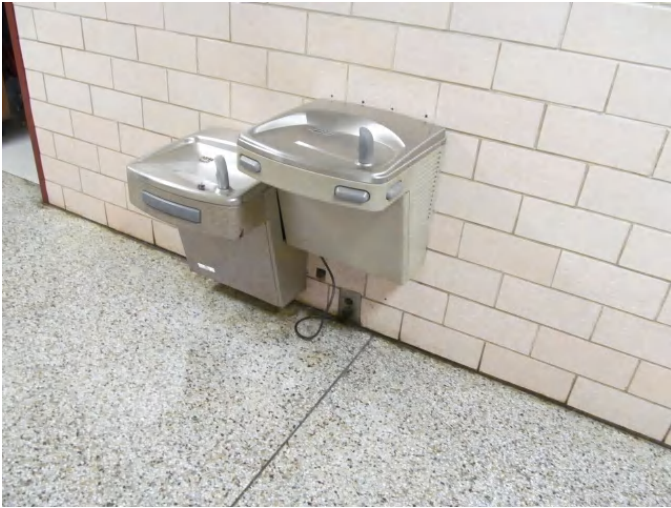
System: D2010 - Plumbing Fixtures

Location: Hallway

Distress: Needs Remediation

Notes: Water fountains protrude into the hallway more than four inches. Protrusion is not ADA compliant if more than four inches.

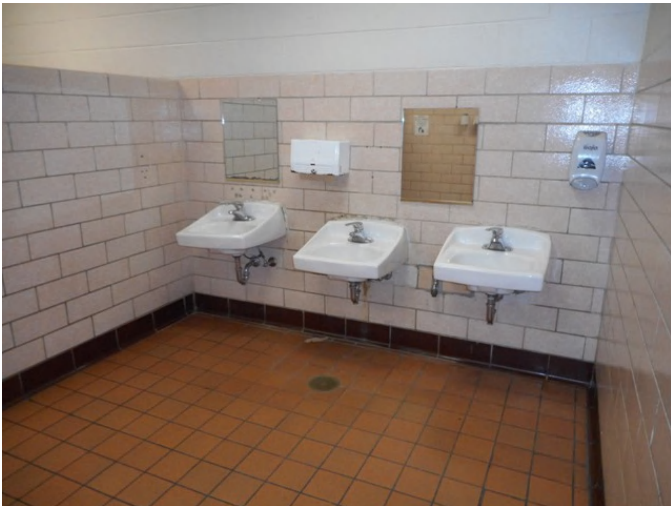
System: D2010 - Plumbing Fixtures

Location: Throughout Building

Distress: Missing

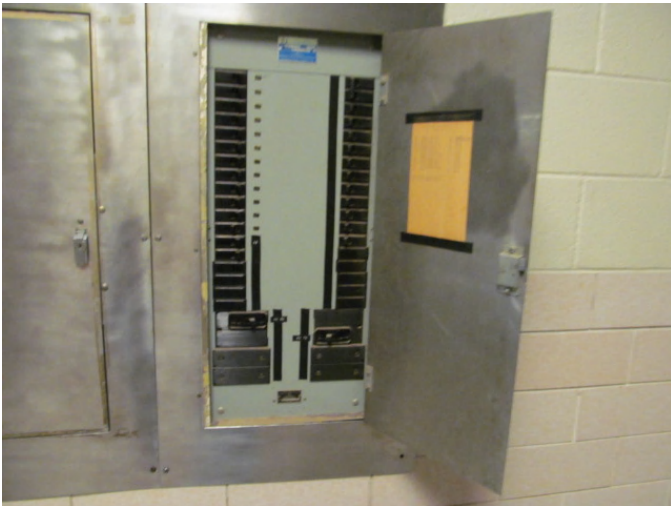
System: D5020 - Branch Wiring

Location: Throughout Building

Distress: Beyond Service Life

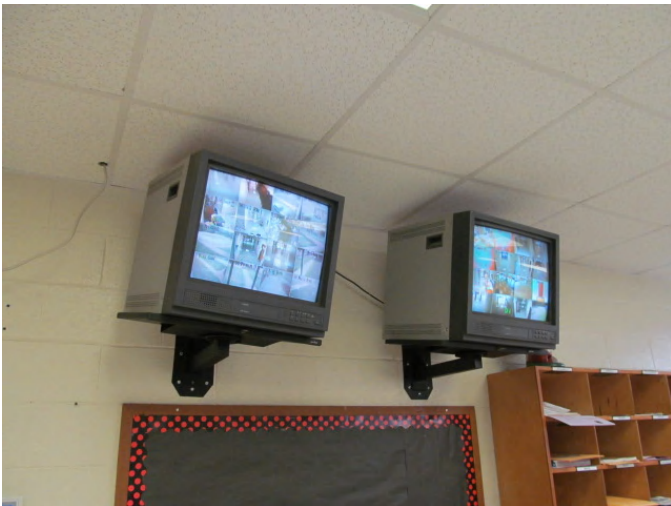
System: D5030 - Communications and Security - Security & CCTV

Location: Throughout Building

Distress: Inadequate

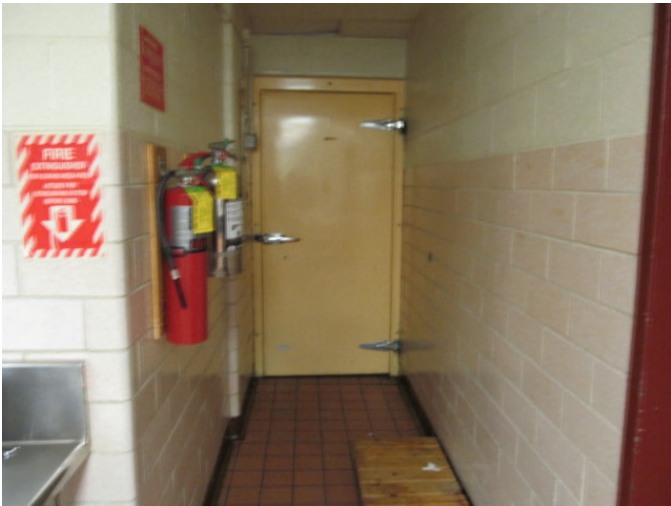
System: E1090 - Other Equipment (Kitchen Equipment)

Location: Kitchen

Distress: Beyond Service Life

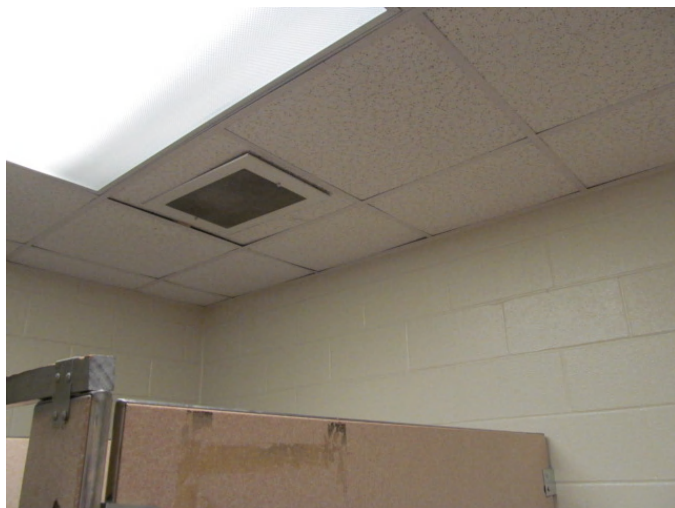
Location: Restrooms

System: D3040 - Distribution & Exhaust Systems

Distress: Beyond Service Life

Notes: The distribution and exhaust systems are beyond their expected service life, damaged, noisy, and should be scheduled for replacement.

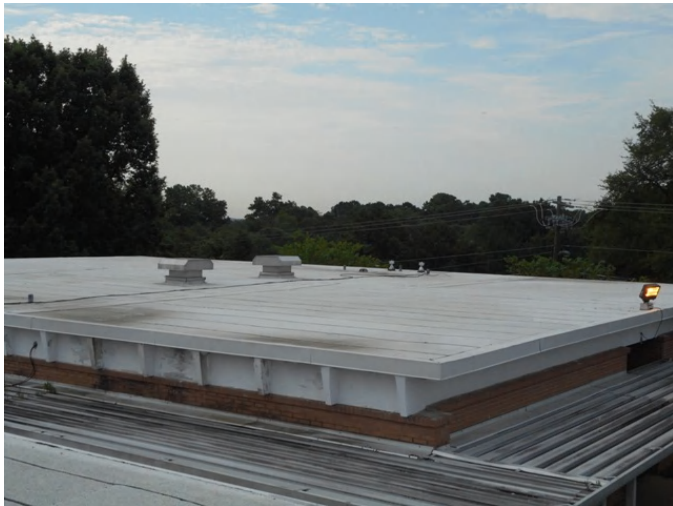
Location: Exterior Walls

System: B2010 - Exterior Walls

Distress: Beyond Service Life

Notes: Painted finishes on exterior trim are faded and stained and should be replaced.

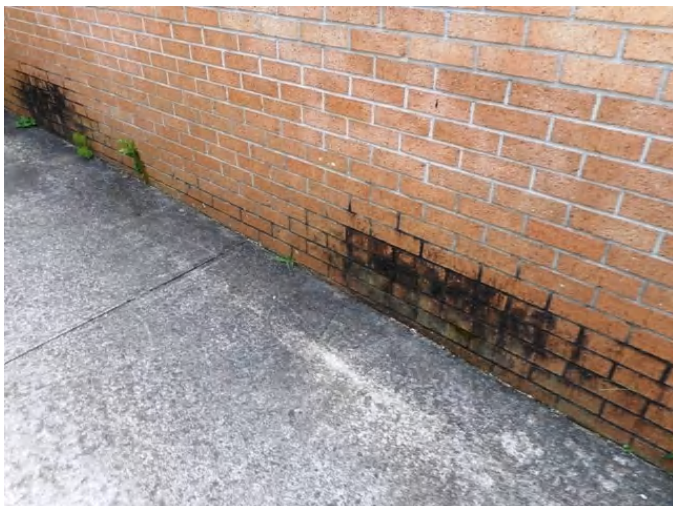
Location: Exterior Wall

System: B2010 - Exterior Walls

Distress: Damaged

Notes: The exterior wall has stains and should be pressure washed.

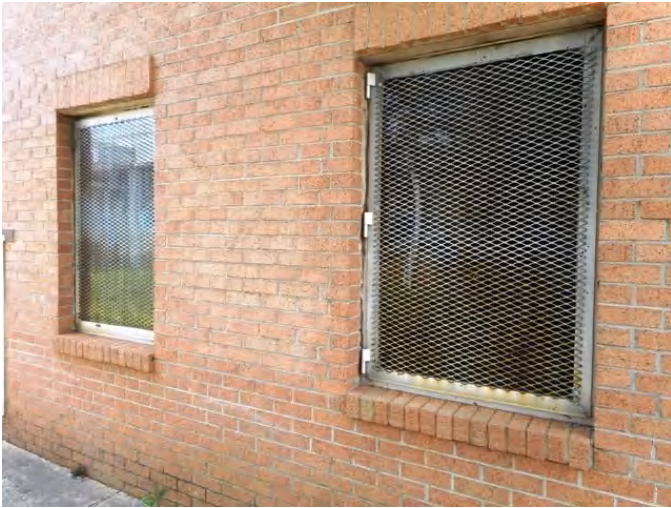
Location: Throughout Building

System: B2020 - Exterior Windows

Distress: Beyond Service Life

Notes: The aluminum frame, single pane windows are aged, not energy efficient, and should be replaced.

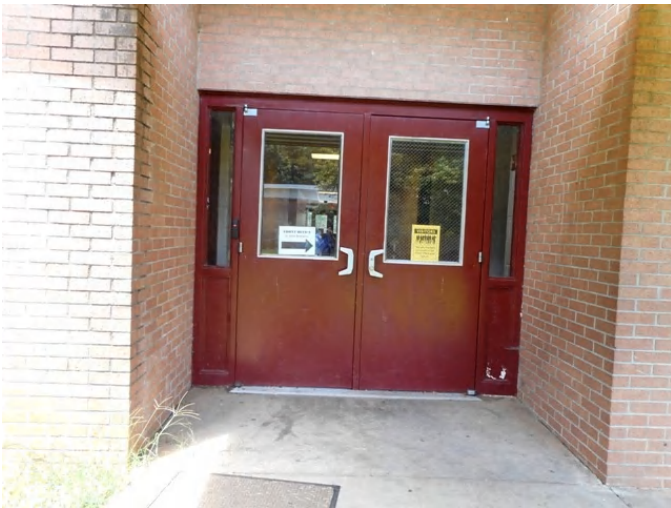
Location: Throughout Building

System: B2030 - Exterior Doors

Distress: Beyond Service Life

Notes: The original metal exterior doors are aged and should be replaced.

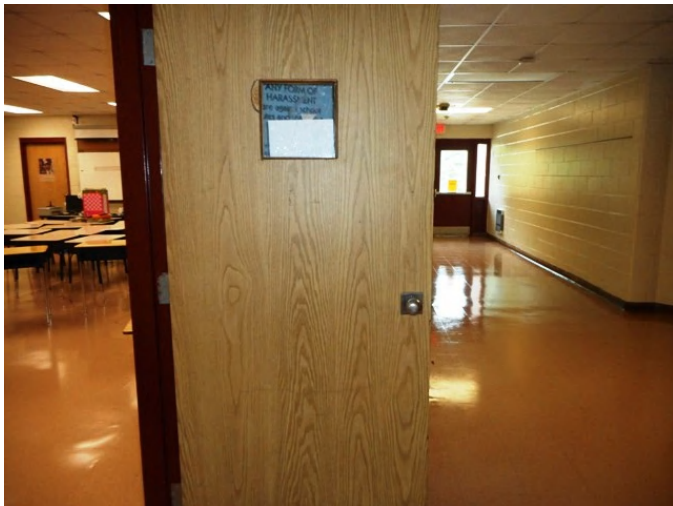
Location: Throughout Building

System: C1020 - Interior Doors

Distress: Beyond Service Life

Notes: The interior doors are aged, failing, not ADA or building code compliant, and should be replaced.

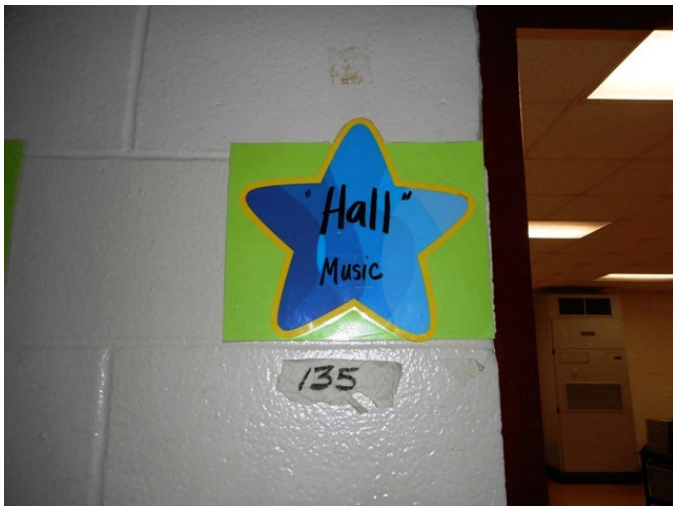
Location: Throughout Building

System: C1030 - Fittings

Distress: Beyond Service Life

Notes: Fittings, such as toilet partitions, handrails and signage, are beyond their expected service life, not ADA compliant, and should be replaced. SPLOST IV scope includes renovating hall restrooms for ADA compliance.

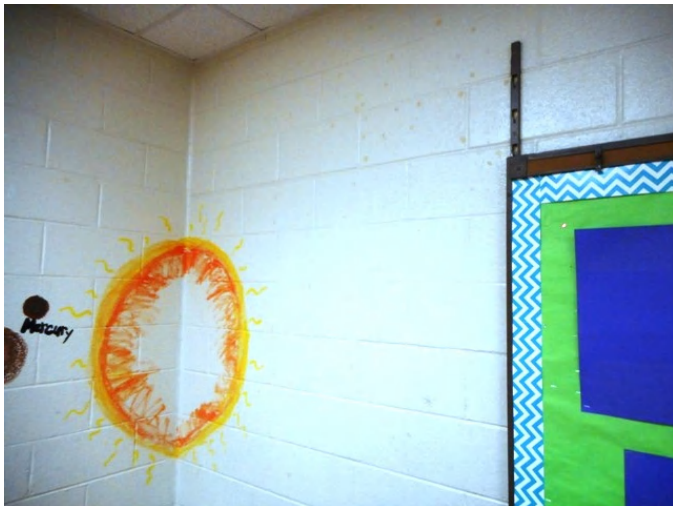
Location: Throughout Building

System: C3010 - Wall Finishes - Paint

Distress: Beyond Service Life

Notes: The painted wall finishes are beyond their expected service life, damaged, fading, and should be replaced.

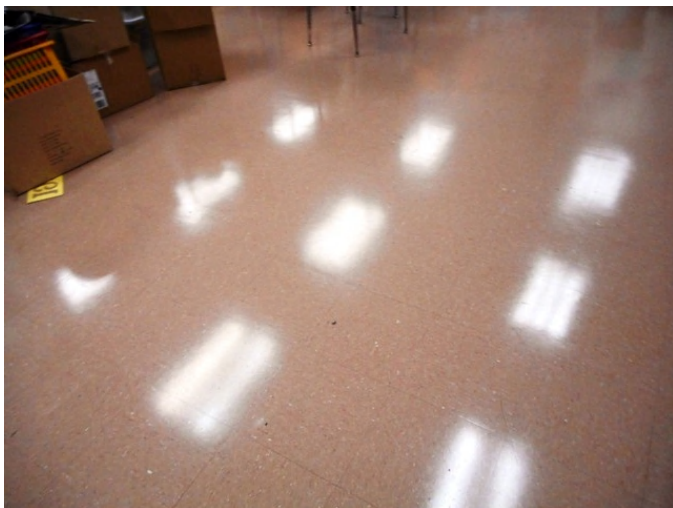
Location: Throughout Building

System: C3020 - Floor Finishes - VCT

Distress: Beyond Service Life

Notes: The original flooring is in poor condition, with different areas bubbling or separating from the substrate, and should be replaced.

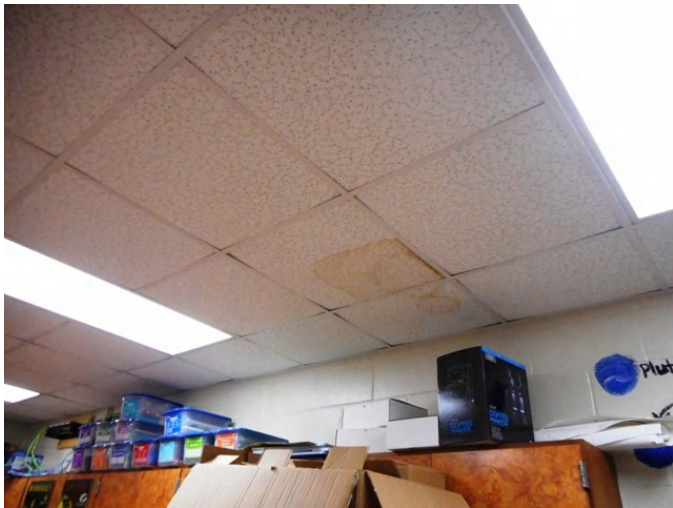
Location: Throughout Building

System: C3030 - Ceiling Finishes

Distress: Beyond Service Life

Notes: The ceiling tiles have been replaced as needed. However the grid shows signs of aging and most tiles are sagging or damaged, and the entire system should be replaced.

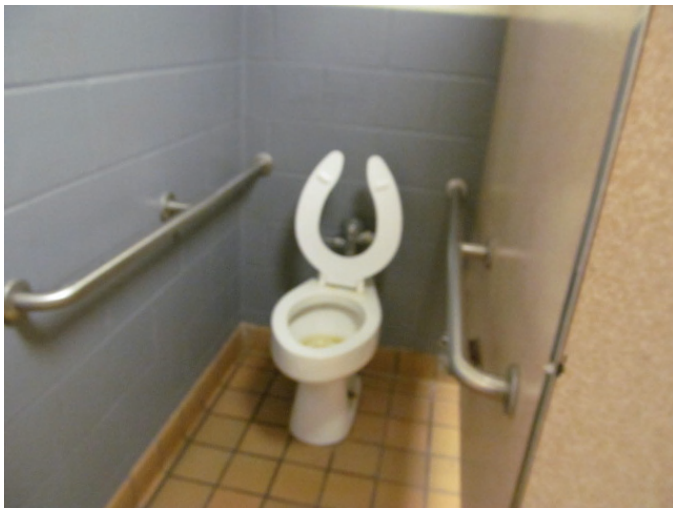
Location: Throughout Building

System: D2010 - Plumbing Fixtures

Distress: Needs Remediation

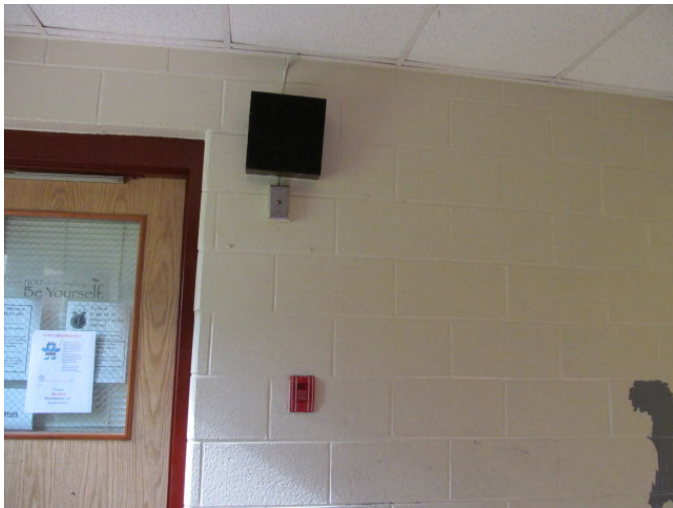
Location: Throughout Building

System: D5030 - Communications and Security - Clock & PA Systems

Distress: Damaged

Notes: The PA and Clock system is reported to be intermittent with regular outages and should be replaced.

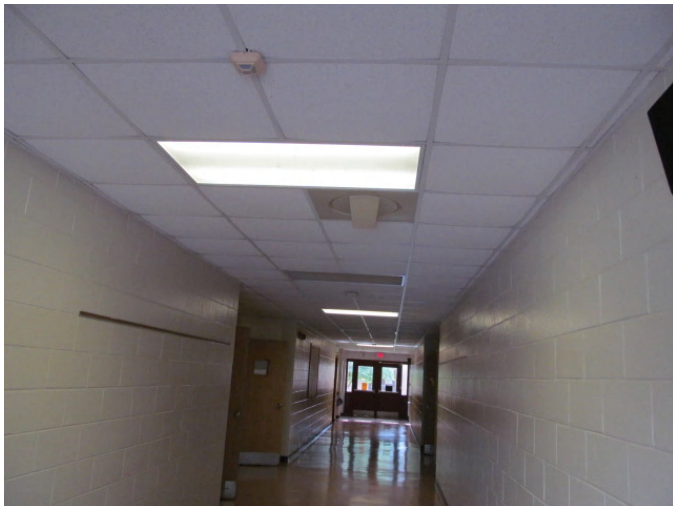
Location: Throughout Building

System: D5030 - Communications and Security - Security & CCTV

Distress: Inadequate

Notes: The security system is inadequate and there is no CCTV system in the classrooms. Replace the security system and add a modern CCTV system with LAN connectivity.

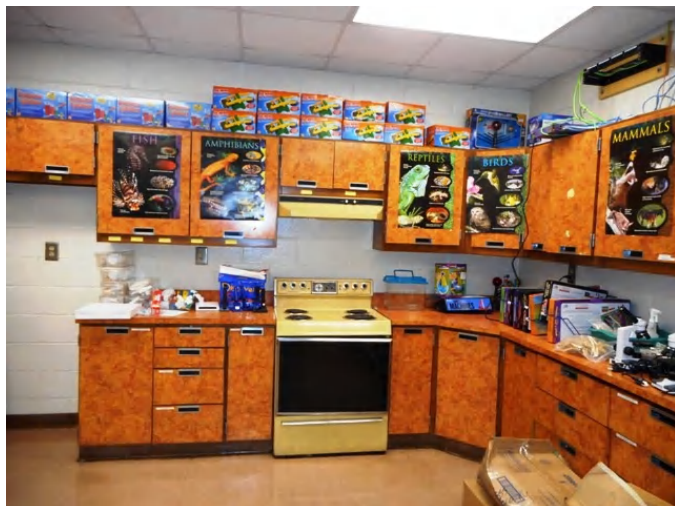
Location: Throughout Building

System: E2010 - Fixed Furnishings

Distress: Beyond Service Life

Notes: Fixed furnishings, such as built-in cabinets, are beyond their expected service life and worn, and should be replaced.

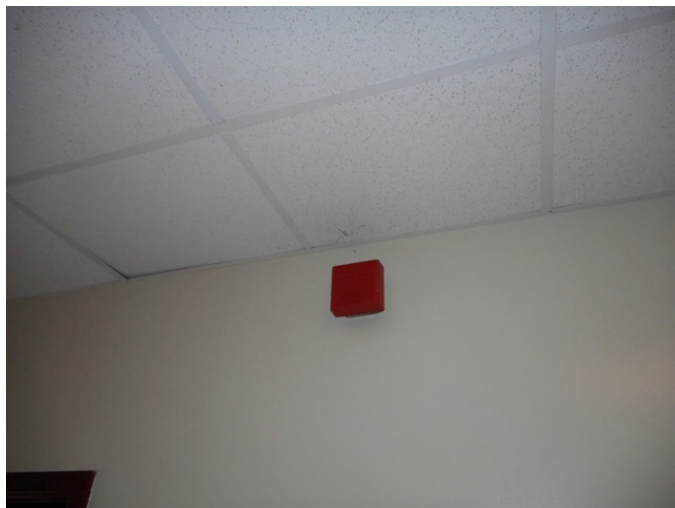
Location: Throughout Building

System: D5030 - Communications and Security - Fire Alarm

Distress: Inadequate

Notes: There are only audible alarms available in location noted; the restrooms do not have horns and strobes. The fire alarm system should be replaced as soon as possible as it is also beyond its expected service life.

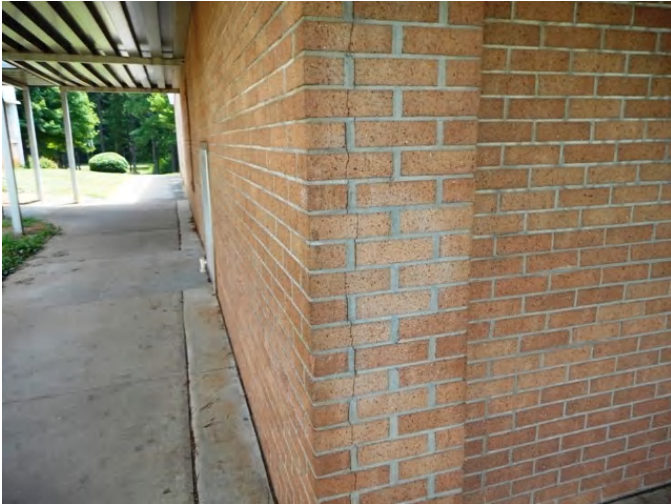
Location: Northwest Exterior Wall

System: B2010 - Exterior Walls

Distress: Damaged

Notes: There is a visible crack on the exterior wall. An engineering study is recommended to determine the cause. Pricing does not include remediation measures.

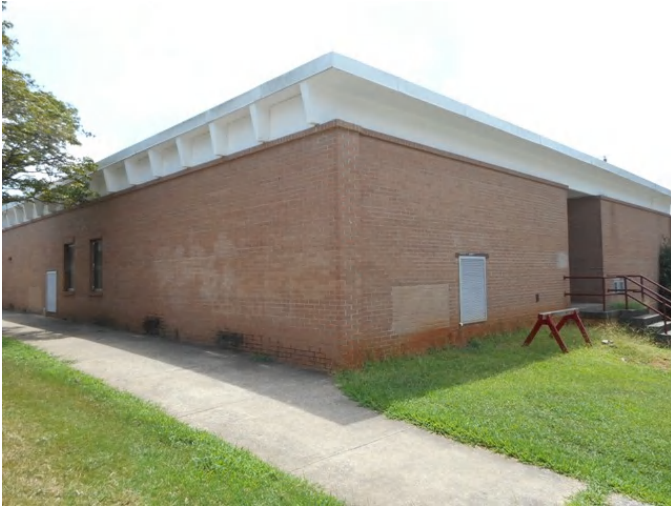
Location: Exterior Walls

System: B2010 - Exterior Walls

Distress: Beyond Service Life

Notes: Painted finishes on exterior trim are faded and stained and should be replaced.

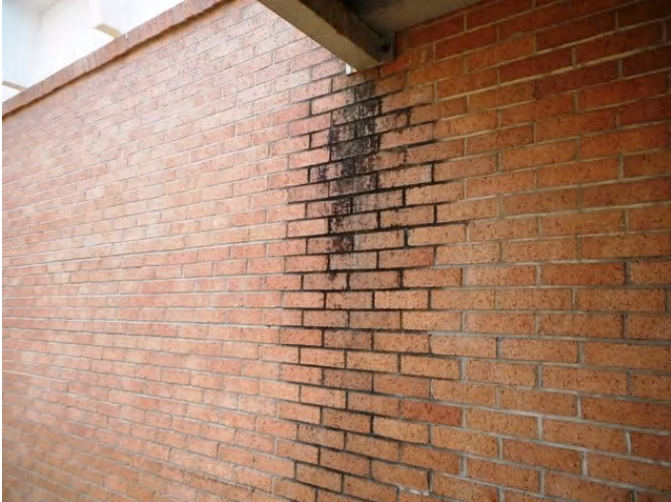
Location: Exterior Wall

System: B2010 - Exterior Walls

Distress: Damaged

Notes: The exterior walls are stained and should be cleaned.

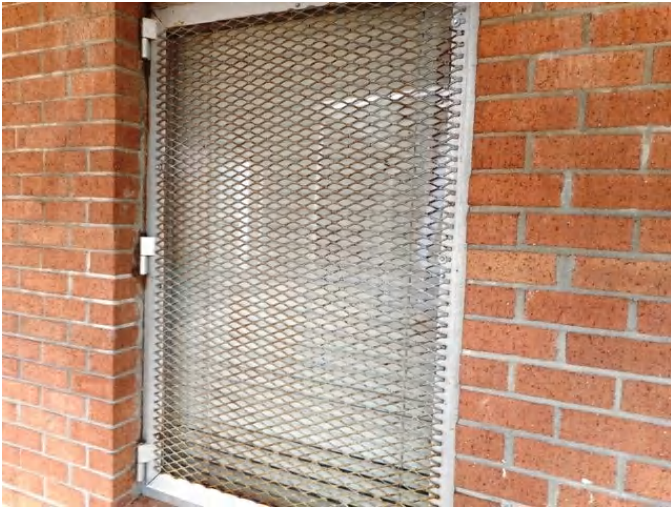
Location: Throughout Building

System: B2020 - Exterior Windows

Distress: Beyond Service Life

Notes: The aluminum frame, single pane windows are aged, not energy efficient, and should be replaced.

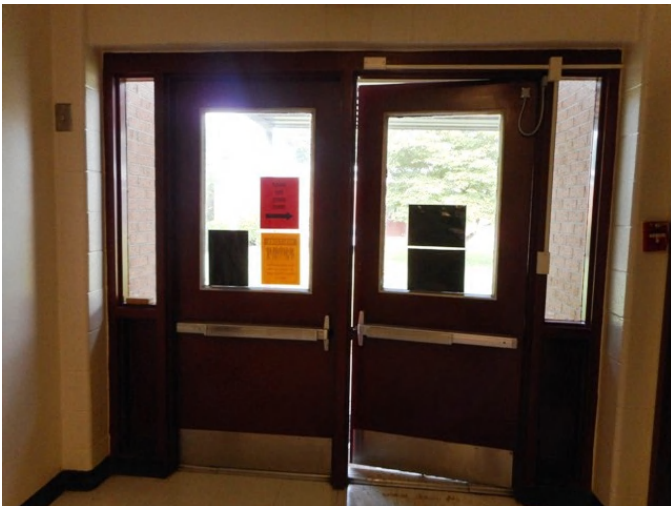
Location: Throughout Building

System: B2030 - Exterior Doors

Distress: Beyond Service Life

Notes: The original exterior doors are aged and should be replaced.

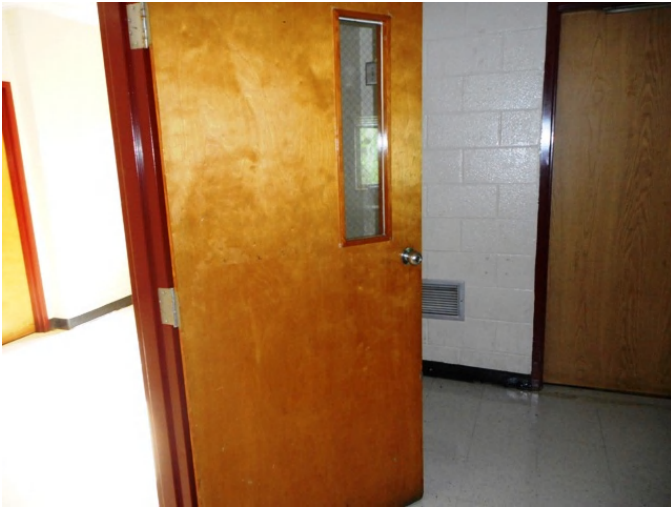
Location: Throughout Building

System: C1020 - Interior Doors

Distress: Beyond Service Life

Notes: The interior doors are aged, not ADA or building code compliant, and should be replaced.

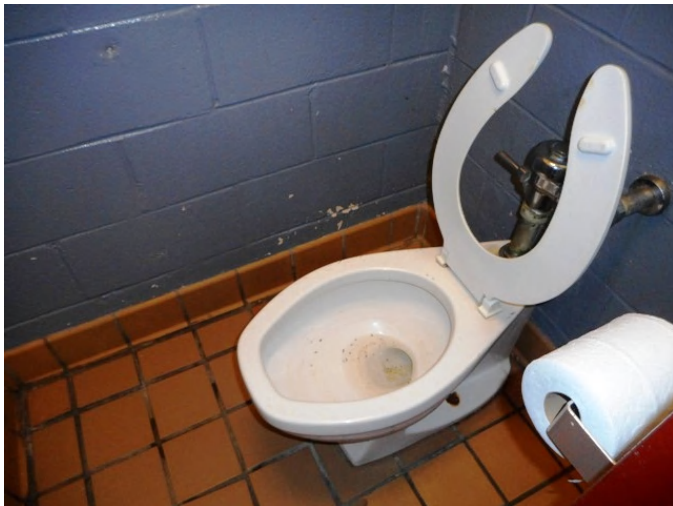
Location: Throughout Building

System: C3010 - Wall Finishes - Paint

Distress: Beyond Service Life

Notes: The painted wall finishes are beyond their expected service life, scuffed and stained, and should be replaced.

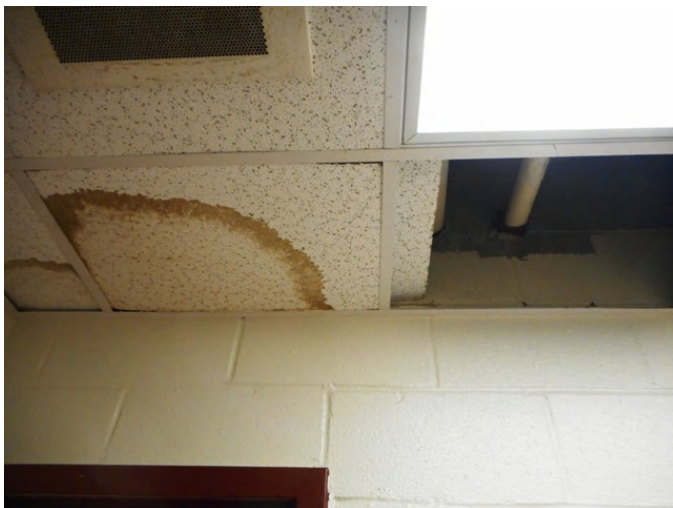
Location: Throughout Building

System: C3030 - Ceiling Finishes

Distress: Beyond Service Life

Notes: The ceiling tiles have been replaced as needed. However the grid shows signs of aging and most tiles are sagging or damaged, and the entire system should be replaced.

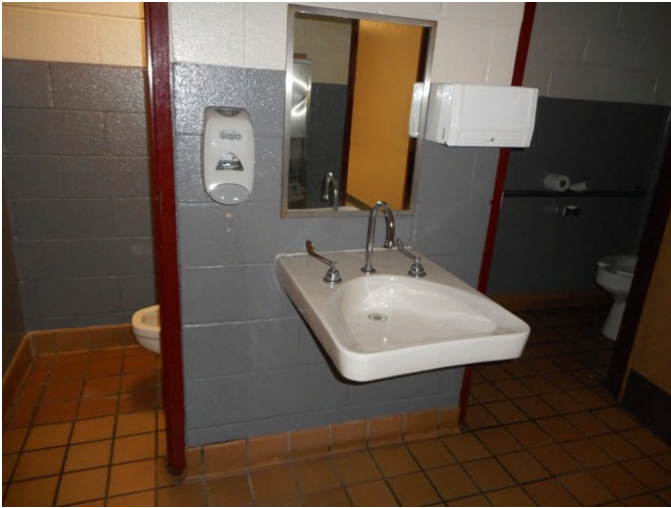
Location: Throughout Building

System: D2010 - Plumbing Fixtures

Distress: Needs Remediation

Notes: The plumbing fixtures are not ADA compliant. SPLOST IV scope includes renovating hall restrooms for ADA compliance.

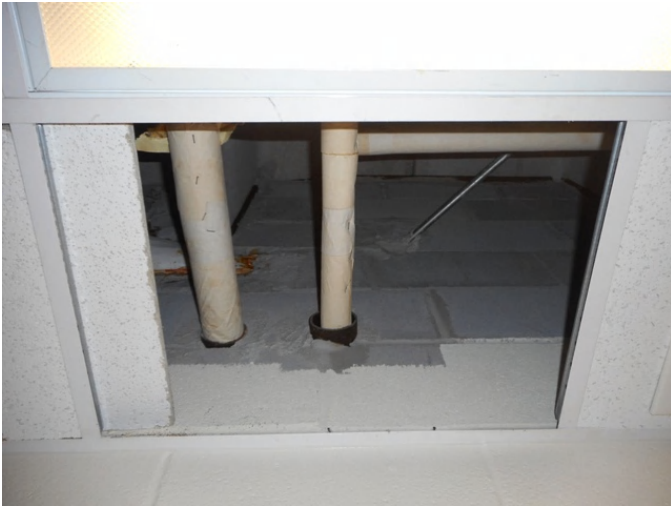
Location: Throughout Building

System: D2020 - Domestic Water Distribution

Distress: Beyond Service Life

Notes: The domestic water distribution system is beyond its expected service life and should be scheduled for replacement.

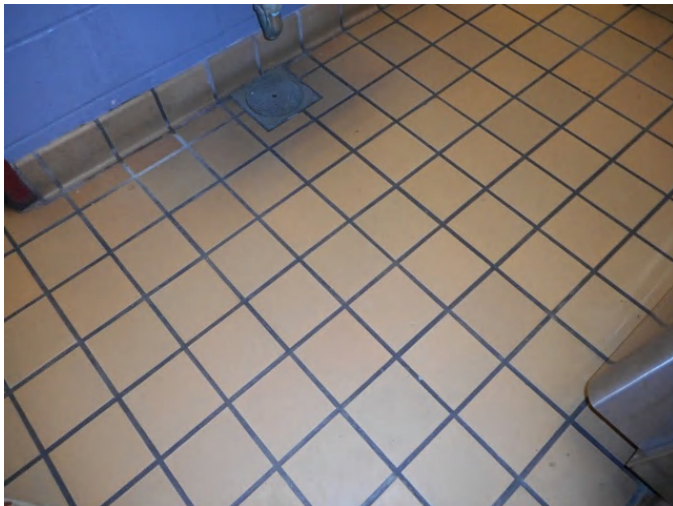
Location: Throughout Building

System: D2030 - Sanitary Waste

Distress: Beyond Service Life

Notes: The sanitary waste system is beyond its expected service life and should be scheduled for replacement.

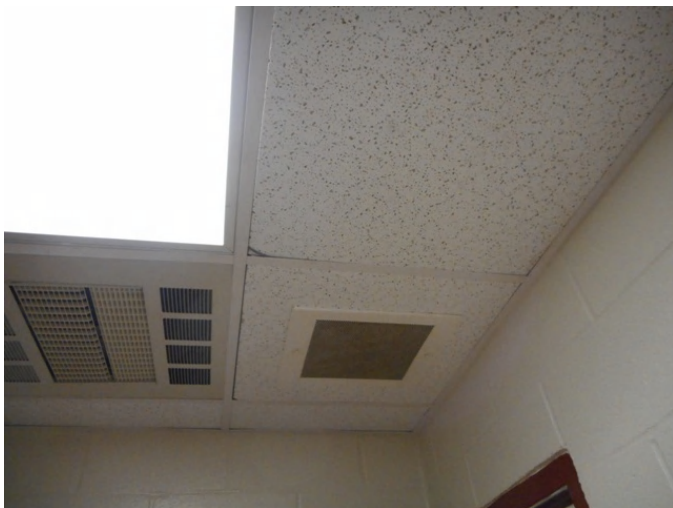
Location: Restrooms

System: D3040 - Distribution & Exhaust Systems

Distress: Beyond Service Life

Notes: The distribution and exhaust systems are beyond their expected service life and should be scheduled for replacement.

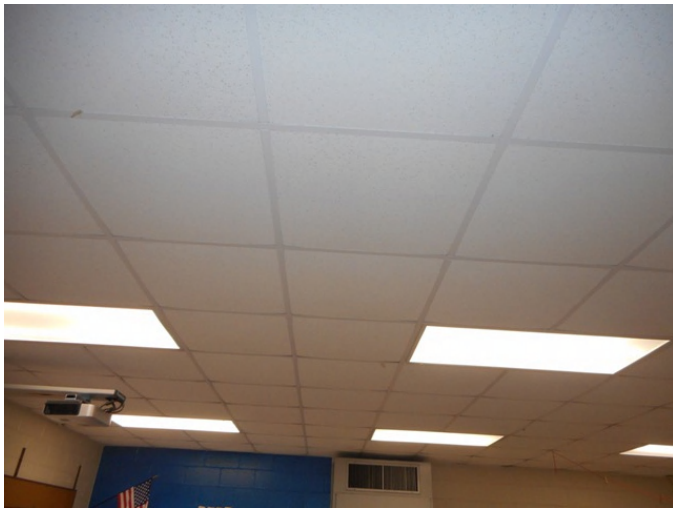
Location: Throughout Building

System: D5030 - Communications and Security - Clock & PA Systems

Distress: Inadequate

Notes: The PA and clock system is reported to be intermittent with regular outages and should be replaced.

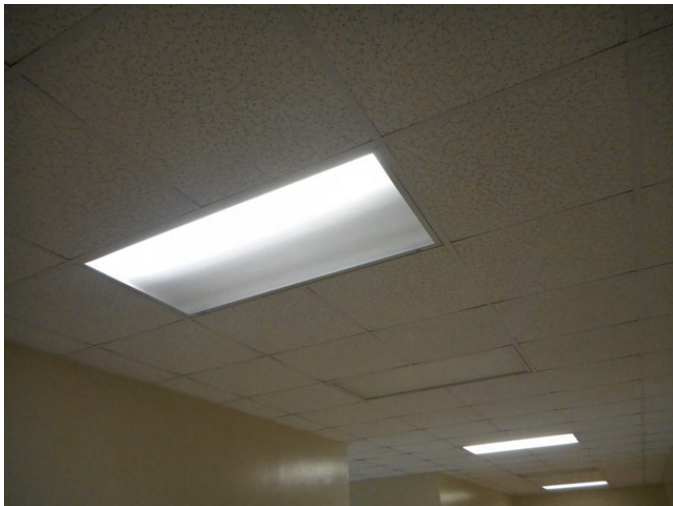
Location: Throughout Building

System: D5030 - Communications and Security - Security & CCTV

Distress: Inadequate

Notes: The security system is inadequate and the CCTV system is missing. Replace the entire system and add a modern CCTV system with LAN connection.

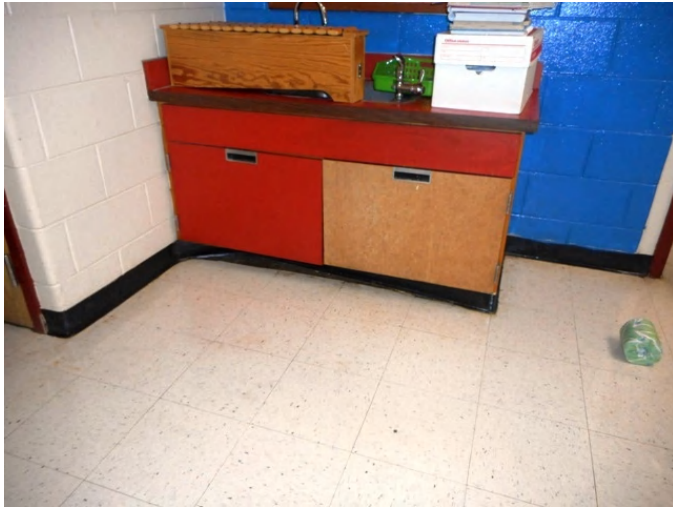
Location: Throughout Building

System: E2010 - Fixed Furnishings

Distress: Beyond Service Life

Notes: Fixed furnishings, such as built-in cabinets and window treatment, are beyond their expected service life and worn, and should be replaced.

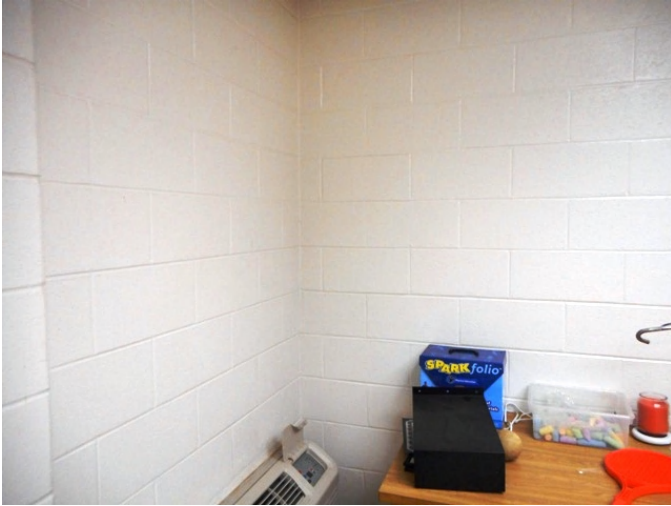
System: C3010 - Wall Finishes - Paint

Location: Throughout Building

Distress: Beyond Service Life

Notes: The painted wall finishes are beyond their expected service life, faded and stained, and should be replaced.

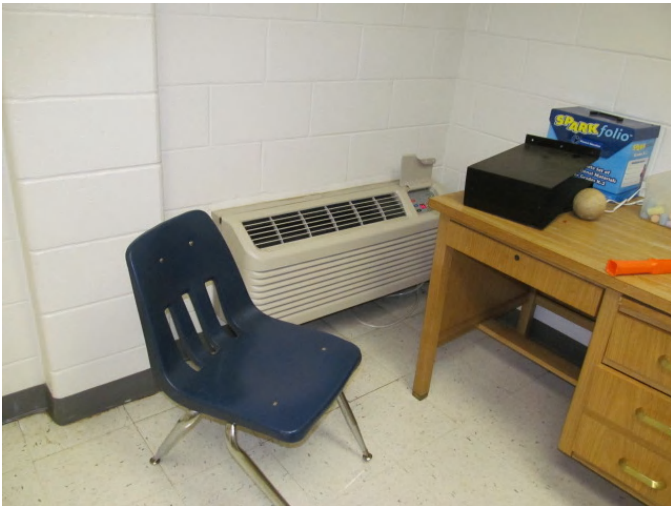
System: D3050 - Terminal & Package Units

Location: Throughout Building

Distress: Inadequate

Notes: One PTAC AC unit is located in the office area of the gym. It is nearing the end of its expected service life and is inadequate. The main gym area does not have air conditioning and it should be provided. SPLOST IV scope includes installing a 20 ton HVAC unit in the gym.

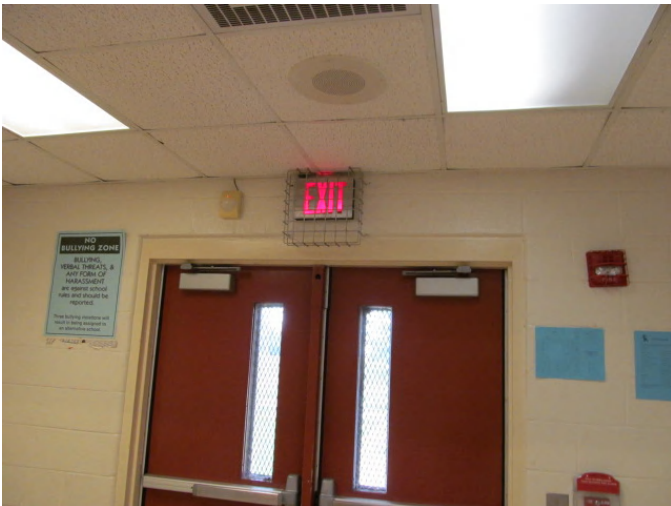
System: D5030 - Communications and Security - Public Address & Clock System

Location: Throughout Building
Distress: Beyond Service Life
Category: Deferred Maintenance
Priority: 3 Priority
Correction: Renew System
Qty: 5,478.00
Unit of Measure: S.F.
Estimate: \$5,303.00
Assessor Name: Ben Nixon
Date Created: 07/29/2015

Notes: The public address and clock system is beyond its expected service life and should be scheduled for replacement.

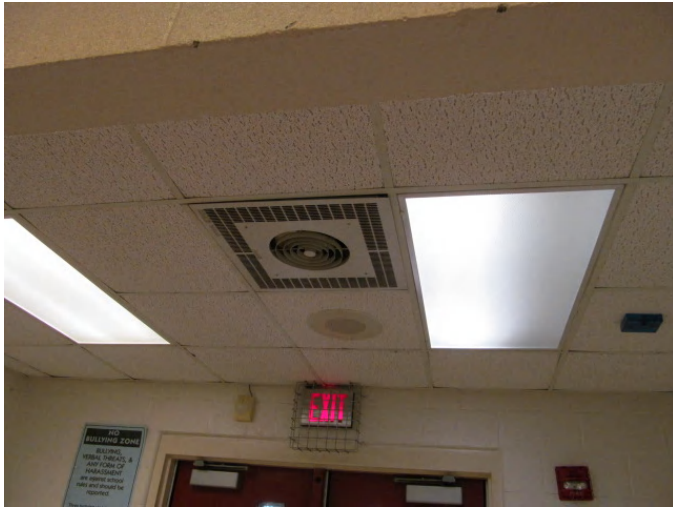
System: D5030 - Communications and Security - Security & CCTV

Location: Throughout Building

Distress: Beyond Service Life

Notes: The security and CCTV systems are beyond their expected service life and should be scheduled for replacement.

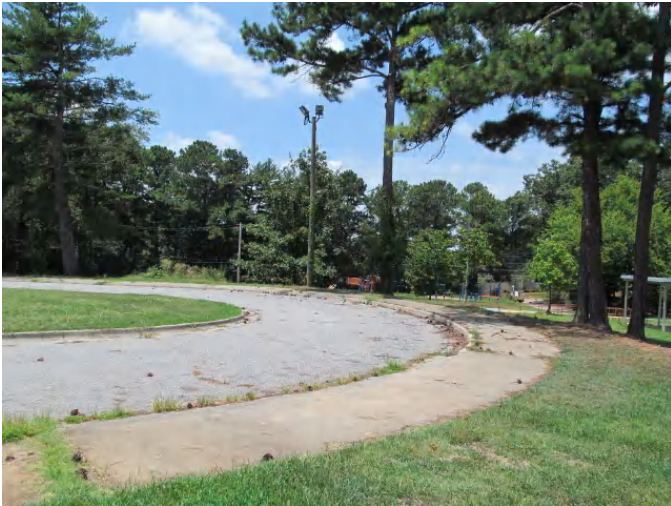
System: G4020 - Site Lighting

Location: Site

Distress: Beyond Service Life

Notes: Site lighting is beyond its expected service life, inadequate, and should be scheduled for replacement/upgraded to improve coverage.

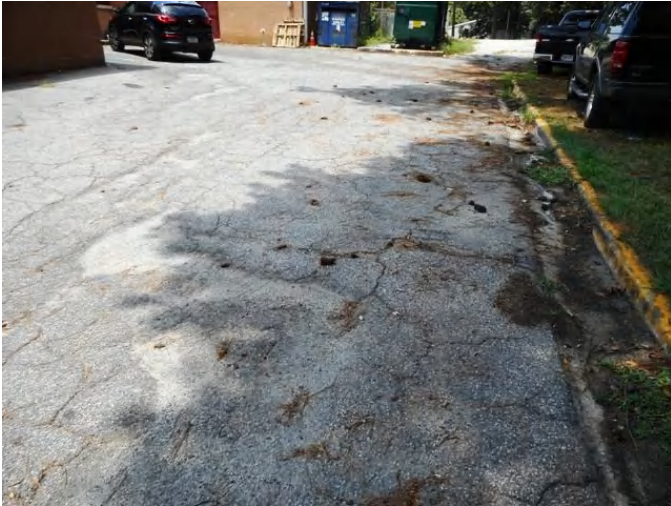
System: G2010 - Roadways

Location: Site

Distress: Beyond Service Life

Notes: Roadways are beyond their expected service life, damaged with many cracks, worn, and should be replaced.

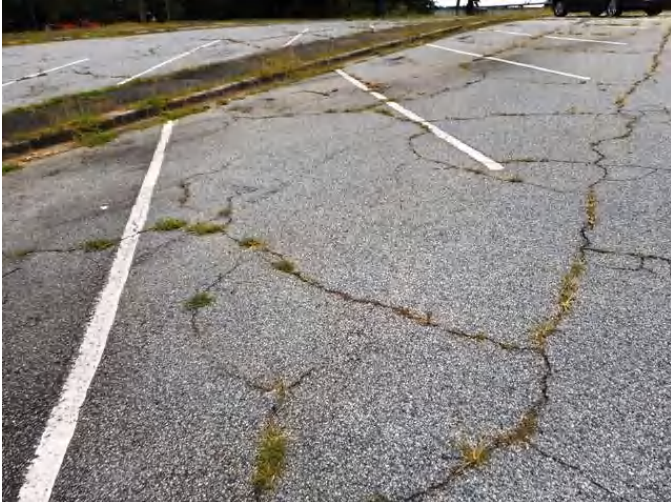
System: G2020 - Parking Lots

Location: Site

Distress: Beyond Service Life

Notes: The parking lot is beyond its expected service life, has many repairs and potholes, is not ADA compliant, and should be replaced and re-striped. Sign heights need to be adjusted per ADA standards.

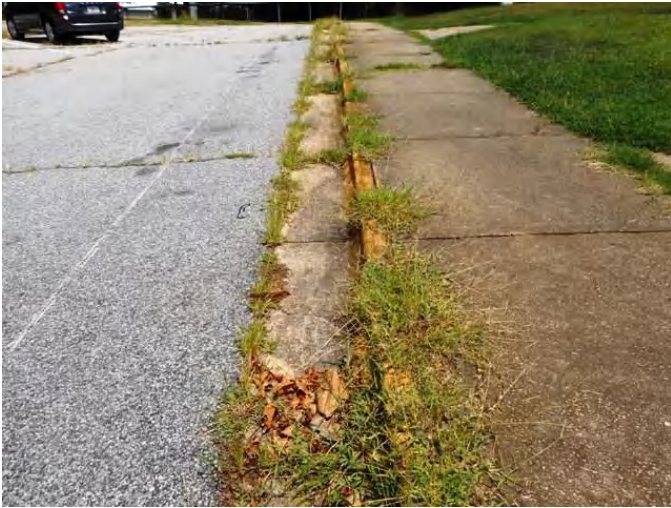
System: G2030 - Pedestrian Paving

Location: Site

Distress: Beyond Service Life

Notes: Pedestrian paving is beyond its expected service life, damaged with cracks and trip hazards, not ADA compliant, and should be replaced.

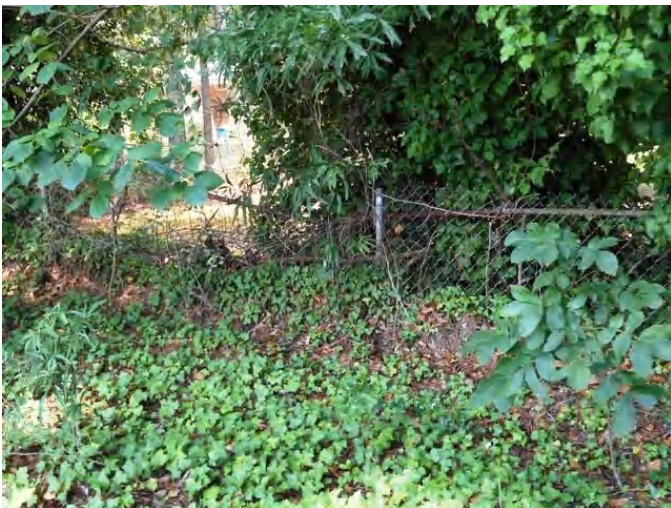
System: G2040 - Fencing & Guardrails

Location: Site

Distress: Beyond Service Life

Notes: Fencing is beyond its expected service life, in poor condition, and should be scheduled for replacement.

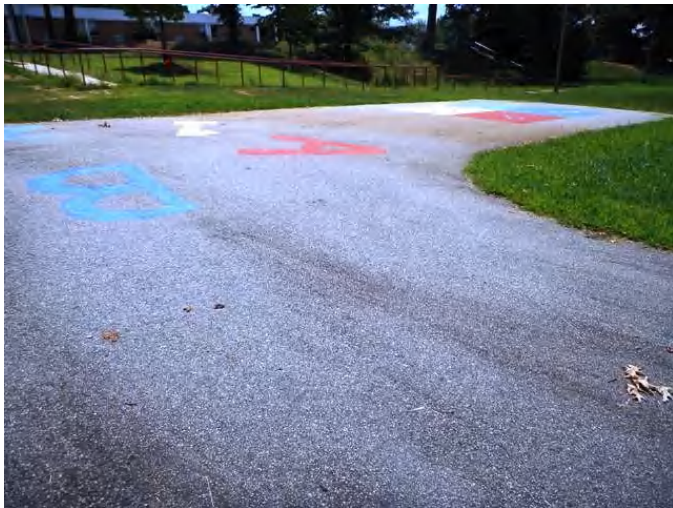
System: G2040 - Hard Surface Play Area

Location: Site

Distress: Beyond Service Life

Notes: The hard surface play area is beyond its expected service life and should be scheduled for replacement.

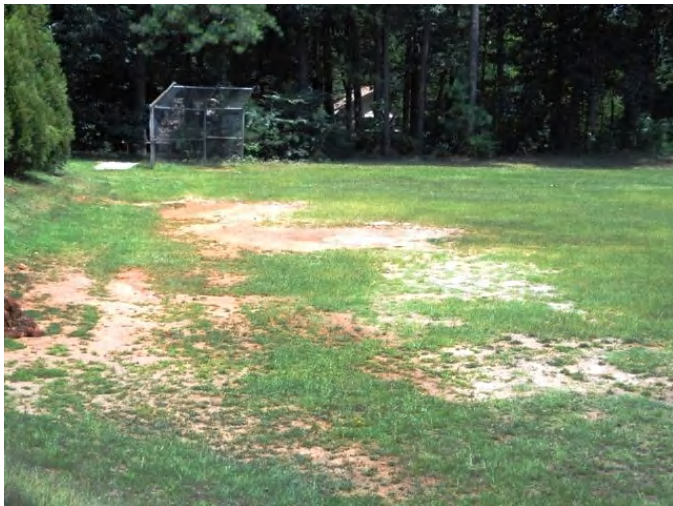
System: G2040 - Playing Field

Location: Site

Distress: Beyond Service Life

Notes: The playing field is beyond its expected service life, has numerous bare spots, and should be re-sodded to prevent erosion.

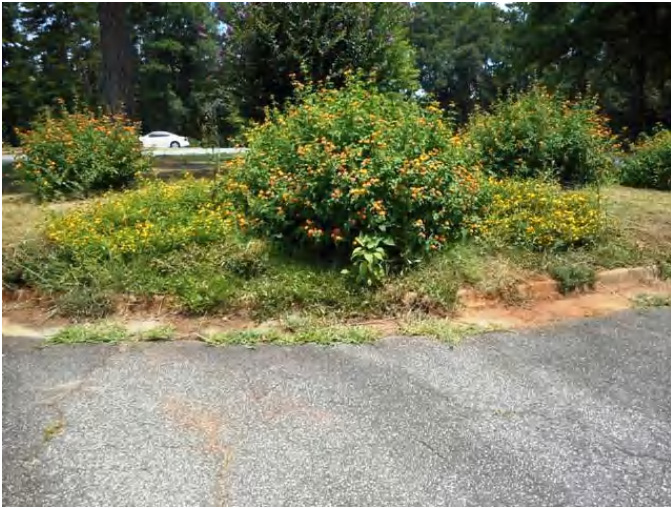
System: G2050 - Landscaping

Location: Site
Distress: Beyond Service Life
Category: Deferred Maintenance
Priority: 3 Priority
Correction: Renew System
Qty: 63,814.00
Unit of Measure: S.F.
Estimate: \$101,783.00
Assessor Name: Eduardo Lopez
Date Created: 07/16/2015

Notes: Landscaping is non-existent, overgrown with weeds, and completely eroded away in some areas, causing sediments to accumulate at lower levels of the parking lot and in storm sewer system.

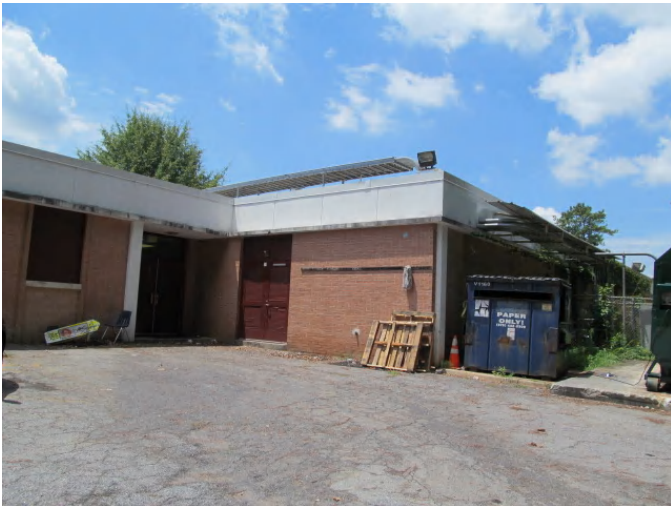
System: G3060 - Fuel Distribution

Location: Site
Distress: Beyond Service Life
Category: Deferred Maintenance
Priority: 3 Priority
Correction: Renew System
Qty: 63,814.00
Unit of Measure: S.F.
Estimate: \$29,482.00
Assessor Name: Sam Mandola
Date Created: 03/08/2016

Notes: Fuel distribution system is beyond its expected service life and should be replaced.

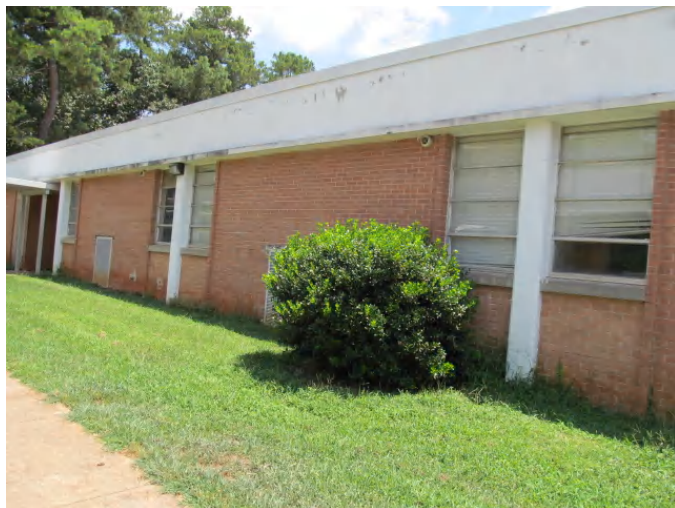
System: G4030 - Site Communications & Security

Location: Site

Distress: Beyond Service Life
