DeKalb County School District/Vacant

Former Briarcliff HS (Open Campus)

School Assessment Report

May 20, 2016

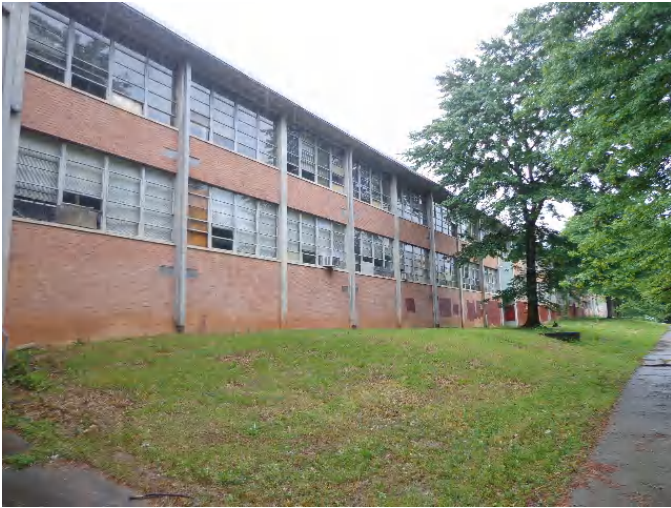
System: B2020 - Exterior Windows

Location: Throughout Building

Distress: Beyond Service Life

Notes: The aluminum frame, operable, single pane windows are aged, rusted and not energy efficient, and should be replaced.

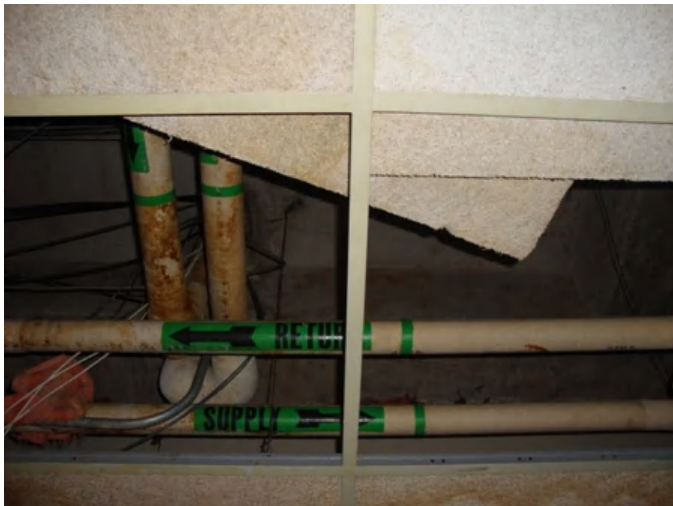
System: D3040 - Distribution Systems & Exhaust Systems

Location: Throughout Building

Distress: Beyond Service Life

Notes: Distribution and exhaust systems are beyond their expected service life and should be scheduled for replacement.

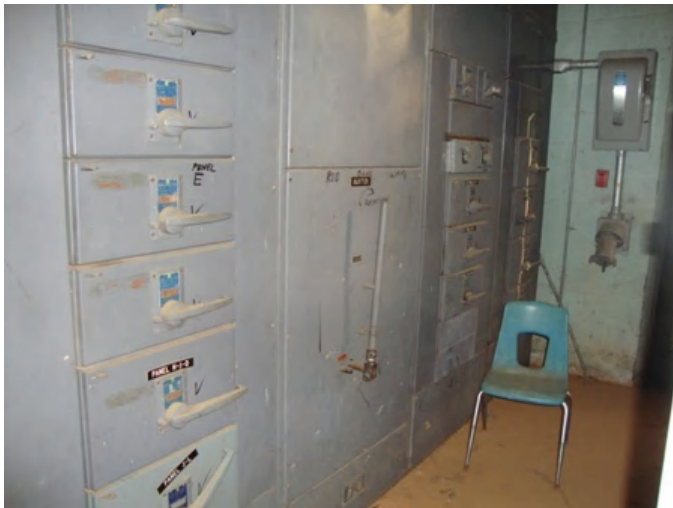
System: D5010 - Electrical Service/Distribution

Location: Throughout Building

Distress: Beyond Service Life

Notes: Electrical/service distribution system is beyond its expected service life and should be scheduled for replacement.

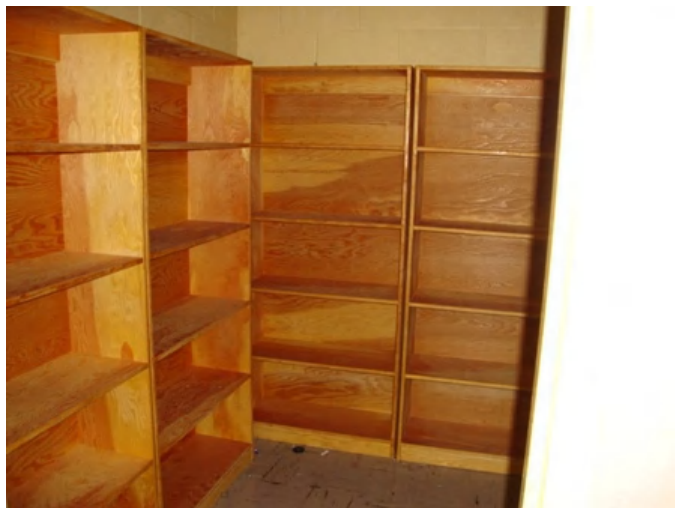
System: E2010 - Fixed Furnishings

Location: Throughout Building

Distress: Beyond Service Life

Notes: The fixed furnishings are aged, in marginal condition, and should be replaced.

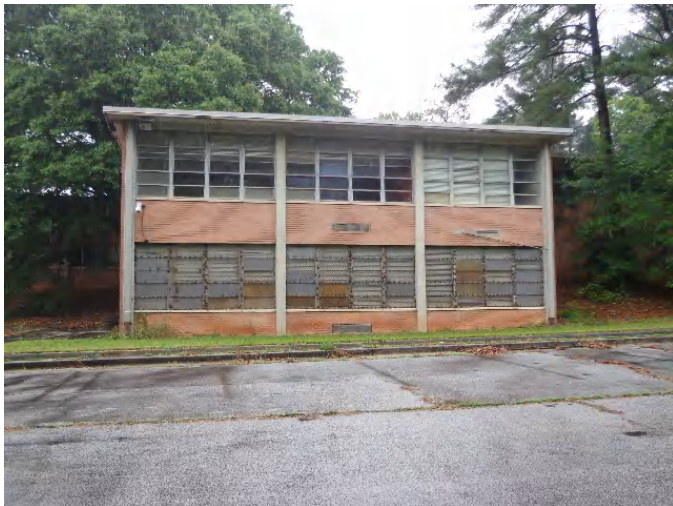
System: B2020 - Exterior Windows

Location: Throughout Building

Distress: Beyond Service Life

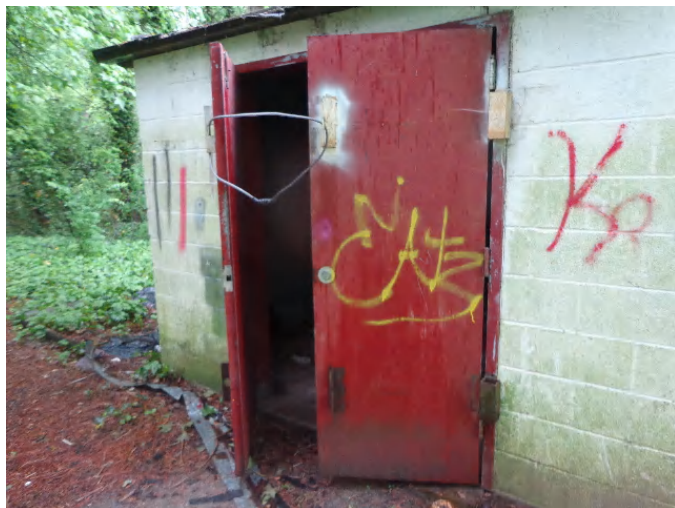
System: B2030 - Exterior Doors

Location: Exterior Wall

Distress: Beyond Service Life

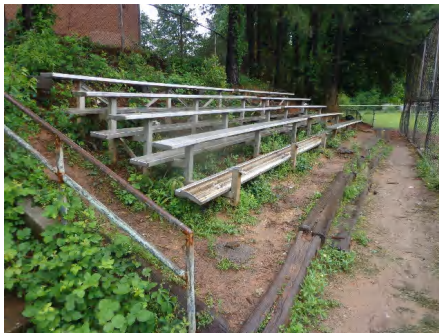
2). Grandstands Near Former Baseball Field - Jul 21, 2015

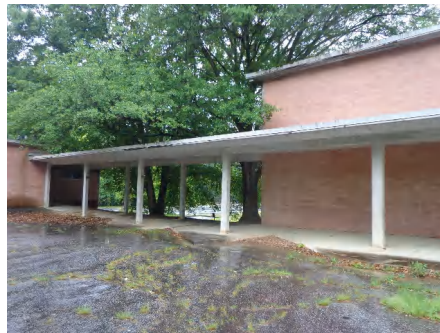
3). Covered Walkway - Jul 21, 2015

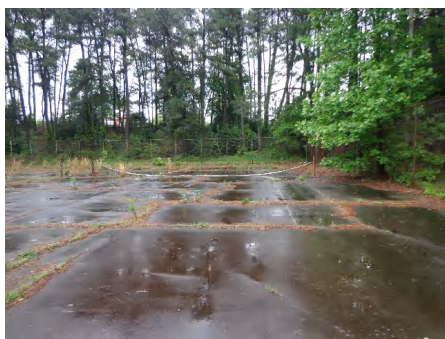
4). Tennis Courts - Jul 21, 2015

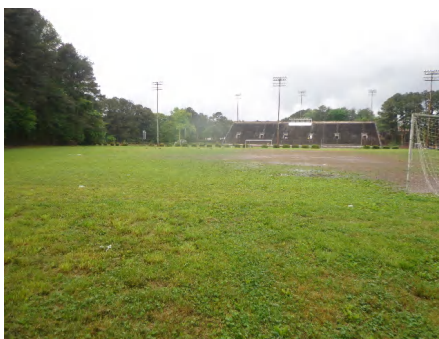
5). Playing Field - Jul 30, 2015

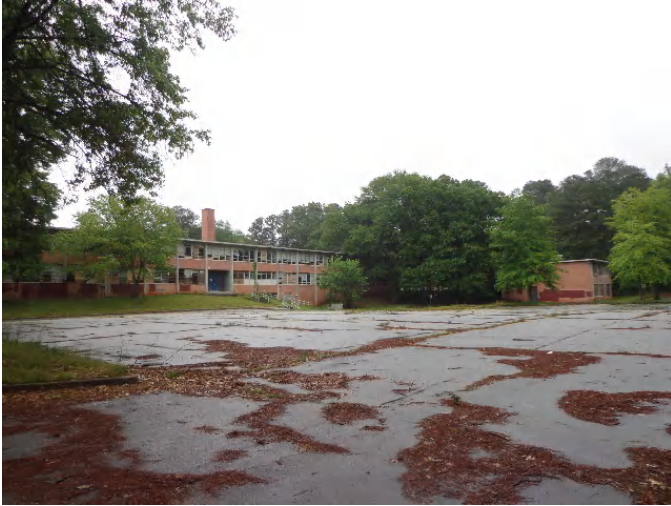
System: G2010 - Roadways

Location: Site

Distress: Beyond Service Life

Notes: The asphaltic roadway is aged, has many road cuts, cracks, potholes and repairs, and should be replaced.

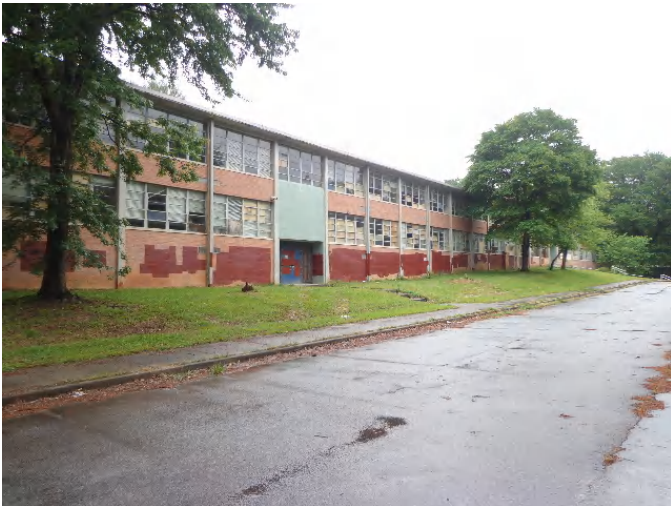
System: G2020 - Parking Lots

Location: Site

Distress: Beyond Service Life

Notes: The parking lot is aged, has many cracks and potholes, and should be replaced and re-striped. Signs heights need to be adjusted per minimum ADA standards.

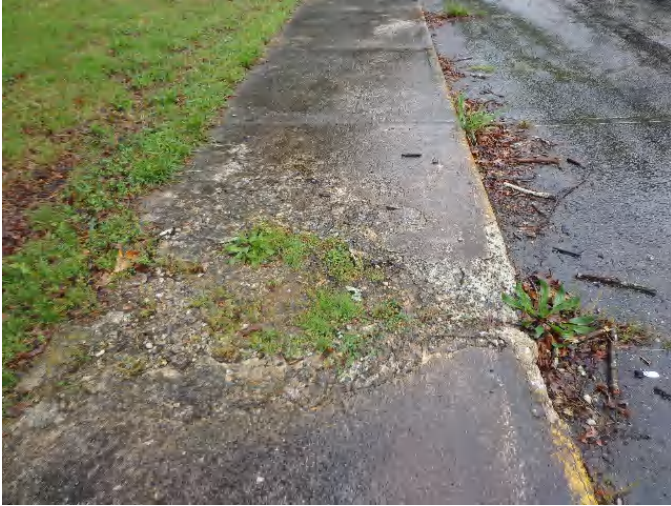
System: G2030 - Pedestrian Paving

Location: Site

Distress: Beyond Service Life

Notes: The pedestrian paving and walkways are aged, damaged, and should be replaced to include missing ramps per ADA standards.

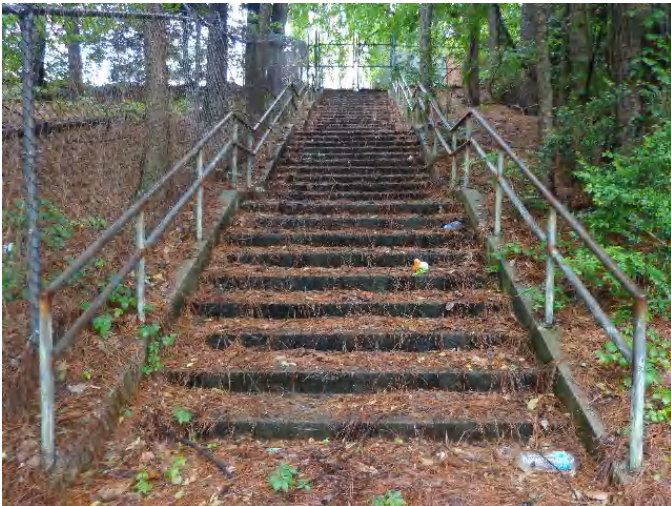
System: G2040 - Fencing & Guardrails

Location: Site

Distress: Beyond Service Life

Notes: Fencing and gates are rusted, failing and beyond expected life, and should be scheduled for replacement.

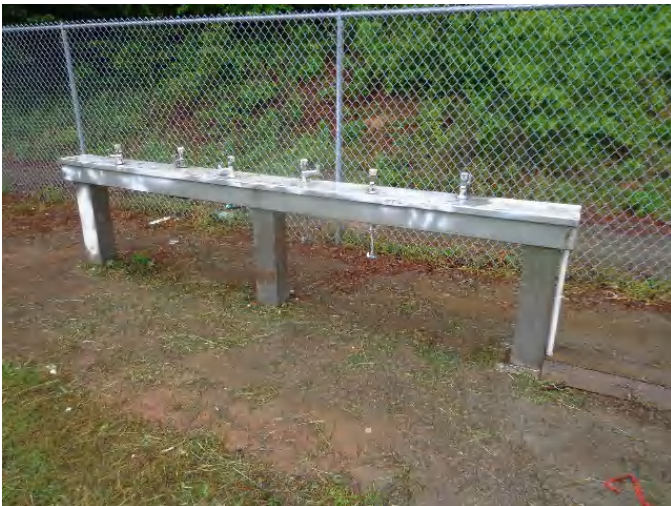
System: G3010 - Water Supply

Location: Site

Distress: Beyond Service Life

Notes: The water supply system is beyond its expected service life and should be scheduled for replacement.

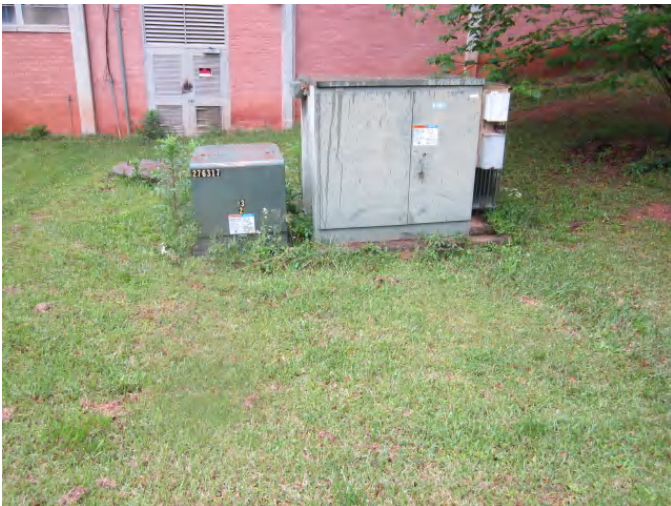
System: G4010 - Electrical Distribution

Location: Site

Distress: Beyond Service Life

Notes: Electrical distribution is beyond its expected service life and should be scheduled for replacement.
