DeKalb County School District/Leased/Charter

International Community Charter at Medlock

School Assessment Report

May 20, 2016

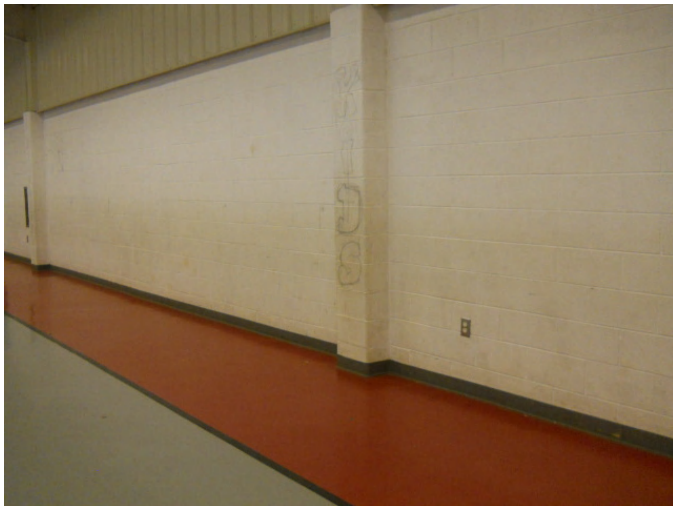
Location: Throughout Gym

System: C3010 - Wall Finishes - Paint

Distress: Beyond Service Life

Notes: The wall finishes are aged, scuffed and stained, and should be re-painted.

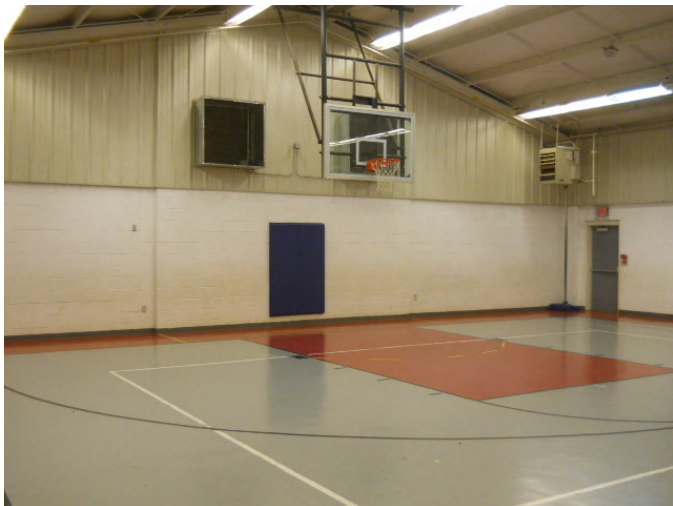
Location: Gym

System: D3050 - Terminal & Package Units

Distress: Missing

Notes: An air conditioning system is missing in the gymnasium and should be installed.

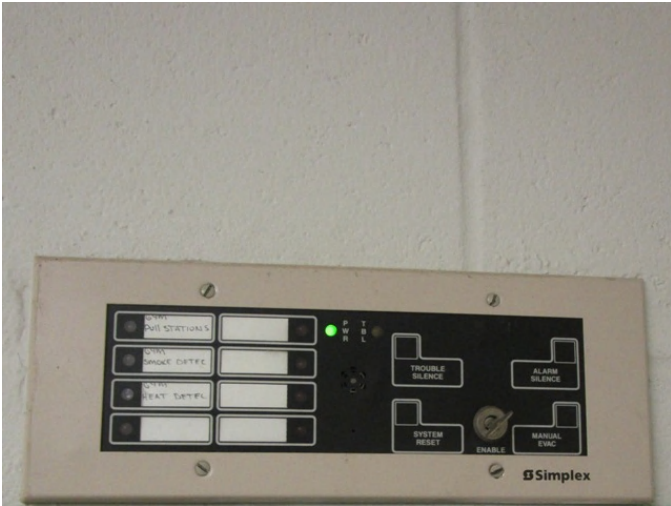
Location: Throughout Building

System: D5030 - Communications and Security - Fire Alarm

Distress: Beyond Service Life

Notes: The security communications system is beyond its expected service life and should be replaced.

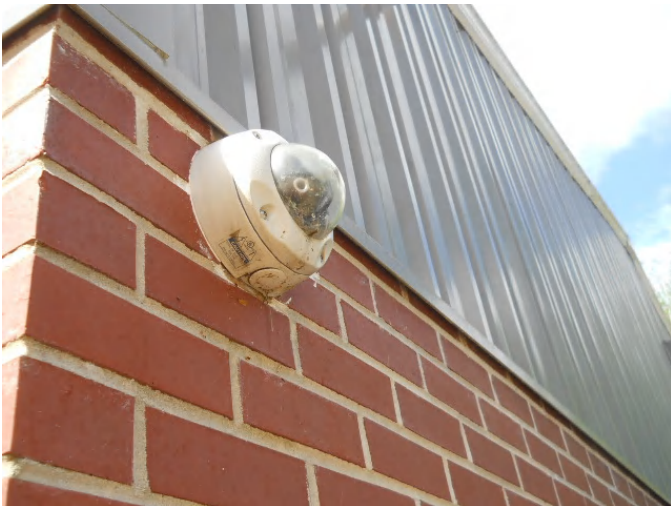
Location: Throughout Building

System: D5030 - Communications and Security - Security & CCTV

Distress: Beyond Service Life

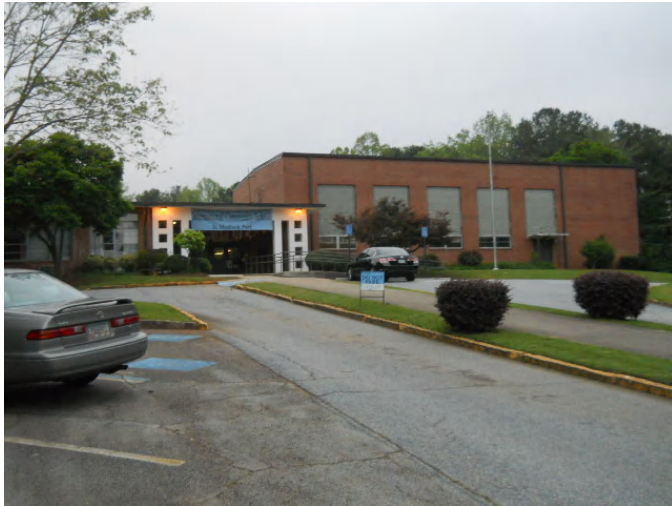
System: G4020 - Site Lighting

Location: Site

Distress: Inadequate

Notes: Site lighting is inadequate (only building-mounted) and should be added for safety reasons. Some, but not all existing lights have been repaired since January 2016.

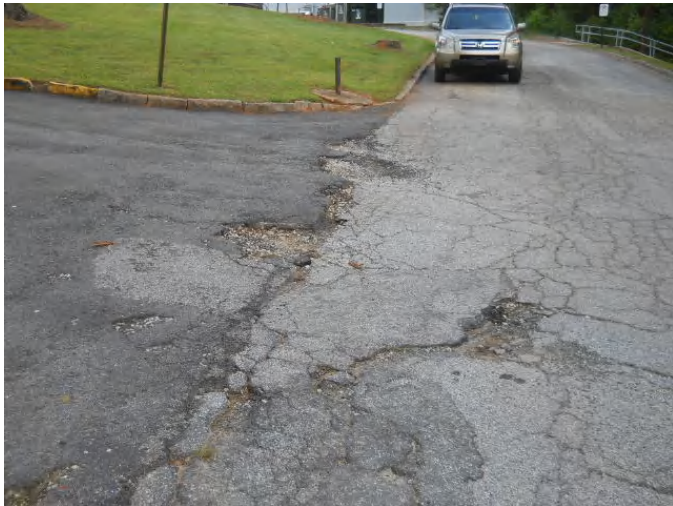
System: G2010 - Roadways

Location: Site

Distress: Beyond Service Life

Notes: The roadway serving the facility is aged, has many road cuts and repairs, and should be replaced.

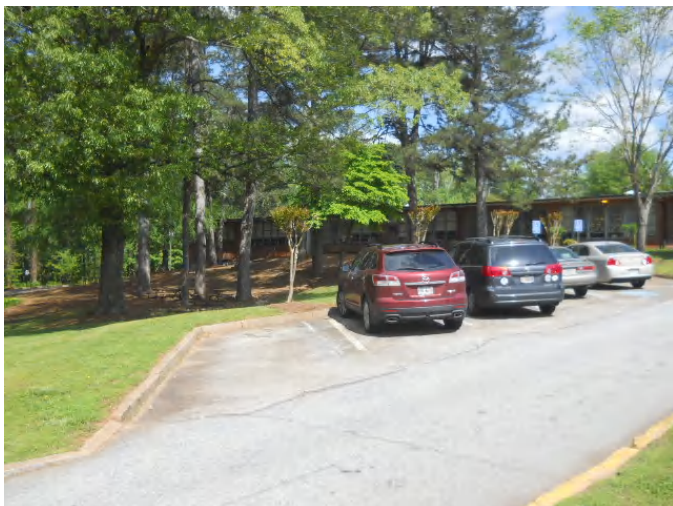
System: G2020 - Parking Lots

Location: Site

Distress: Beyond Service Life

Notes: The parking lot is aged, has many repairs and potholes, and should be re-surfaced. The parking lot signage and markings are also not ADA compliant.

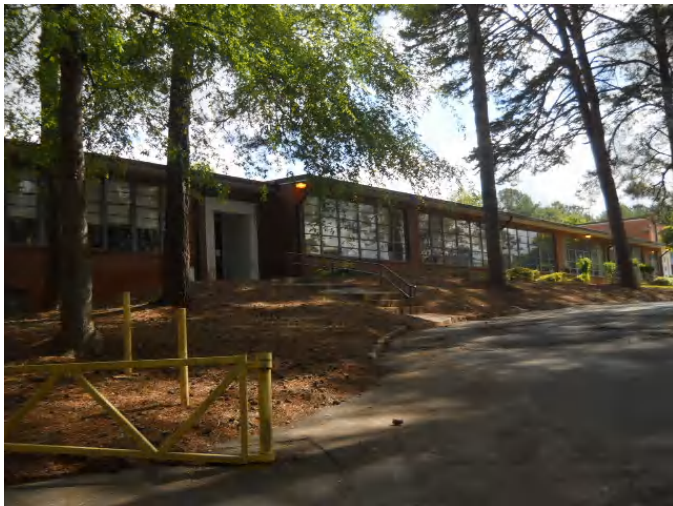
System: G2030 - Pedestrian Paving

Location: Site

Distress: Beyond Service Life

Notes: Pedestrian paving and walkways are beyond their expected service life, damaged, not ADA compliant, and should be replaced.

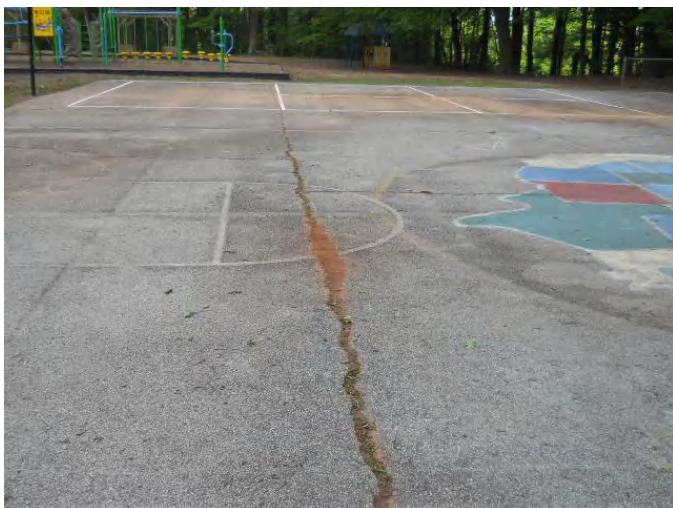
System: G2040 - Hard Surface Play Area

Location: Site

Distress: Beyond Service Life

Notes: The paved play area is deteriorating and should be replaced.

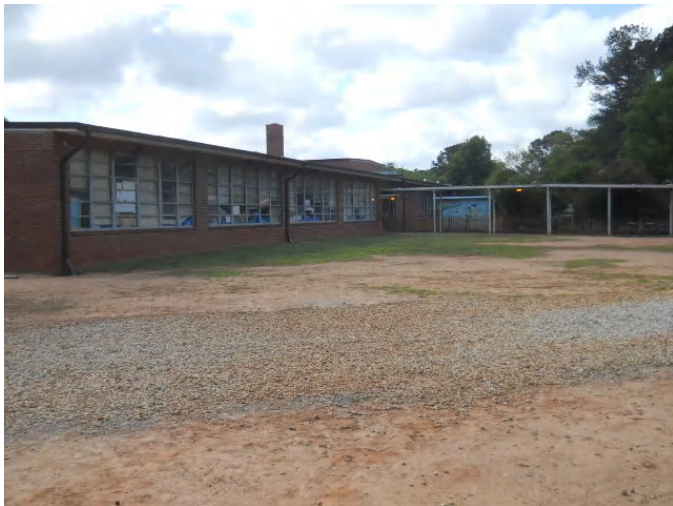
System: G2040 - Playing Field

Location: Site

Distress: Beyond Service Life

Notes: Playing field is beyond its expected service life, worn and bare, and should be replaced to prevent erosion.

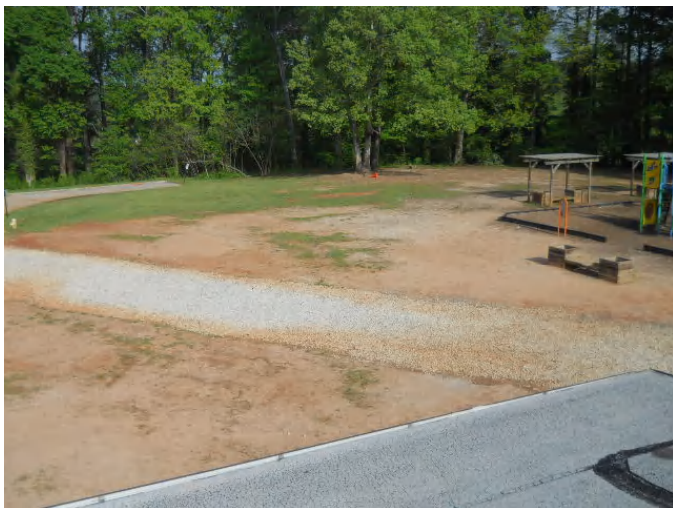
System: G2050 - Landscaping

Location: Site

Distress: Beyond Service Life

Notes: Landscaping is beyond its expected service life, bare in between the gym and playgrounds, and should be renewed.

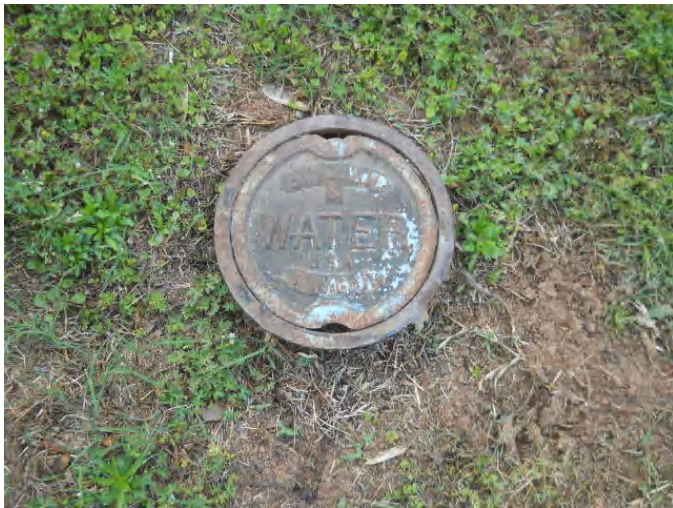
System: G3010 - Water Supply

Location: Site

Distress: Beyond Service Life

Notes: The domestic water supply system is beyond its expected service life and should be replaced.

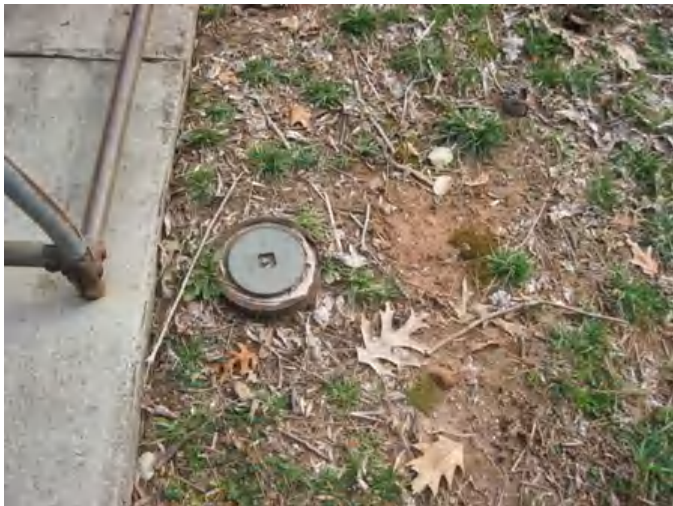
System: G3020 - Sanitary Sewer

Location: Site

Distress: Beyond Service Life

Notes: The sanitary sewer system is beyond its expected service life. The system has reported stoppages and minimal cleanouts, is inadequate, and should be replaced.

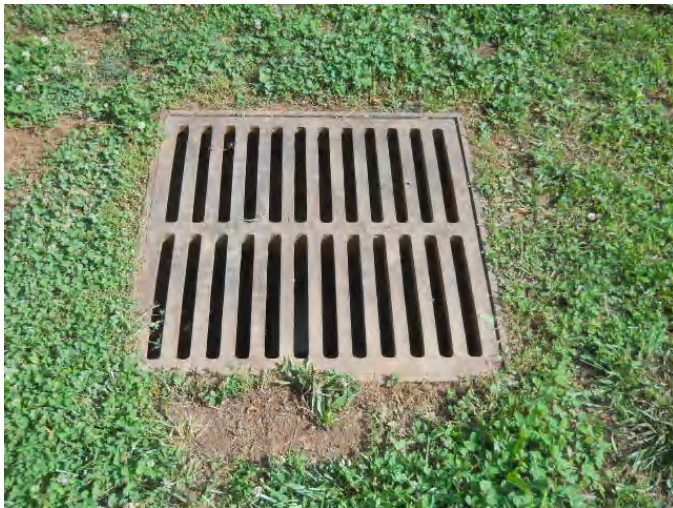
System: G3030 - Storm Sewer

Location: Site

Distress: Beyond Service Life

Notes: The storm sewer system surrounding the building is beyond expected service life, inadequate, and should be renewed and improved.

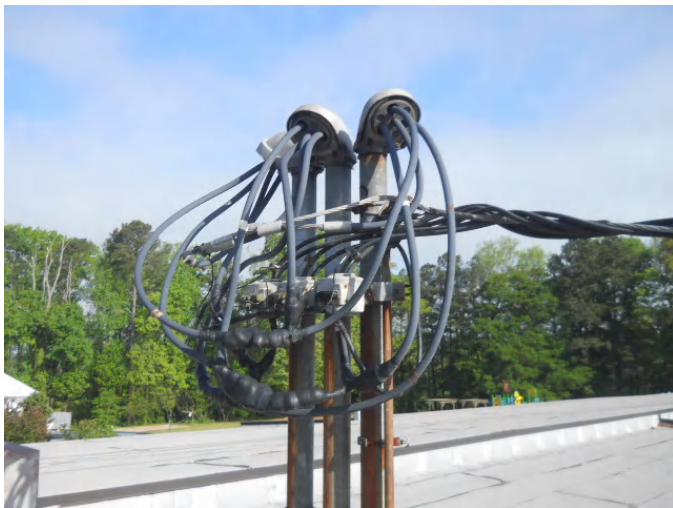
System: G4010 - Electrical Distribution

Location: Site

Distress: Beyond Service Life

Notes: The electrical distribution system into the structure is beyond expected service life and should be scheduled for replacement.
