DeKalb County School District/Elementary Schools

Livsey Elementary

School Assessment Report

May 19, 2016

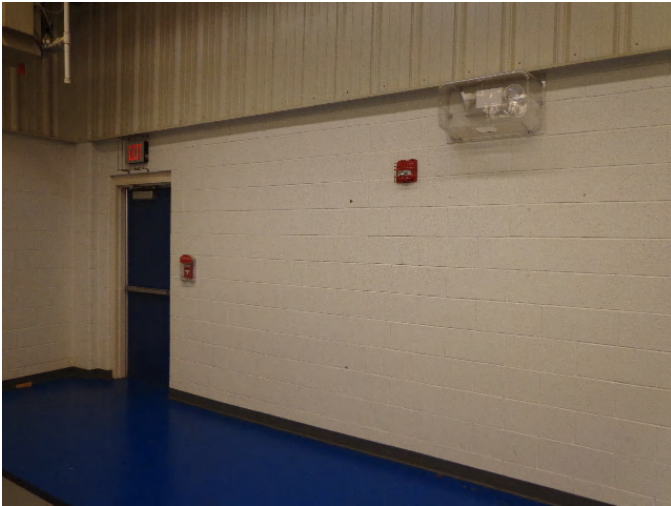
System: C3010 - Wall Finishes - Paint

Location: Throughout Building

Distress: Beyond Service Life

Notes: The painted wall finishes are beyond their expected service life, scuffed and stained, and should be replaced.

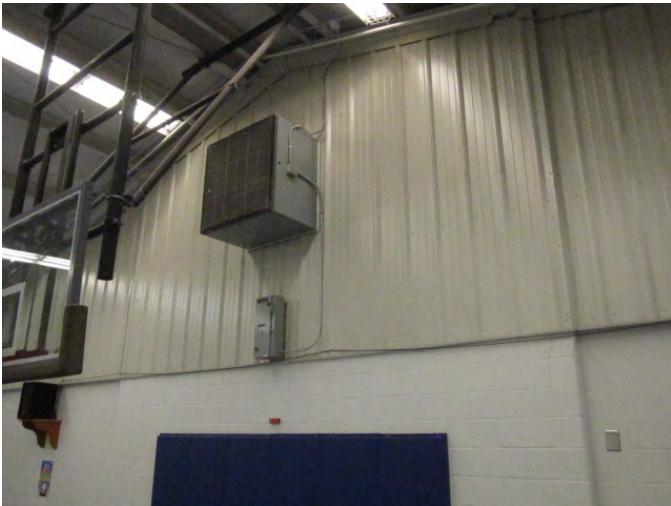
System: D3050 - Terminal & Package Units

Location: Gym

Distress: Missing

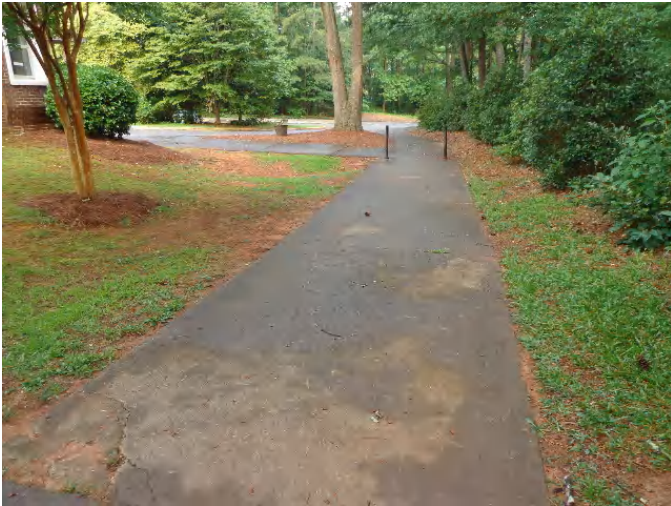
System: G2030 - Pedestrian Paving

Distress: Beyond Service Life

Notes: Some improvements have been made in the front of the school to include ADA-compliant ramps. However, the system in general is beyond its expected service life, uneven, and should be replaced to eliminate trip hazards.

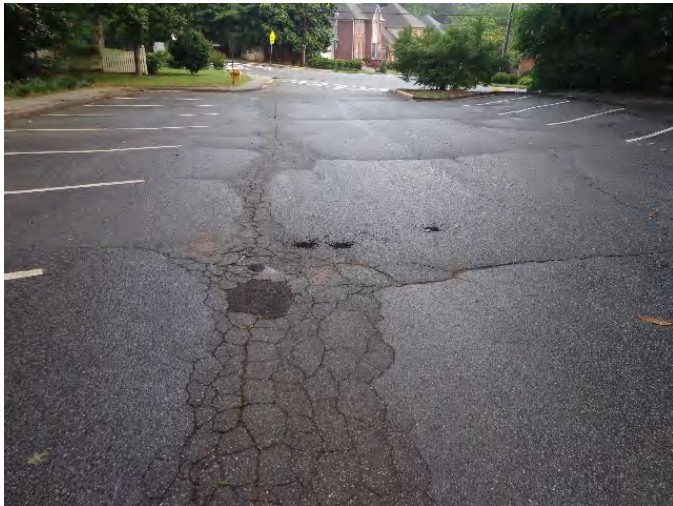
System: G2010 - Roadways

Distress: Beyond Service Life

Notes: Roadways are beyond their expected service life, damaged with cracks and potholes, and should be replaced.

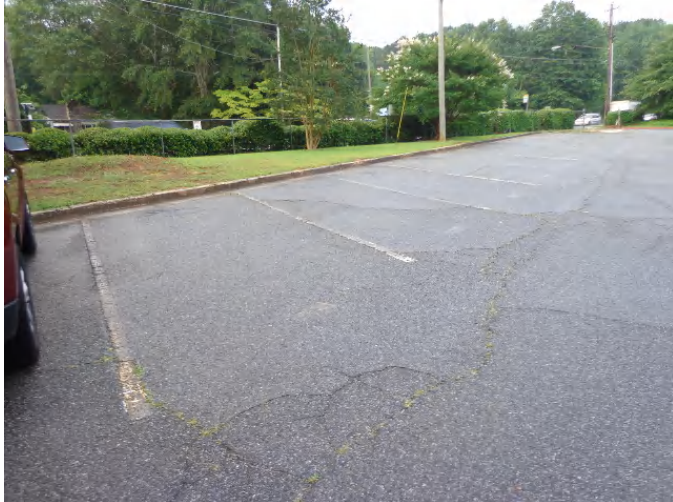
System: G2020 - Parking Lots

Distress: Beyond Service Life

Notes: Some improvements have been made to include ADA parking spaces, signage, and partial striping. However, the surface is aged with many cracks and should be replaced and re-stripped. If possible, add accessible parking spaces next to the school, so that one would not have to cross behind parked vehicles.

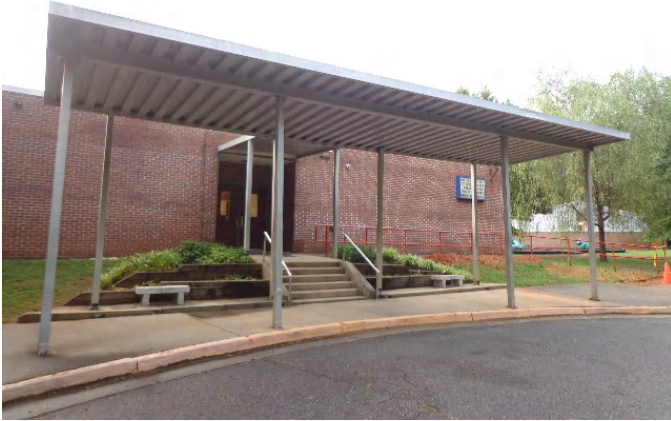
System: G2040 - Canopies

Distress: Inadequate

Notes: The school bus canopy structure was improperly anchored to the building. Building settlement has caused the lighter structure to eventually separate. It is recommended to maintain the canopy structure separate from the existing building and to provide a flashing between them to direct rain water. The canopy will require adjustment due to the same conditions.

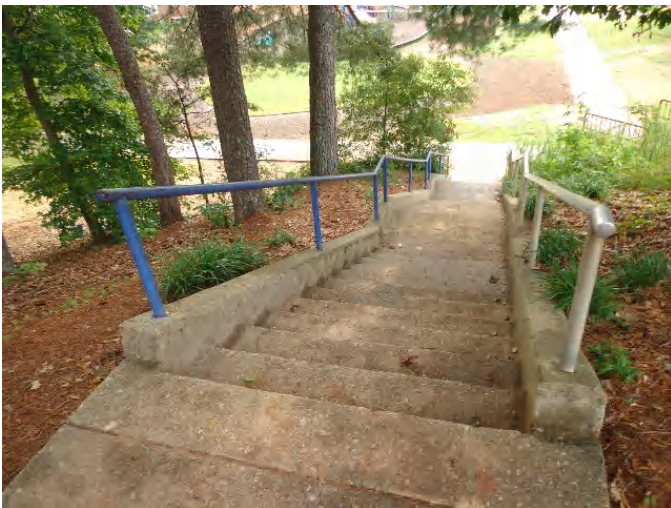
System: G2040 - Fencing & Guardrails

Distress: Beyond Service Life

Notes: Fencing is beyond its expected service life, rusted, and should be scheduled for replacement.

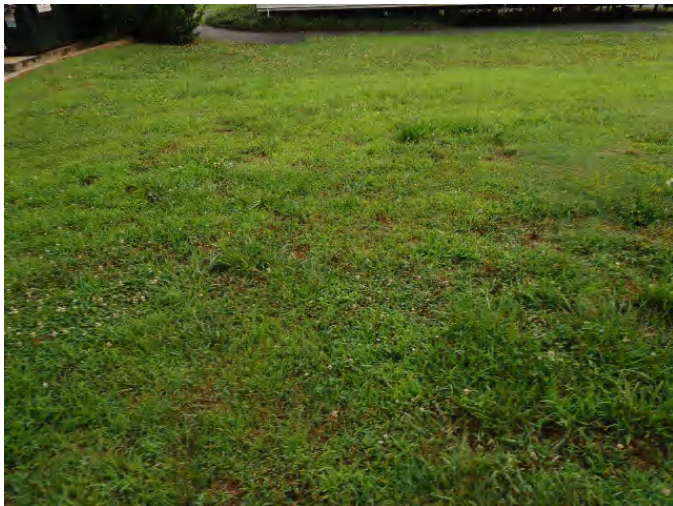
System: G2040 - Playing Field

Distress: Beyond Service Life

Notes: The playing field is beyond its expected service life, has bare spots, and should be re-sodded to prevent erosion.

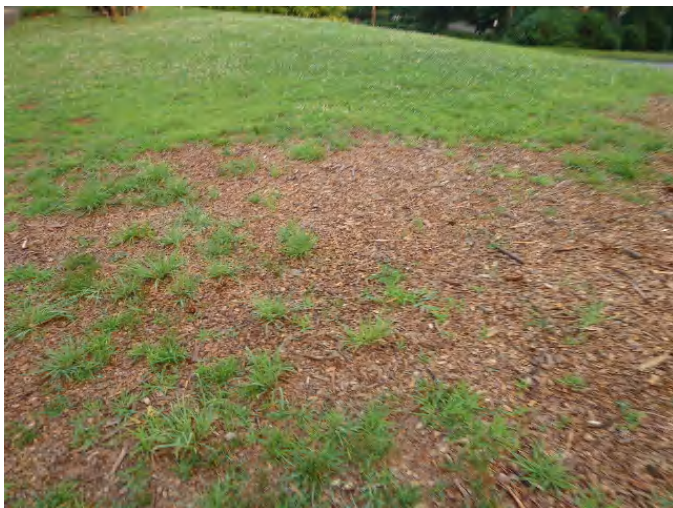
System: G2050 - Landscaping

Distress: Beyond Service Life

Notes: Landscaping is in poor condition, especially at front entrance and playground, and should be replaced. The parking lot and playground areas need to have tree roots removed as they are a trip hazard.

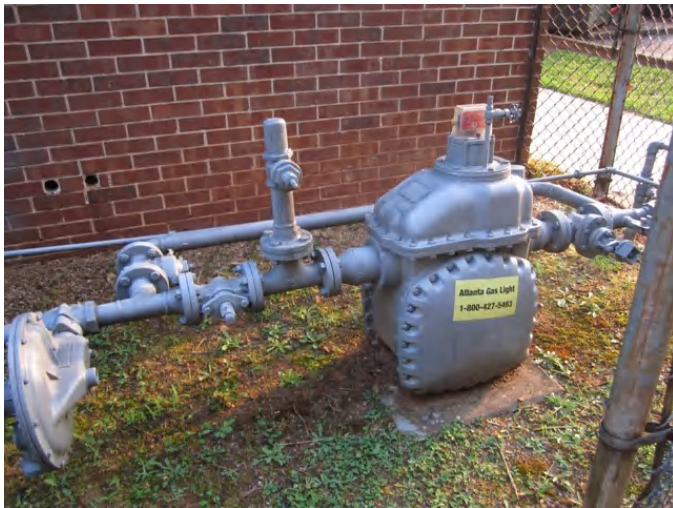
System: G3060 - Fuel Distribution

Distress: Beyond Service Life

Notes: Natural gas service is beyond its expected service life and should be scheduled for replacement.

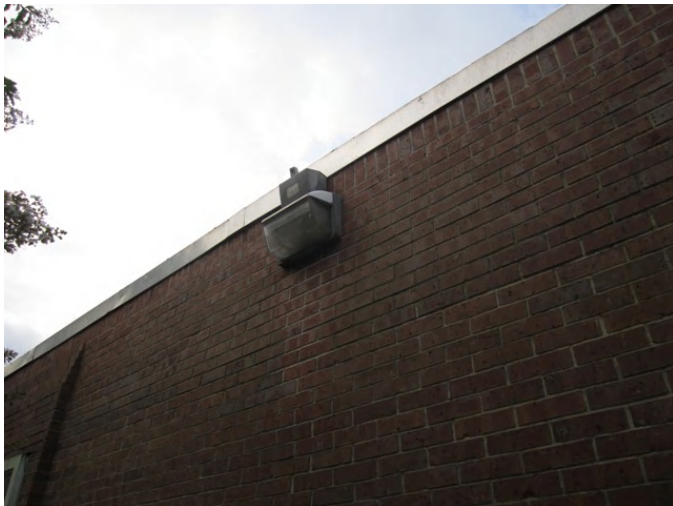
System: G4020 - Site Lighting

Distress: Beyond Service Life

Notes: Site lighting is beyond its expected service life, inadequate at the circle driveway, front entrance and parking lots, and should be scheduled for replacement.

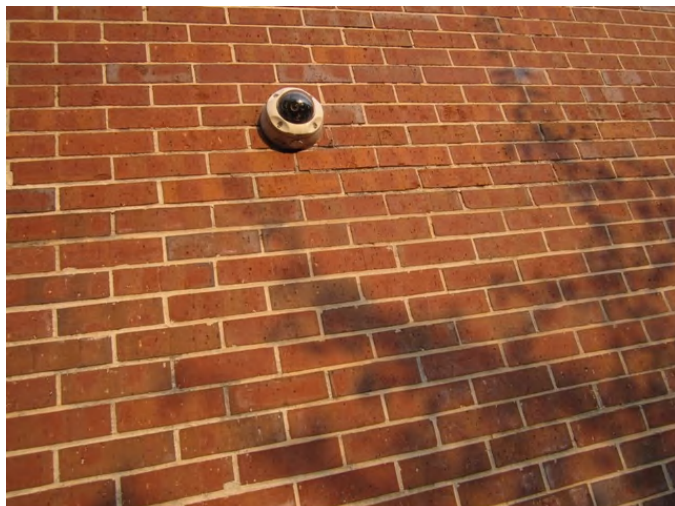
System: G4030 - Site Communications & Security

Distress: Beyond Service Life

Notes: The site communications and security systems are beyond their expected service life and should be scheduled for replacement.
