DeKalb County School District/High Schools

Martin Luther King Jr. High

School Assessment Report

May 19, 2016

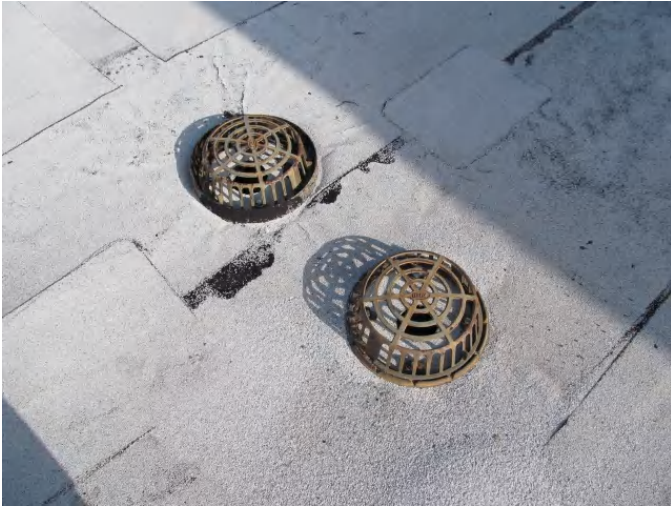
System: B3010 - Roof Coverings - BUR

Location: Roof

Distress: Damaged

Notes: The new roof is not sloped to drain properly, is reported to leak, has improperly installed roof drains that are missing key drain components, and should be replaced.

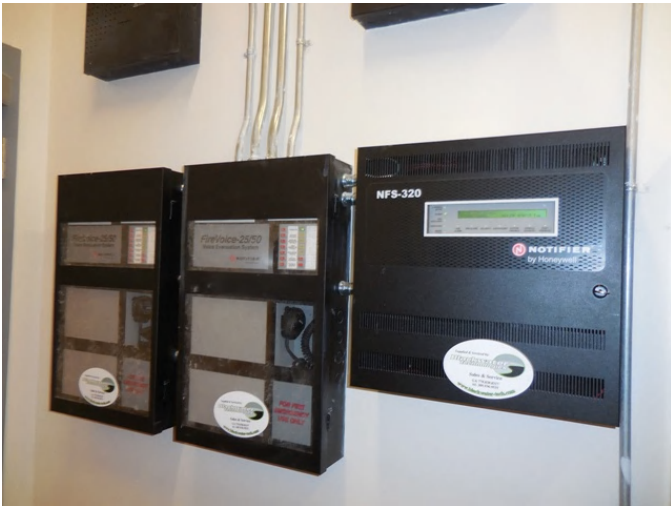
System: D5030 - Communications and Security - Fire Alarm

Location: Throughout Building

Distress: Inadequate

Notes: Staff reports that the fire panels do not communicate with each other between the old and new sections of the school. Both systems need to be tied together.

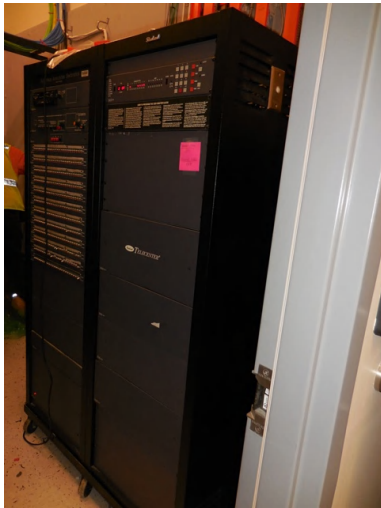
System: D5030 - Communications and Security - PA & Clock Systems

Location: Throughout Building

Distress: Needs Remediation

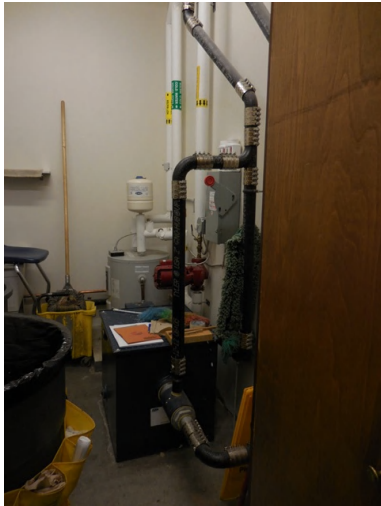
System: D2030 - Sanitary Waste

Location: Room 129

Distress: Needs Remediation

Notes: A sewage lift pump was installed in Room 129 (Janitor Closet) across from the principal and councilors offices. Area is constantly plagued with foul odor.

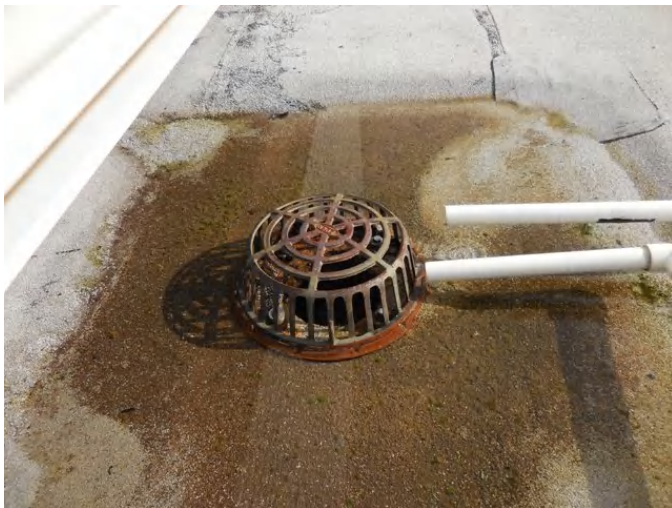
System: D2040 - Rain Water Drainage

Location: Throughout Building

Distress: Inadequate

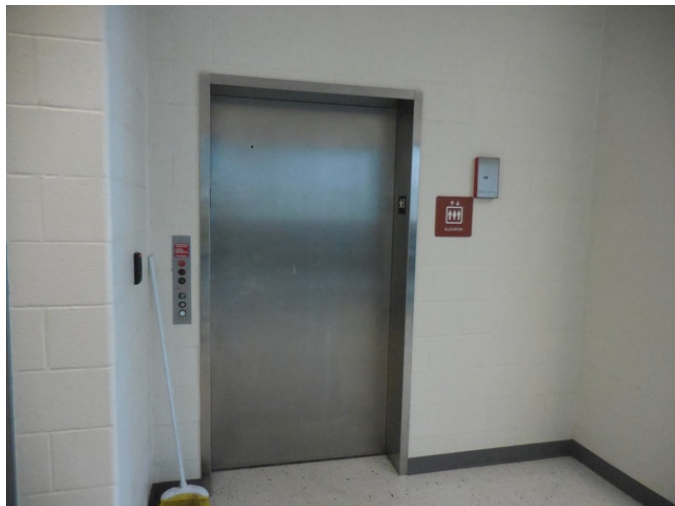
System: D1010 - Elevators and Lifts

Location: Elevator

Distress: Beyond Service Life

Notes: Recommend repair/replacement of the elevator, including entry card access reader and controls.

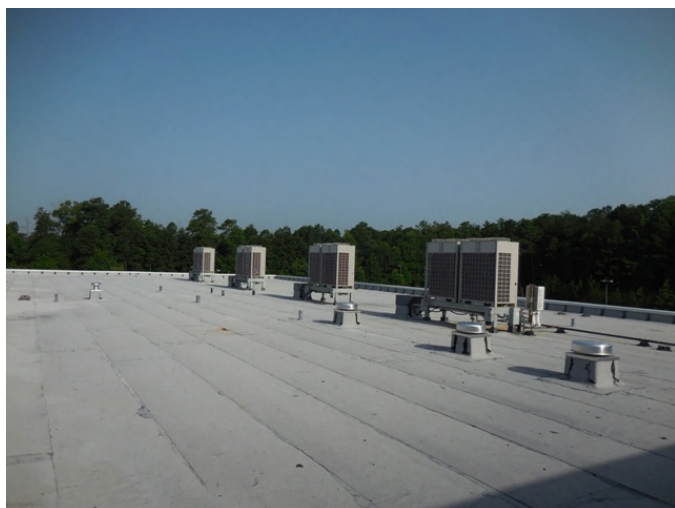
System: D3050 - Terminal & Package Units

Location: Roof and Throughout Building

Distress: Inadequate

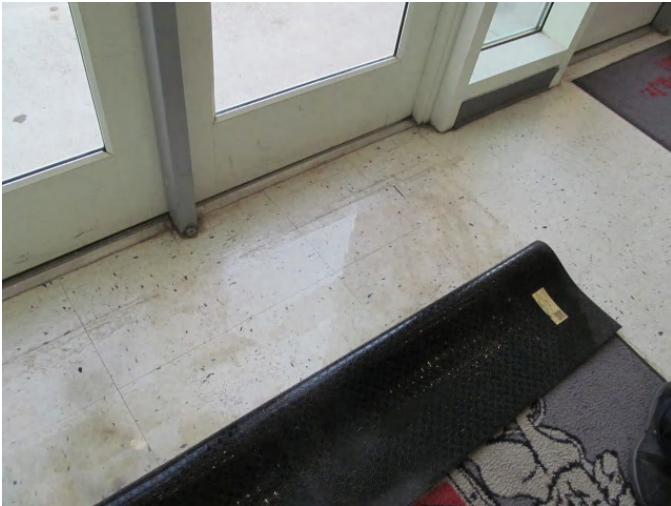
System: G2030 - Pedestrian Paving

Location: Exterior of Old and New Buildings

Distress: Needs Remediation

Notes: The area near pedestrian paving should be re-graded and the pedestrian paving replaced to drain rainwater away from the building.

Correction: Remove and replace concrete sidewalk, 4' wide

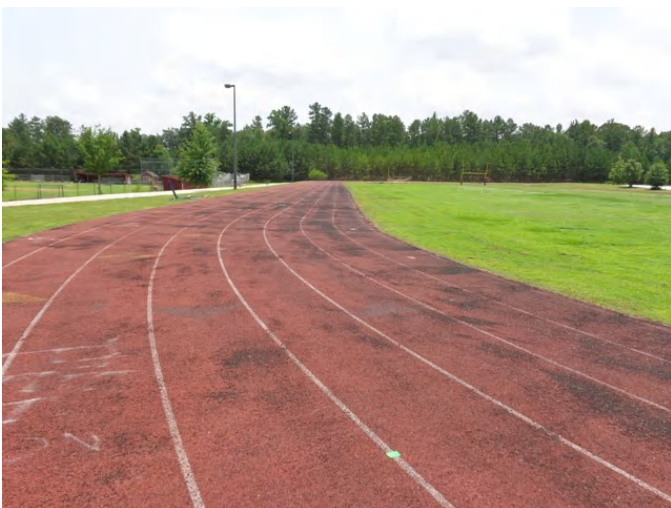
System: G2040 - Track

Location: Site

Distress: Damaged

Notes: The track is damaged, has tripping hazards, and should be replaced.

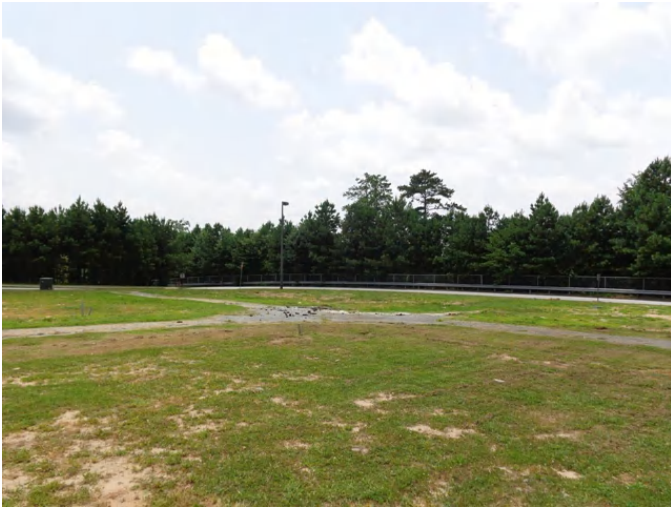
System: G2050 - Landscaping

Location: Site

Distress: Needs Remediation

Notes: Landscaping is worn and bare in numerous places throughout the site and should be replaced to prevent erosion. The area adjacent to the new building should be regraded to prevent flooding. Large portions of the site have rocks that cause tripping hazards. The retention pond requires maintenance to control mosquitoes. The controls to the site irrigation system have been vandalized and need to be replaced.

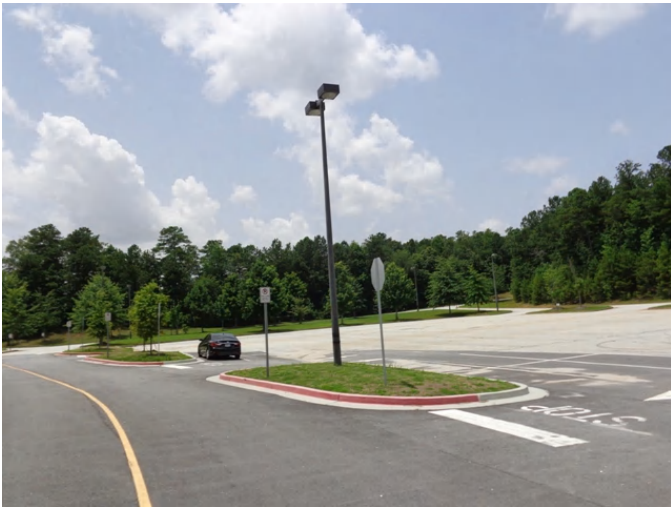
System: G4020 - Site Lighting

Location: Site

Distress: Inadequate

Notes: Site lighting is inadequate and should be replaced/expanded to provide better coverage.

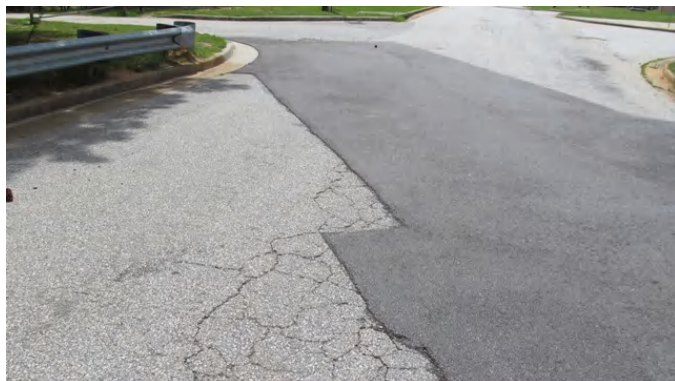
System: G2010 - Roadways

Location: Site

Distress: Damaged

Notes: Roadways are damaged with many cracks, potholes and repairs, and should be replaced.

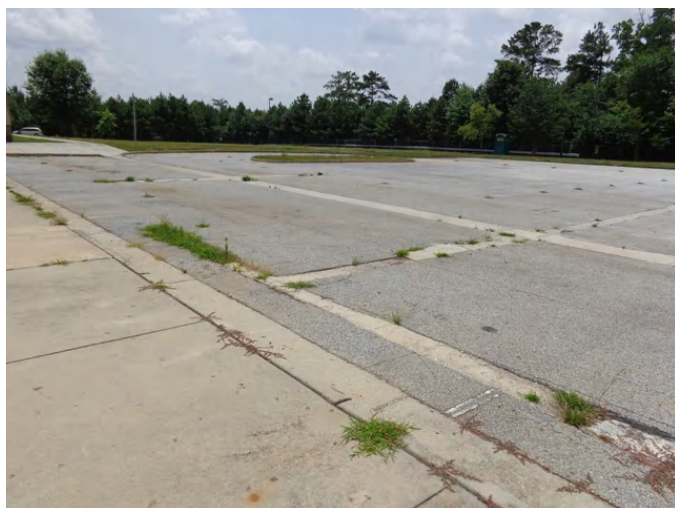
System: G2020 - Parking Lots

Location: Site

Distress: Inadequate

Notes: The parking lots are sloped to drain into the building, do not have adequate runoff drainage or storm drainage, and should be replaced. Instructional markings and signage are also inadequate and should be upgraded.

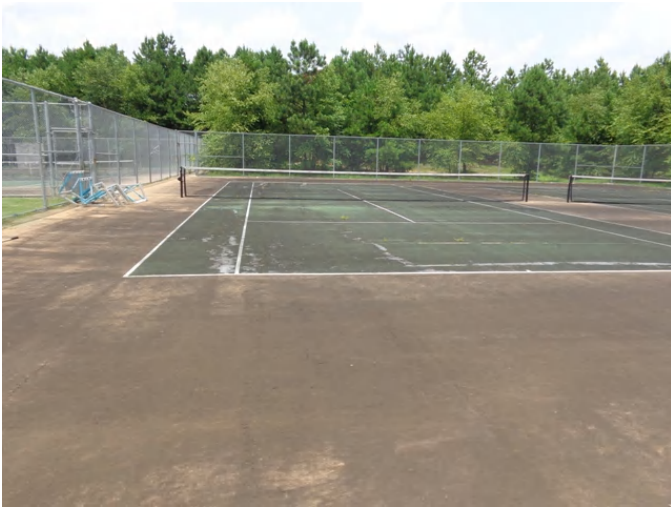
System: G2040 - Tennis Courts

Location: Site

Distress: Damaged

Notes: The tennis courts are damaged and should be repaired/replaced.
