DeKalb County School District/Elementary Schools

Redan Elementary

School Assessment Report

May 20, 2016

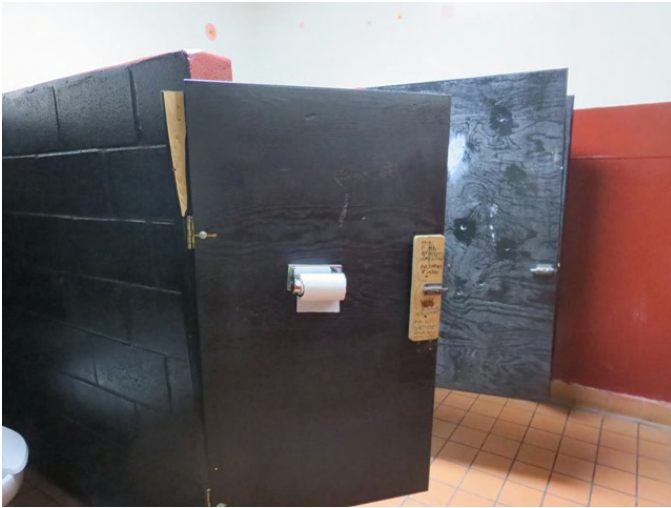
System: C1030 - Fittings

Location: Throughout Building

Distress: Beyond Service Life

Notes: Fittings, such as toilet partitions, handrails, signage and lockers, are beyond their expected service life, damaged, not ADA compliant, and should be replaced. SPLOST project 126-422 to renovate unisex adult restrooms in halls.

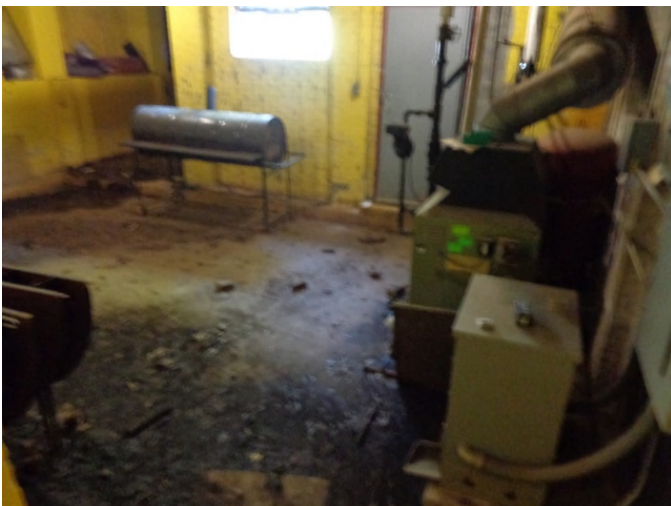
System: D2040 - Rain Water Drainage

Location: Basement

Distress: Needs Remediation

Notes: The drainage system in the basement is not functioning correctly. SPLOST project 126-422 to replace the basement drainage system.

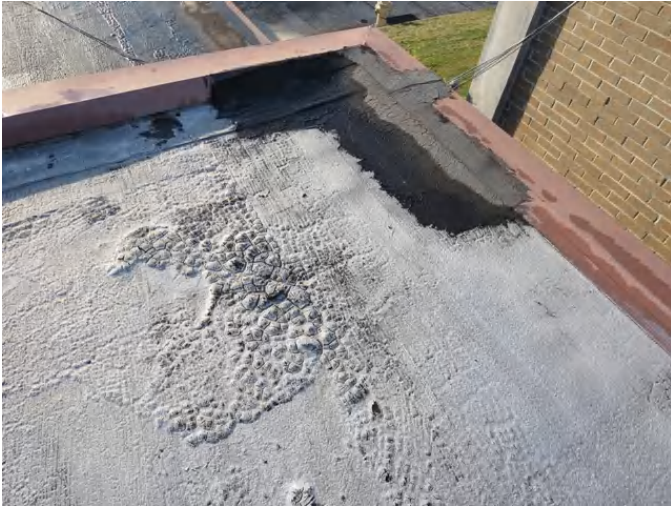
System: B3010 - Roof Coverings - BUR

Location: Roof

Distress: Beyond Service Life

Notes: The built-up roof covering is aged, showing signs of failure and should be replaced. SPLOST project 126-422 to replace the roof and roof openings as appropriate.

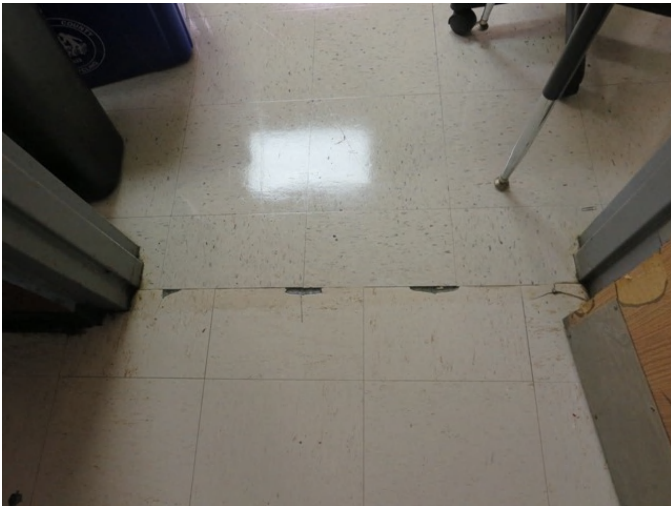
System: C3020 - Floor Finishes - VCT

Location: Throughout Building

Distress: Beyond Service Life

Notes: The VCT flooring is aged, cracked and worn, and should be replaced.

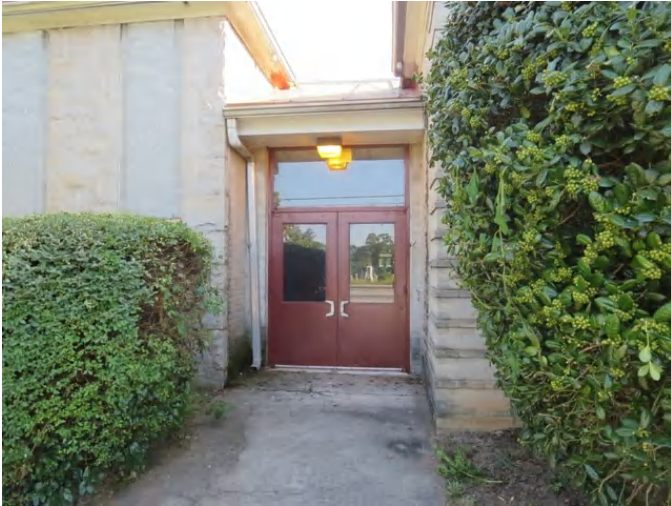
System: B2030 - Exterior Doors

Location: Throughout Building

Distress: Beyond Service Life

Notes: The original exterior doors are aged, dented, not easy to operate, not ADA compliant, and should be replaced.

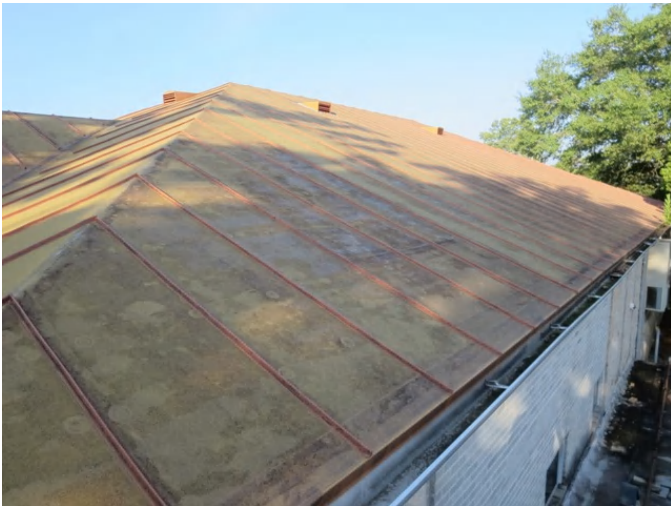
System: B3010 - Roof Coverings - EPDM

Location: Roof

Distress: Beyond Service Life

Notes: The EPDM pitched roof coverings are aging, showing signs of failure, and should be replaced. SPLOST project 126-422 to replace the roof and roof openings as appropriate.

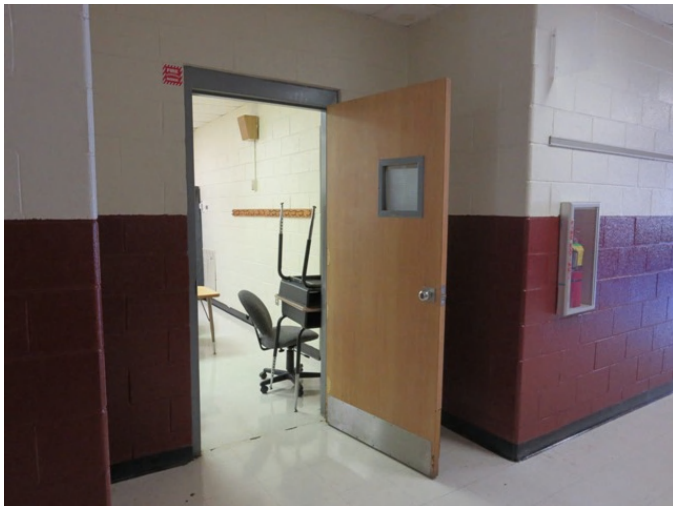
System: C1020 - Interior Doors

Location: Throughout Building

Distress: Beyond Service Life

Notes: The interior doors are aged, failing, not ADA or building code compliant, and should be repaired or replaced.

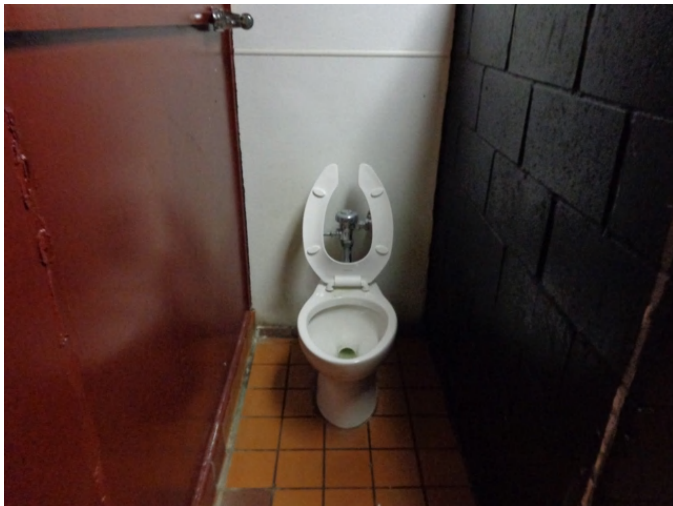
System: D2030 - Sanitary Waste

Location: Throughout Building

Distress: Beyond Service Life

Notes: The sanitary waste system is beyond its expected service life, has frequent back-ups and odors, and should be scheduled for replacement.

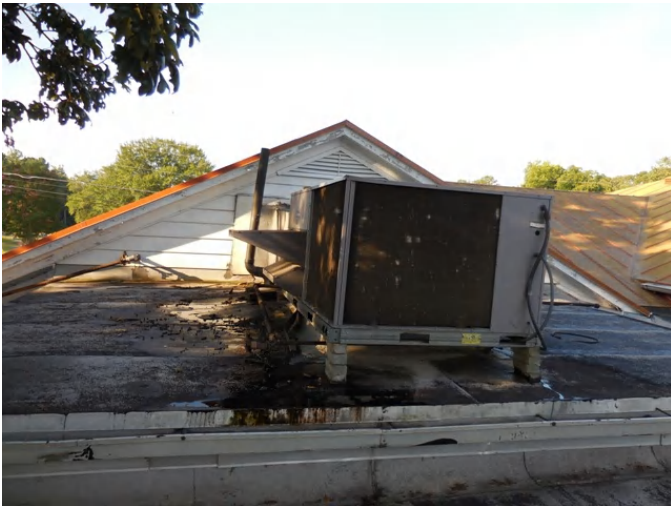
System: D3050 - Terminal & Package Units

Location: Roof/Wall Mounted

Distress: Beyond Service Life

Notes: Package and wall mounted heat pumps are beyond their expected service life and should be scheduled for replacement. SPLOST project 126-422 to replace the roof top units, water source heat pumps and fan coil units.

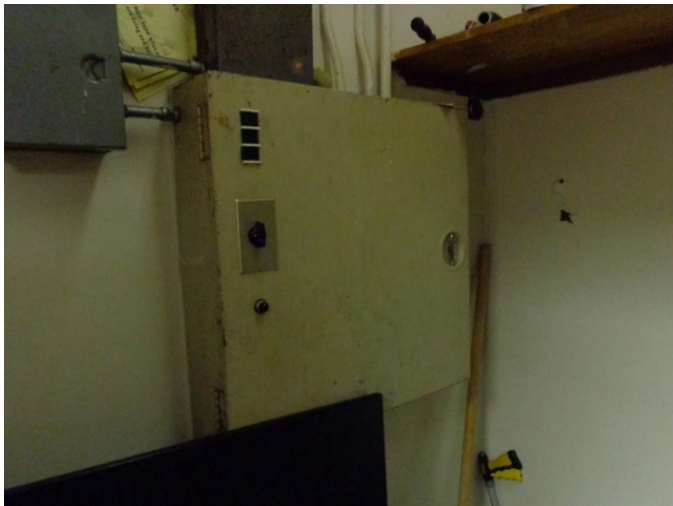
System: D3060 - Controls & Instrumentation

Location: Throughout Building

Distress: Beyond Service Life

Notes: The controls and instrumentation system is beyond its expected service life, aged, and should be scheduled for replacement.

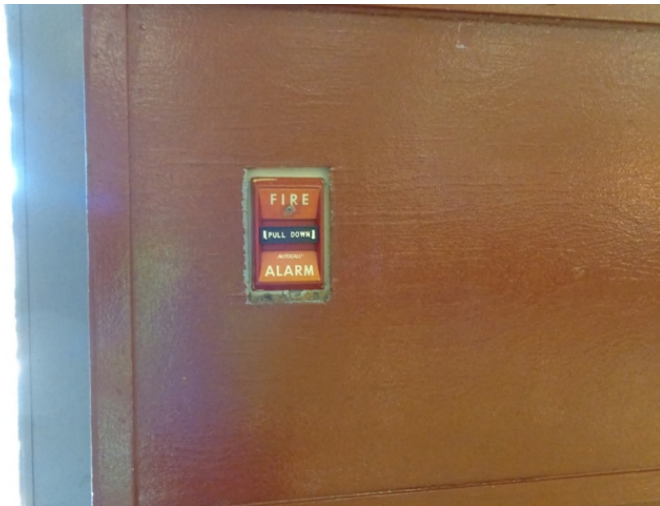
System: D5030 - Communications and Security - Fire Alarm

Location: Throughout Building

Distress: Beyond Service Life

Notes: The fire alarm system, including pull stations and strobes, are beyond their service life, not building code compliant, and should be scheduled for replacement. Visible alarms (strobes) are missing in multiple occupancy, common use areas, such as restrooms.

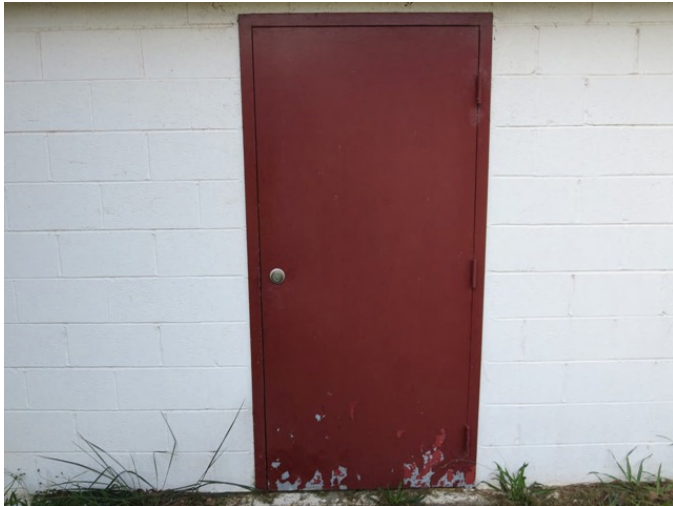
System: B2030 - Exterior Doors

Location: Exterior Wall

Distress: Beyond Service Life

Notes: The original exterior doors are aged, rusted, and should be replaced.

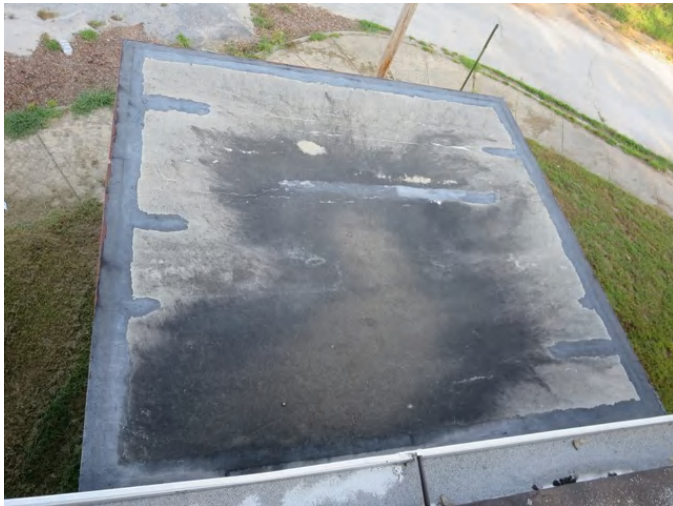
System: B3010 - Roof Coverings

Location: Roof

Distress: Beyond Service Life

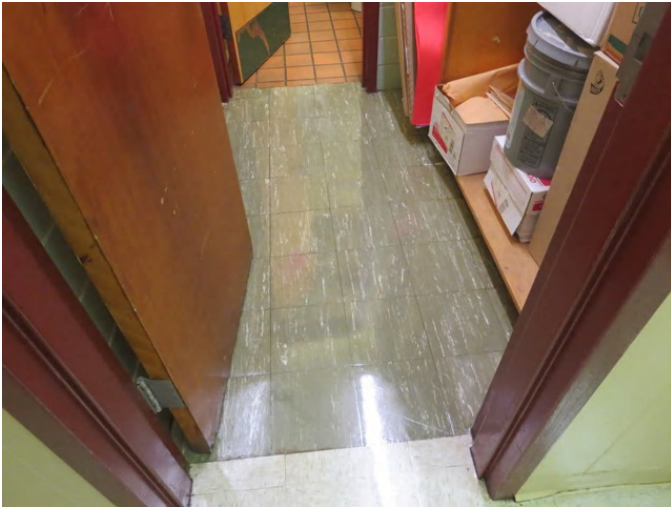
System: C3020 - Floor Finishes - VCT

Location: Cafeteria and Offices

Distress: Beyond Service Life

Notes: The VCT flooring is aged, cracked and worn, includes some 9" x 9" tiles, and should be replaced. The sunken area in the floor between the 1968 and 1975 buildings is a safety hazard, resulting in trips and falls, and should be leveled.

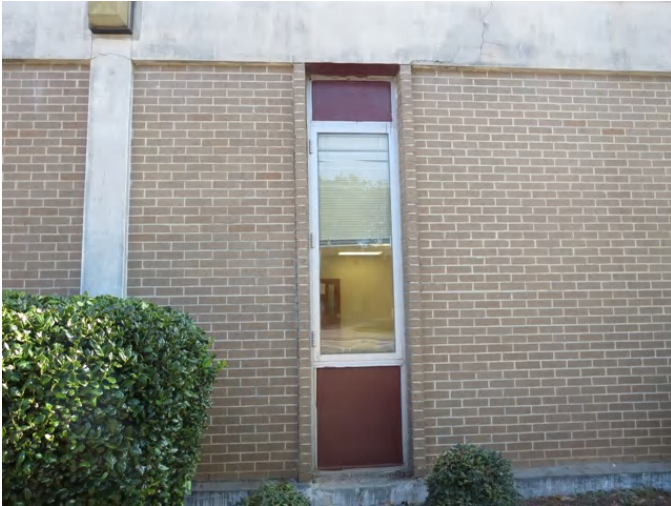
System: B2020 - Exterior Windows

Location: Throughout Building

Distress: Beyond Service Life

Notes: The aluminum frame, operable, single pane windows are aged, damaged, not energy efficient, and should be replaced.

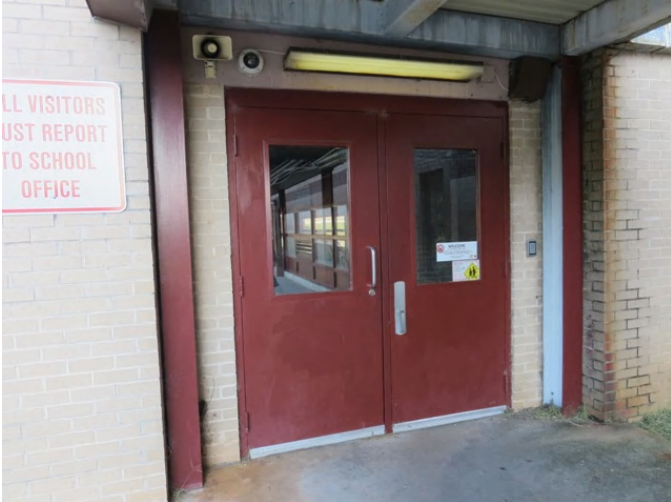
System: B2030 - Exterior Doors

Location: Throughout Building

Distress: Beyond Service Life

Notes: The exterior doors are aged, damaged, not easy to operate, not ADA compliant, and should be replaced.

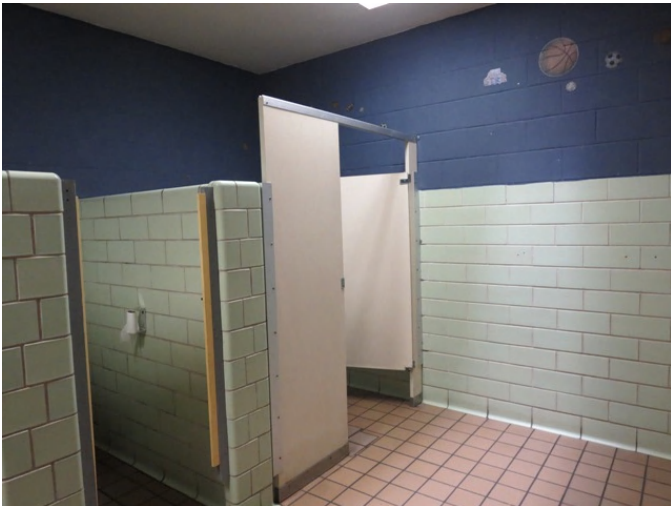
System: C1030 - Fittings

Location: Throughout Building

Distress: Beyond Service Life

Notes: Fittings, such as toilet partitions, handrails and signage, are beyond their expected service life, not ADA compliant, and should be replaced. SPLOST project 126-422 to renovate unisex adult restrooms in halls.

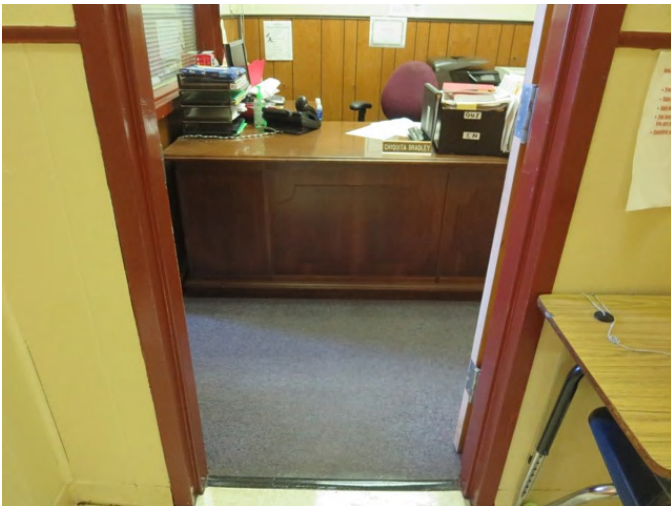
System: C3020 - Floor Finishes - Carpet

Location: Offices

Distress: Beyond Service Life

Notes: The carpet in the meeting room is stained, showing signs of failure, and should be replaced.

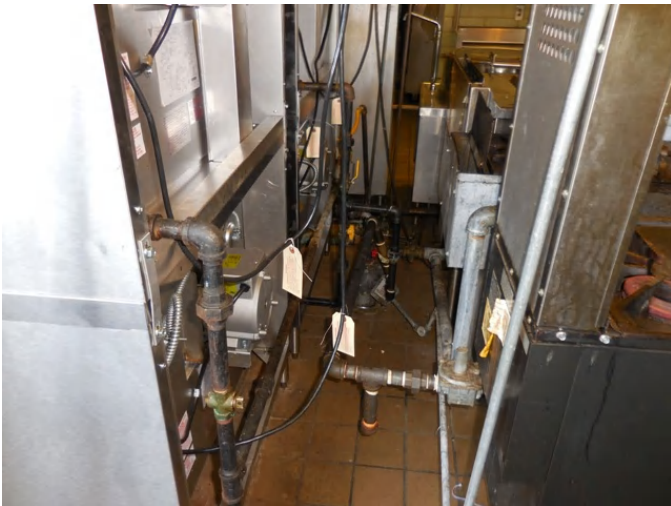
System: D2090 - Other Plumbing Systems - Natural Gas

Location: Throughout Building

Distress: Beyond Service Life

Notes: The natural gas system is beyond its expected service life and should be scheduled for replacement.

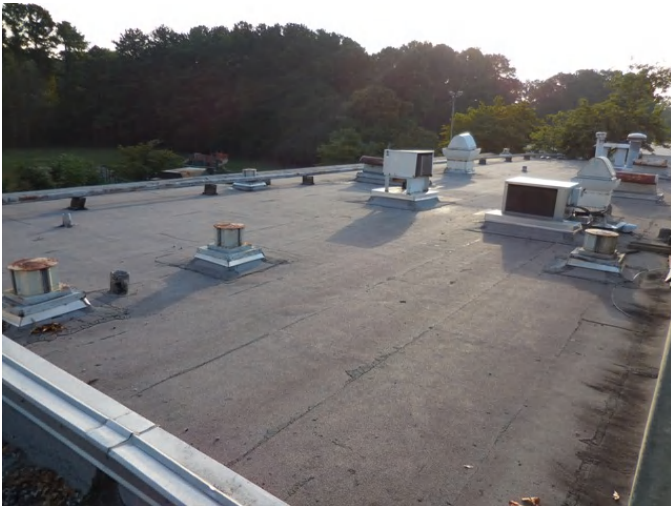
System: D3040 - Distribution & Exhaust Systems

Location: Throughout Building

Distress: Beyond Service Life

Notes: Roof top exhaust fans are not functional and the ventilation system is dirty. The system is beyond its expected service life and should be scheduled for replacement.

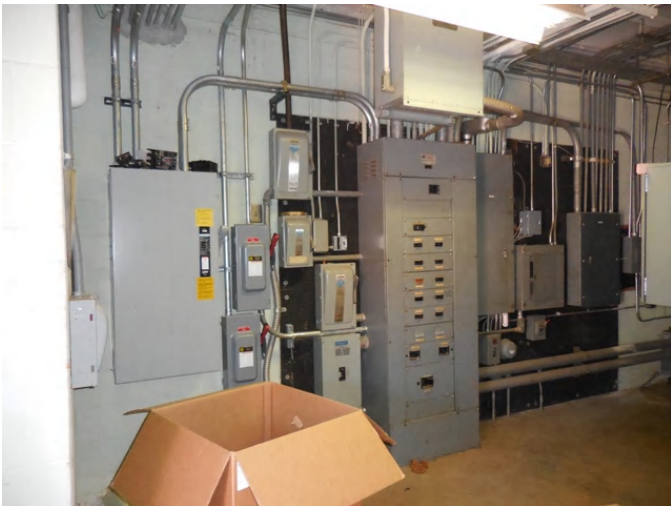
System: D5010 - Electrical Service/Distribution

Location: Main Switch Room/Throughout Building

Distress: Beyond Service Life

Notes: The electrical service/distribution system is beyond its expected service life and should be scheduled for replacement. SPLOST project 126-422 to replace the electrical distribution system.

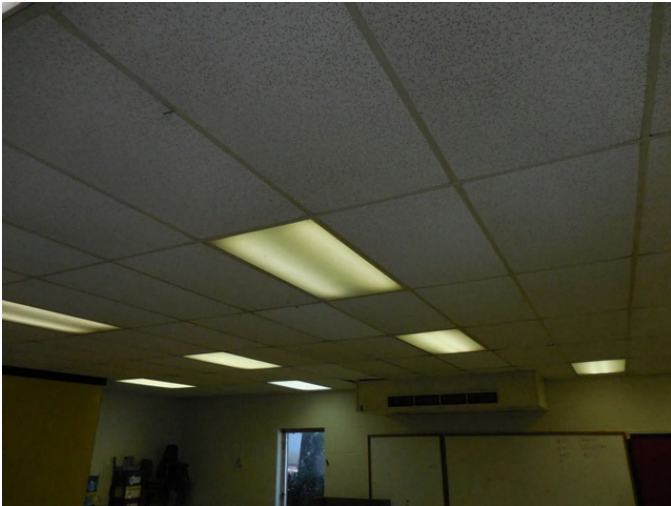
System: D5020 - Lighting

Location: Throughout Building

Distress: Beyond Service Life

Notes: The lighting system is beyond its expected service life and should be scheduled for replacement with energy efficient light fixtures. SPLOST project 126-422 to replace the lighting system throughout the building.

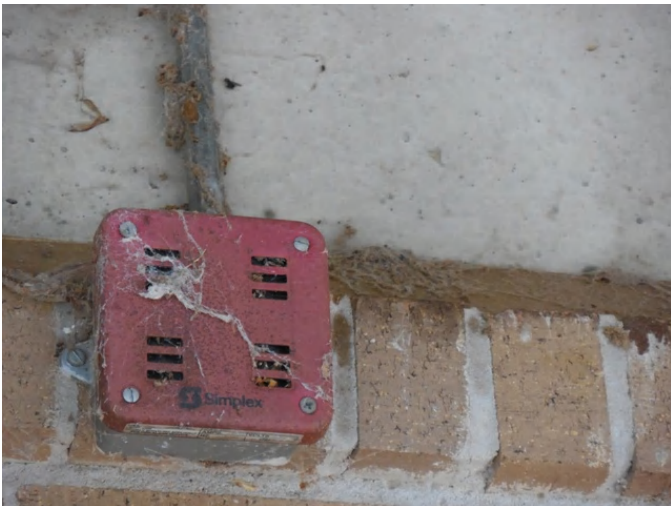
System: D5030 - Communications and Security - Fire Alarm

Location: Throughout Building

Distress: Beyond Service Life

Notes: Fire alarm, pull stations, and strobes are beyond their expected service life, not building code compliant, and should be scheduled for replacement. Visible alarms (strobes) are missing in multiple occupancy, common use areas, such as restrooms.

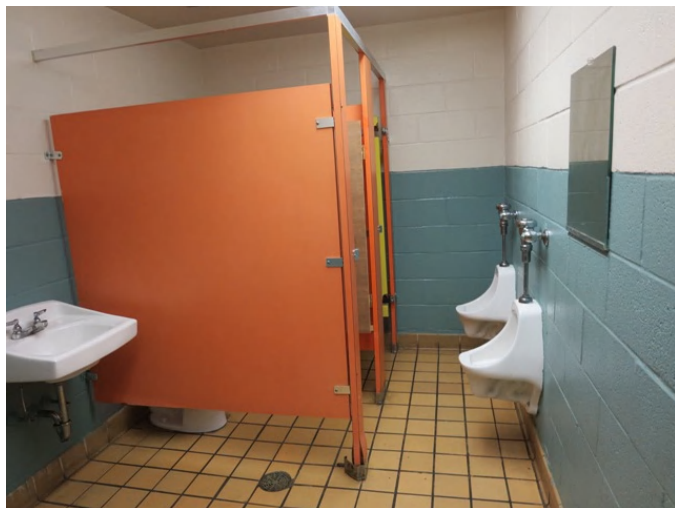
System: C1030 - Fittings

Location: Throughout Building

Distress: Beyond Service Life

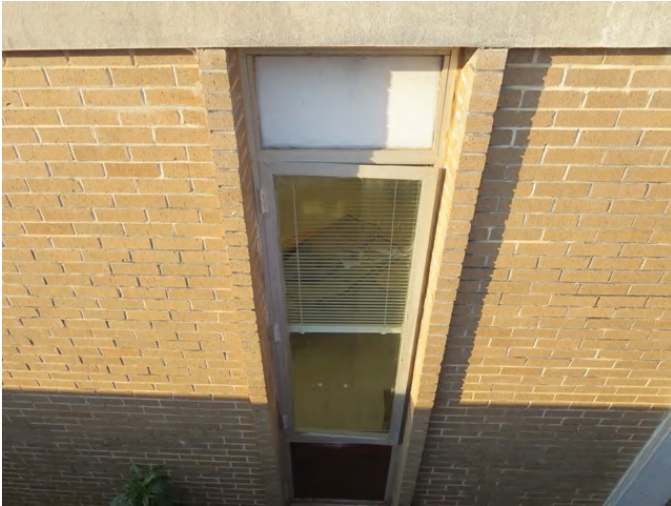
System: B2020 - Exterior Windows

Location: Throughout Building

Distress: Beyond Service Life

Notes: The aluminum frame, operable, single pane windows are aged, corroded, not energy efficient, and should be replaced.

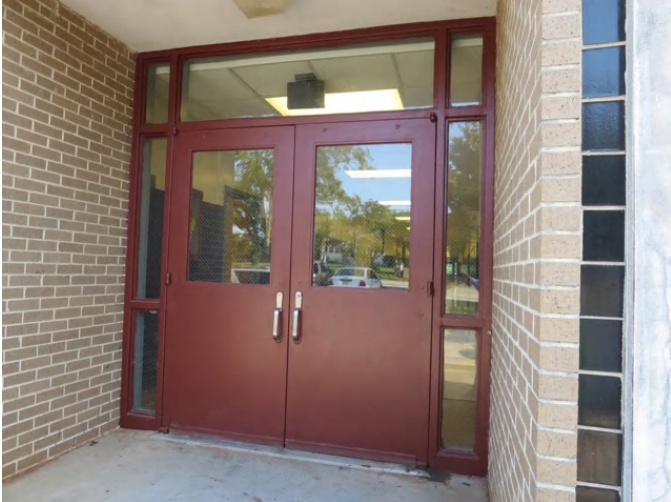
System: B2030 - Exterior Doors

Location: Throughout Building

Distress: Beyond Service Life

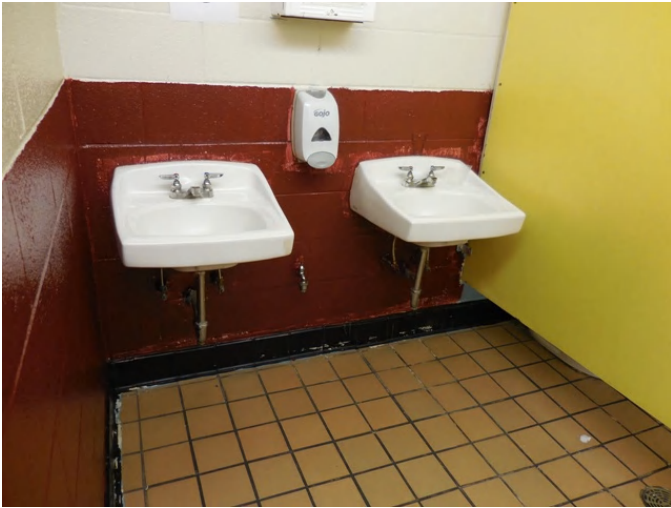
System: D2020 - Domestic Water Distribution

Location: Throughout Building

Distress: Beyond Service Life

Notes: The domestic water distribution system is beyond its expected service life, aged, and should be scheduled for replacement.

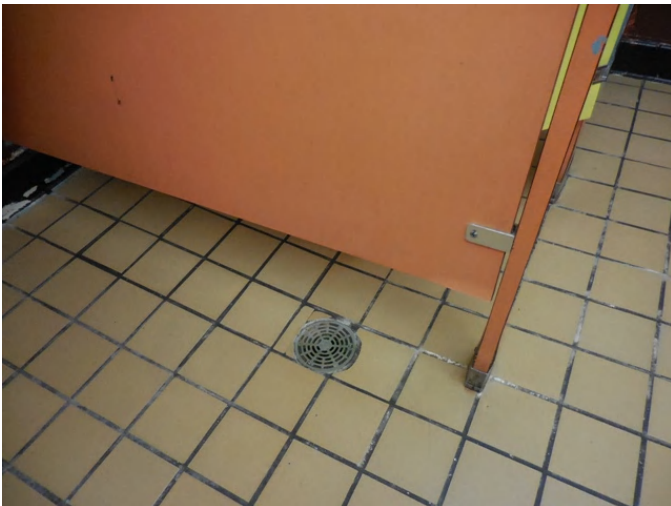
System: D2030 - Sanitary Waste

Location: Throughout Building

Distress: Beyond Service Life

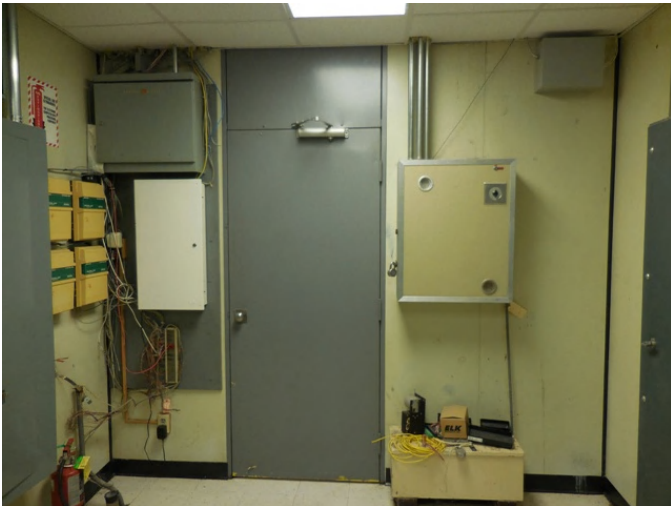
System: D3060 - Controls & Instrumentation

Location: Throughout Building

Distress: Beyond Service Life

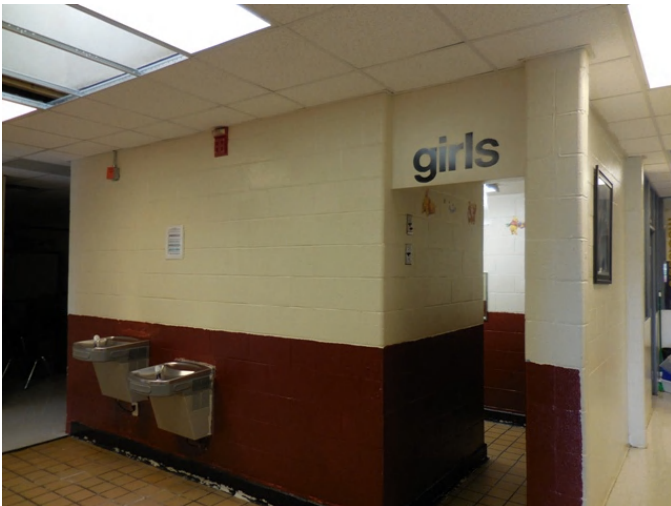
System: D5030 - Communications and Security - Fire Alarm

Location: Throughout Building
Distress: Beyond Service Life
Category: Deferred Maintenance / Building Code Compliance
Priority: 3 Priority
Correction: Renew System
Qty: 21,000.00
Unit of Measure: S.F.
Estimate: \$28,413.00
Assessor Name: Sam Mandola
Date Created: 04/11/2015

Notes: Fire alarm, pull stations, and strobes are beyond their expected service life, not building code compliant, and should be scheduled for replacement. Visible alarms (strobes) are missing in multiple occupancy, common use areas, such as restrooms.

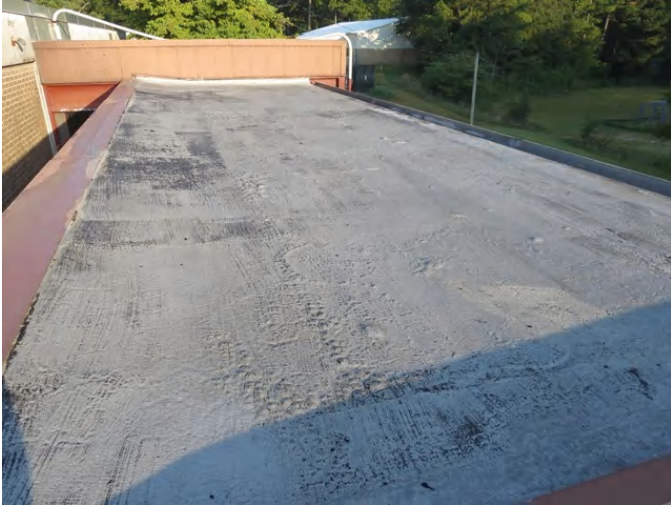
System: B3010 - Roof Coverings - BUR

Location: Roof

Distress: Beyond Service Life

Notes: The roof covering is beyond its expected service life, has reported leaks, and should be replaced. SPLOST project 126-422 to replace the roof and roof openings as appropriate.

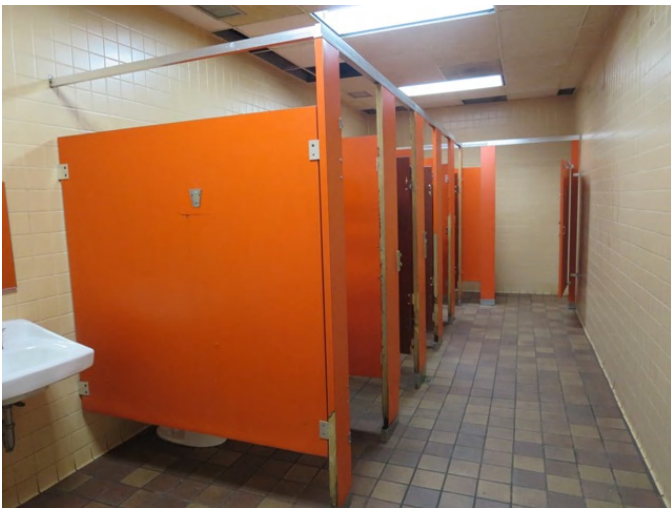
System: C1030 - Fittings

Location: Throughout Building

Distress: Beyond Service Life

Notes: Fittings, such as toilet partitions, handrails and signage, are beyond their expected service life, not ADA compliant, and should be replaced. SPLOST project 126-422 to renovate unisex adult restrooms in halls.

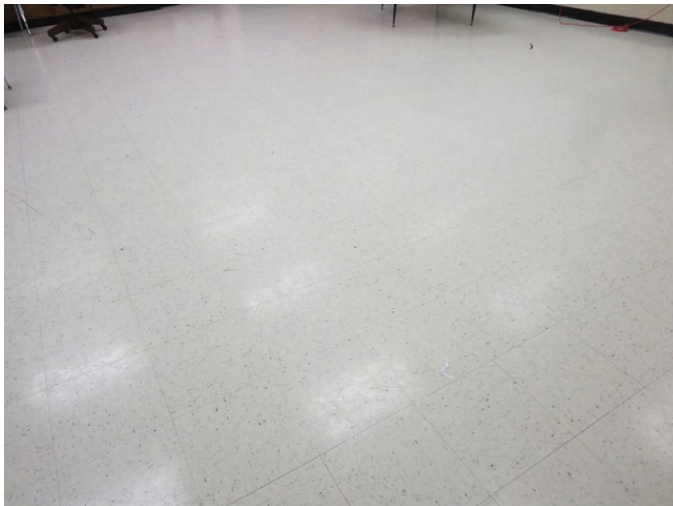
System: C3020 - Floor Finishes - VCT

Location: Corridors and Classrooms

Distress: Beyond Service Life

Notes: The VCT flooring is aged and worn, and should be replaced.

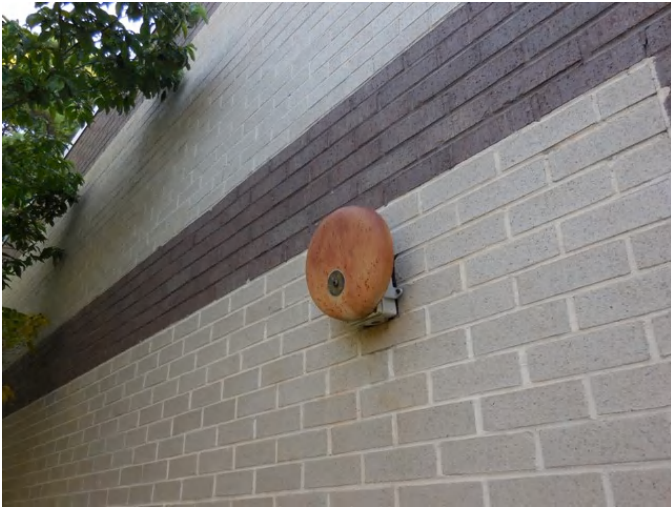
System: D5030 - Communications and Security - Fire Alarm

Location: Throughout Building

Distress: Beyond Service Life

Notes: Fire alarm, pull stations, and strobes are beyond their expected service life, not building code compliant, and should be scheduled for replacement. Visible alarms (strobes) are missing in multiple occupancy, common use areas, such as restrooms.

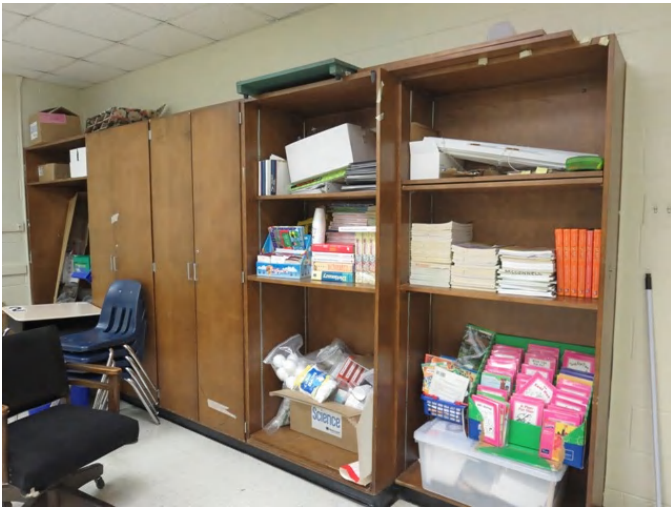
System: E2010 - Fixed Furnishings

Location: Throughout Building

Distress: Beyond Service Life

Notes: Fixed furnishings, such as built-in cabinets, are beyond their expected service life and worn, and should be replaced.

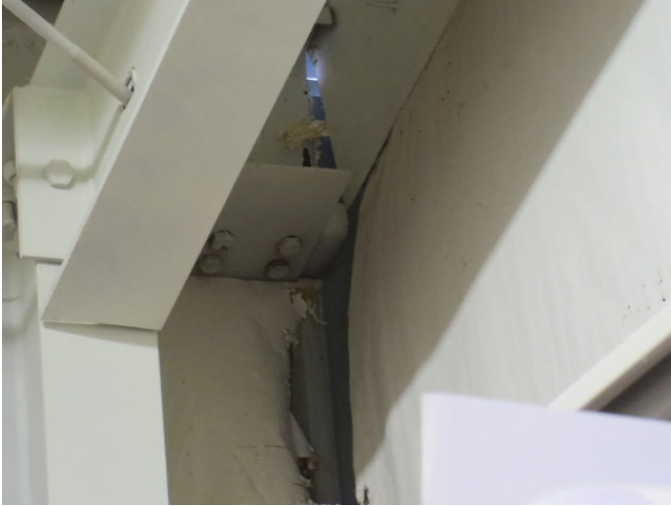
System: B2010 - Exterior Walls

Location: Exterior Wall

Distress: Damaged

Notes: Exterior metal wall has a penetration allowing fauna to get into the building.

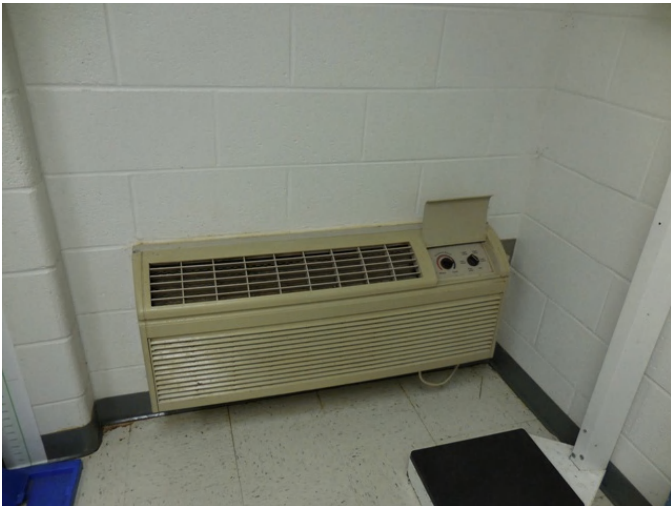
System: D3050 - Terminal & Package Units

Location: Throughout Building

Distress: Inadequate

Notes: One PTAC AC unit is located in the office area of the gym. It is nearing the end of its expected service life, worn, and constantly breaking down. The main gym area does not have air conditioning and it should be provided. SPLOST project 126-422 to install a 20-ton HVAC package in the gym.

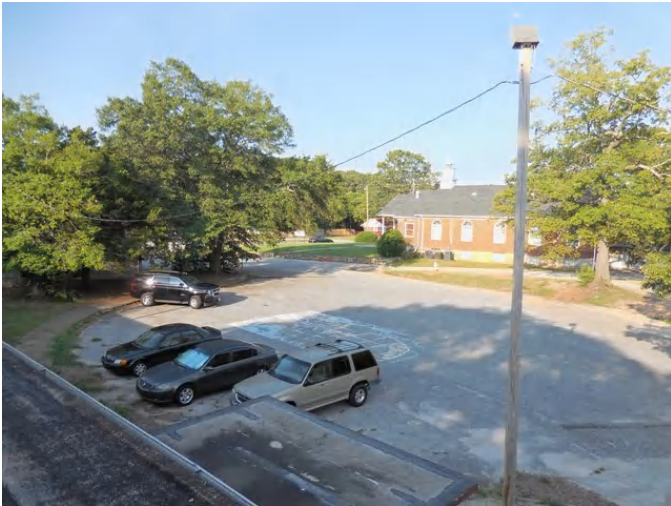
System: G4020 - Site Lighting

Location: Site

Distress: Inadequate

Notes: Site lighting is nearing the end of its expected service life, inadequate, and should be replaced and expanded.

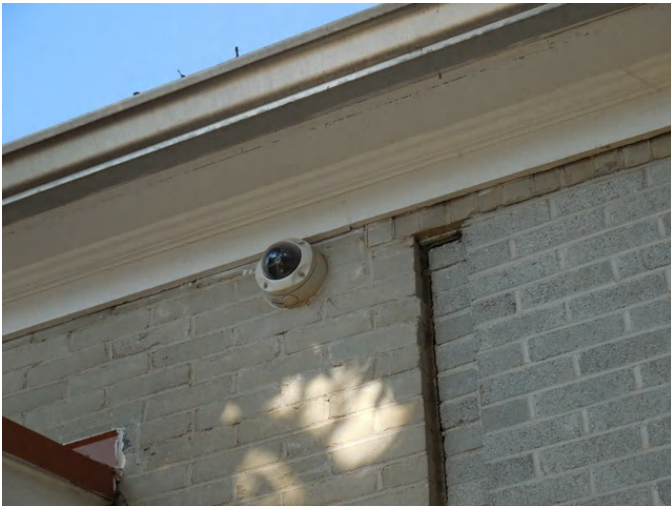
System: G4030 - Site Communications & Security

Location: Site

Distress: Inadequate

Notes: Security and CCTV system is inadequate, beyond its expected service life, and should be replaced/upgraded to provide full coverage.

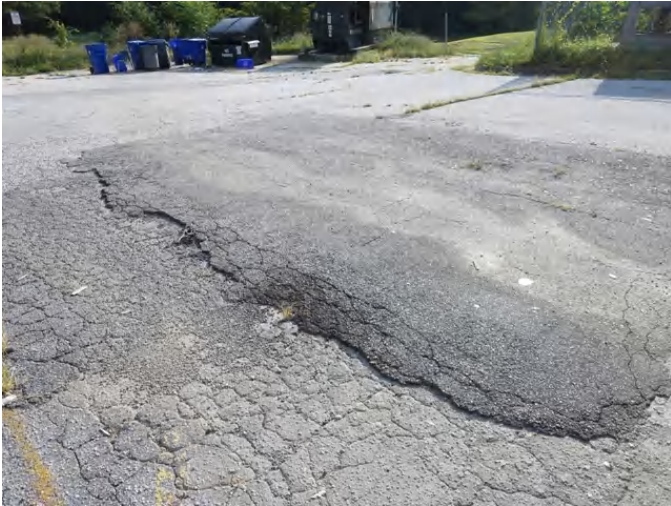
System: G2010 - Roadways

Location: Site

Distress: Beyond Service Life

Notes: Roadways are beyond their expected service life, damaged with many cracks and potholes, worn, and should be replaced.

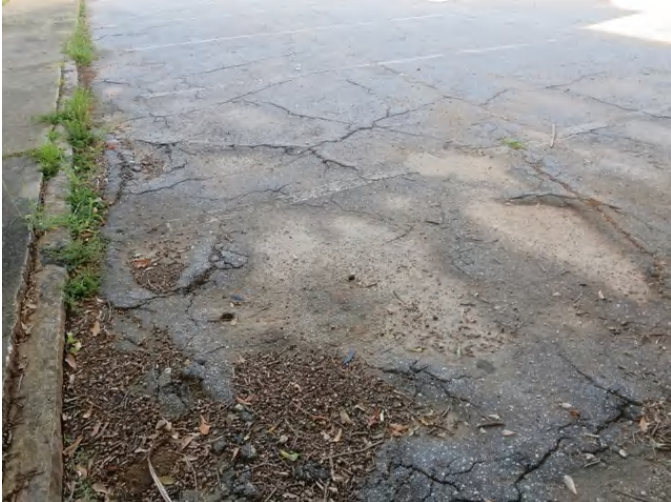
System: G2020 - Parking Lots

Location: Site

Distress: Beyond Service Life

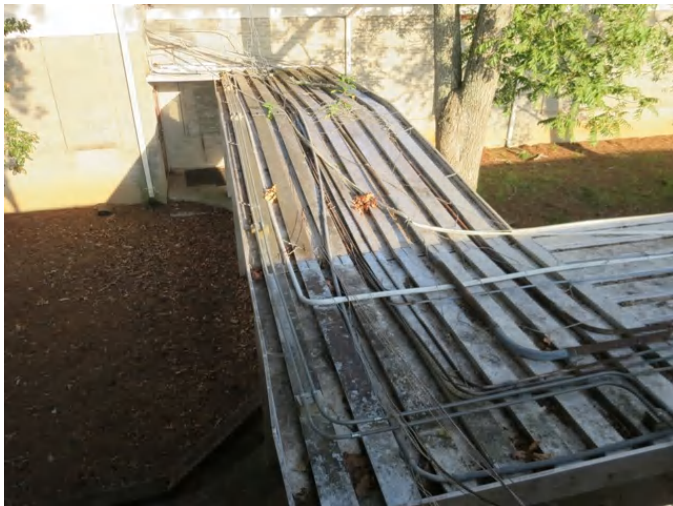
System: G2040 - Covered Walkways - Metal 1978

Location: Between Buildings 2010 and 2022
Distress: Beyond Service Life
Category: Deferred Maintenance / Safety
Priority: 3 Priority
Correction: Renew System
Qty: 870.00
Unit of Measure: S.F.
Estimate: \$46,625.00
Assessor Name: Sam Mandola
Date Created: 08/11/2015

Notes: The covered walkway is beyond its expected service life, badly deteriorating, and should be replaced.

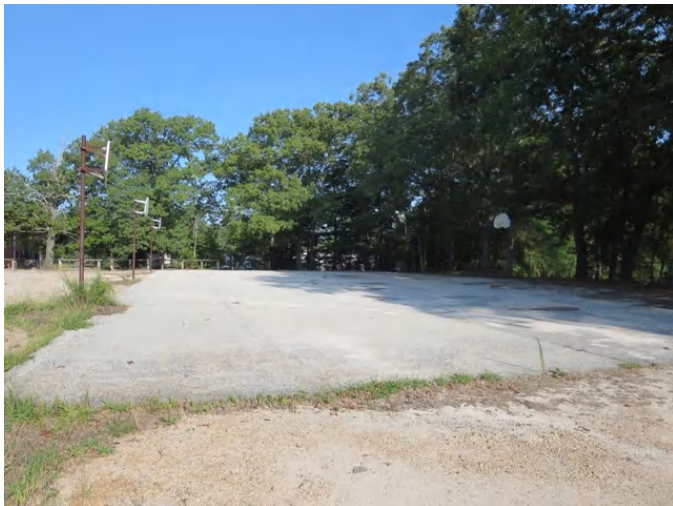
System: G2040 - Hard Surface Play Area

Location: Site
Distress: Beyond Service Life
Category: Deferred Maintenance
Priority: 3 Priority
Correction: Renew System
Qty: 7,844.00
Unit of Measure: S.F.
Estimate: \$54,014.00
Assessor Name: Sam Mandola
Date Created: 10/30/2015

Notes: The hard surface play area is beyond its expected service life, damaged, and should be scheduled for replacement. The basketball goals are rusted and damaged, and should be replaced.

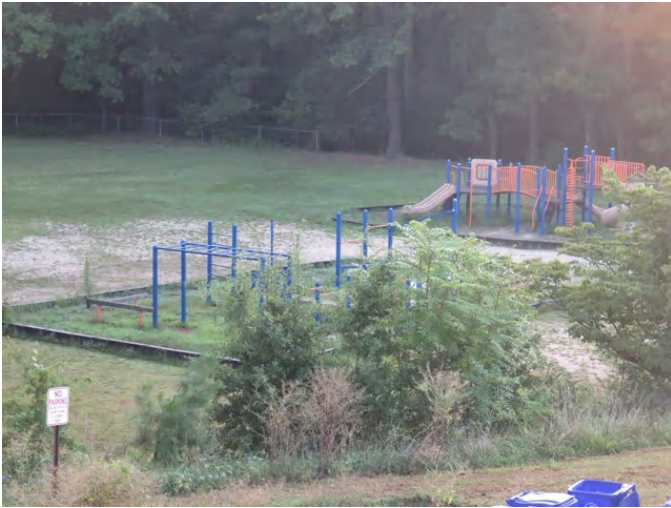
System: G2040 - Playing Field

Location: Site

Distress: Beyond Service Life

Notes: The playing fields are beyond their expected service life, have bare spots, and should be re-sodded to prevent erosion.

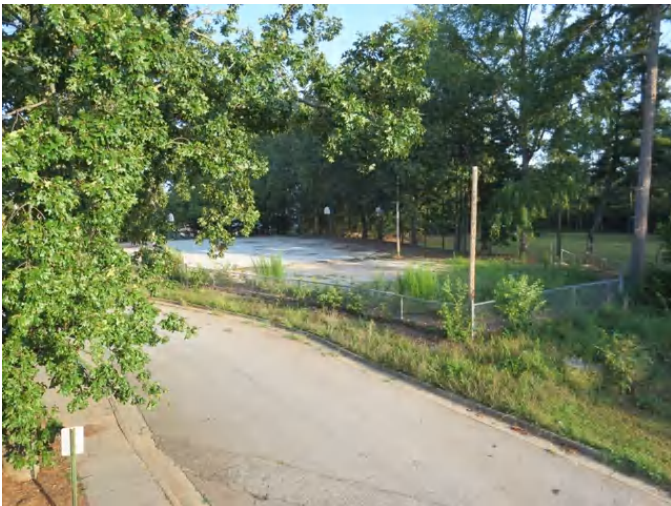
System: G2050 - Landscaping

Location: Site

Distress: Beyond Service Life
