DeKalb County School District/Elementary Schools

# Rock Chapel Elementary

## School Assessment Report

May 20, 2016

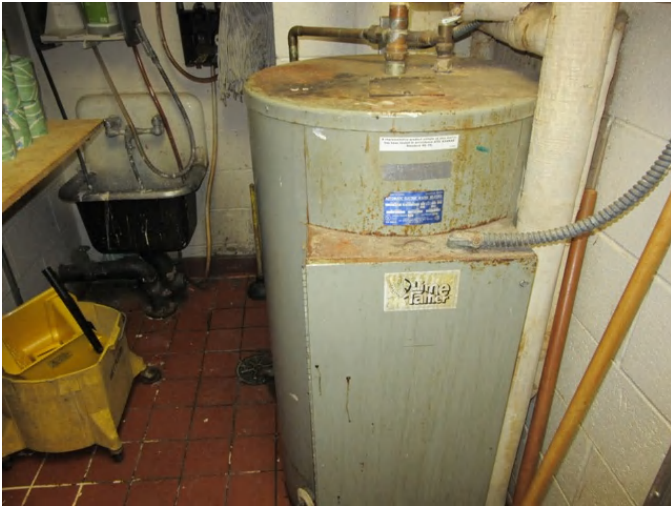
#### System: D2020 - Domestic Water Distribution

**Location:** Throughout Building

**Distress:** Beyond Service Life

**Notes:** The domestic water distribution system is beyond its expected service life, has water quality issues, and should be scheduled for replacement.

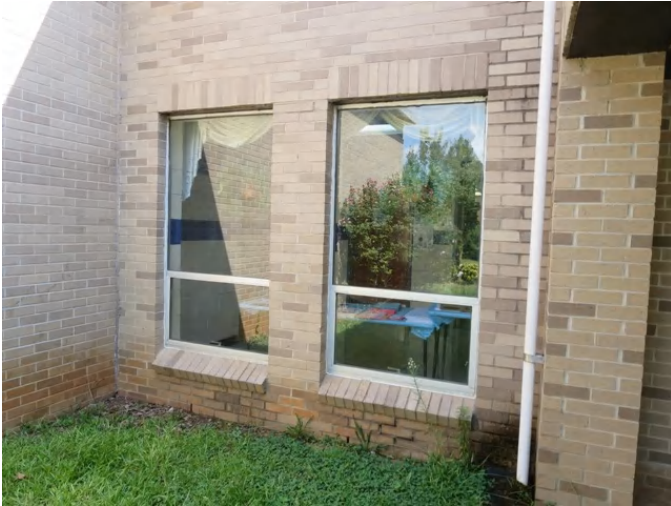
**System: B2020 - Exterior Windows**

**Location:** Throughout Building

**Distress:** Beyond Service Life

**Notes:** The aluminum frame, operable, single pane windows are aged, damaged, not energy efficient, and should be replaced.

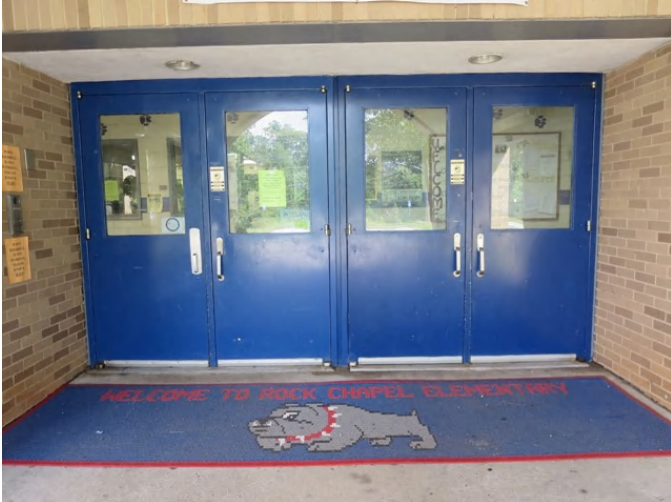
**System: B2030 - Exterior Doors**

**Location:** Throughout Building

**Distress:** Beyond Service Life

**Notes:** The original exterior doors are aged, dented, and should be replaced.

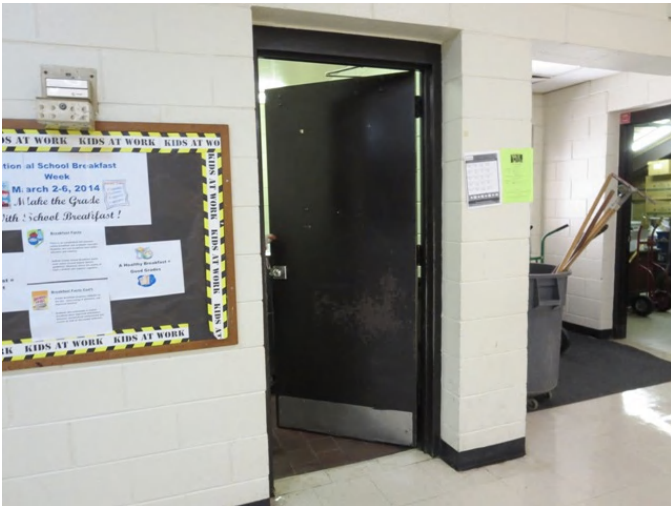
### **System: C1020 - Interior Doors**

**Location:** Throughout Building

**Distress:** Beyond Service Life

**Notes:** The interior doors are aged, failing, not ADA or building code compliant, and should be repaired or replaced. SPLOST project 323-422 to replace all interior doors and hardware.

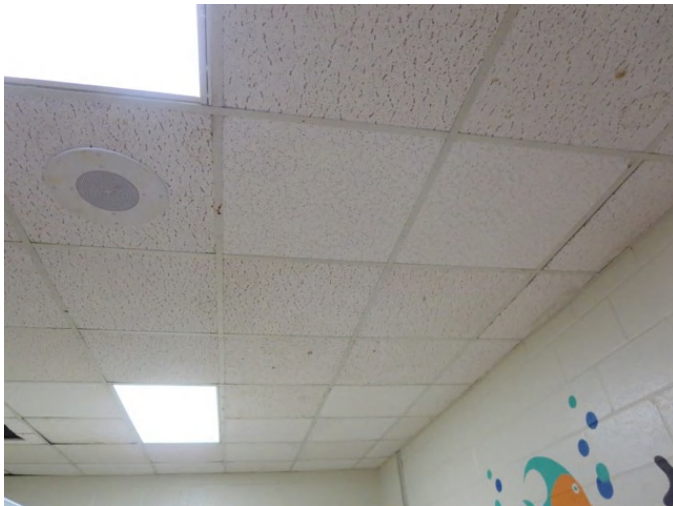
**System: C3030 - Ceiling Finishes**

**Location:** Throughout Building

**Distress:** Beyond Service Life

**Notes:** The acoustical ceiling system is beyond its expected service life, damaged, and should be replaced.

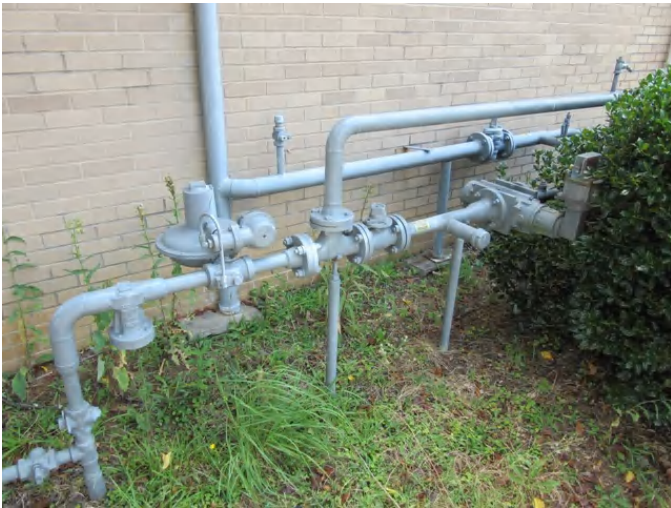
**System: D2090 - Other Plumbing Systems - Natural Gas**

**Location:** Southwest Side of Building

**Distress:** Beyond Service Life

**Notes:** The natural gas system is beyond its expected service life and should be scheduled for replacement.

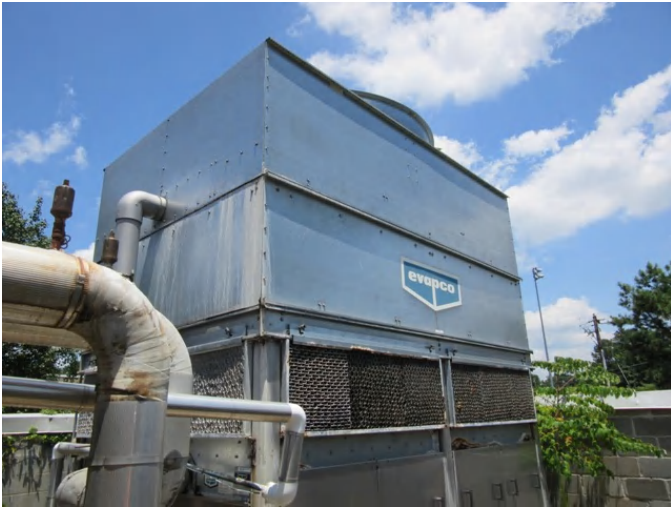
**System: D3030 - Cooling Generating Systems**

**Location:** Outside Mechanical Room

**Distress:** Beyond Service Life

**Notes:** The cooling generating system is beyond its expected service life, inadequate, and should be scheduled for replacement.

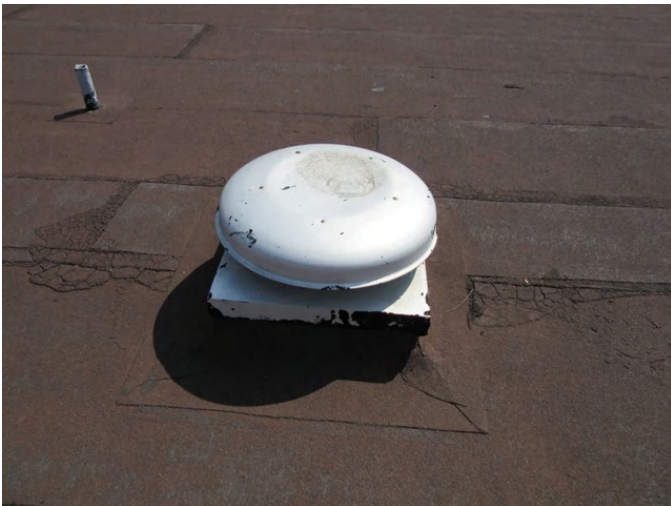
**System: D3040 - Distribution & Exhaust Systems**

**Location:** Throughout Building

**Distress:** Beyond Service Life

**Notes:** The distribution and exhaust systems are beyond their expected service life, non-functional, and should be scheduled for replacement.

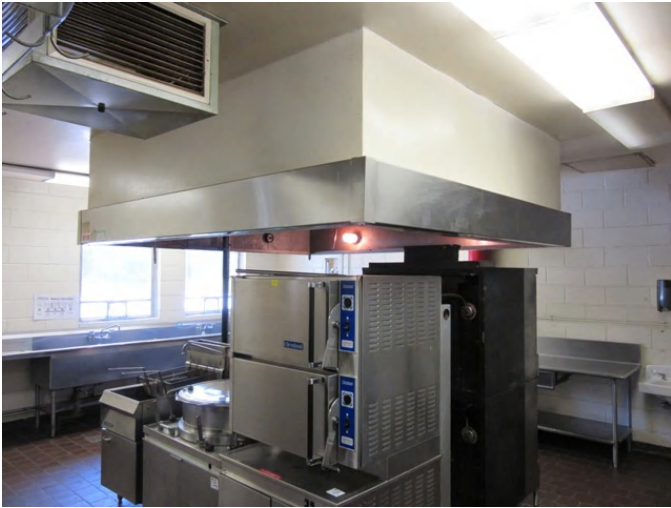
**System: D3090 - Other HVAC Systems/Equip - Kitchen Hood**

**Location:** Kitchen

**Distress:** Beyond Service Life

**Notes:** The kitchen hood system is beyond its expected service life and should be scheduled for replacement.

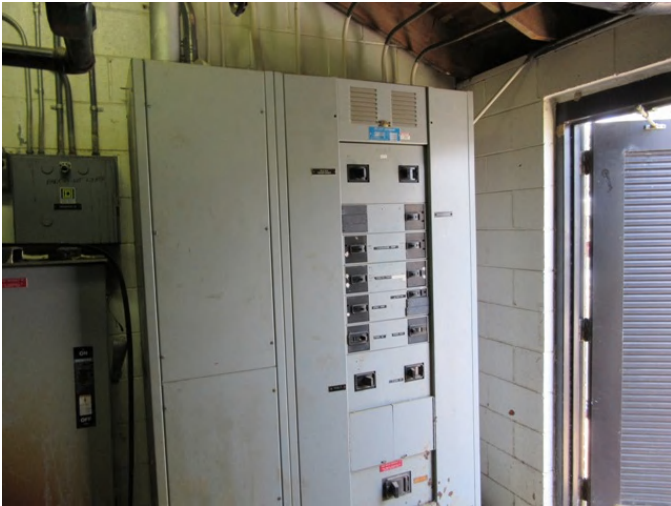
**System: D5010 - Electrical Service/Distribution**

**Location:** Main Switch Room/Throughout Building

**Distress:** Beyond Service Life

**Notes:** The electrical service and distribution system is beyond its expected service life, no longer supports modern load requirements, and should be scheduled for replacement.

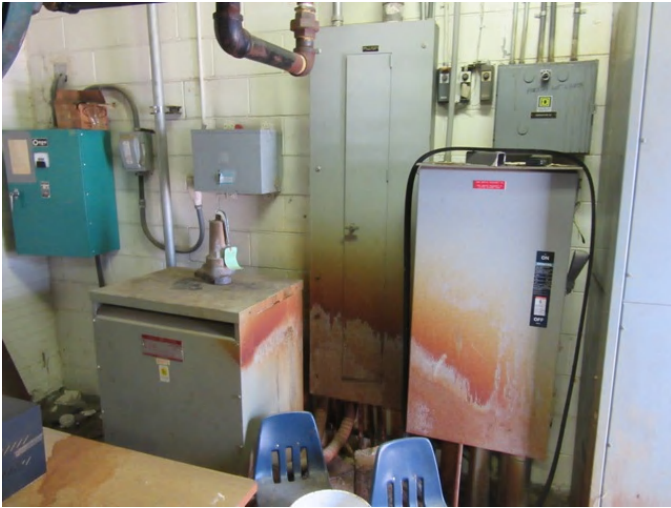
**System: D5020 - Branch Wiring**

**Location:** Throughout Building

**Distress:** Beyond Service Life

**Notes:** The branch wiring system is beyond its expected service life, not building code compliant, and should be scheduled for replacement. Electrical outlets in wet areas are not GFI. There are exposed wires in the mechanical room.

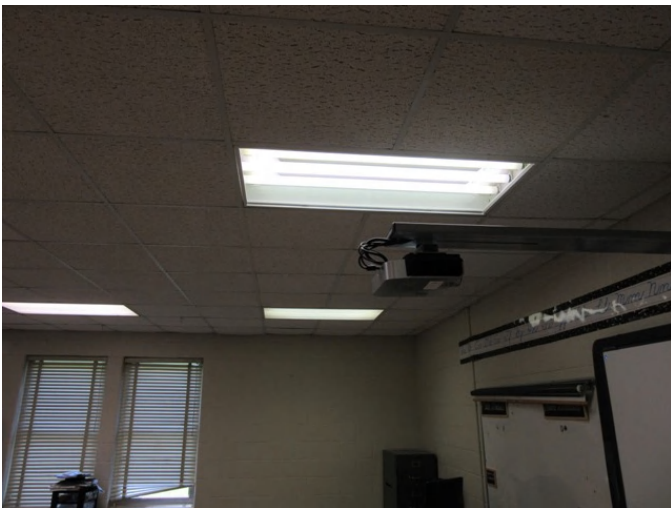
**System: D5020 - Lighting**

**Location:** Throughout Building

**Distress:** Beyond Service Life

**Notes:** The lighting system is beyond its expected service life, inefficient, and should be scheduled for replacement.

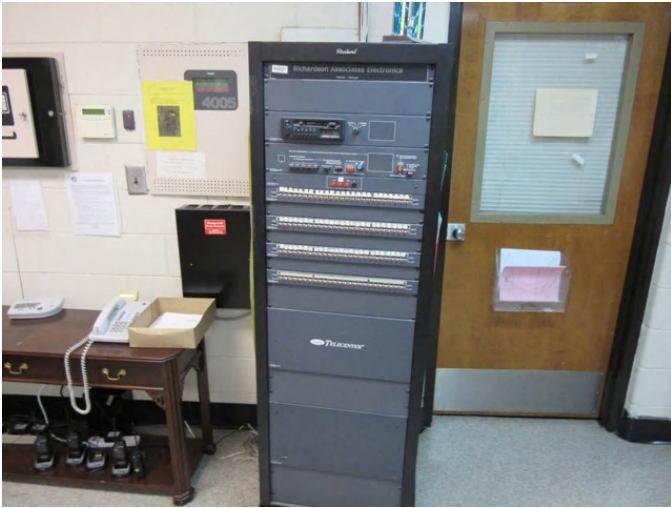
**System: D5030 - Communications and Security - Clock & PA Systems**

**Location:** Throughout Building

**Distress:** Beyond Service Life

**Notes:** Clock and PA systems are beyond their expected service life and should be scheduled for replacement.

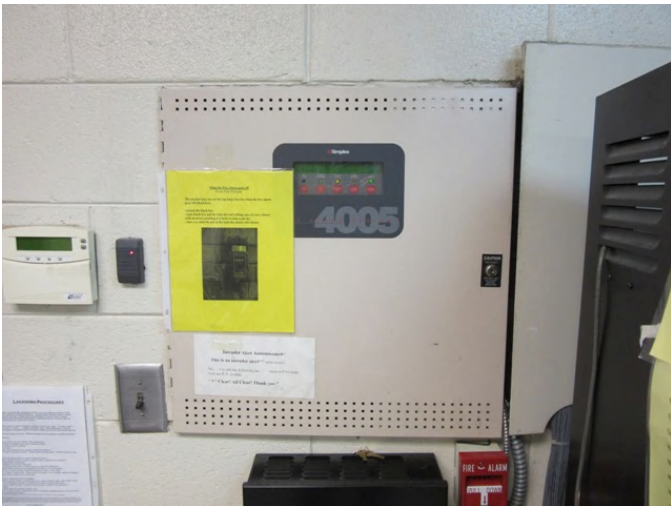
**System: D5030 - Communications and Security - Fire Alarm**

**Location:** Throughout Building

**Distress:** Beyond Service Life

**Notes:** The fire alarm system is beyond its expected service life and should be scheduled for replacement. Restrooms are not code compliant.

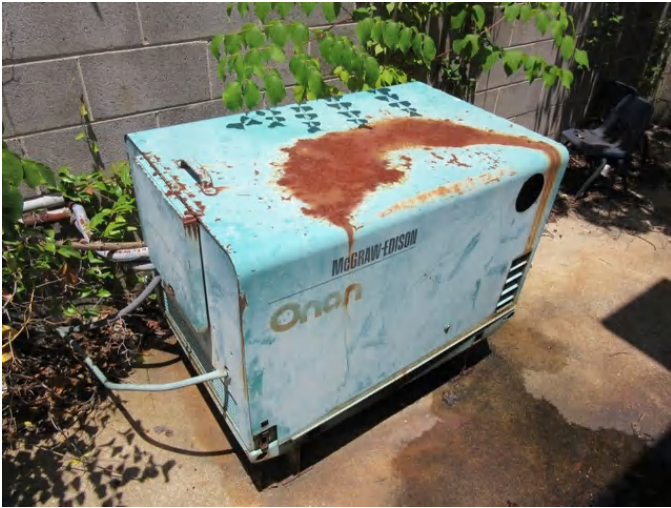
**System: D5090 - Other Electrical Systems - Emergency Generator**

**Location:** Northwest Side of Building

**Distress:** Beyond Service Life

**Notes:** The generator is beyond its expected service life and should be replaced. SPLOST project 323-422 to replace the emergency generator.

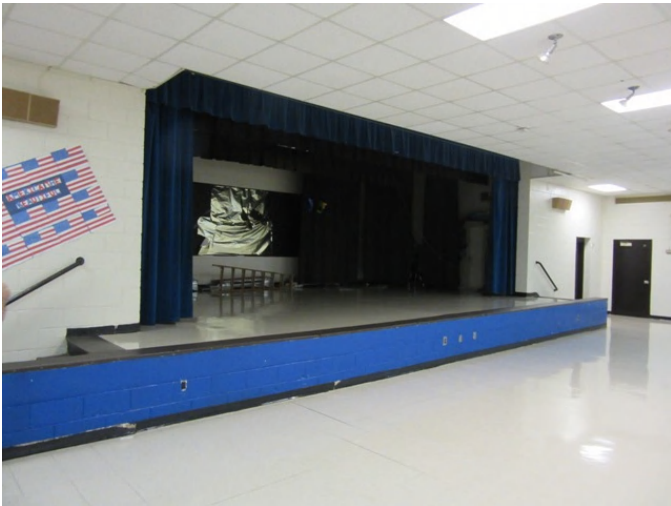
**System: F1020 - Institutional Equipment**

**Location:** Throughout Building

**Distress:** Beyond Service Life

**Notes:** Institutional equipment, such as theater and stage equipment, is beyond its expected service life and should be scheduled for replacement. An independent report identified suspected hazardous materials in the stage curtains.

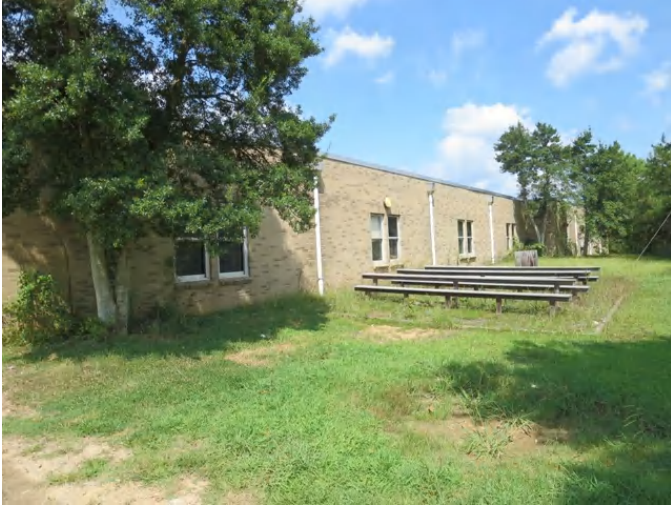
#### System: B2020 - Exterior Windows

**Location:** Throughout Building

**Distress:** Beyond Service Life

**Notes:** The aluminum frame, operable, single pane windows are aged, not energy efficient, and should be replaced.

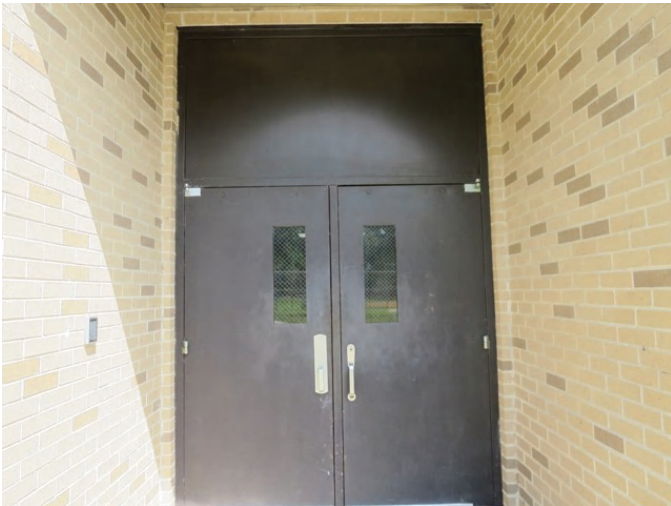
#### System: B2030 - Exterior Doors

**Location:** Throughout Building

**Distress:** Beyond Service Life

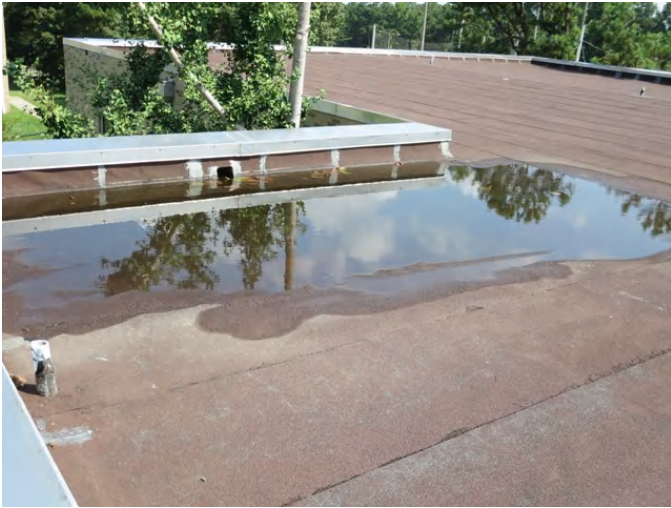
**System: B3010 - Roof Coverings - BUR**

**Location:** Roof

**Distress:** Beyond Service Life

**Notes:** The built-up roof covering is aged, showing signs of failure, and should be replaced. SPLOST project 323-422 to replace the roof on the 1983 addition and 1969 and 1975 buildings.

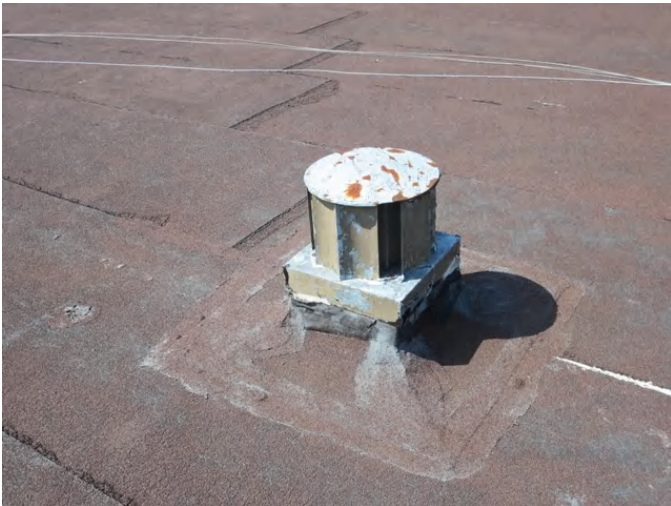
**System: B3020 - Roof Openings**

**Location:** Roof

**Distress:** Beyond Service Life

**Notes:** The original metal roof openings are rusted, damaged, and should be replaced. SPLOST project 323-422 to replace the roof openings and add ladders and roof hatches on all buildings.

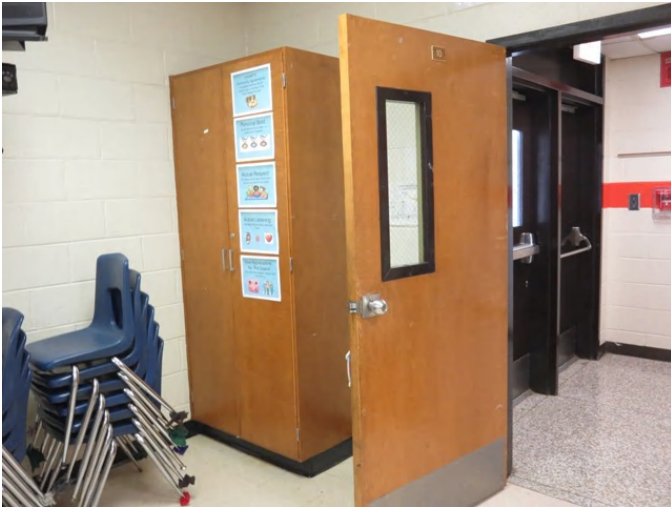
**System: C1020 - Interior Doors**

**Location:** Throughout Building

**Distress:** Beyond Service Life

**Notes:** The interior doors are aged, failing, not ADA compliant, and should be replaced. SPLOST project 323-422 to replace all interior doors and hardware.

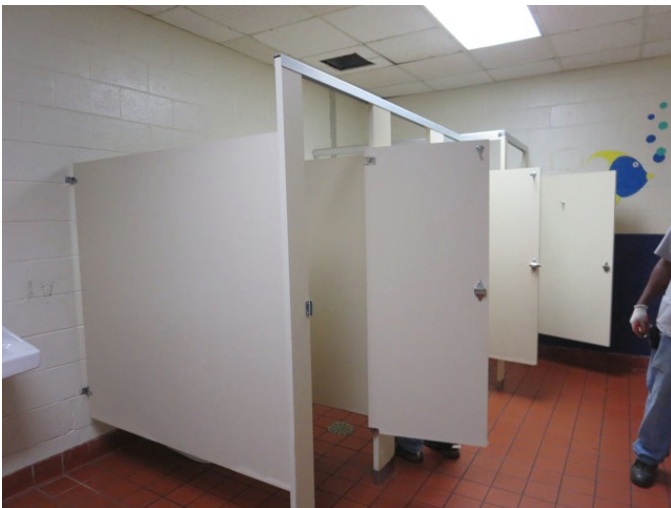
**System: C1030 - Fittings**

**Location:** Throughout Building

**Distress:** Beyond Service Life

**Notes:** Fittings, such as toilet partitions, handrails and signage, are beyond their expected service life and should be replaced.

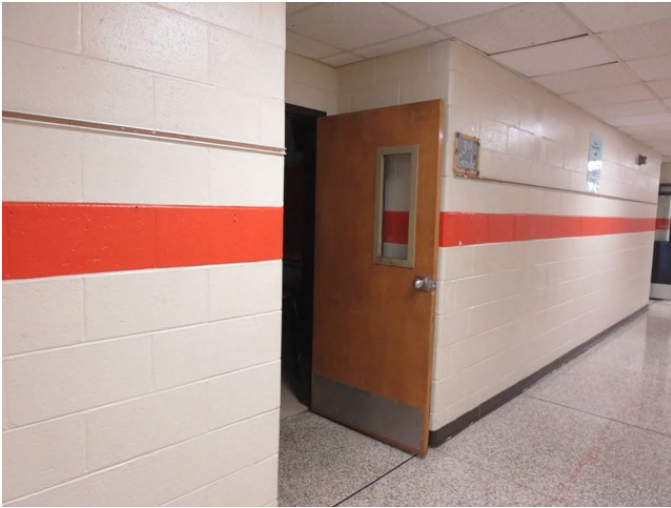
**System: C3010 - Wall Finishes - Paint**

**Location:** Throughout Building

**Distress:** Beyond Service Life

**Notes:** The painted wall finishes are beyond their expected service life and should be replaced. SPLOST project 323-422 to paint interior walls and door frames.

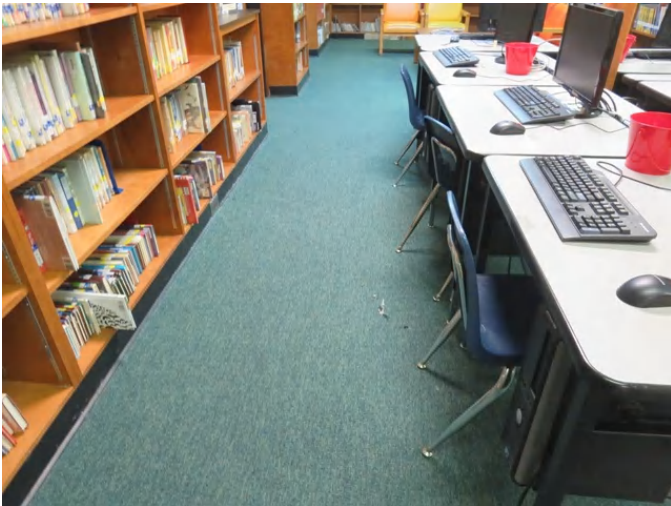
**System: C3020 - Floor Finishes - Carpet**

**Location:** Media Center

**Distress:** Beyond Service Life

**Notes:** The carpet is stained, showing signs of failure, and should be replaced. SPLOST project 323-422 to replace carpet throughout all buildings, as needed.

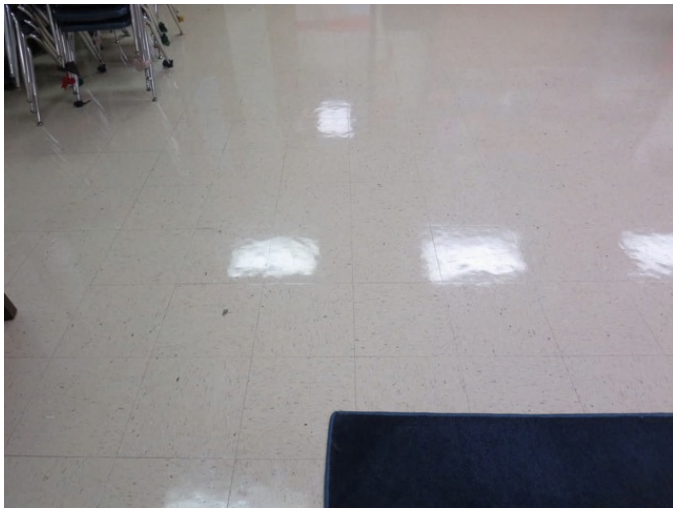
**System: C3020 - Floor Finishes - VCT**

**Location:** Classrooms

**Distress:** Beyond Service Life

**Notes:** The VCT flooring is aged, cracked and worn, and should be replaced.

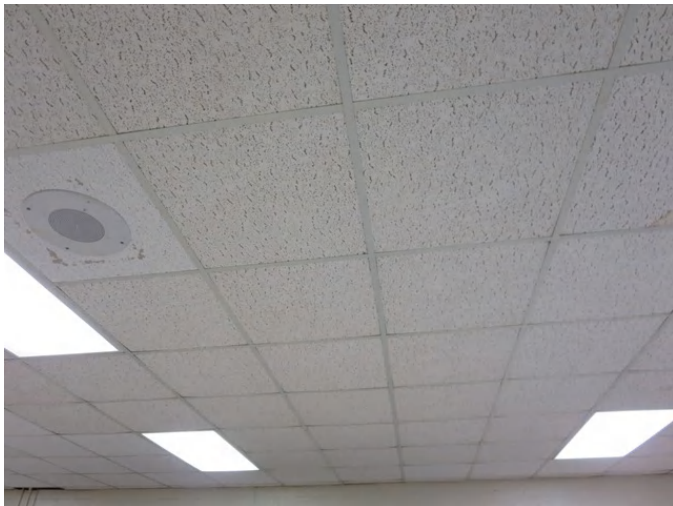
**System: C3030 - Ceiling Finishes**

**Location:** Throughout Building

**Distress:** Beyond Service Life

**Notes:** The acoustical ceiling system is deteriorating due to age and the environment, and should be replaced.

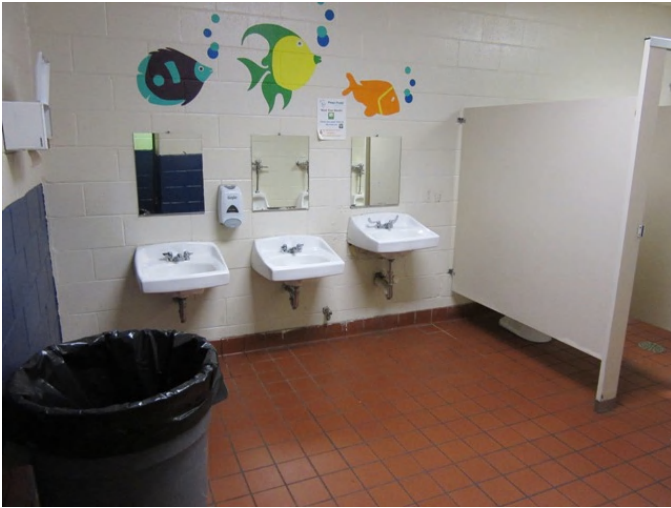
**System: D2010 - Plumbing Fixtures**

**Location:** Throughout Building

**Distress:** Beyond Service Life

**Notes:** The plumbing fixtures are beyond their expected service life and should be scheduled for replacement.

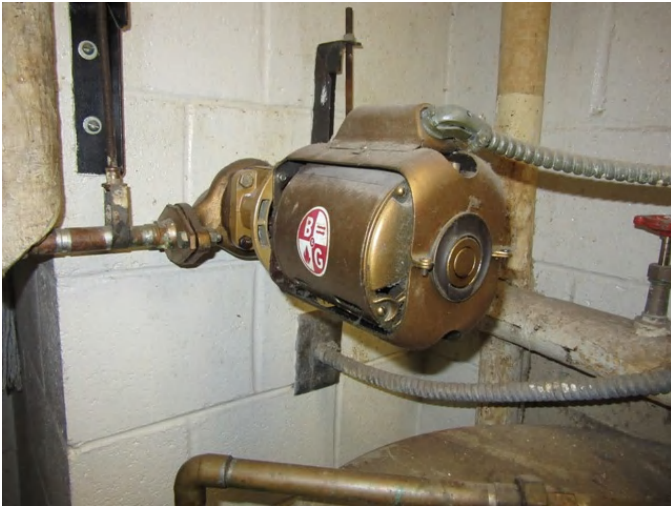
**System: D2020 - Domestic Water Distribution**

**Location:** Custodial Closet

**Distress:** Beyond Service Life

**Notes:** The domestic water distribution system is beyond its expected service life and should be scheduled for replacement.

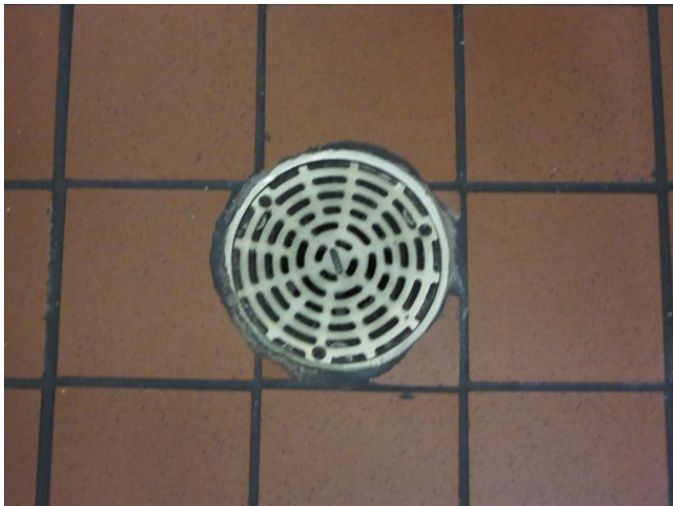
**System: D2030 - Sanitary Waste**

**Location:** Throughout Building

**Distress:** Beyond Service Life

**Notes:** The sanitary waste system is beyond its expected service life and should be scheduled for replacement.

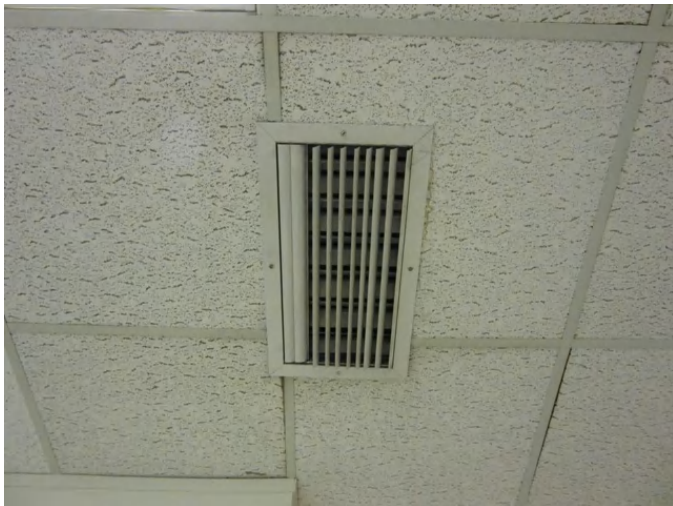
**System: D3040 - Distribution & Exhaust Systems**

**Location:** Throughout Building

**Distress:** Beyond Service Life

**Notes:** The distribution and exhaust systems are beyond their expected service life and should be scheduled for replacement.

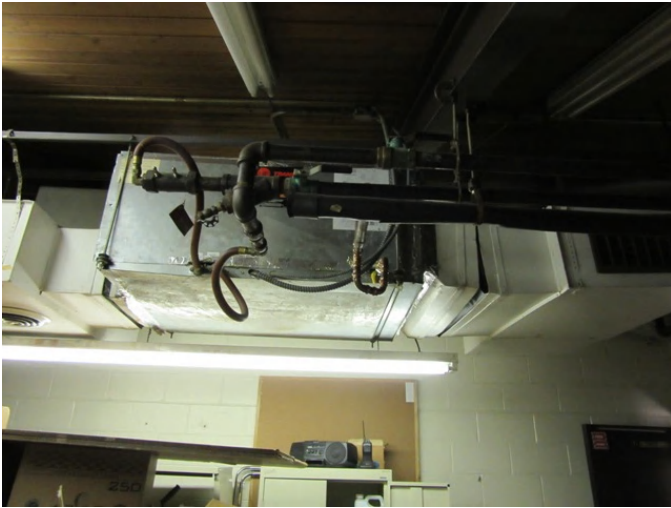
**System: D3050 - Terminal & Package Units**

**Location:** Throughout Building

**Distress:** Beyond Service Life

**Notes:** The terminal and package units are beyond their expected service life and should be scheduled for replacement.

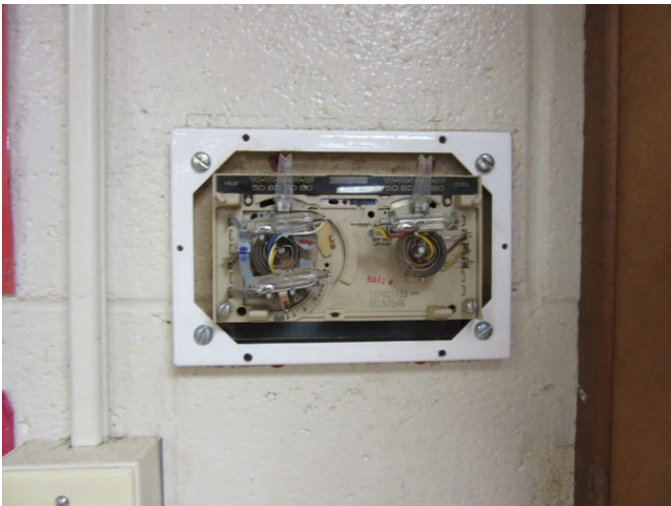
**System: D3060 - Controls & Instrumentation**

**Location:** Throughout Building

**Distress:** Beyond Service Life

**Notes:** The controls and instrumentation system is beyond its expected service life and should be scheduled for replacement.

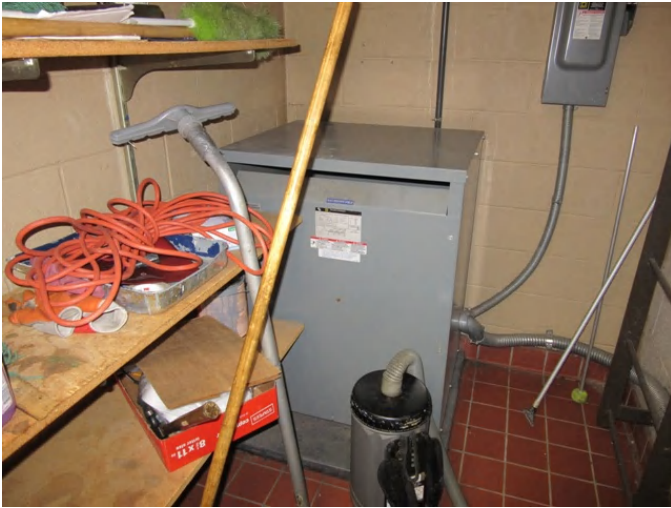
**System: D5020 - Branch Wiring**

**Location:** Throughout Building

**Distress:** Beyond Service Life

**Notes:** The branch wiring system is beyond its expected service life, not building code compliant, and should be scheduled for replacement. Electrical outlets in wet areas are not GFI.

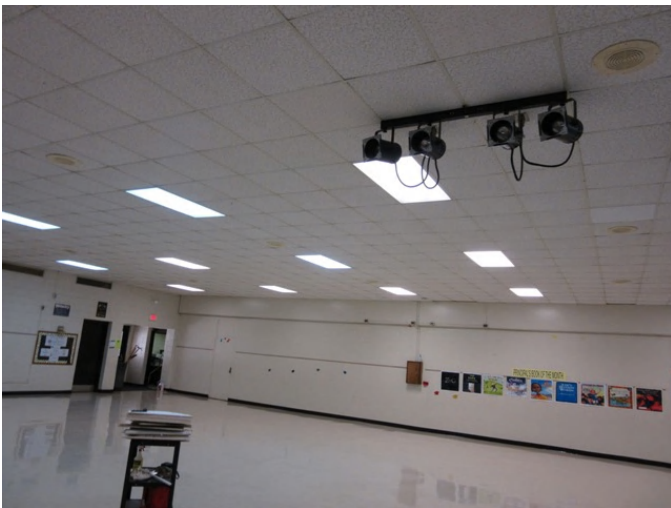
**System: D5020 - Lighting**

**Location:** Throughout Building

**Distress:** Beyond Service Life

**Notes:** The lighting system is beyond its expected service life and should be scheduled for replacement.

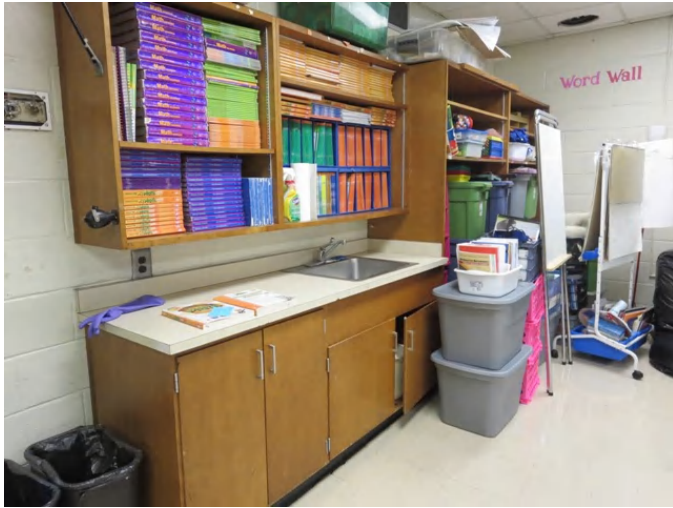
**System: E2010 - Fixed Furnishings**

**Location:** Throughout Building

**Distress:** Beyond Service Life

**Notes:** Fixed furnishings, such as built-in cabinets and window treatment, are beyond their expected service life and worn, and should be replaced.

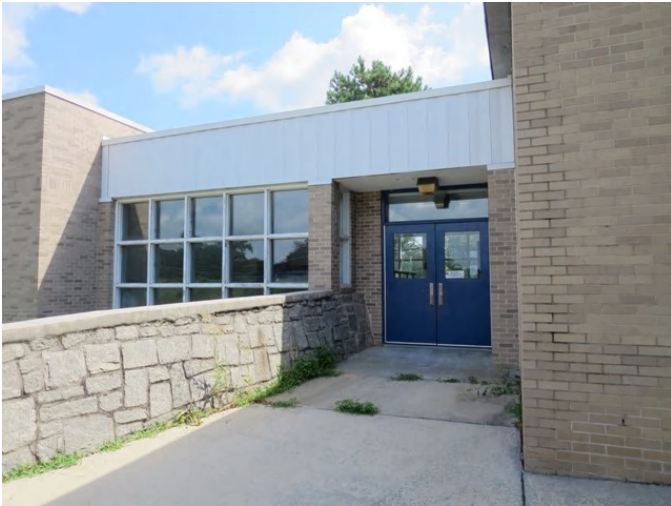
#### **System: B2020 - Exterior Windows**

**Location:** Southwest Exterior Wall

**Distress:** Inadequate

**Notes:** The storefront window is corroding and paint is peeling off. Refinish 10' x 15' steel frame window.

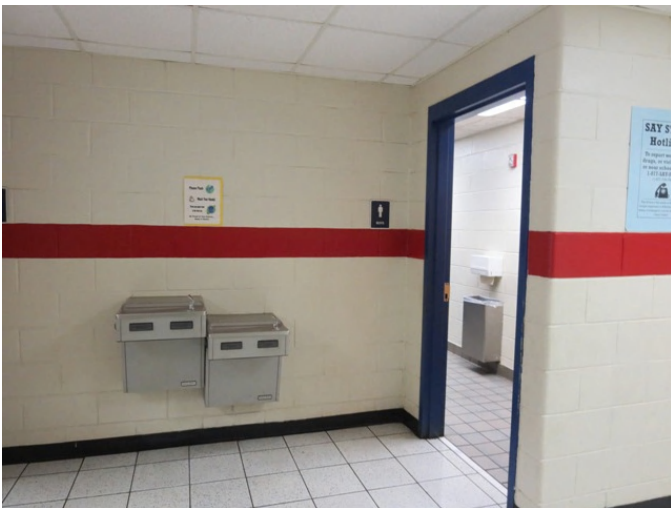
#### **System: C3010 - Wall Finishes - Paint**

**Location:** Throughout Building

**Distress:** Beyond Service Life

**Notes:** The painted wall finish is deteriorating due to age and use, and should be replaced. SPLOST project 323-422 to paint interior walls and door frames.

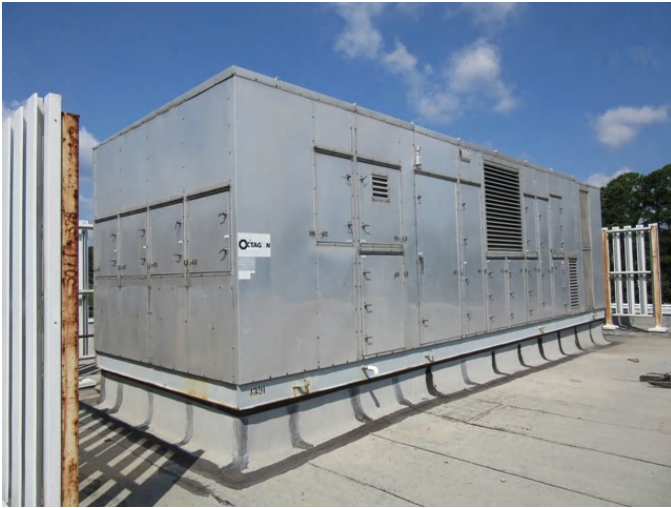
**System: D3050 - Terminal & Package Units**

**Location:** Roof

**Distress:** Beyond Service Life

**Notes:** The rooftop package unit is beyond its expected service life and should be scheduled for replacement.

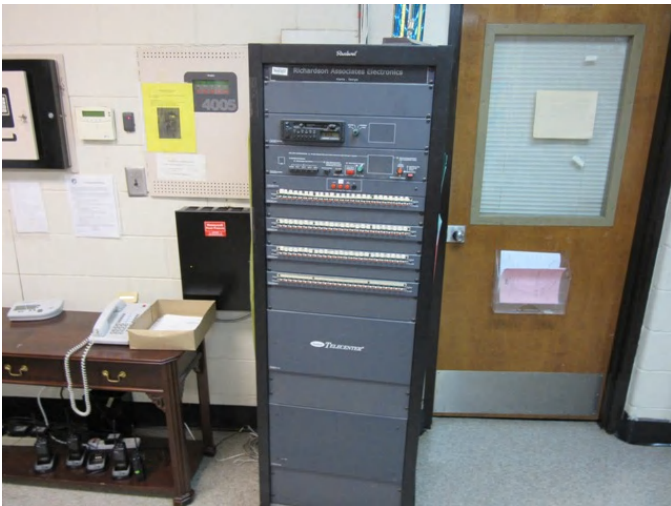
**System: D5030 - Communications and Security - Clock & PA Systems**

**Location:** Throughout Building

**Distress:** Beyond Service Life

**Notes:** Clock and PA systems are beyond their expected service life and should be scheduled for replacement.

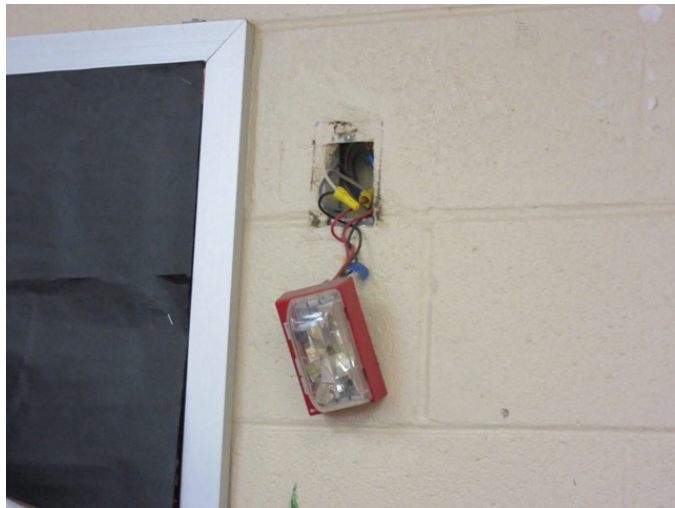
**System: D5030 - Communications and Security - Fire Alarm**

**Location:** Throughout Building

**Distress:** Beyond Service Life

**Notes:** The fire alarm system is beyond its expected service life and should be scheduled for replacement.
