DeKalb County School District/Middle Schools

# Ronald McNair Sr. Middle

## School Assessment Report

May 20, 2016

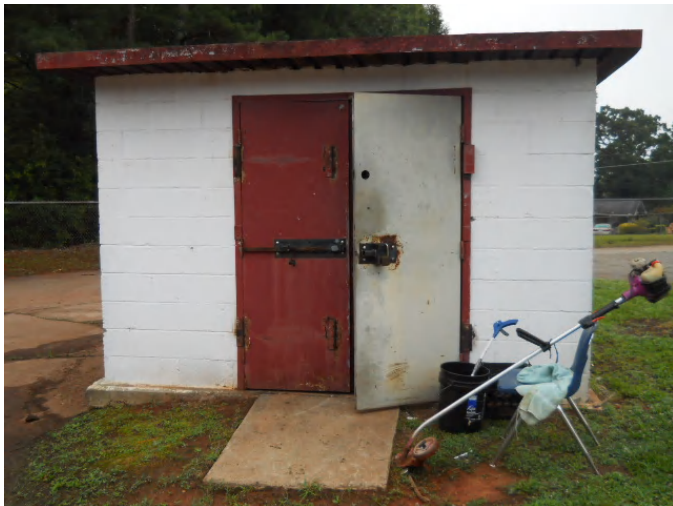
#### **System: B2030 - Exterior Doors**

**Location:** Exterior Wall

**Distress:** Beyond Service Life

**Notes:** The exterior doors are beyond their expected service life and should be replaced.

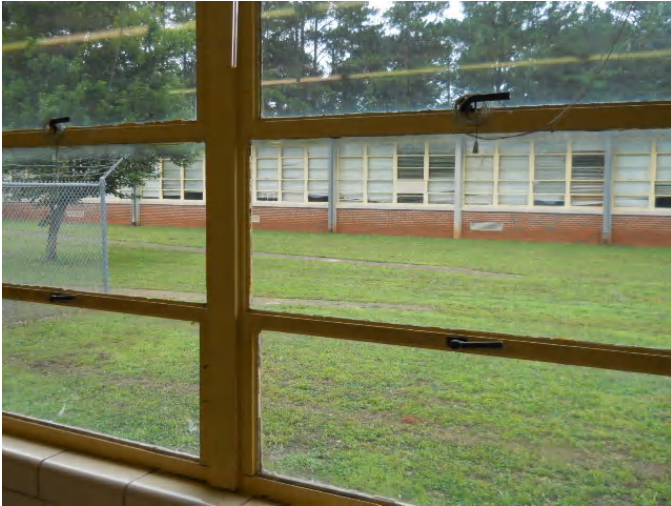
**System: B2020 - Exterior Windows**

**Location:** Throughout Building

**Distress:** Beyond Service Life

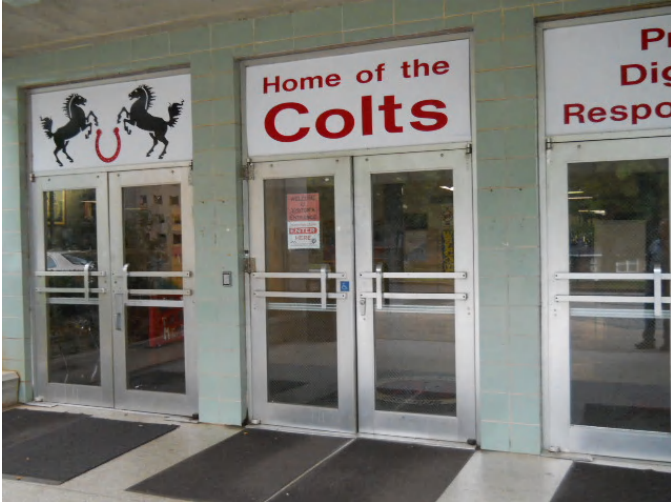
**System: B2030 - Exterior Doors**

**Location:** Throughout Building

**Distress:** Beyond Service Life

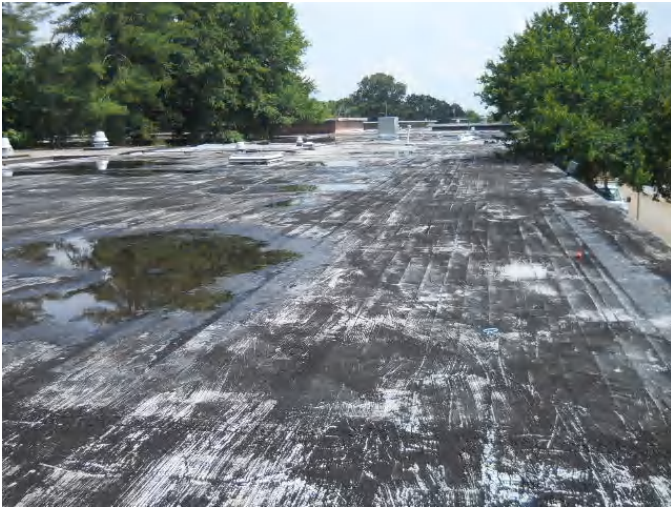
**System: B3010 - Roof Coverings - BUR**

**Location:** Roof

**Distress:** Beyond Service Life

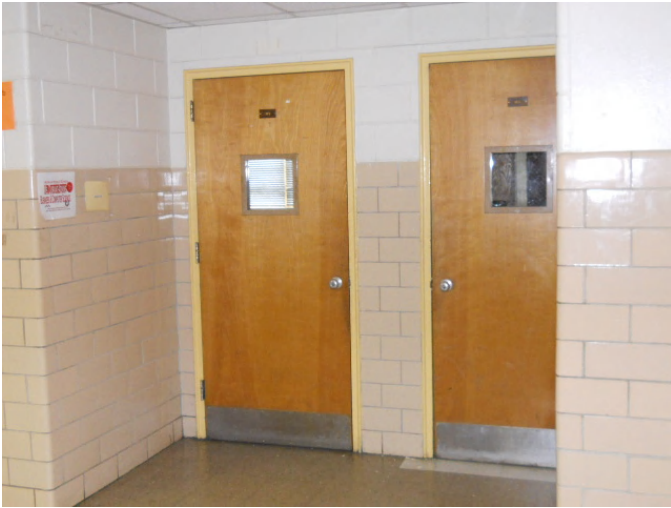
**System: C1020 - Interior Doors**

**Location:** Throughout Building

**Distress:** Beyond Service Life

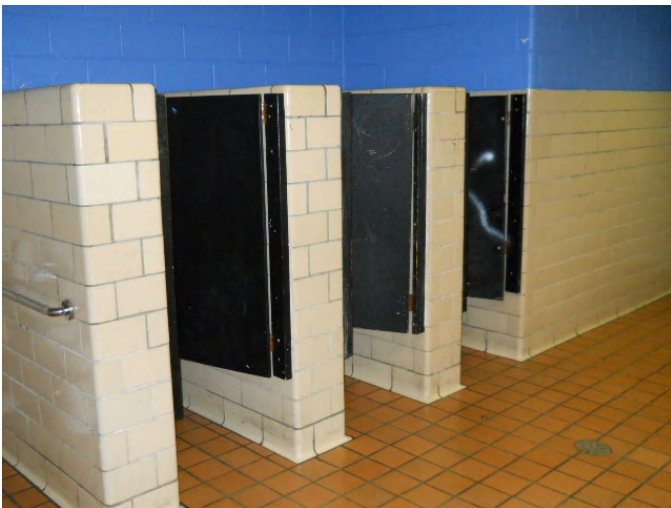
**System: C1030 - Fittings**

**Location:** Throughout Building

**Distress:** Beyond Service Life

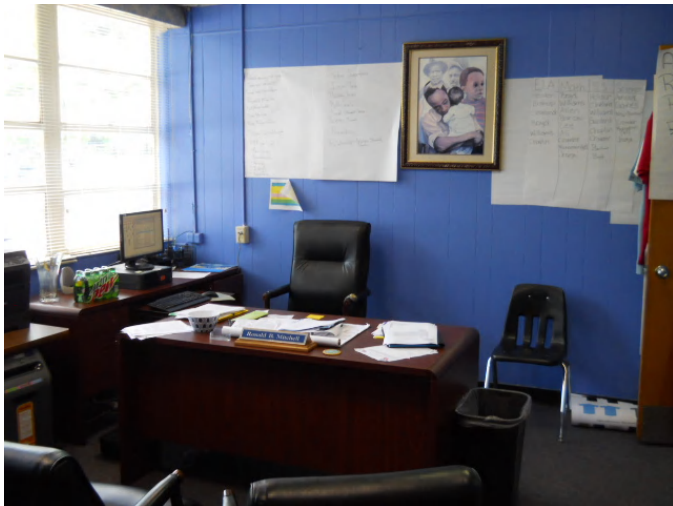
**System: C3010 - Wall Finishes - Wall Coverings**

**Location:** Offices

**Distress:** Beyond Service Life

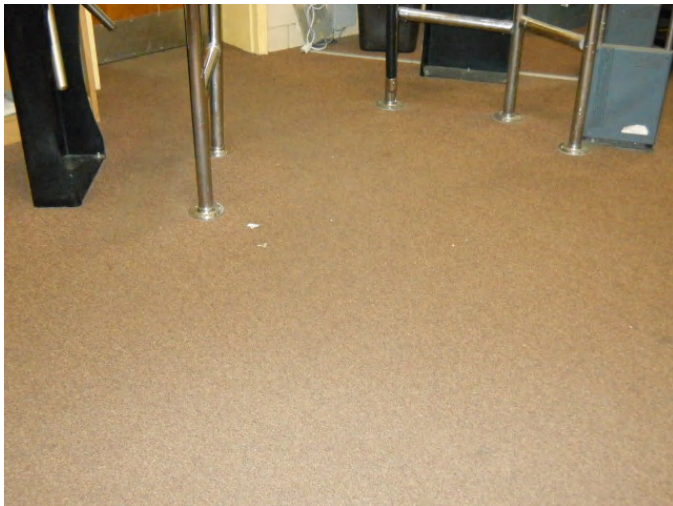
**System: C3020 - Floor Finishes - Carpet**

**Location:** Media Center, Offices

**Distress:** Beyond Service Life

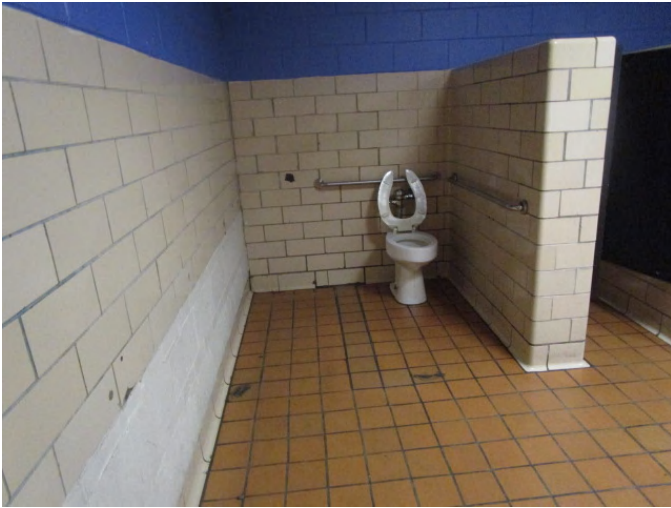
**System: D2010 - Plumbing Fixtures**

**Location:** Throughout Building

**Distress:** Beyond Service Life

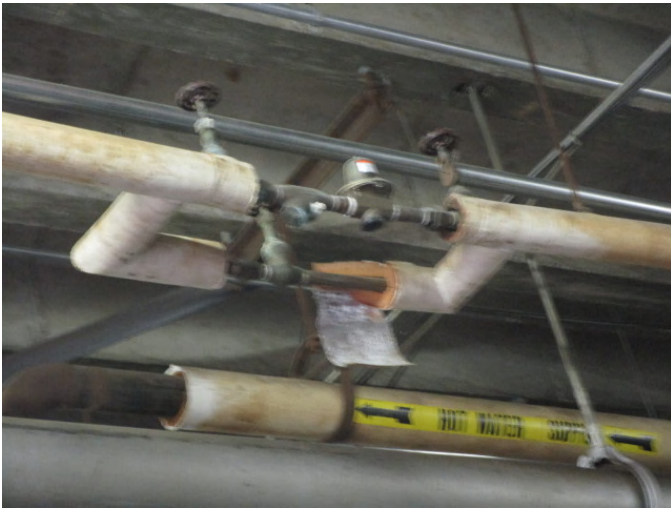
**System: D2020 - Domestic Water Distribution**

**Location:** Throughout Building

**Distress:** Beyond Service Life

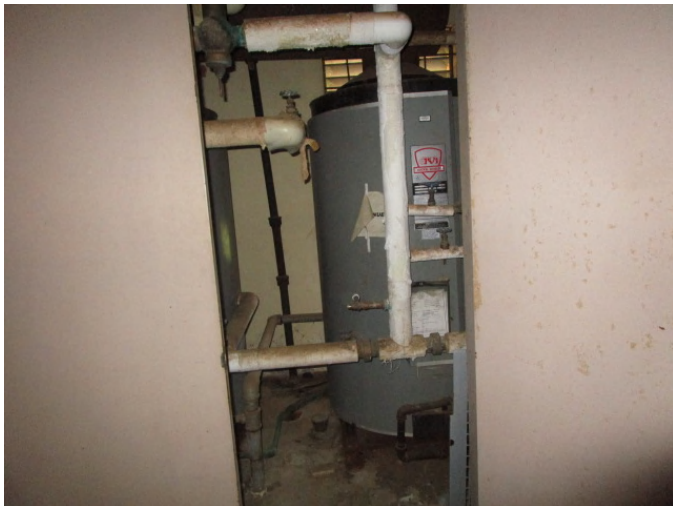
**Location:** Throughout Building

**System: D2090 - Other Plumbing Systems - Natural Gas**

**Distress:** Beyond Service Life

**Notes:** The natural gas system is beyond its expected service life and should be scheduled for replacement.

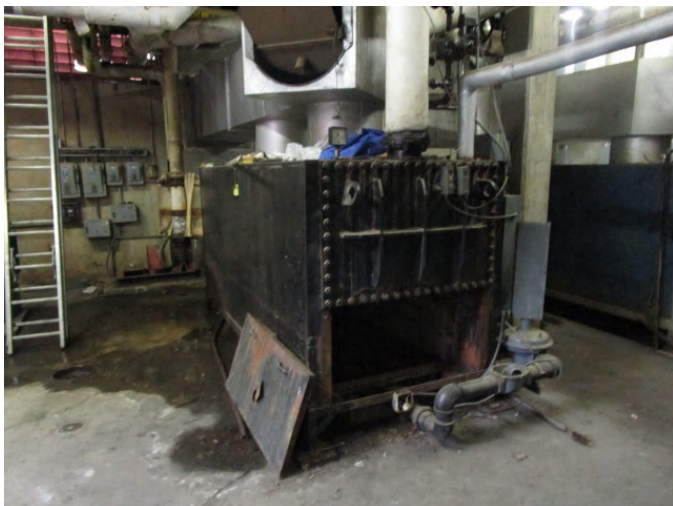
**Location:** Mechanical Room

**System: D3020 - Heat Generating Systems**

**Distress:** Beyond Service Life

**Notes:** The heat generating system is beyond its expected service life and should be scheduled for replacement.

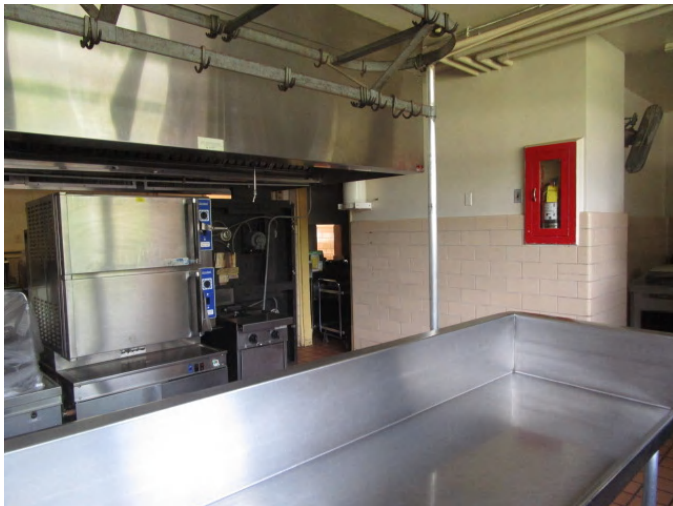
**Location:** Kitchen

**System: D3090 - Other HVAC Systems/Equip - Kitchen Hood**

**Distress:** Beyond Service Life

**Notes:** The kitchen hood is beyond its expected service life and should be scheduled for replacement.

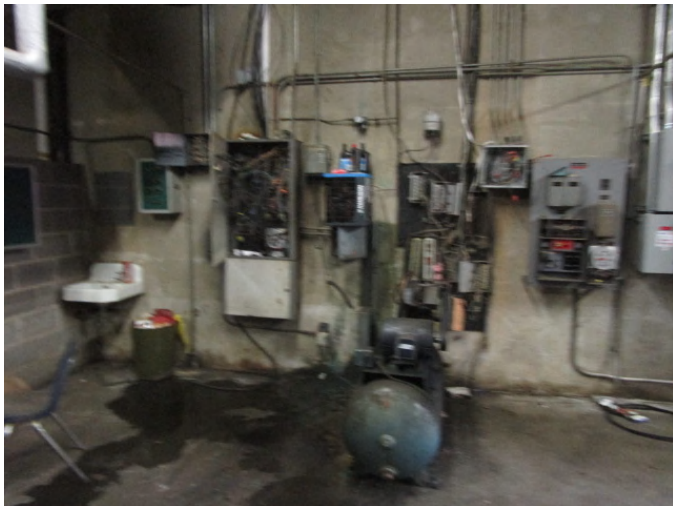
**Location:** Throughout Building

**System: D5020 - Branch Wiring**

**Distress:** Beyond Service Life

**Notes:** The branch wiring system is beyond its expected service life and should be scheduled for replacement.

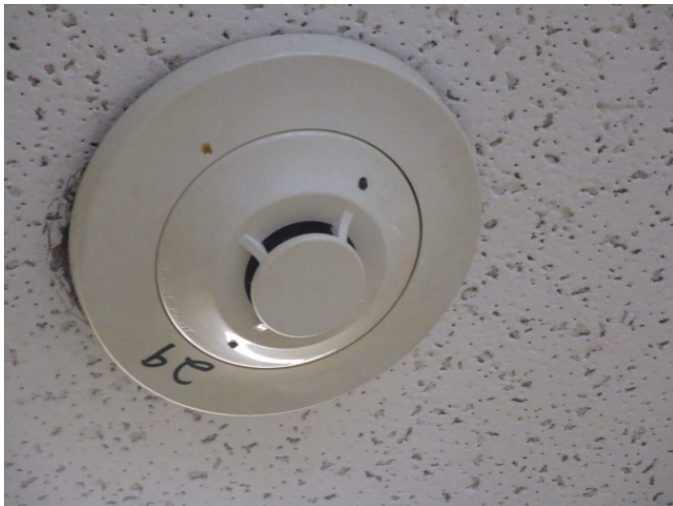
**Location:** Throughout Building

**System: D5030 - Communications and Security - Fire Alarm**

**Distress:** Beyond Service Life

**Notes:** The fire alarm system is beyond its expected service life and should be scheduled for replacement.

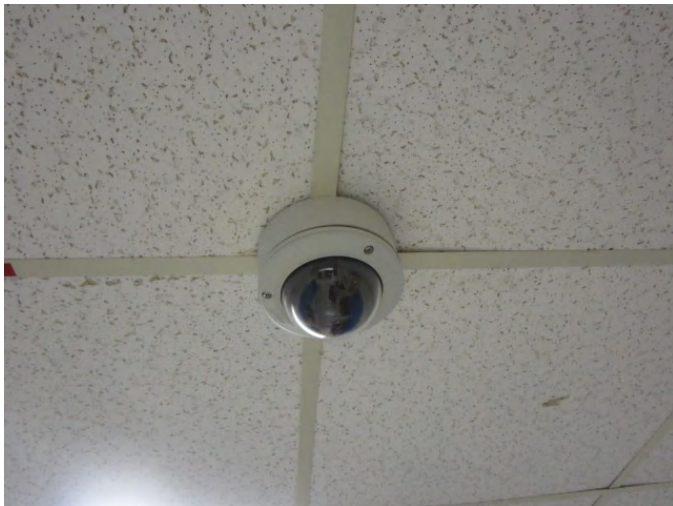
**Location:** Throughout Building

**System: D5030 - Communications and Security - Security & CCTV**

**Distress:** Beyond Service Life

**Notes:** The security and CCTV systems are beyond their expected service life and should be scheduled for replacement.

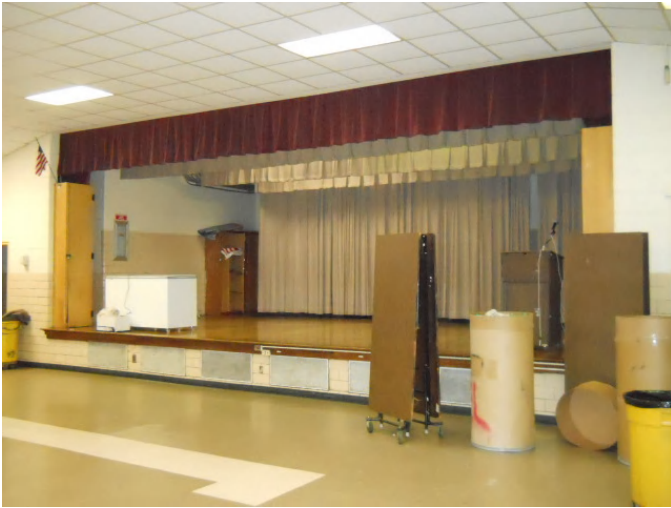
**Location:** Throughout Building

**System: E1020 - Institutional Equipment**

**Distress:** Beyond Service Life

**Notes:** Institutional equipment, such as theater and stage equipment and audio-visual equipment, is beyond its expected service life and should be scheduled for replacement.

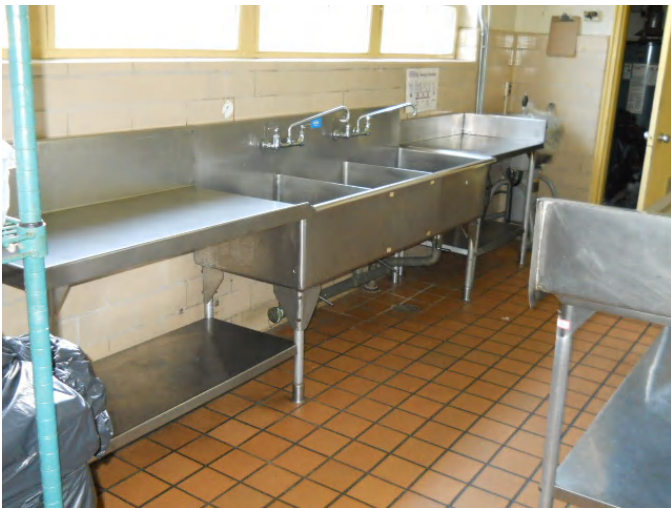
**Location:** Kitchen

**System: E1090 - Other Equipment (Kitchen Equipment)**

**Distress:** Beyond Service Life

**Notes:** The kitchen equipment is beyond expected service life and should be scheduled for replacement.

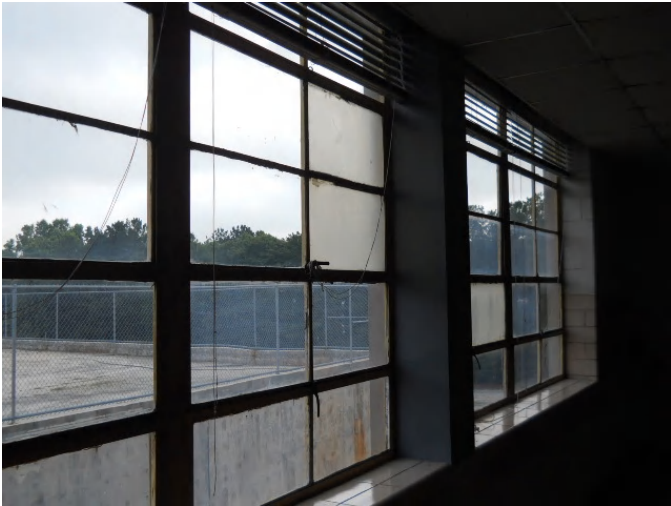
**Location:** Throughout Building

#### **System: B2020 - Exterior Windows**

**Distress:** Beyond Service Life

**Notes:** The exterior window system is beyond its expected service life, not energy efficient, and should be replaced.

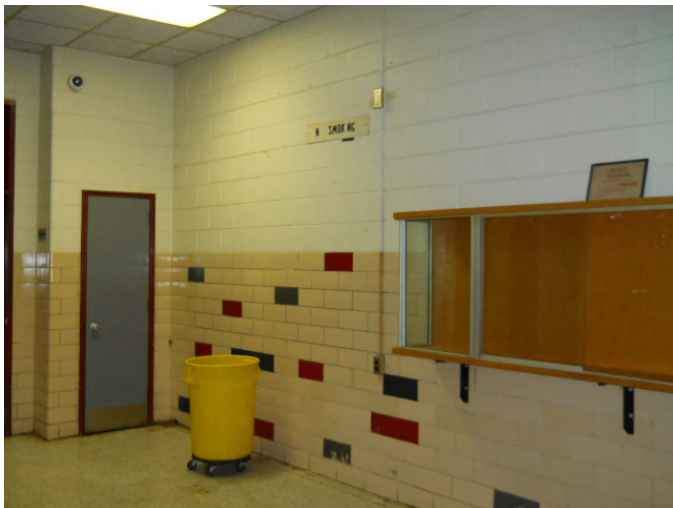
**Location:** Throughout Building

**System: C3010 - Wall Finishes - Paint**

**Distress:** Beyond Service Life

**Notes:** The painted wall finishes are beyond their expected service life and should be replaced.

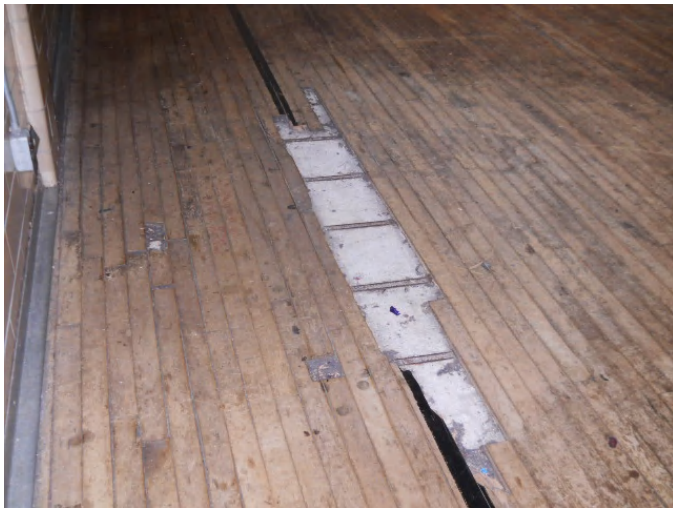
**Location:** Gyms

**System: C3020 - Floor Finishes - Wood**

**Distress:** Beyond Service Life

**Notes:** The wood floor finishes are beyond their expected service life and should be replaced. The upper gym and stage floor areas are permanently off limits do to the poor condition of the floor.

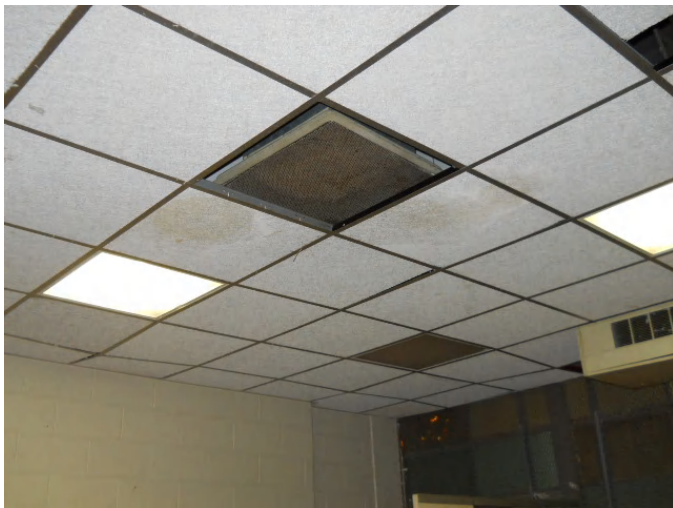
**Location:** Throughout Building

**System: C3030 - Ceiling Finishes**

**Distress:** Beyond Service Life

**Notes:** The ceiling finishes are beyond their expected service life, stained, and should be replaced.

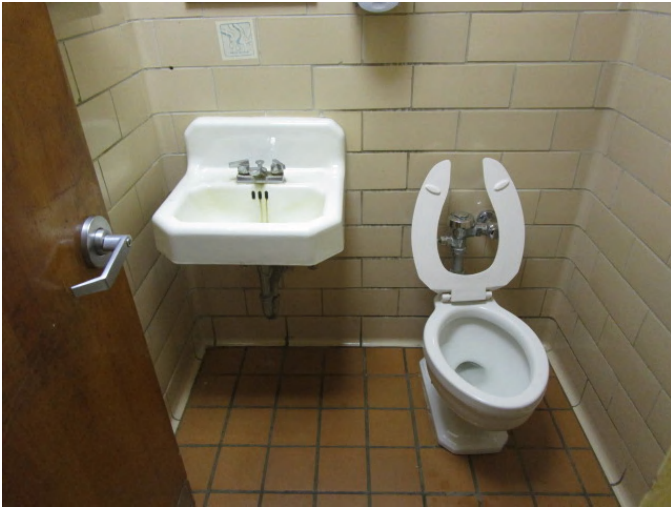
**Location:** Throughout Building

**System: D2010 - Plumbing Fixtures**

**Distress:** Beyond Service Life

**Notes:** Plumbing fixtures are beyond their expected service life, not ADA compliant, and should be scheduled for replacement. Some water fountains protrude into the hallway more than four inches. Protrusion is not ADA Compliant if more than four inches.

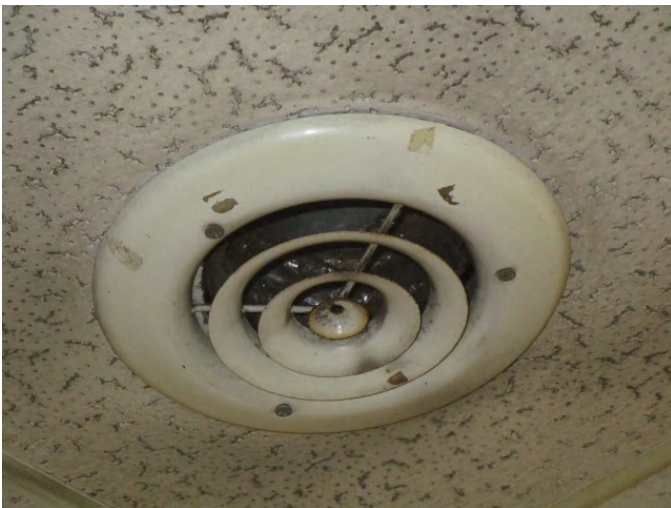
**Location:** Throughout Building

**System: D3040 - Distribution Systems**

**Distress:** Beyond Service Life

**Notes:** The distribution and exhaust systems are beyond their expected service life and should be scheduled for replacement.

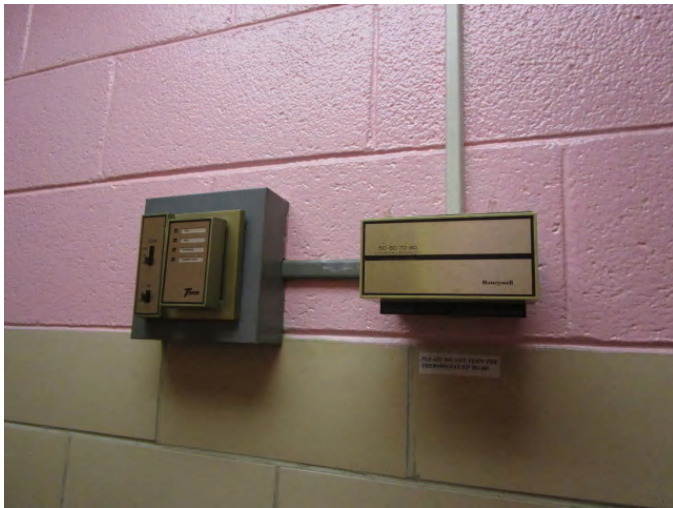
**Location:** Throughout Building

**System: D3060 - Controls & Instrumentation**

**Distress:** Beyond Service Life

**Notes:** Controls and instrumentation are beyond their expected service life and should be scheduled for replacement.

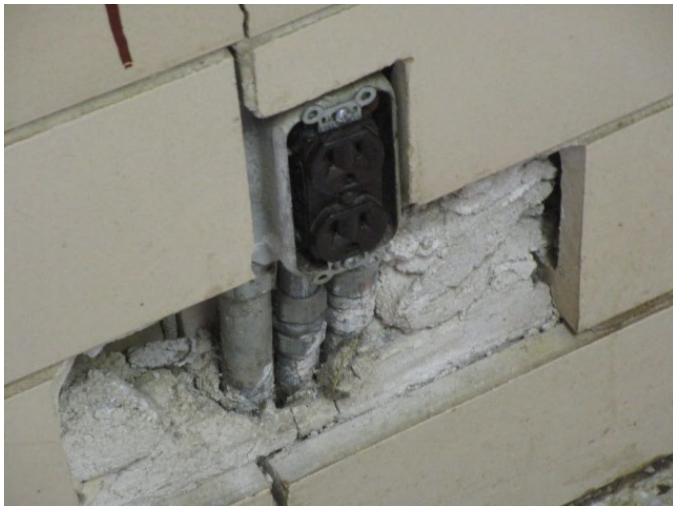
**Location:** Throughout Building

**System: D5020 - Lighting and Branch Wiring**

**Distress:** Beyond Service Life

**Notes:** Lighting and branch wiring are beyond their expected service life and should be replaced.

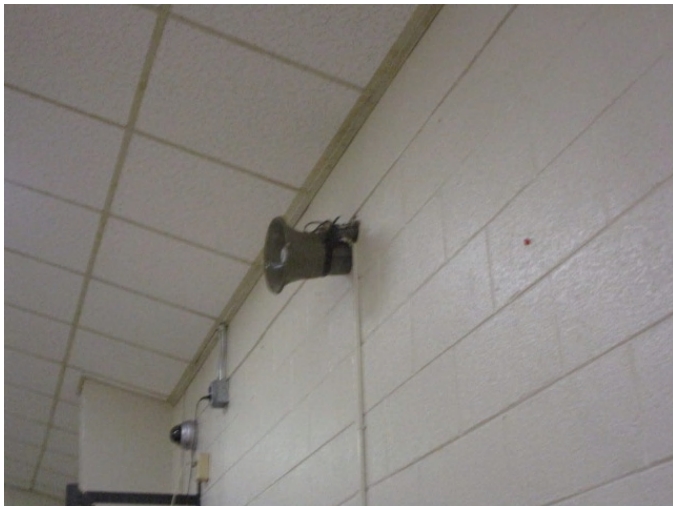
**Location:** Throughout Building

**System: D5030 - Communications and Security**

**Distress:** Beyond Service Life

**Notes:** The communications and security systems are beyond their expected service life and should be scheduled for replacement.

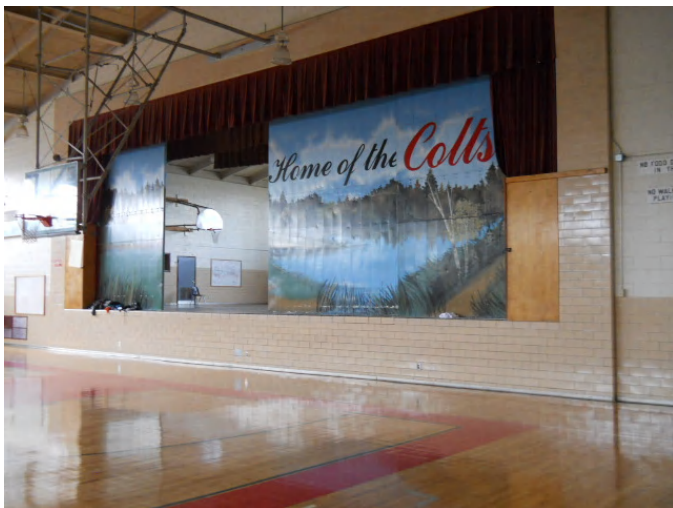
**Location:** Stage

**System: E1020 - Institutional Equipment**

**Distress:** Beyond Service Life

**Notes:** Theater and stage equipment is beyond its expected service life and should be scheduled for replacement.

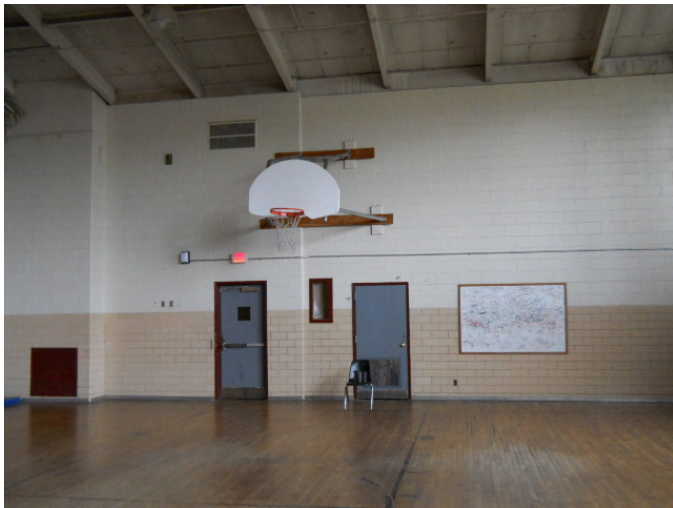
**Location:** Gym

**System: E1090 - Other Equipment**

**Distress:** Beyond Service Life

**Notes:** The athletic equipment is beyond its expected service life and should be scheduled for replacement.

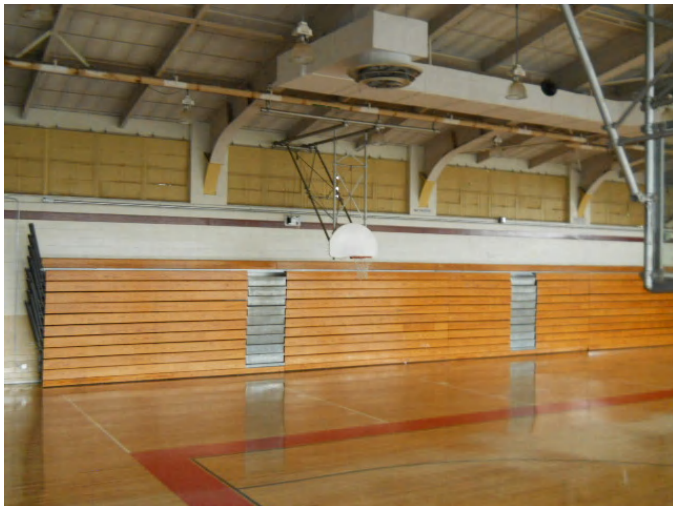
**Location:** Gym

**System: E2010 - Fixed Furnishings**

**Distress:** Beyond Service Life

**Notes:** The fixed multiple seating system is beyond its expected service life and should be scheduled for replacement.

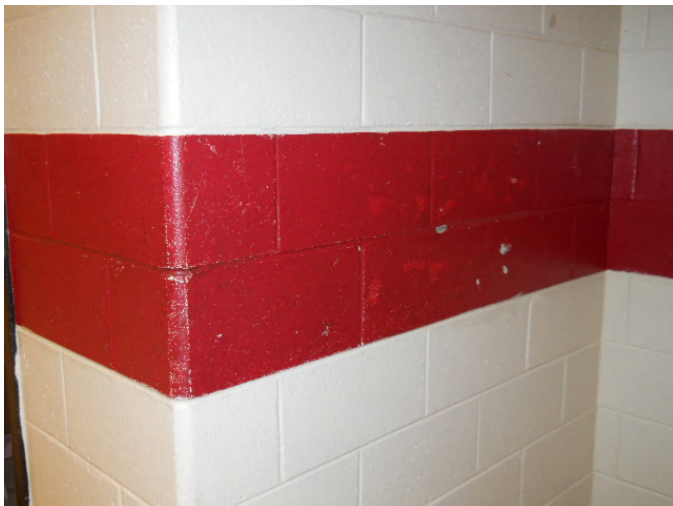
**Location:** Throughout Building

**System: C3010 - Wall Finishes - Paint**

**Distress:** Beyond Service Life

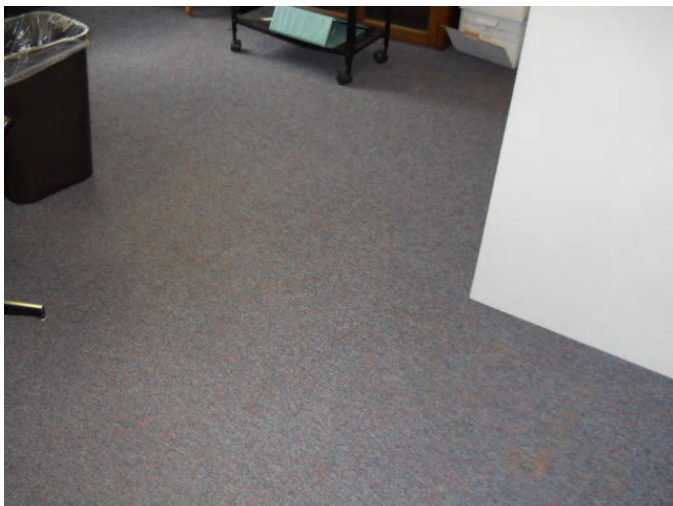
**Location:** Offices

**System: C3020 - Floor Finishes - Carpet**

**Distress:** Beyond Service Life

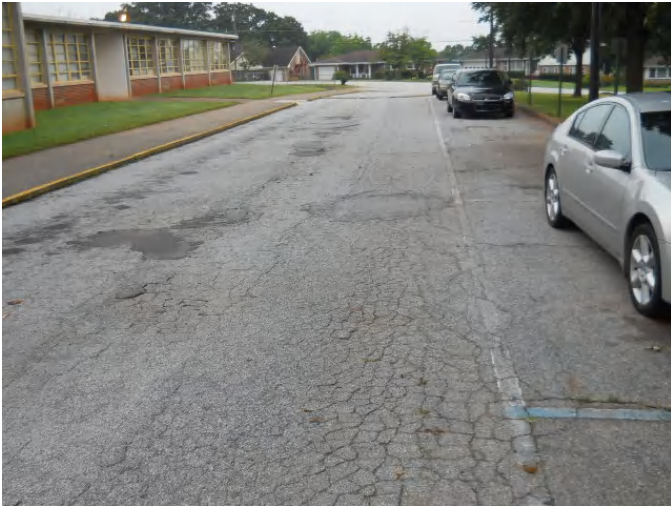
#### System: G2010 - Roadways

**Location:** Site

**Distress:** Beyond Service Life

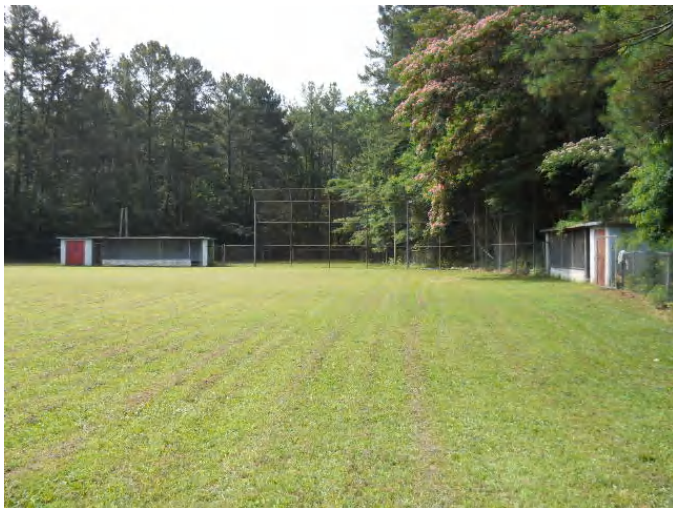
**System: G2040 - Baseball Field**

**Location:** Site

**Distress:** Beyond Service Life

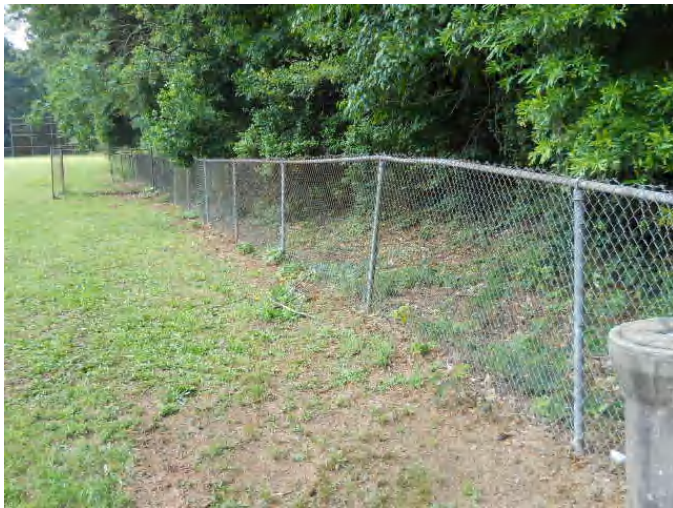
**System: G2040 - Fencing & Guardrails**

**Location:** Site

**Distress:** Beyond Service Life

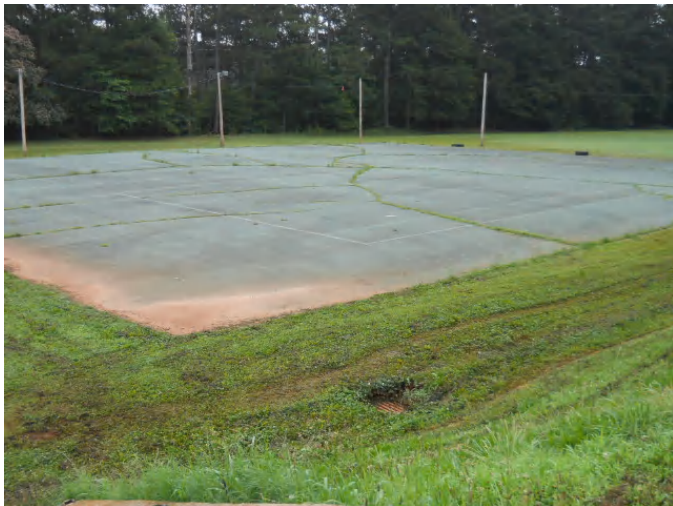
**System: G2040 - Tennis Courts**

**Location:** Site

**Distress:** Beyond Service Life

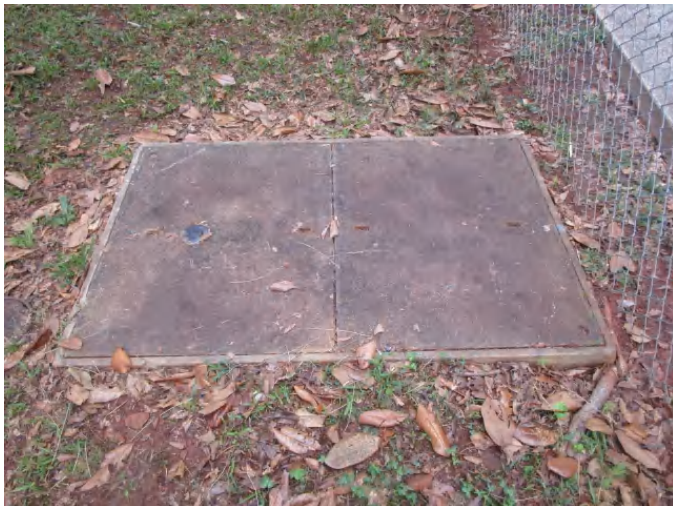
**System: G3010 - Water Supply**

**Location:** Site

**Distress:** Beyond Service Life

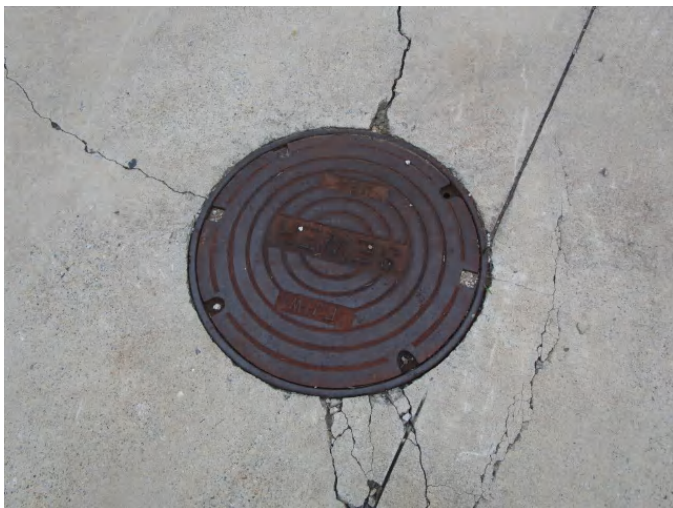
**System: G3020 - Sanitary Sewer**

**Location:** Site

**Distress:** Beyond Service Life

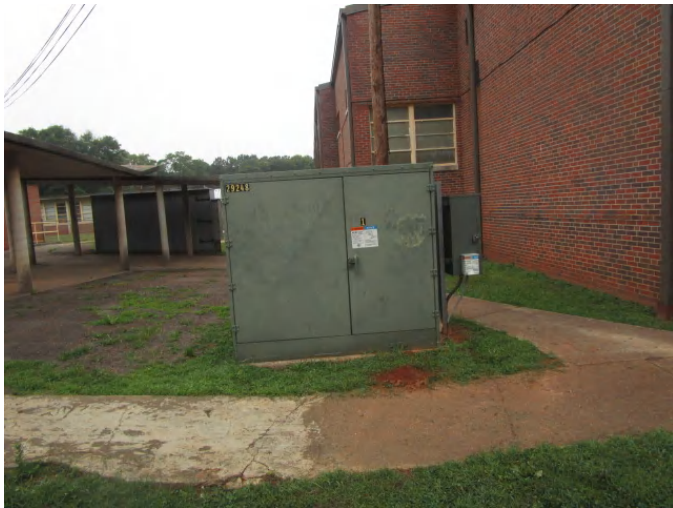
**System: G4010 - Electrical Distribution**

**Location:** Site

**Distress:** Beyond Service Life

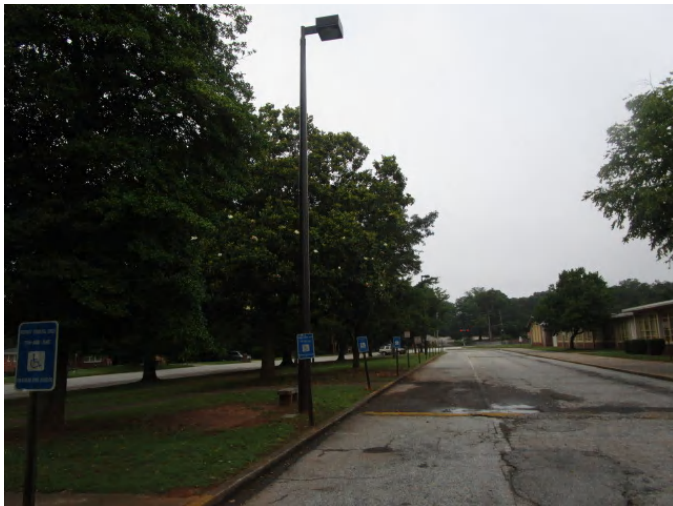
**System: G4020 - Site Lighting**

**Location:** Site

**Distress:** Beyond Service Life
