DeKalb County School District/Admin/Support

Sam A. Moss Service Center

School Assessment Report

May 19, 2016

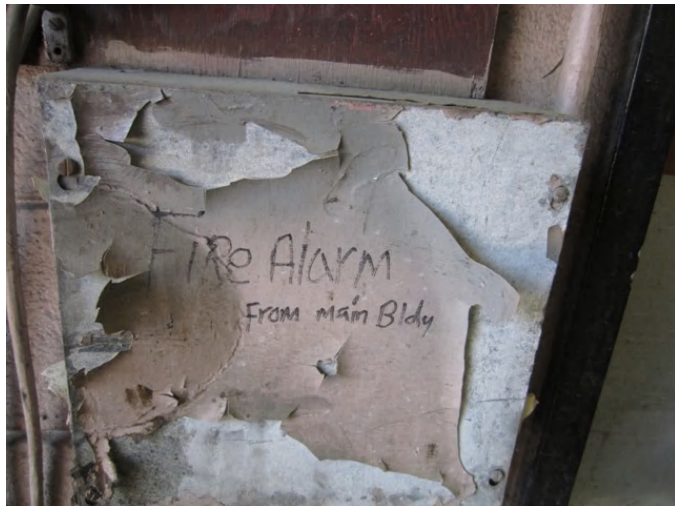
System: D5030 - Communications and Security - Fire Alarm

Location: Throughout Building

Distress: Beyond Service Life

Notes: The fire alarm system is beyond its expected service life and should be scheduled for replacement.

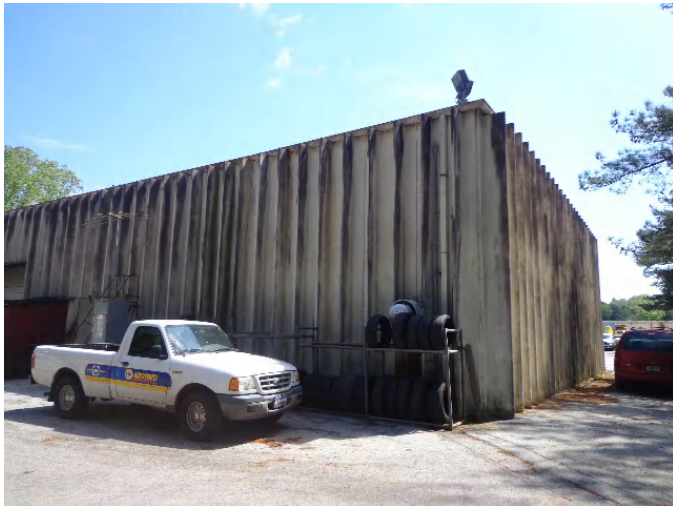
System: B2010 - Exterior Walls

Location: Exterior Walls

Distress: Beyond Service Life

Notes: The exterior walls are aged, faded, and stained, and should be cleaned and repainted.

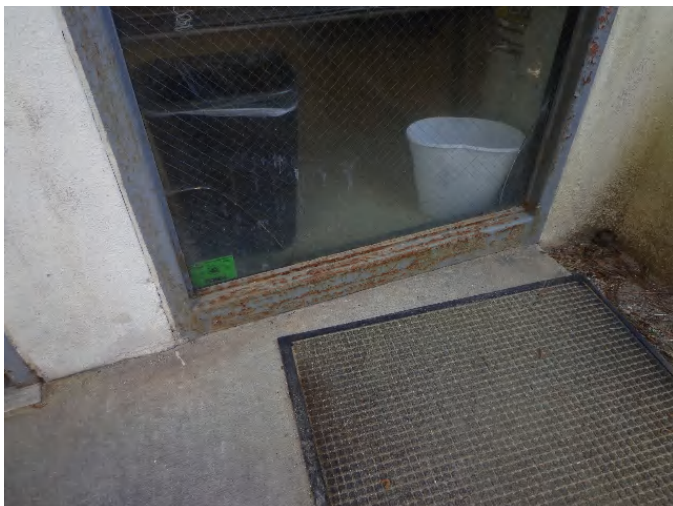
System: B2020 - Exterior Windows

Location: Exterior Walls

Distress: Beyond Service Life

Notes: The windows are aged, rusted and not energy efficient, and should be replaced.

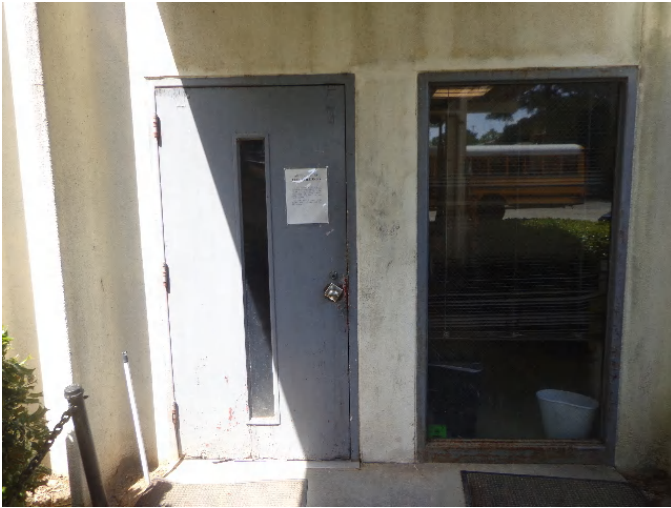
System: B2030 - Exterior Doors

Location: Exterior Walls

Distress: Beyond Service Life

Notes: The original exterior doors are aged, rusted, and should be replaced.

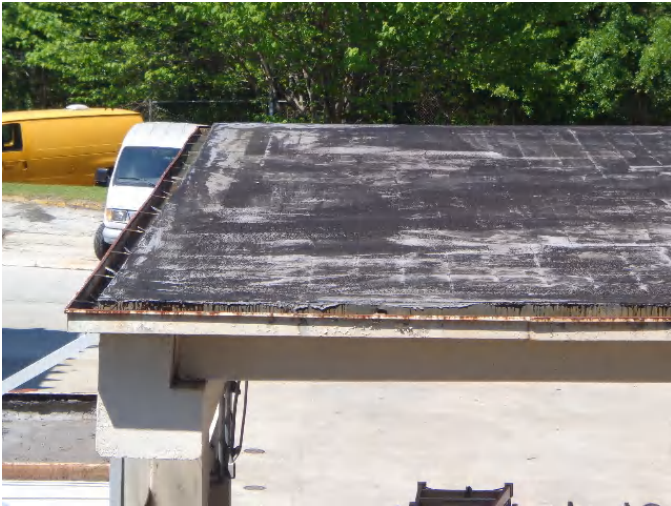
System: B3010 - Roof Coverings - BUR

Location: Roof

Distress: Beyond Service Life

Notes: The built-up roof covering is aged, showing signs of failure, has ponding water, and should be scheduled for replacement. SPLOST project 325-422 to replace the roof on the 1970 fleet services center building.

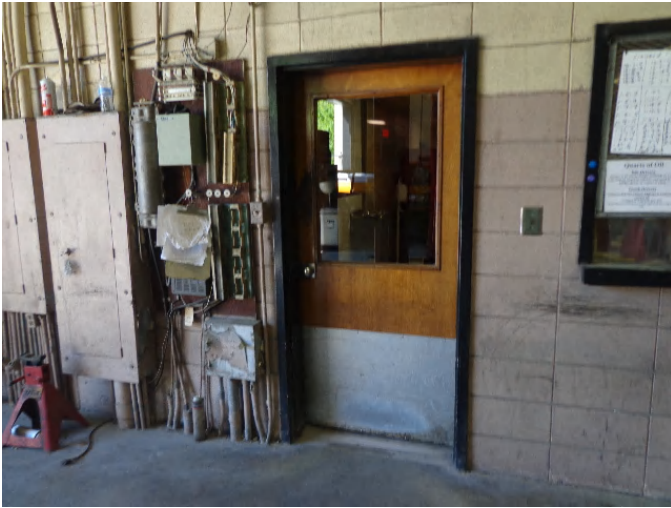
System: C1020 - Interior Doors

Location: Throughout Building

Distress: Beyond Service Life

Notes: The interior doors are aged, failing, (hardware is) not ADA compliant, and should be replaced.

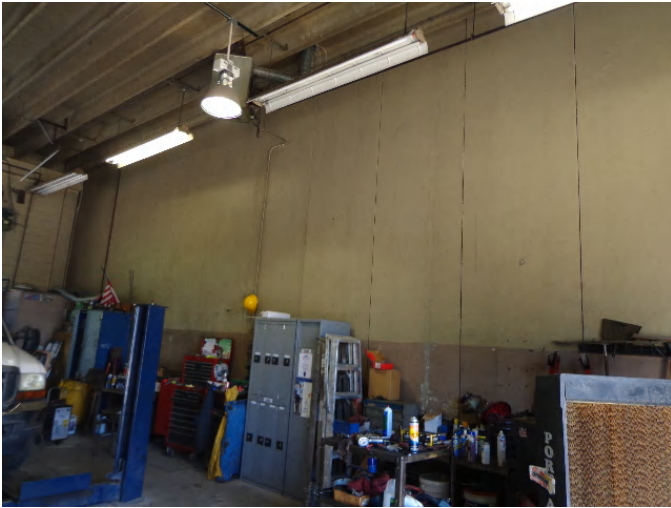
System: C3010 - Wall Finishes

Location: Throughout Building

Distress: Beyond Service Life

Notes: The painted wall finish is aged, scuffed and stained, and should be replaced.

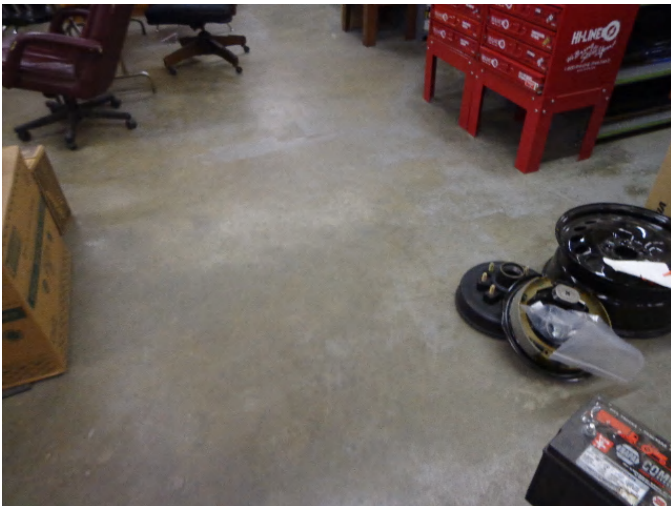
System: C3020 - Floor Finishes - Finished Concrete

Location: Throughout Building

Distress: Beyond Service Life

Notes: Floor finish is beyond its expected service life and should be re-applied.

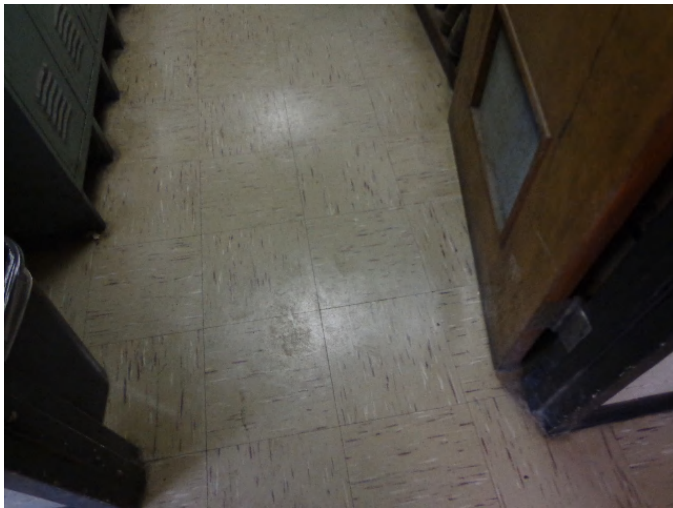
System: C3020 - Floor Finishes - VCT

Location: Throughout Building

Distress: Beyond Service Life

Notes: The VCT flooring is aged, cracked and worn, and should be replaced.

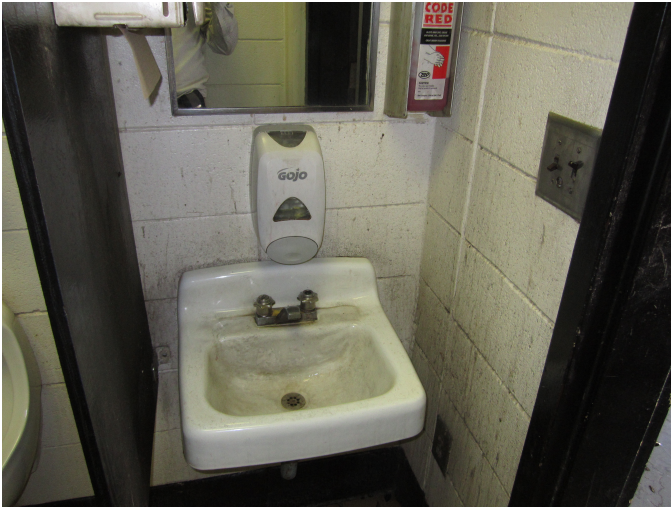
System: D2010 - Plumbing Fixtures

Location: Throughout Building

Distress: Beyond Service Life

Notes: The plumbing fixtures are beyond their expected service life, not ADA compliant, and should be scheduled for replacement.

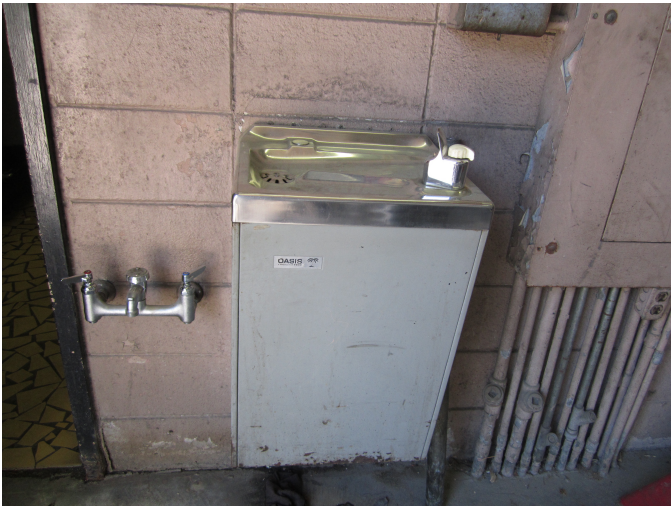
System: D2020 - Domestic Water Distribution

Location: Throughout Building

Distress: Beyond Service Life

Notes: The domestic water distribution system is beyond its expected service life, has water quality issues, and should be scheduled for replacement.

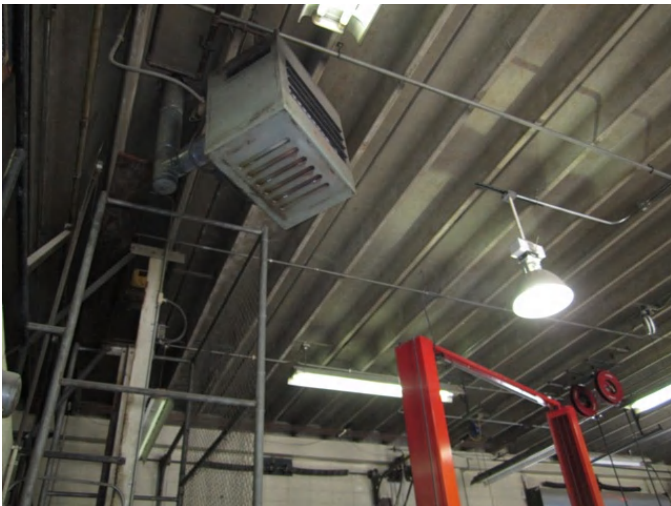
System: D2090 - Other Plumbing Systems -Natural Gas

Location: Throughout Building

Distress: Beyond Service Life

Notes: The natural gas system is beyond its expected service life and should be scheduled for replacement.

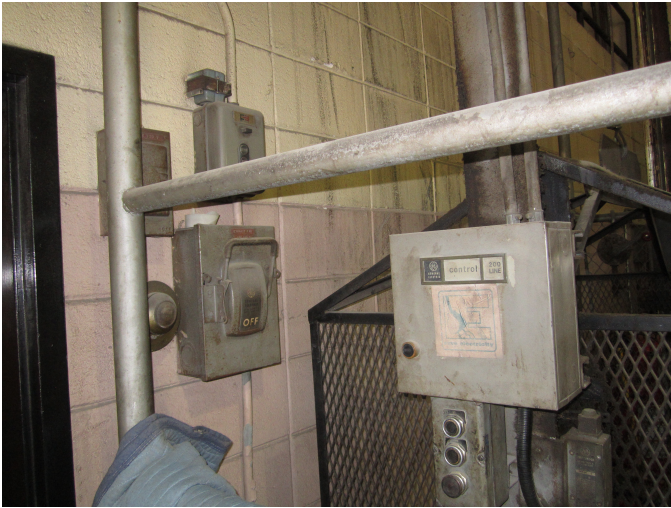
System: D3060 - Controls & Instrumentation

Location: Throughout Building

Distress: Beyond Service Life

Notes: Controls and instrumentation are beyond their expected service life and should be scheduled for replacement.

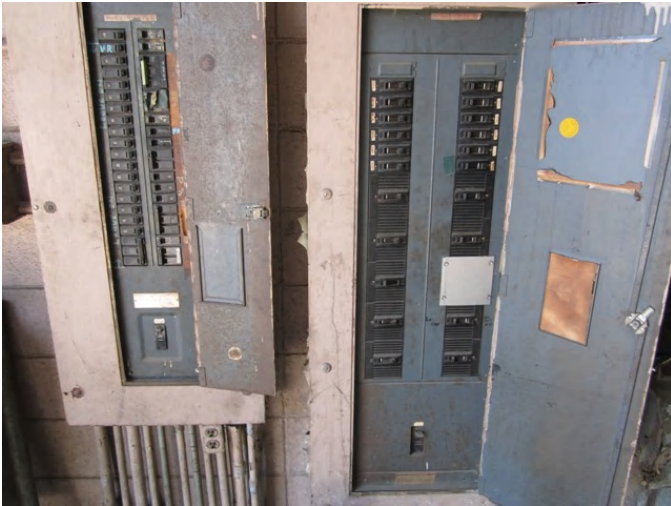
System: D5010 - Electrical Service/Distribution

Location: Throughout Building

Distress: Beyond Service Life

Notes: Electrical service/distribution is beyond its expected service life and should be scheduled for replacement.

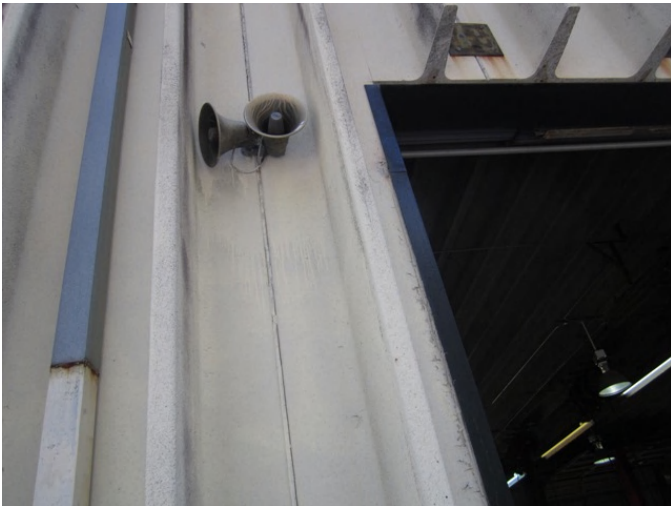
System: D5030 - Communications and Security - PA & Clock Systems

Location: Throughout Building

Distress: Beyond Service Life

Notes: PA and clock systems are beyond their expected service life and should be scheduled for replacement.

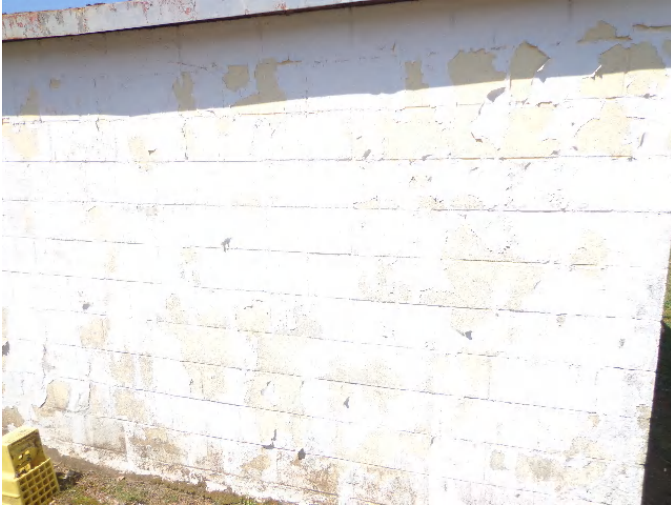
System: B2010 - Exterior Walls

Location: Exterior Walls

Distress: Beyond Service Life

Notes: The exterior wall finish is aged, stained and peeling, and should be replaced.

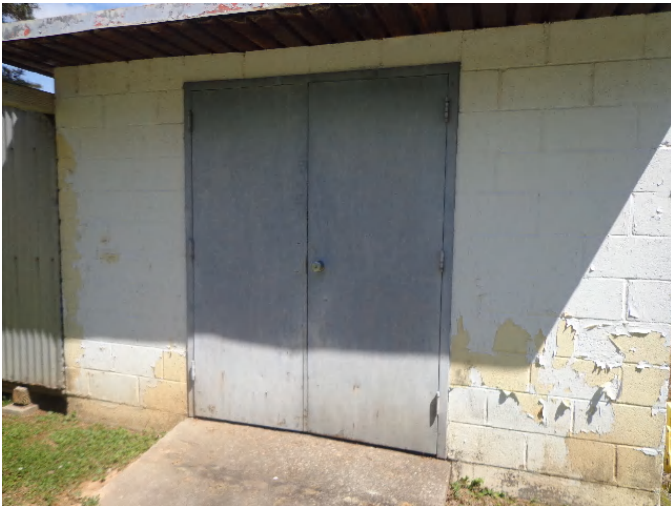
System: B2030 - Exterior Doors

Location: Exterior Walls

Distress: Beyond Service Life

Notes: The original exterior doors are aged, rusted, and should be replaced.

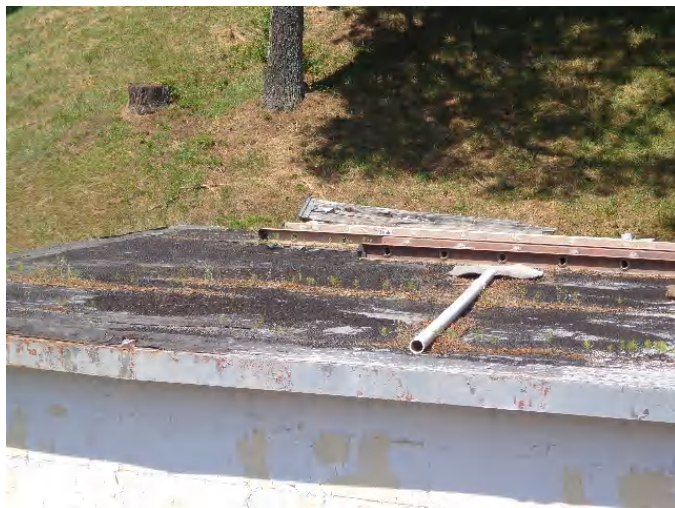
System: B3010 - Roof Coverings

Location: Roof

Distress: Beyond Service Life

Notes: The built-up roof covering is aged, showing signs of failure, and should be replaced.

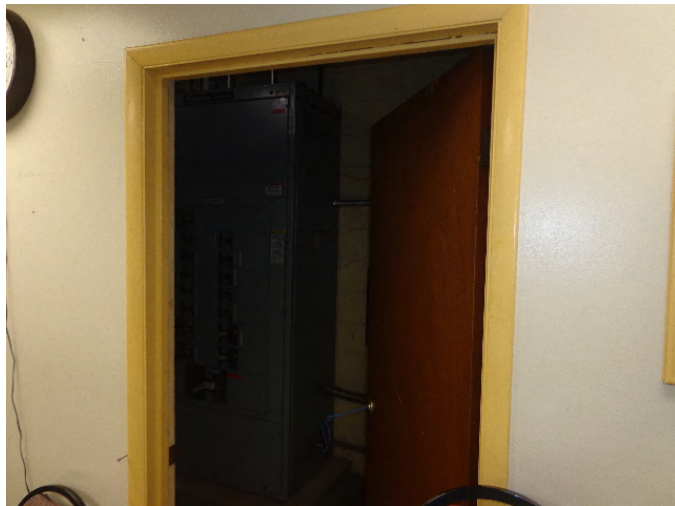
System: C1010 - Partitions

Location: Electrical Room

Distress: Needs Remediation

Correction: Add/replace partitions to meet 1-hr rating

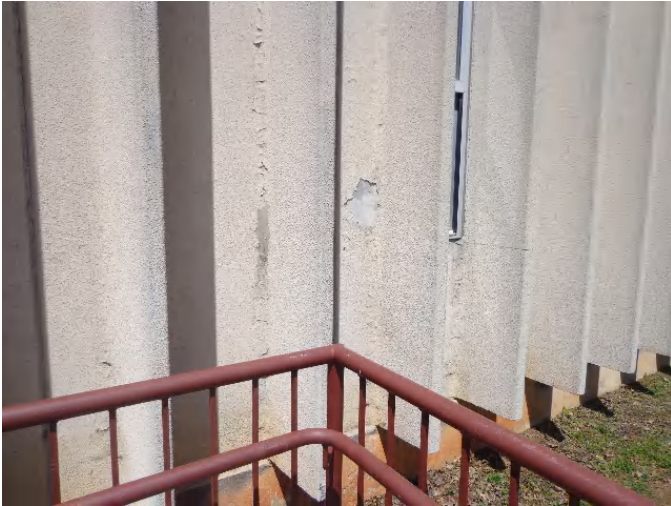
System: B2010 - Exterior Walls

Location: East and West Exterior Walls

Distress: Beyond Service Life

Notes: Exterior wall finish is stained, fading and peeling, and should be replaced.

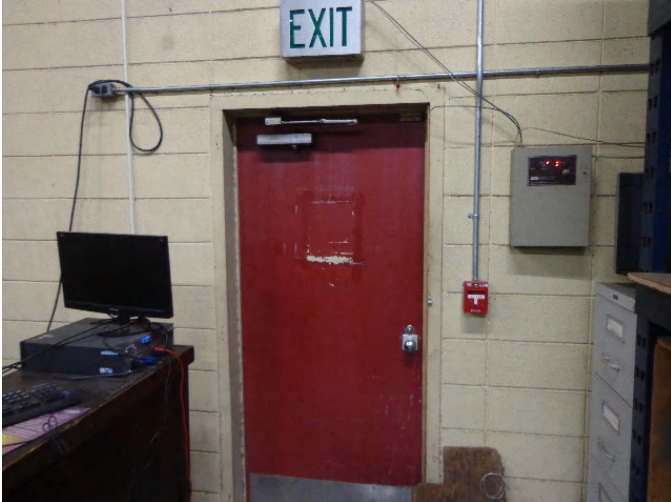
System: B2030 - Exterior Doors

Location: Exterior Walls

Distress: Beyond Service Life

Notes: The original exterior doors are aged, not code compliant, and should be scheduled for replacement. The emergency exit doors in the warehouse do not have a panic hardware installed on them.

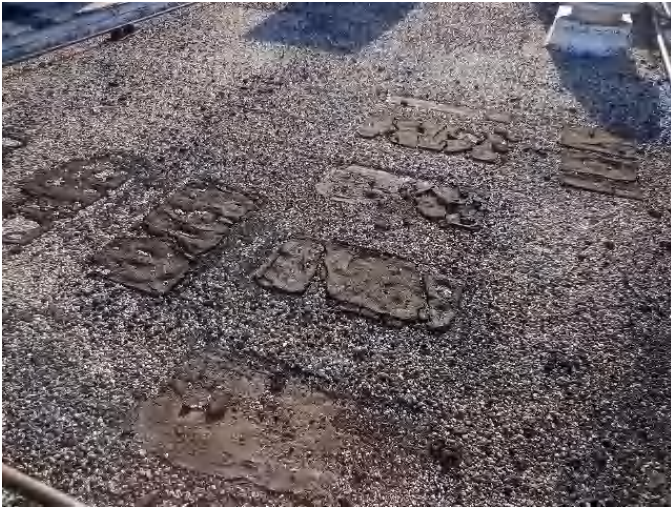
System: B3010 - Roof Coverings - BUR

Location: Roof

Distress: Beyond Service Life

Notes: The built-up roof covering is aged, showing signs of failure, and has ponding water and leaks. SPLOST project 325-422 to replace the low roof, repair the high roof, and replace roof openings on the 1970 warehouse building.

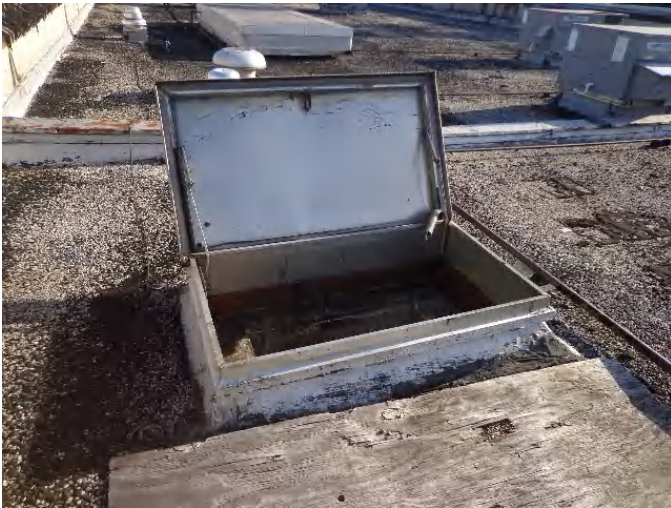
System: B3020 - Roof Openings

Location: Roof

Distress: Beyond Service Life

Notes: Roof openings, including roof hatch, are beyond their expected service life and should be replaced in conjunction with the roof. SPLOST project 325-422 to replace roof openings.

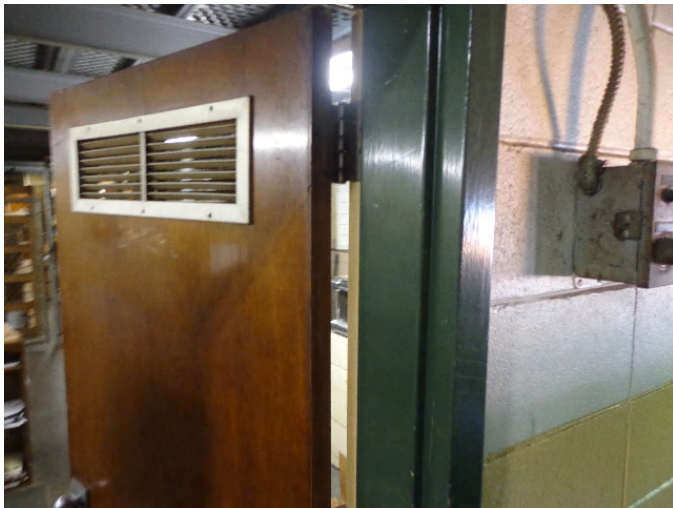
System: C1020 - Interior Doors

Location: Throughout Building

Distress: Beyond Service Life

Notes: The interior doors are aged, failing, (hardware is) not ADA compliant, and should be replaced.

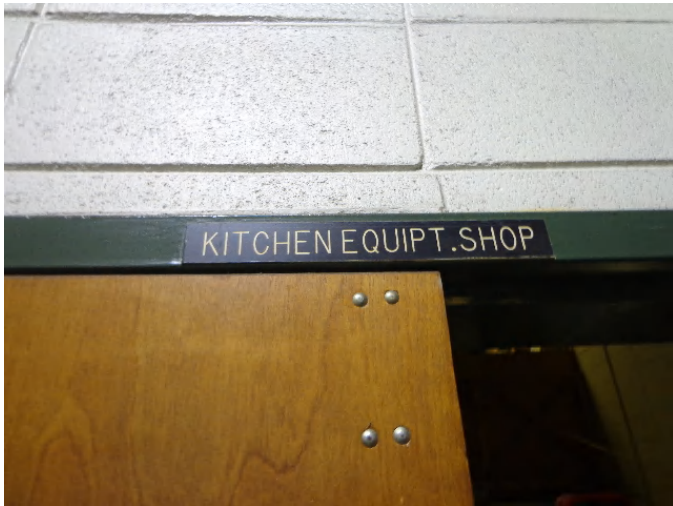
System: C1030 - Fittings

Location: Throughout Building

Distress: Beyond Service Life

Notes: Fittings, such as toilet partitions, handrails and signage, are in marginal condition, not ADA compliant, and should be replaced.

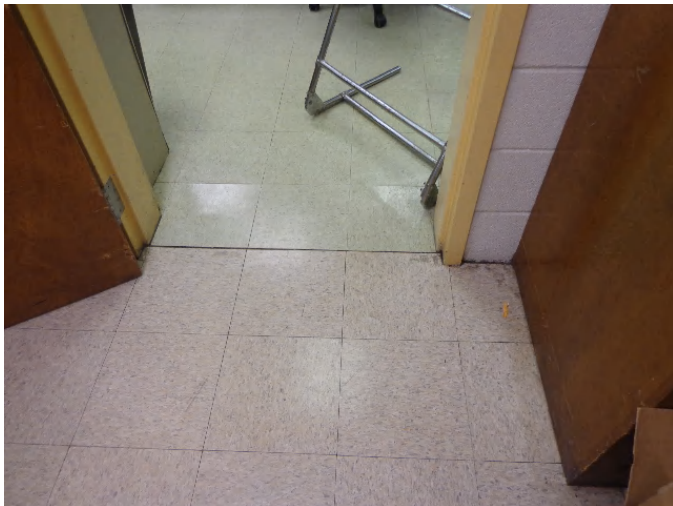
System: C3020 - Floor Finishes - VCT

Location: Throughout Building

Distress: Beyond Service Life

Notes: The VCT flooring is aged, cracked and worn, and should be replaced.

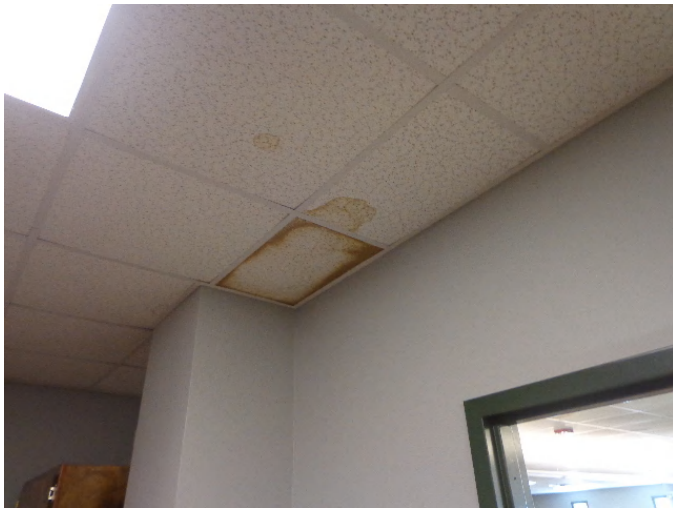
System: C3030 - Ceiling Finishes

Location: Throughout Building

Distress: Beyond Service Life

Notes: The acoustical ceiling tiles have been replaced as needed. However, many are damaged and the entire system should be replaced.

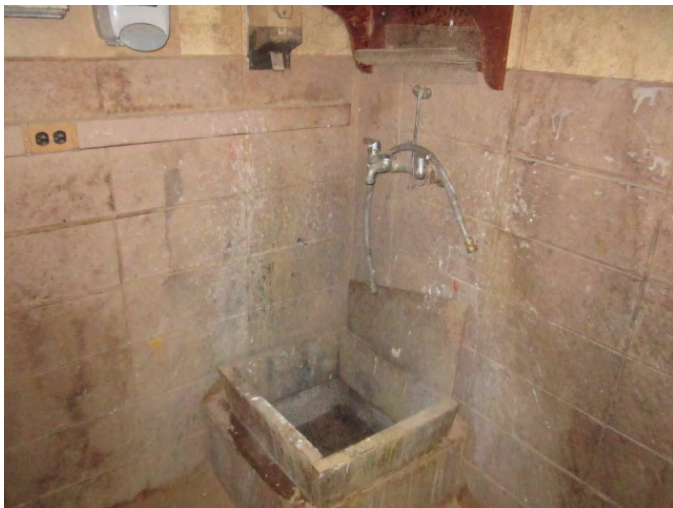
System: D2010 - Plumbing Fixtures

Location: Throughout Building

Distress: Beyond Service Life

Notes: Plumbing fixtures are beyond their expected service life, not ADA compliant, and should be scheduled for replacement.

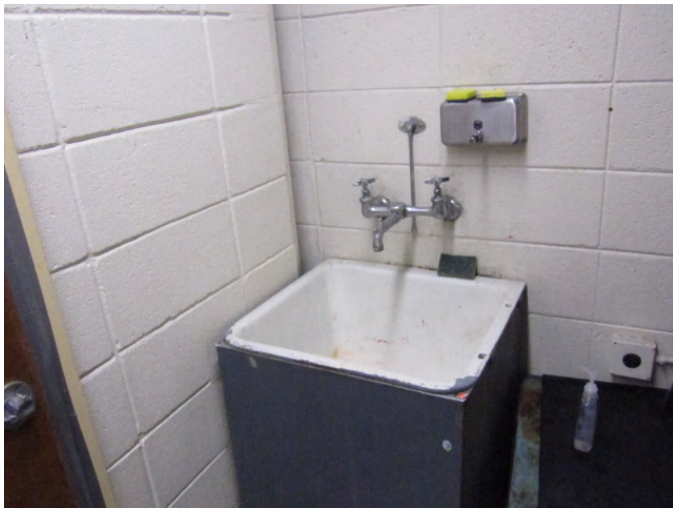
System: D2020 - Domestic Water Distribution

Location: Throughout Building

Distress: Beyond Service Life

Notes: The domestic water distribution system is beyond its expected service life, has water quality issues, and should be scheduled for replacement.

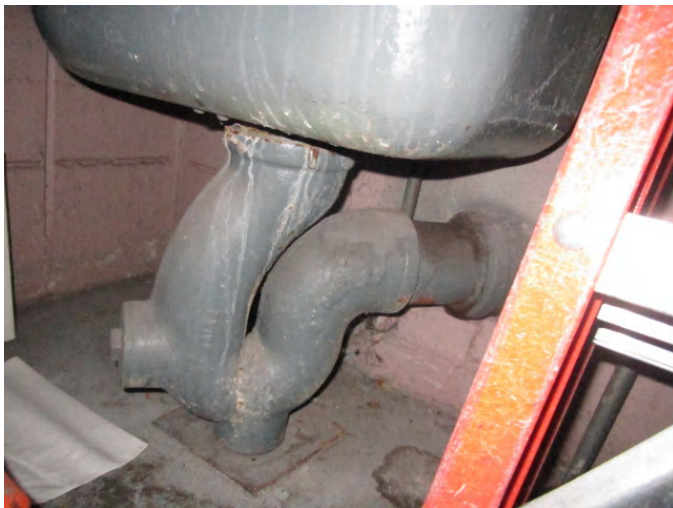
System: D2030 - Sanitary Waste

Location: Throughout Building

Distress: Beyond Service Life

Notes: The sanitary waste system is beyond its expected service life and should be scheduled for replacement.

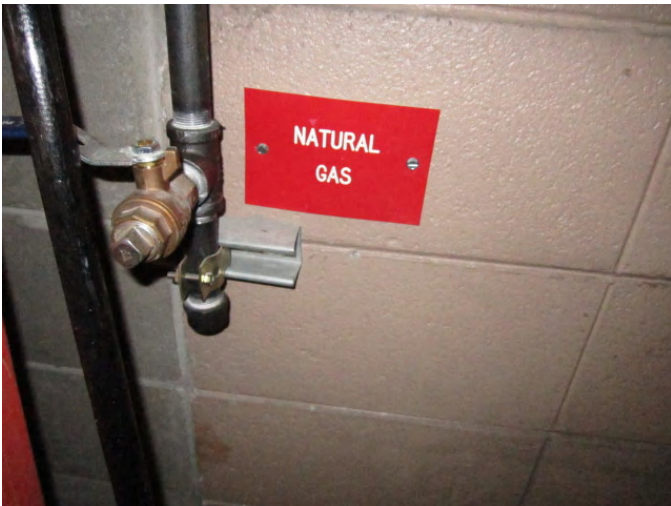
System: D2090 - Other Plumbing Systems - Natural Gas

Location: Throughout Building

Distress: Beyond Service Life

Notes: The natural gas system is beyond its expected service life and should be scheduled for replacement.

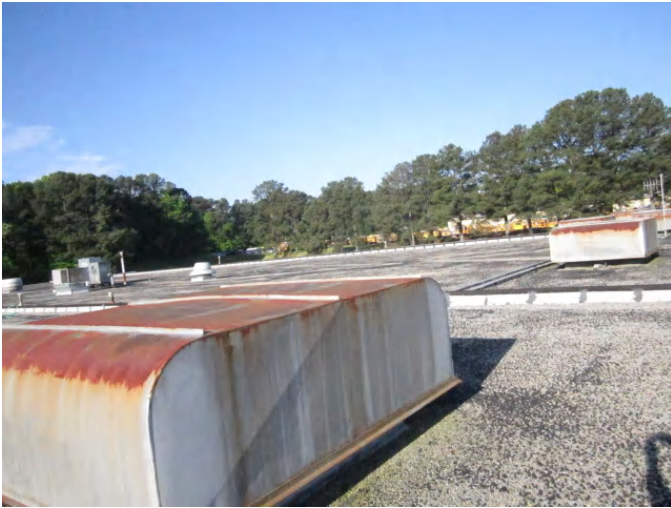
System: D3040 - Distribution Systems & Exhaust Systems

Location: Throughout Building

Distress: Beyond Service Life

Notes: Distribution and exhaust systems are beyond their expected service life and should be scheduled for replacement.

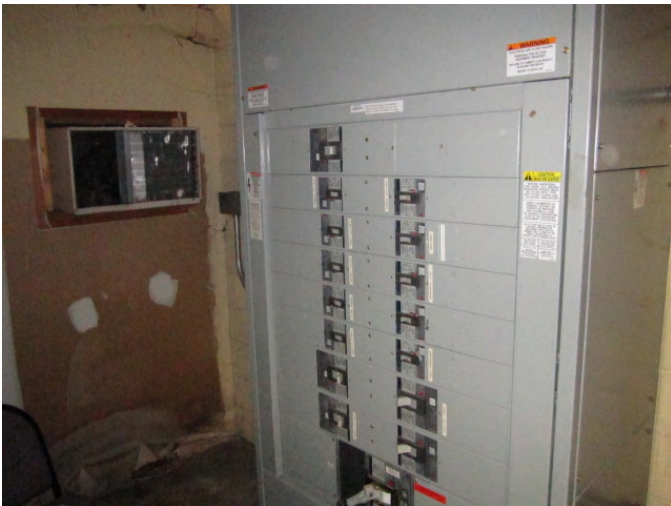
System: D5010 - Electrical Service/Distribution

Location: Throughout Building

Distress: Beyond Service Life

Notes: Electrical service/distribution is beyond its expected service life and should be scheduled for replacement. One panel (G-480/277 V) was observed with missing blanking plates, posing risk of exposure to energized bus and conductors. Some electrical rooms also have stored materials that need to be removed.

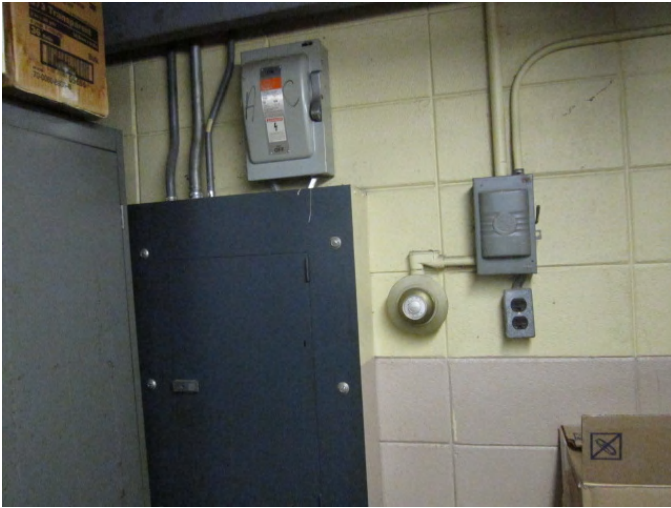
System: D5020 - Branch Wiring

Location: Throughout Building

Distress: Beyond Service Life

Notes: The branch wiring is beyond its expected service life and should be scheduled for replacement.

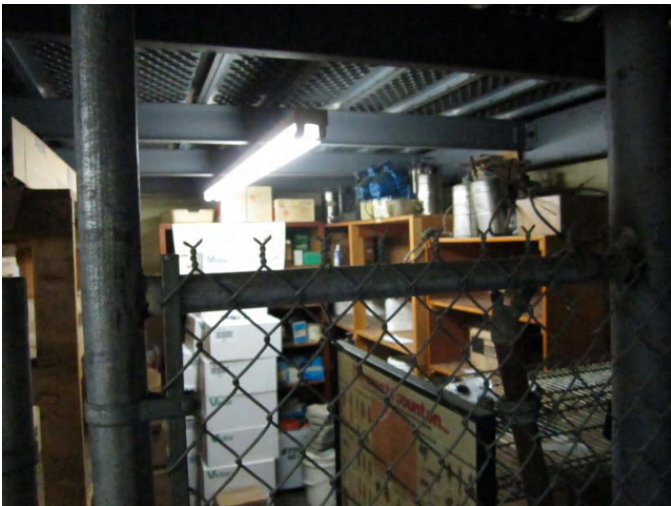
System: D5020 - Lighting

Location: Throughout Building

Distress: Beyond Service Life

Notes: The lighting system is beyond its expected service life and should be scheduled for replacement. There is a lack of exit signs near main service electric switchgear and inadequate lighting in that area.

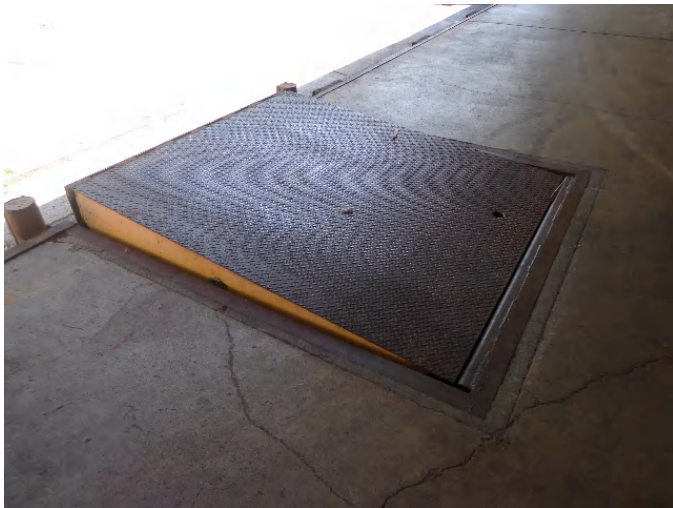
System: E1030 - Vehicular Equipment - Loading Dock Equip.

Location: Loading Dock

Distress: Beyond Service Life

Notes: The loading dock equipment is beyond its expected service life and should be scheduled for replacement.

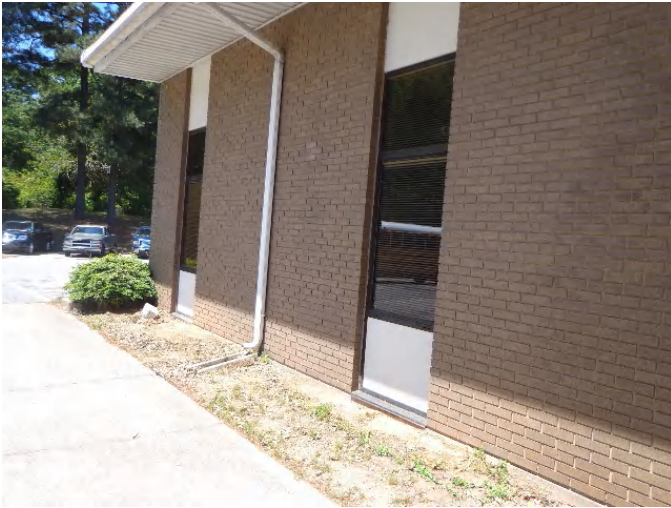
System: B2020 - Exterior Windows

Location: Exterior Walls

Distress: Beyond Service Life

Notes: The aluminum frame, operable, single pane windows are aged, not energy efficient, and should be scheduled for replacement.

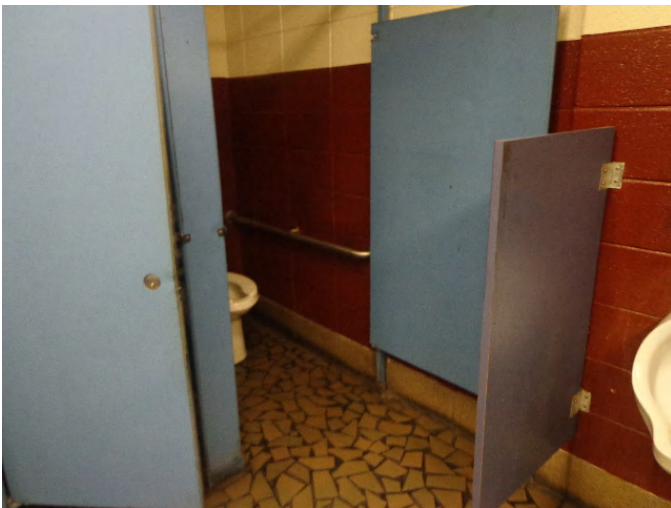
System: C1030 - Fittings

Location: Throughout Building

Distress: Beyond Service Life

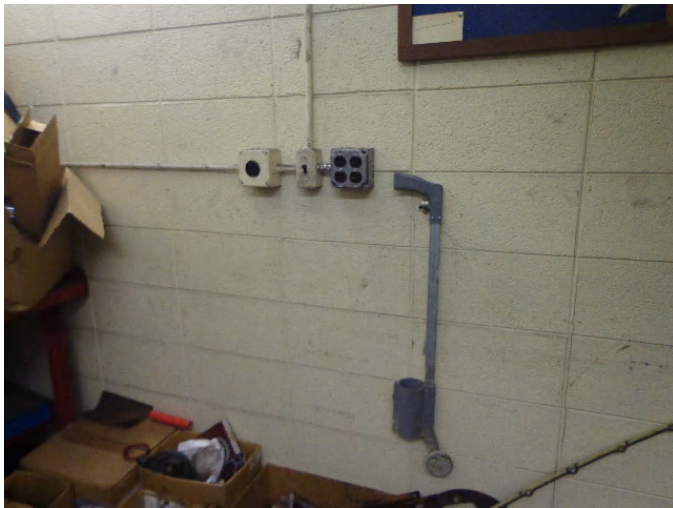
System: C3010 - Wall Finishes - Paint

Distress: Beyond Service Life

Notes: The painted wall finish is aged, scuffed and stained, and should be replaced.

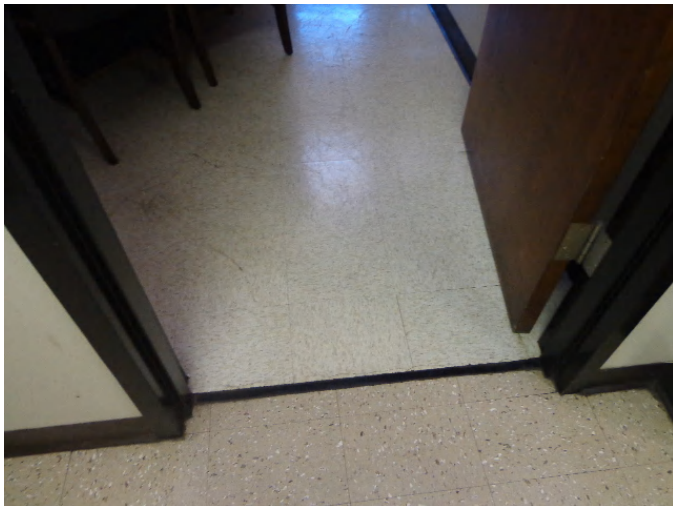
System: C3020 - Floor Finishes - VCT

Distress: Beyond Service Life

Notes: The VCT flooring is aged, cracked and worn, and should be replaced.

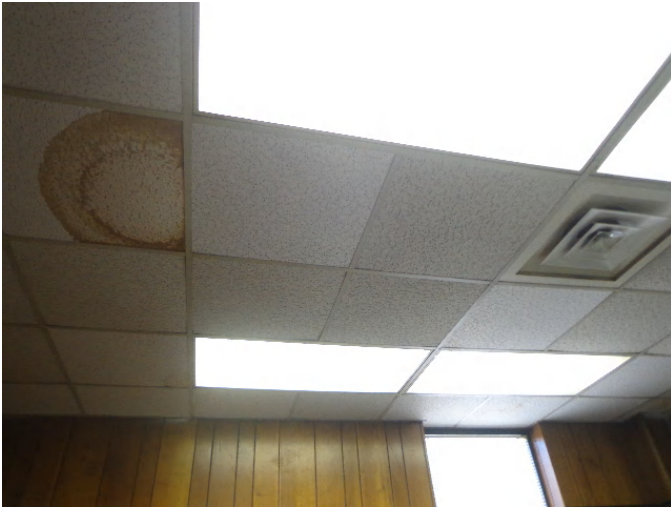
System: C3030 - Ceiling Finishes

Distress: Beyond Service Life

Notes: The acoustical ceiling tiles have been replaced as needed. However, the grid shows signs of aging and most tiles are sagging or damaged, and the entire system should be replaced.

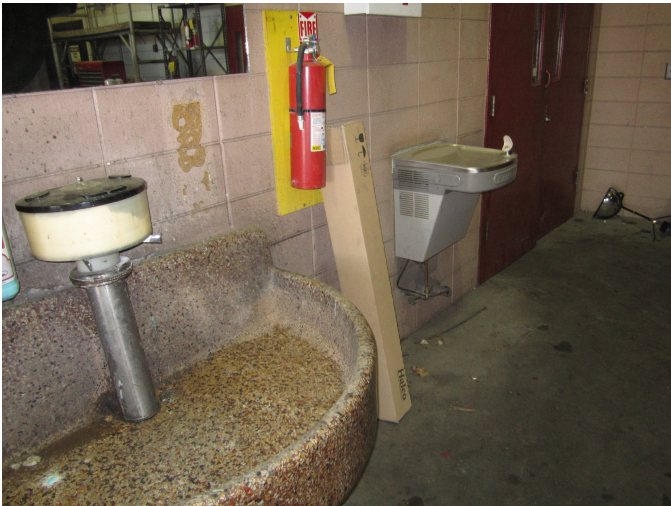
System: D2010 - Plumbing Fixtures

Distress: Beyond Service Life

Notes: The plumbing fixtures are beyond their expected service life, not ADA compliant, and should be scheduled for replacement.

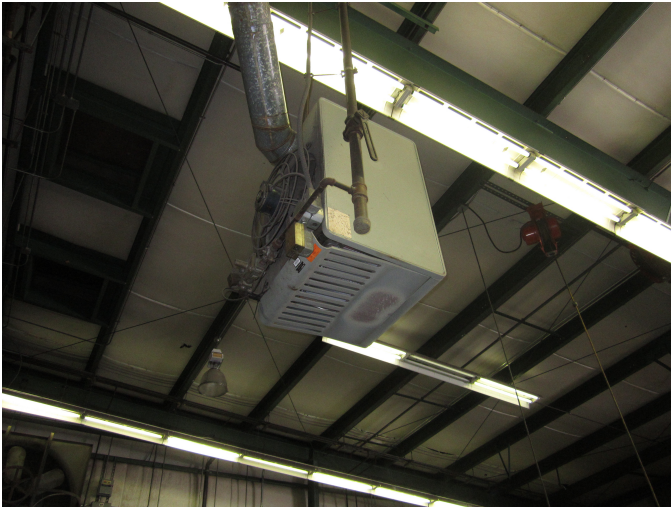
System: D3050 - Terminal & Package Units

Distress: Beyond Service Life

Notes: Terminal and package units are beyond their expected service life, inadequate, and should be scheduled for replacement.

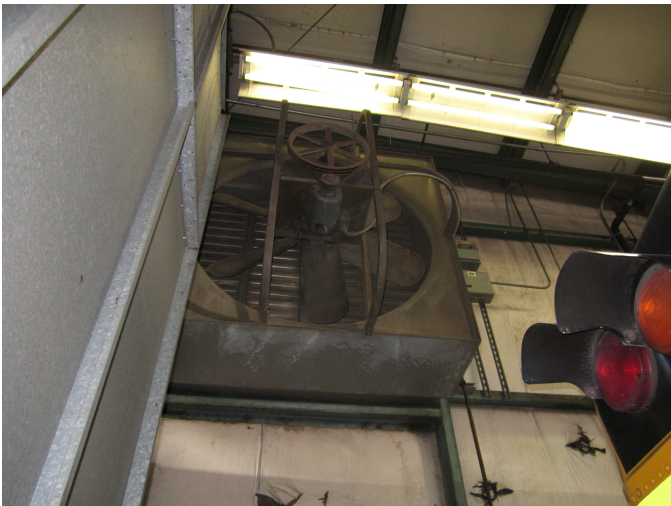
System: D3060 - Controls & Instrumentation

Distress: Beyond Service Life

Notes: Controls and instrumentation are beyond their expected service life and should be scheduled for replacement.

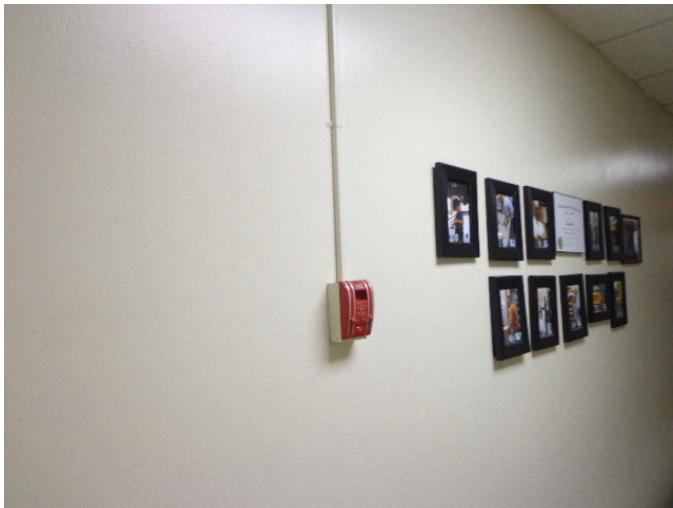
System: D5030 - Communications and Security - Fire Alarm

Distress: Beyond Service Life

Notes: The fire alarm system is beyond its expected service life and should be scheduled for replacement.

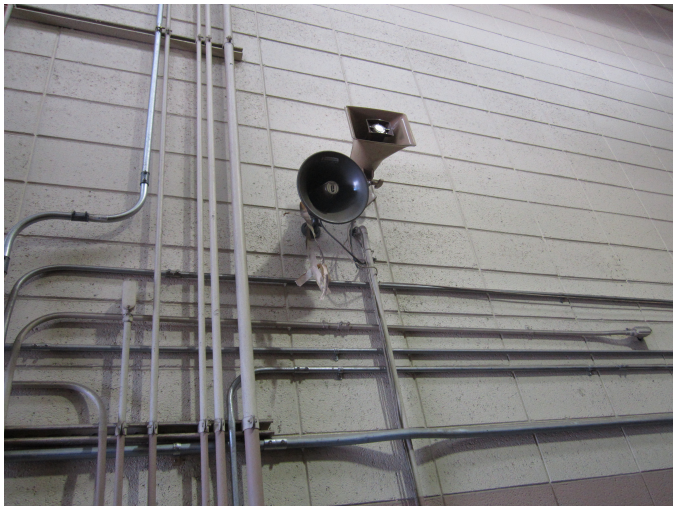
System: D5030 - Communications and Security - PA & Clock Systems

Distress: Beyond Service Life

Notes: The PA system is beyond its expected service life and should be scheduled for replacement.

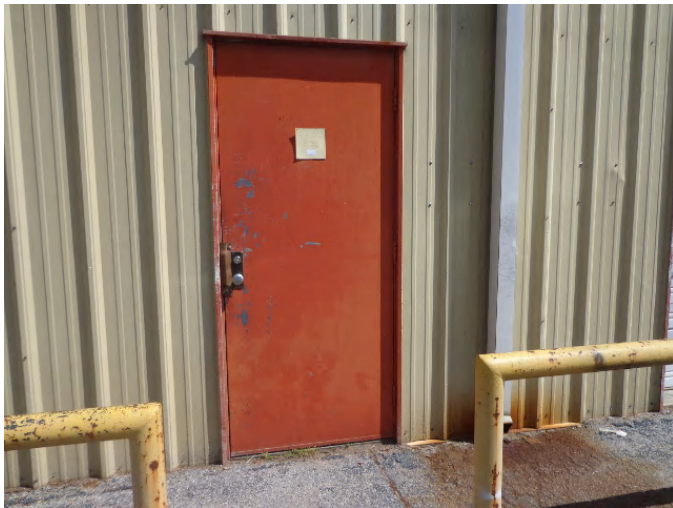
System: B2030 - Exterior Doors

Distress: Beyond Service Life

Notes: The original exterior doors, including roll-up doors, are aged, rusted, and should be replaced.

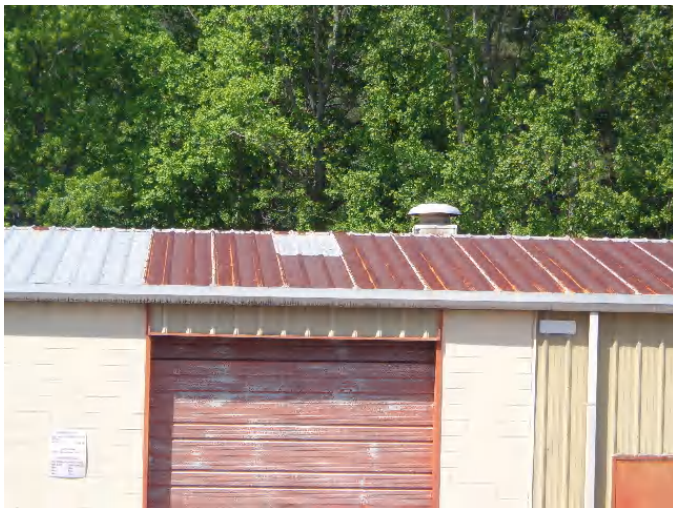
System: B3010 - Roof Coverings

Distress: Beyond Service Life

Notes: The metal roof is aged, showing signs of failure, and should be scheduled for replacement. SPLOST project 325-422 to repair the metal roof on the 1977 small equipment center building.

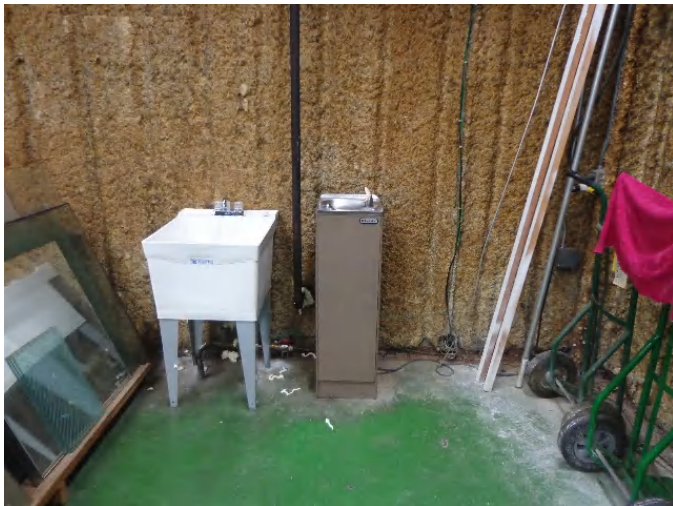
System: D2010 - Plumbing Fixtures

Location: Throughout Building
Distress: Beyond Service Life
Category: Deferred Maintenance / Accessibility Code Compliance
Priority: 3 Priority
Correction: Renew System
Qty: 6,000.00
Unit of Measure: S.F.
Estimate: \$13,134.00
Assessor Name: Eduardo Lopez
Date Created: 08/26/2015

Notes: Plumbing fixtures are beyond their expected service life, not ADA compliant, and should be replaced.

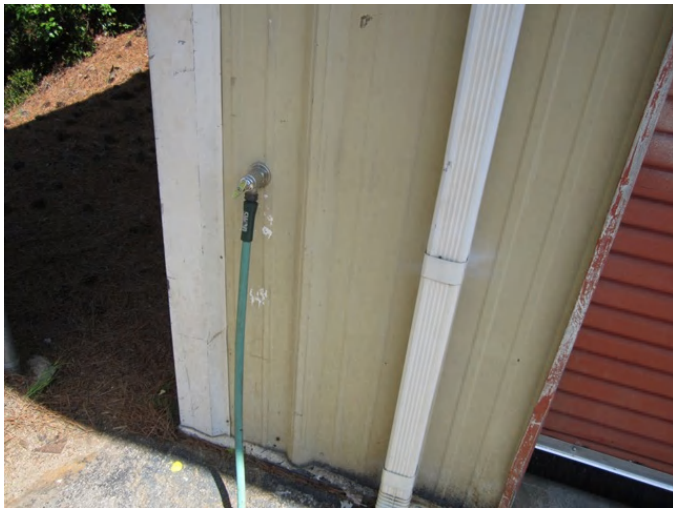
System: D2020 - Domestic Water Distribution

Distress: Beyond Service Life

Notes: The domestic water distribution system is beyond its expected service life, has water quality issues, and should be replaced.

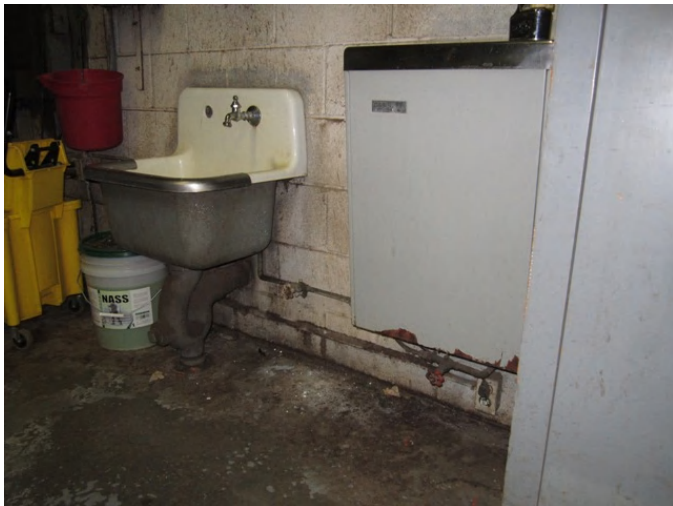
System: D2030 - Sanitary Waste

Distress: Beyond Service Life

Notes: The sanitary waste system is beyond its expected service life and should be replaced.

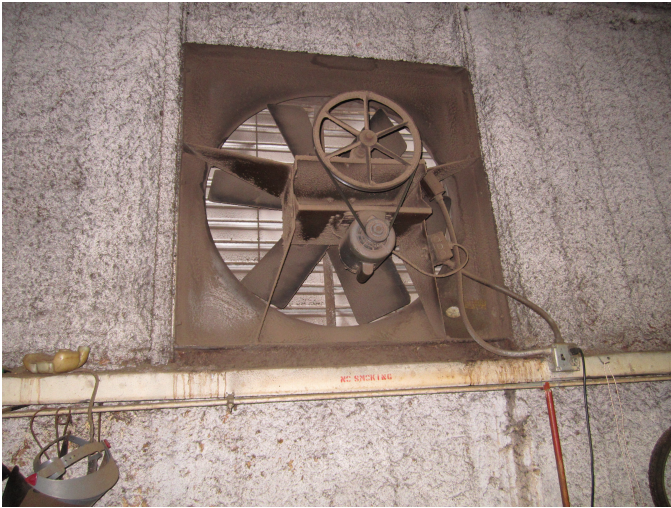
System: D3040 - Distribution Systems

Distress: Beyond Service Life

Notes: Distribution systems are beyond their expected service life, in poor condition, and should be scheduled for replacement.

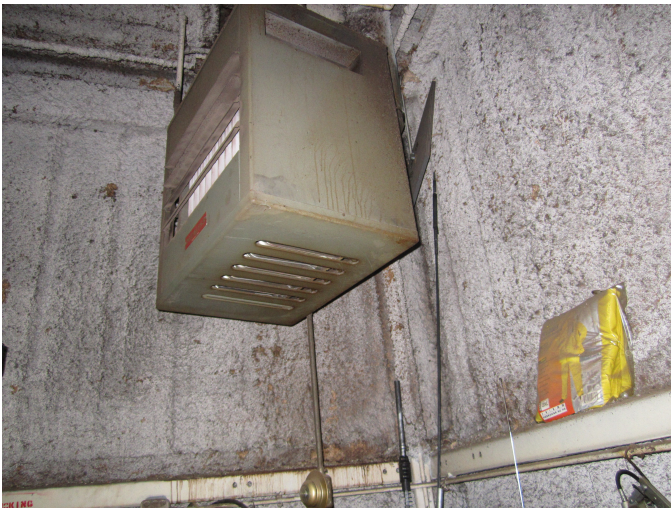
System: D3050 - Terminal & Package Units

Distress: Beyond Service Life

Notes: Terminal and package units are beyond their expected service life, in poor condition, and should be scheduled for replacement.

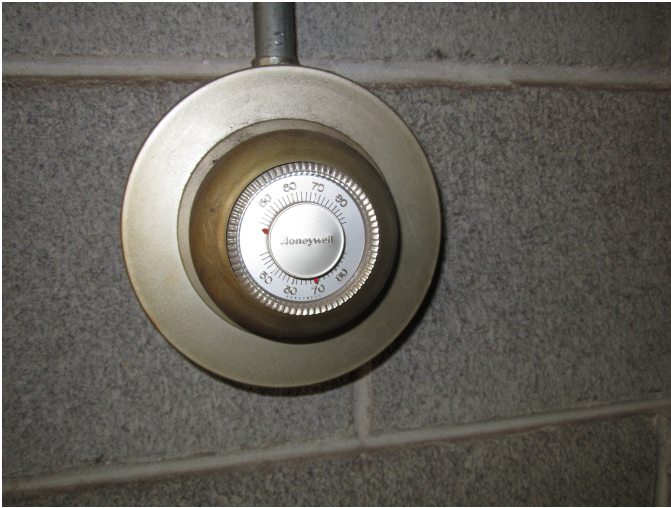
System: D3060 - Controls & Instrumentation

Distress: Beyond Service Life

Notes: Controls and instrumentation are beyond their expected service life and should be scheduled for replacement.

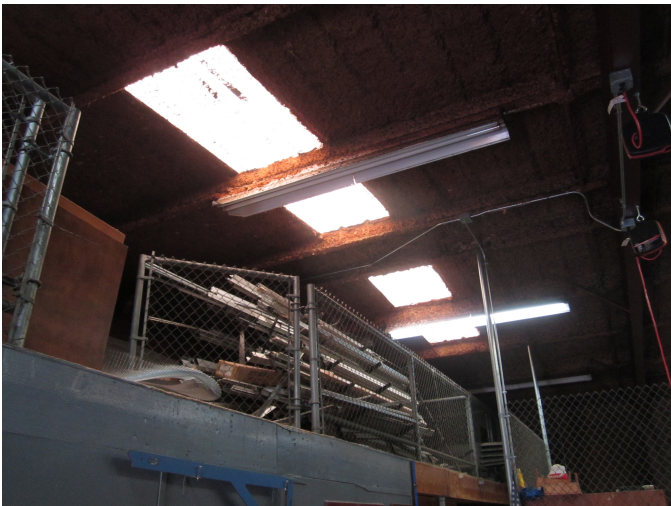
System: D5020 - Lighting and Branch Wiring

Distress: Beyond Service Life

Notes: Lighting and branch wiring are beyond their expected service life, inadequate, and should be scheduled for replacement. Lighting is severely lacking at front (South) of building.

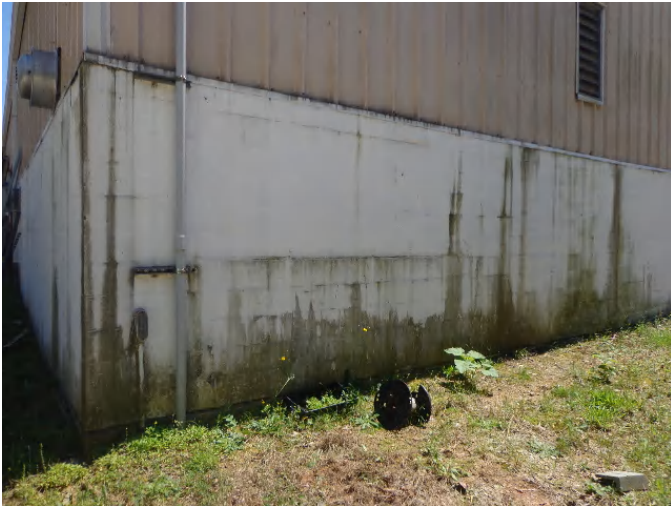
System: B2010 - Exterior Walls

Distress: Beyond Service Life

Notes: Exterior CMU wall finish is stained, faded, and should be re-painted.

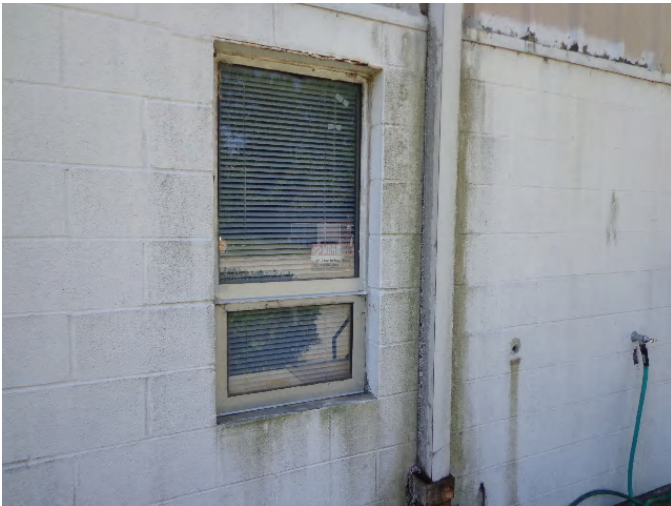
System: B2020 - Exterior Windows

Distress: Beyond Service Life

Notes: The aluminum frame, operable, single pane windows are aged, rusted, not energy efficient, and should be replaced.
