DeKalb County School District/Admin/Support

Sam A. Moss Service Center

School Assessment Report

May 19, 2016

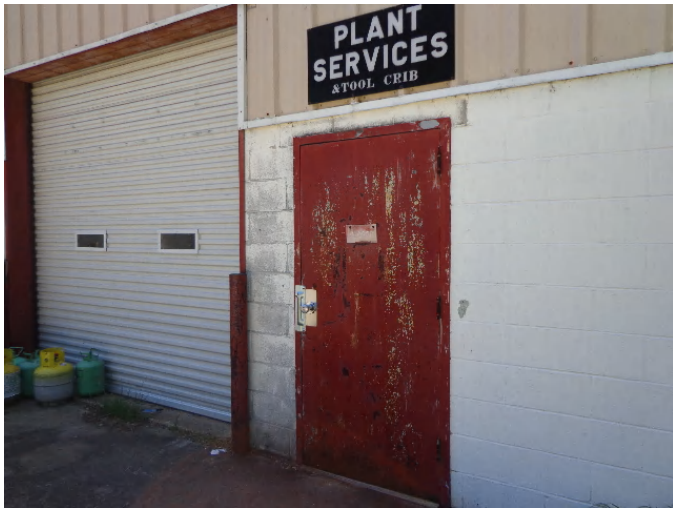
System: B2030 - Exterior Doors

Distress: Beyond Service Life

Notes: The original exterior doors are aged, rusted, and should be replaced.

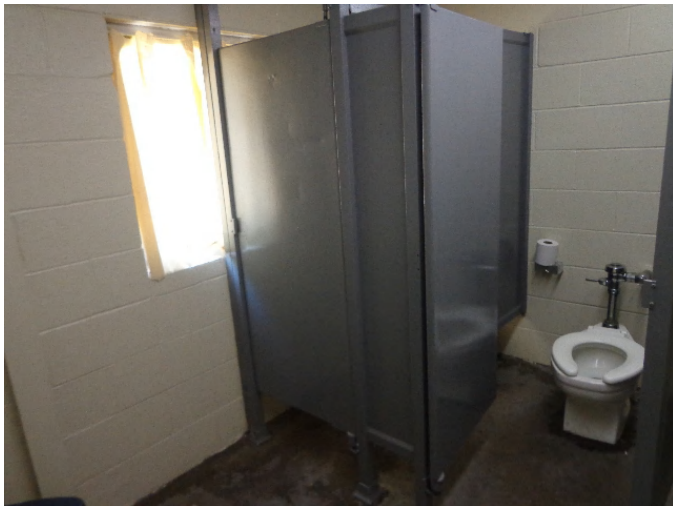
System: C1030 - Fittings

Distress: Beyond Service Life

Notes: Fittings, such as toilet partitions, handrails and signage, are aged, in marginal condition, not ADA compliant, and system should be replaced.

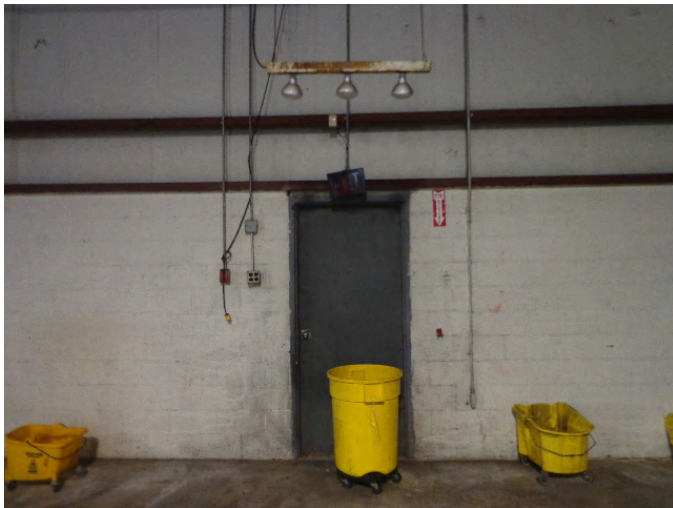
System: C3010 - Wall Finishes

Distress: Beyond Service Life

Notes: The painted wall finish is aged, scuffed, fading and stained, and should be replaced.

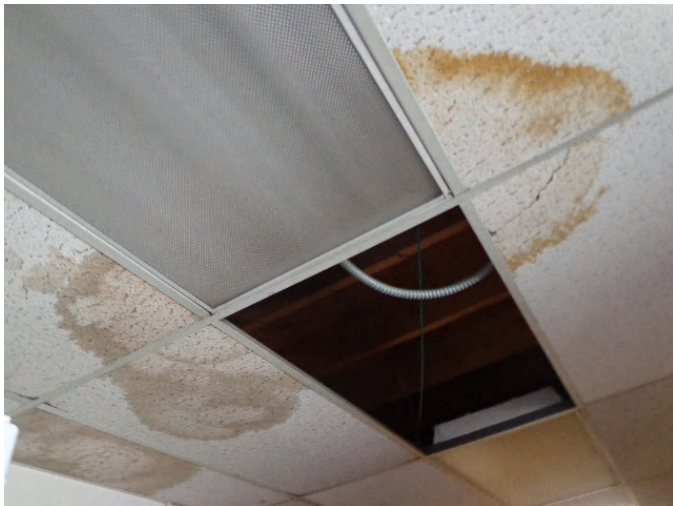
System: C3030 - Ceiling Finishes

Distress: Beyond Service Life

Notes: The acoustical ceiling tiles have been replaced as needed. However, the grid shows signs of aging and most tiles are aging or damaged. The insulation peeling off from the exposed ceilings as well. The entire system should be replaced.

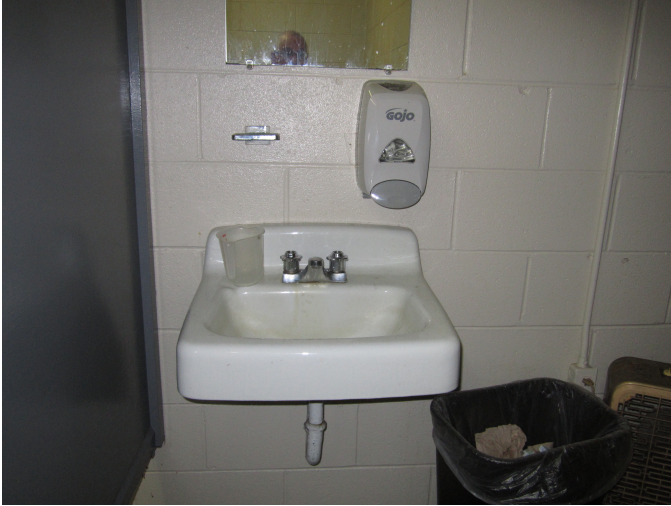
System: D2010 - Plumbing Fixtures

Distress: Beyond Service Life

Notes: Plumbing fixtures are beyond their expected service life, not ADA compliant, and should be scheduled for replacement.

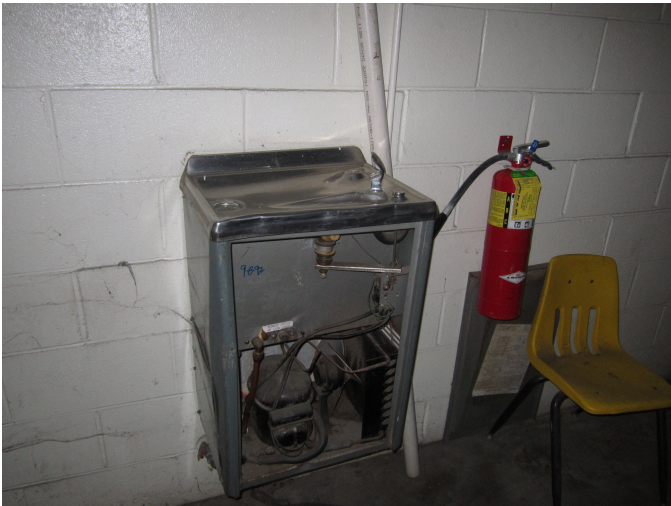
System: D2020 - Domestic Water Distribution

Distress: Beyond Service Life

Notes: The domestic water distribution system is beyond its expected service life, has water quality issues, and should be scheduled for replacement.

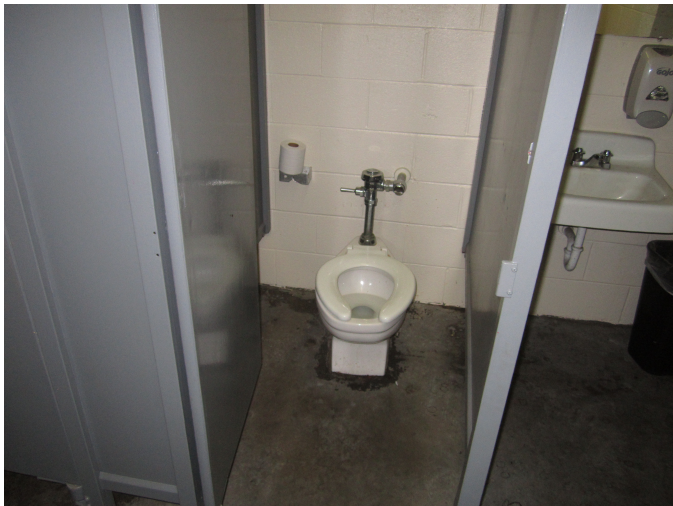
System: D2030 - Sanitary Waste

Location: Throughout Building
Distress: Beyond Service Life
Category: Deferred Maintenance
Priority: 3 Priority
Correction: Renew System
Qty: 30,000.00
Unit of Measure: S.F.
Estimate: \$33,660.00
Assessor Name: Sam Mandola
Date Created: 05/06/2015

Notes: The sanitary waste system is beyond its expected service life and should be scheduled for replacement.

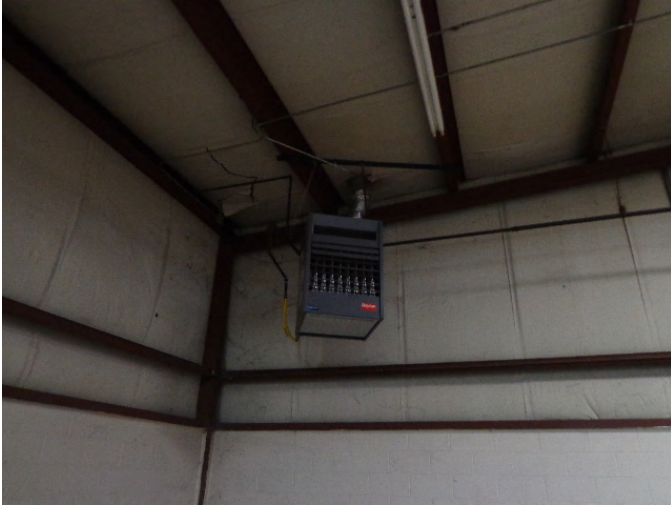
System: D3050 - Terminal & Package Units

Distress: Beyond Service Life

Notes: Terminal and package units are beyond their expected service life, in fair to poor condition, and should be scheduled for replacement.

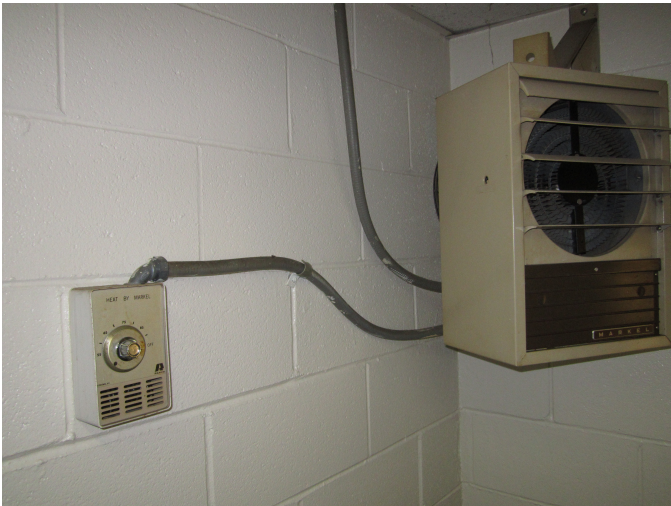
System: D3060 - Controls & Instrumentation

Distress: Beyond Service Life

Notes: Controls and instrumentation are beyond their expected service life, in fair to poor condition, and should be scheduled for replacement.

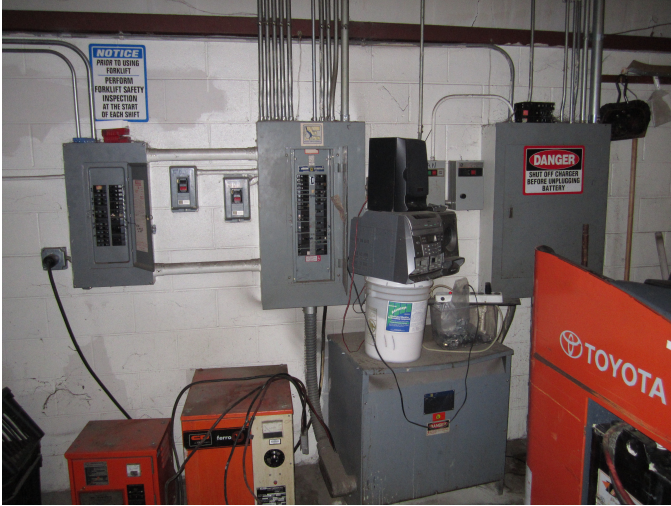
System: D5020 - Lighting and Branch Wiring

Distress: Beyond Service Life

Notes: Lighting and branch wiring is beyond its expected service life and should be scheduled for replacement.

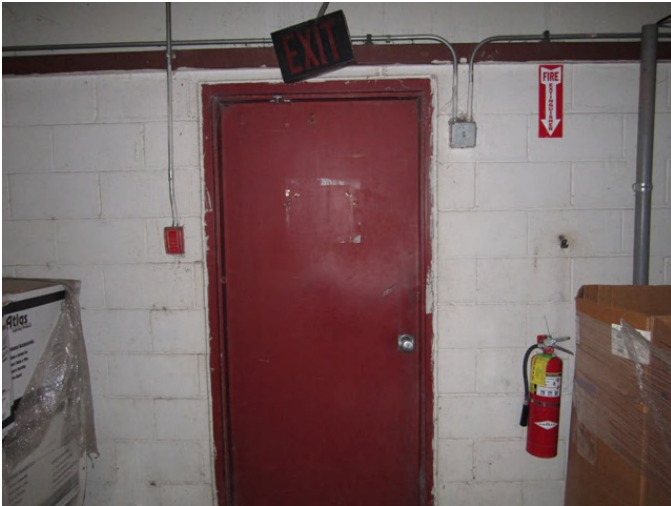
System: D5030 - Communications and Security - Fire Alarm

Distress: Beyond Service Life

Notes: The fire alarm system is beyond its expected service life and should be scheduled for replacement.

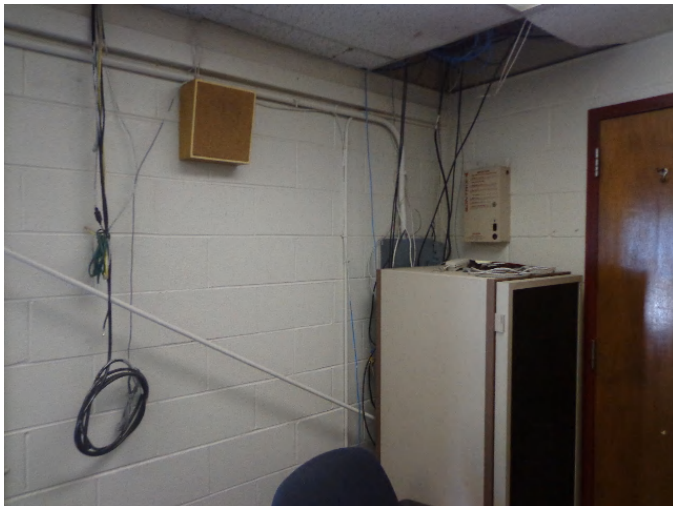
System: D5030 - Communications and Security - PA & Clock Systems

Distress: Beyond Service Life

Notes: The PA system is beyond its expected service life and should be scheduled for replacement.

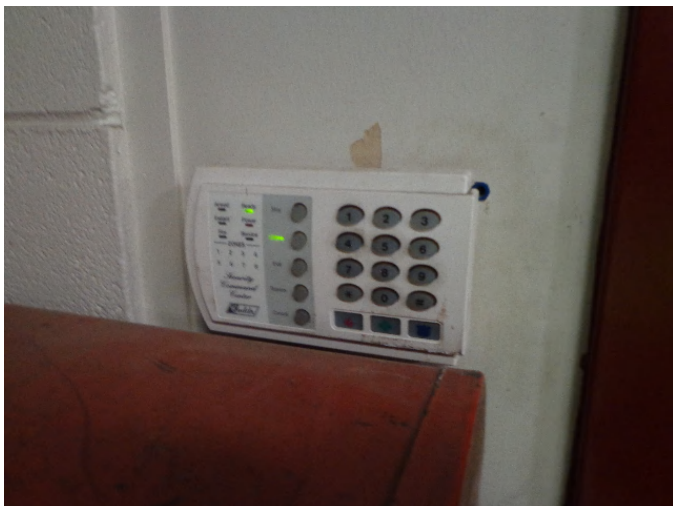
System: D5030 - Communications and Security - Security & CCTV

Distress: Beyond Service Life

Notes: The security and CCTV system is beyond its expected service life and should be scheduled for replacement.

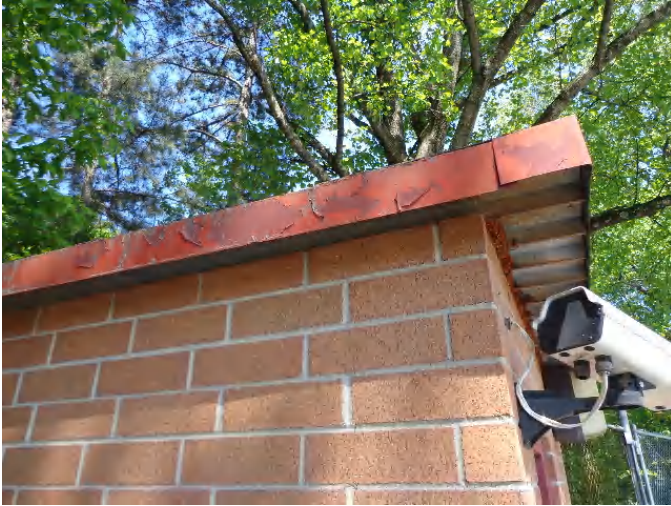
System: B3010 - Roof Coverings - BUR

Distress: Beyond Service Life

Notes: The built-up roof covering is aged, showing signs of failure, and should be replaced.

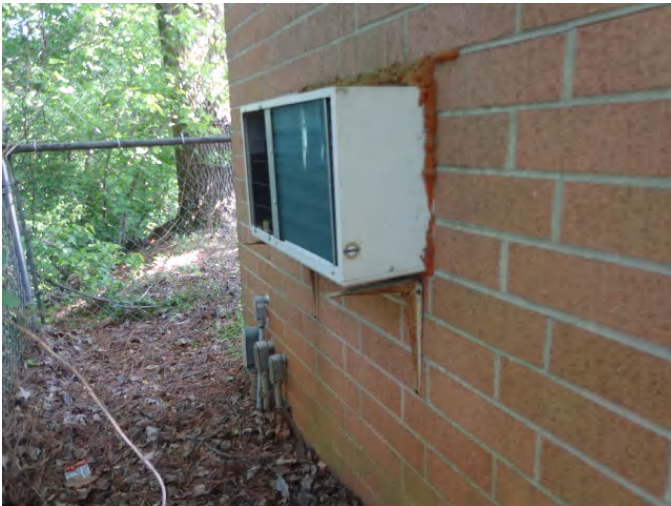
System: D3050 - Terminal & Package Units

Distress: Beyond Service Life

Notes: Through-the-wall air conditioner is beyond its expected service life and should be scheduled for replacement.

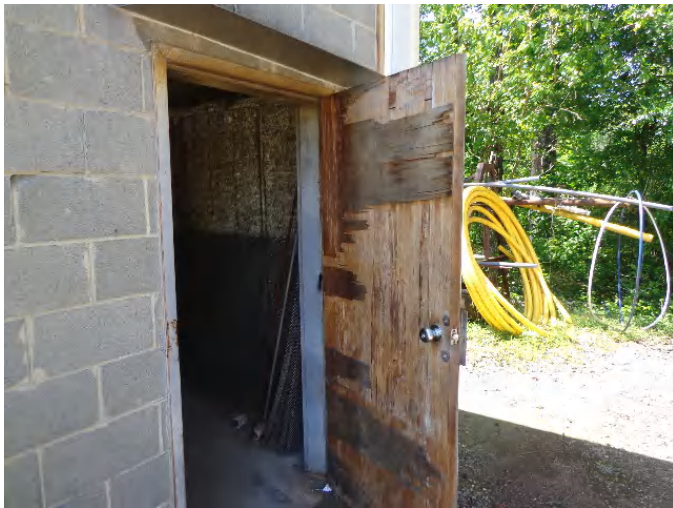
System: B2030 - Exterior Doors

Distress: Beyond Service Life

Notes: The original exterior doors are aged, rusted, and should be replaced.

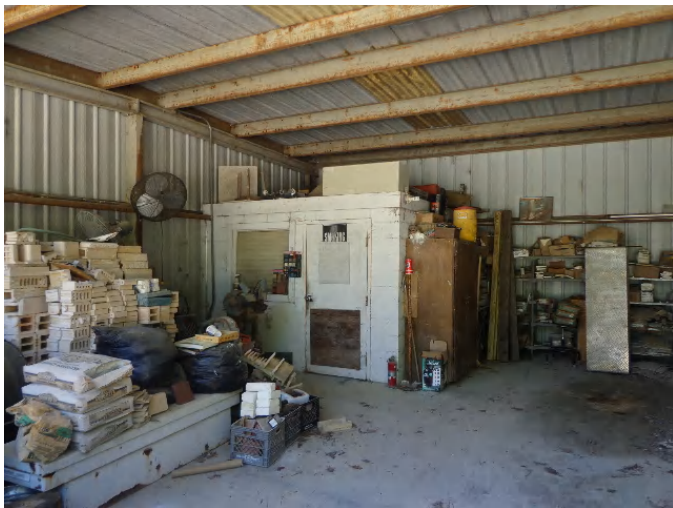
System: C3010 - Wall Finishes

Distress: Beyond Service Life

Notes: Columns are rusting and should be treated and re-painted.

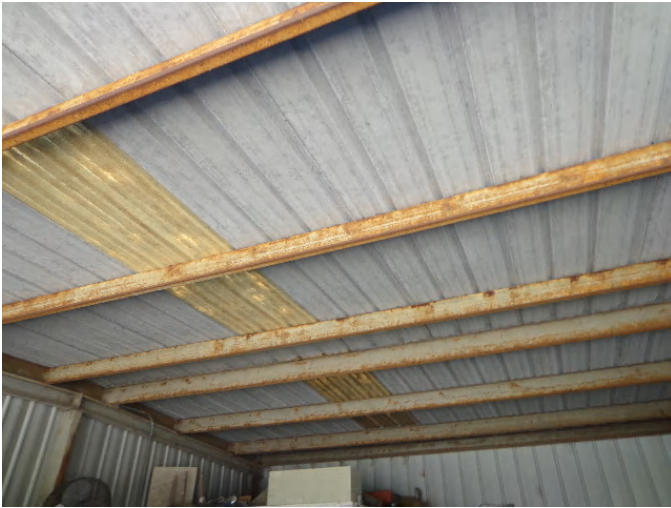
System: C3030 - Ceiling Finishes

Distress: Beyond Service Life

Notes: Ceiling structure is rusting and should be treated and re-painted.

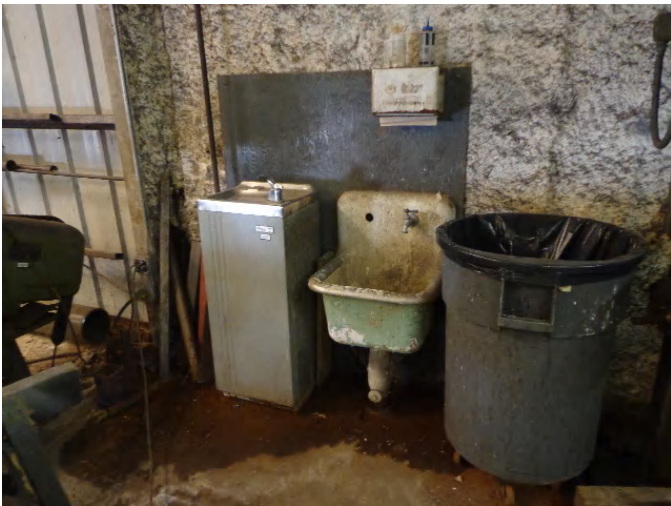
System: D2010 - Plumbing Fixtures

Distress: Beyond Service Life

Notes: Plumbing fixtures are beyond their expected service life and should be scheduled for replacement.

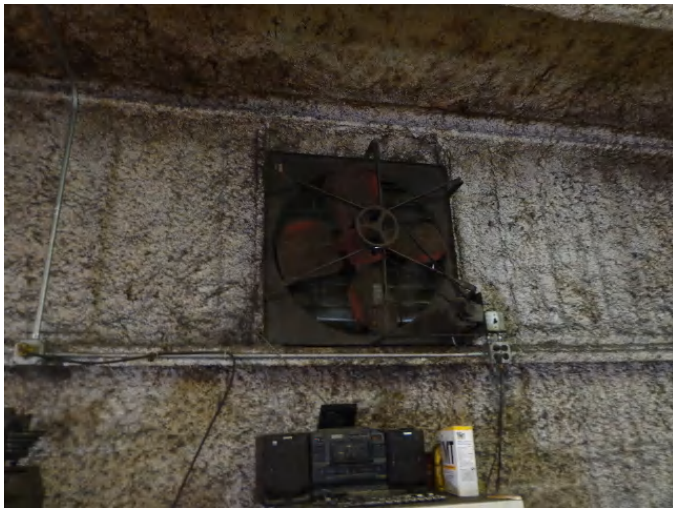
System: D3040 - Distribution System

Distress: Beyond Service Life

Notes: Distribution systems are beyond their expected service life and should be scheduled for replacement.

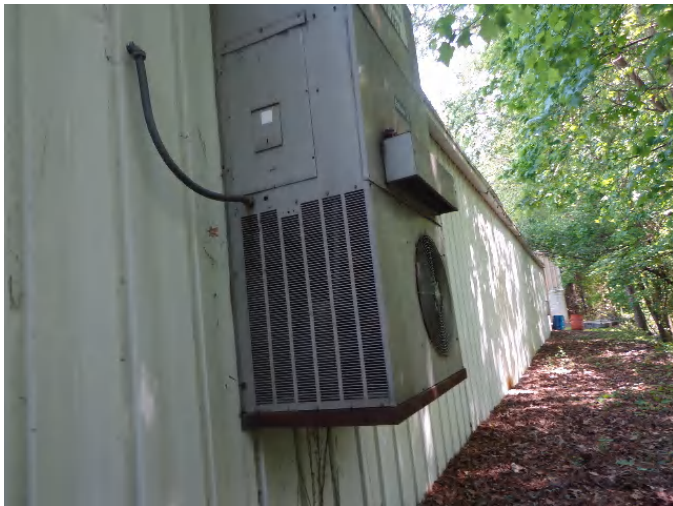
System: D3050 - Terminal & Package Units

Distress: Beyond Service Life

Notes: Terminal and package units are beyond their expected service life, inadequate, and should be scheduled for replacement.

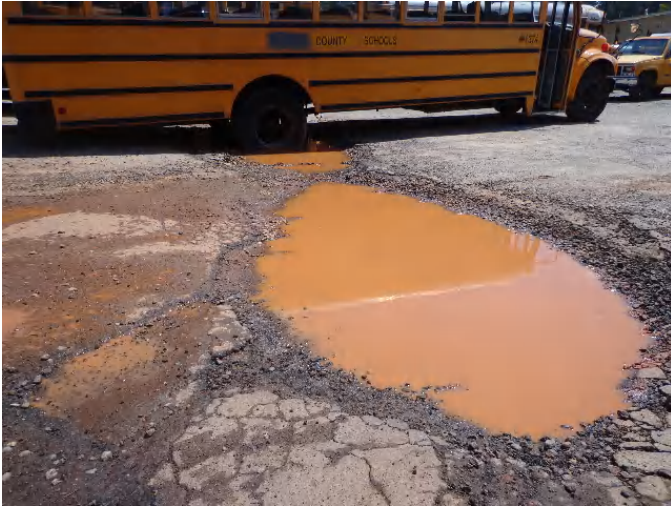
System: G2010 - Roadways

Distress: Beyond Service Life

Notes: Roadways are aged, have many road cuts, cracks and potholes, have drainage issues, and should be repaved.

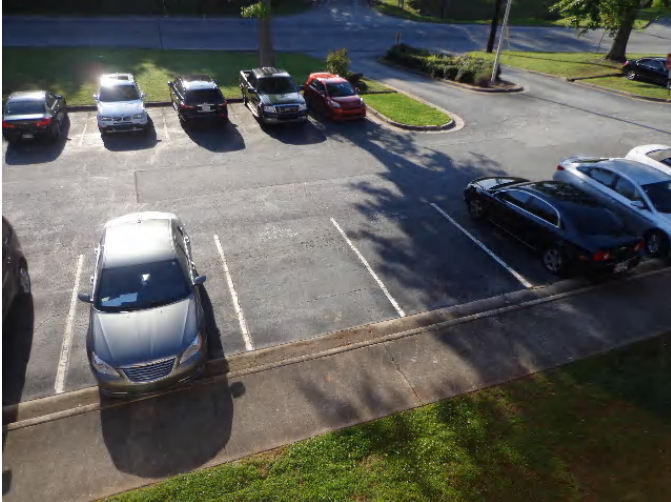
System: G2020 - Parking Lots

Distress: Beyond Service Life

Notes: The parking lot is aged, has many repairs and potholes, has drainage issues, is inadequate in areas, and should be repaved and re-stripped to comply with ADA standards.

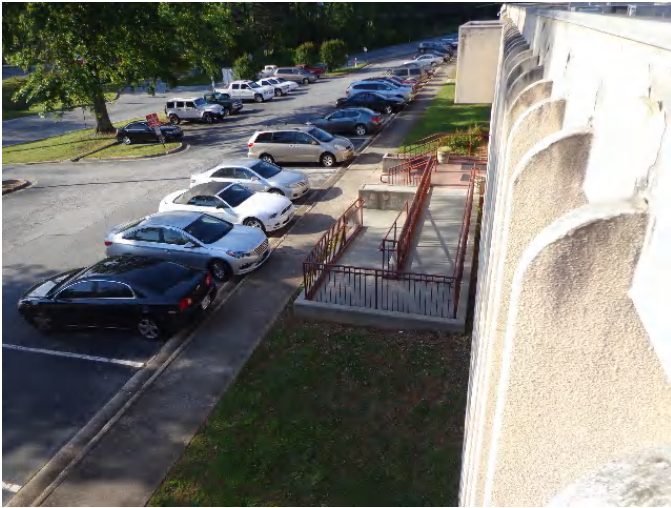
System: G2030 - Pedestrian Paving

Distress: Beyond Service Life

Notes: Pedestrian paving is aged and damaged in areas, and should be replaced to include missing accessible routes per ADA standards.

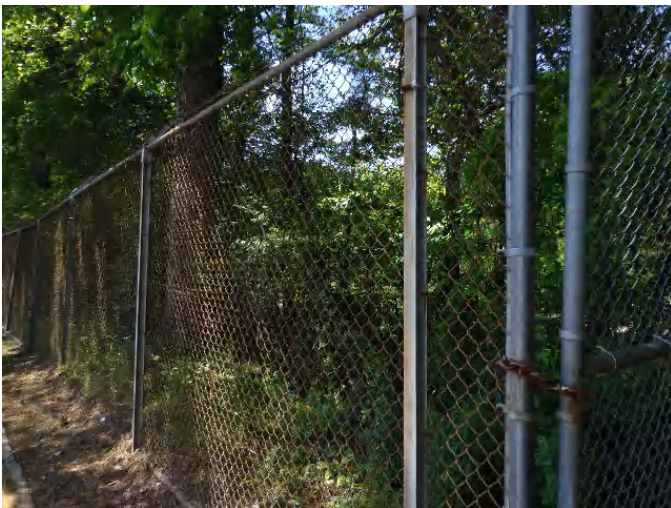
System: G2040 - Fencing & Guardrails

Distress: Beyond Service Life

Notes: The fence and gates are beyond their expected service life, rusted and failing, and should be scheduled for replacement.

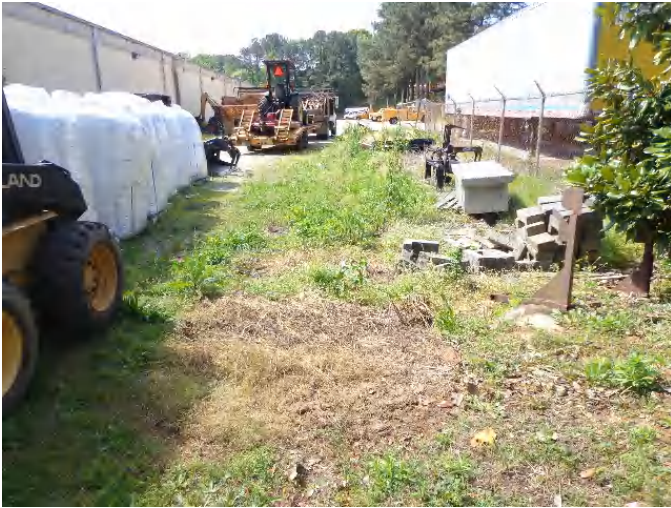
System: G2050 - Landscaping

Distress: Beyond Service Life

Notes: Landscaping is in poor condition with overgrown weeds and eroded areas, and should be renewed.

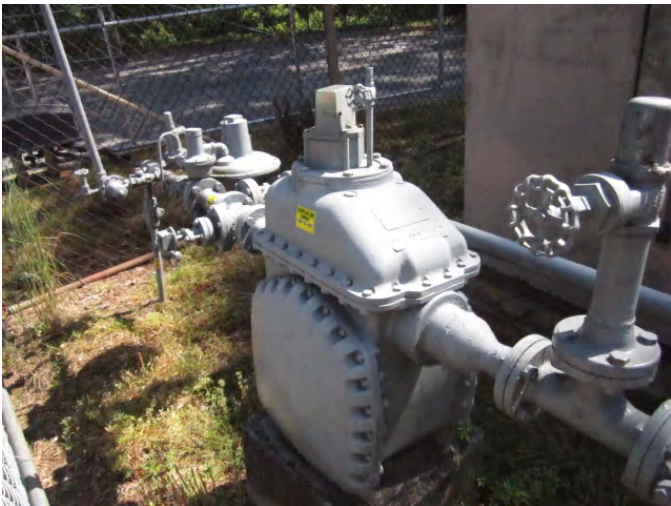
System: G3060 - Fuel Distribution

Distress: Beyond Service Life

Notes: The natural gas service is beyond its expected service life and should be scheduled for replacement.

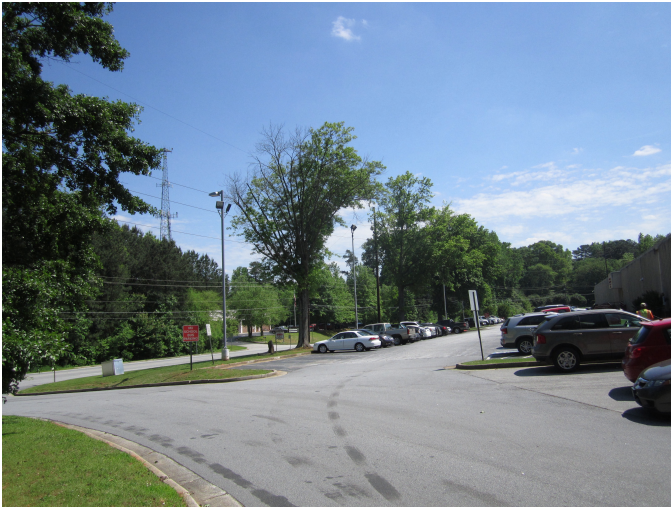
System: G4020 - Site Lighting

Distress: Beyond Service Life

Notes: Site lighting is beyond its expected service life, in poor condition, and should be scheduled for replacement. Site lighting along the roadways and parking area near the small equipment center and north of the warehouse building is inadequate.

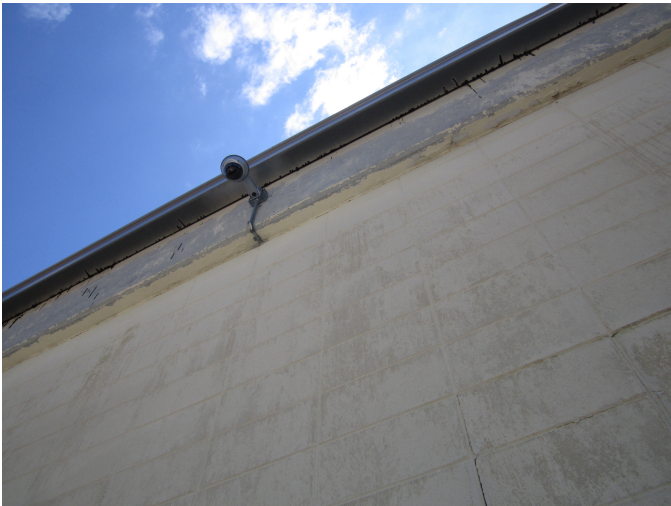
System: G4030 - Site Communications & Security

Distress: Beyond Service Life

Notes: The system is beyond its expected service life and should be scheduled for replacement. The systems are aged and should be replaced.
