DeKalb County School District/Elementary Schools

Stoneview Elementary

School Assessment Report

May 20, 2016

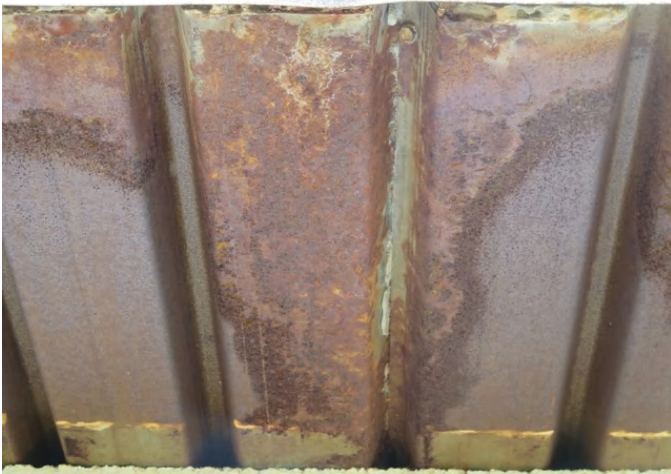
System: B1020 - Roof Construction

Location: Roof

Distress: Damaged

Notes: The metal roof decking is rusted and should be replaced.

Correction: Replace steel decking

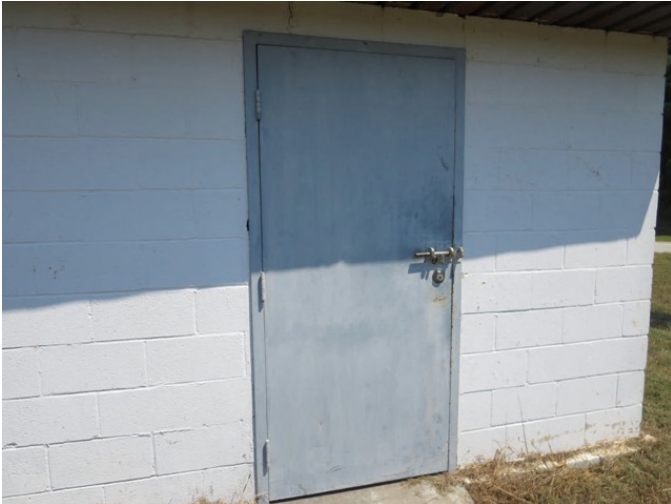
System: B2030 - Exterior Doors

Location: West Elevation

Distress: Beyond Service Life

Notes: The original exterior door is aged, rusted, and should be replaced.

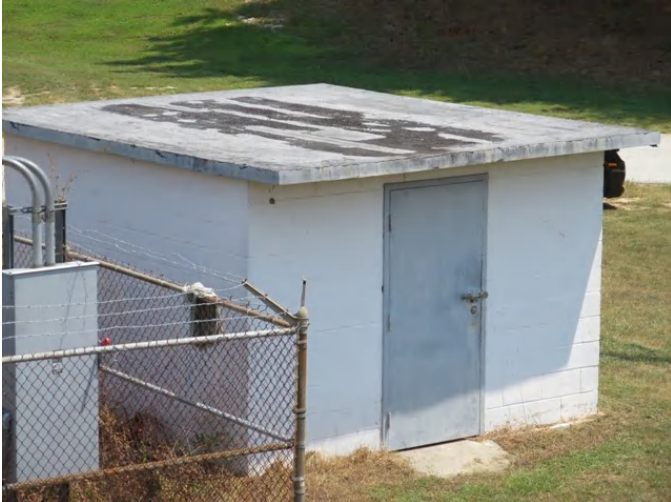
System: B3010 - Roof Coverings

Location: Roof

Distress: Beyond Service Life

Notes: The built-up roof covering is aged, failing, and should be replaced.

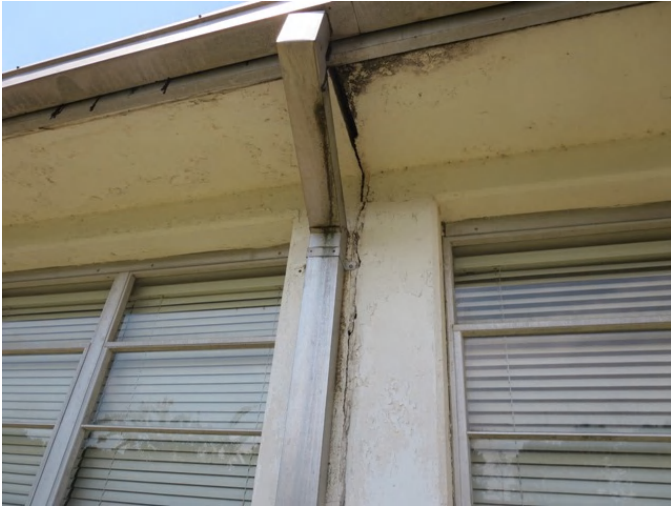
System: B2010 - Exterior Walls

Location: Exterior Walls

Distress: Beyond Service Life

Notes: Painted finishes on exterior soffits are faded and stained and should be replaced.

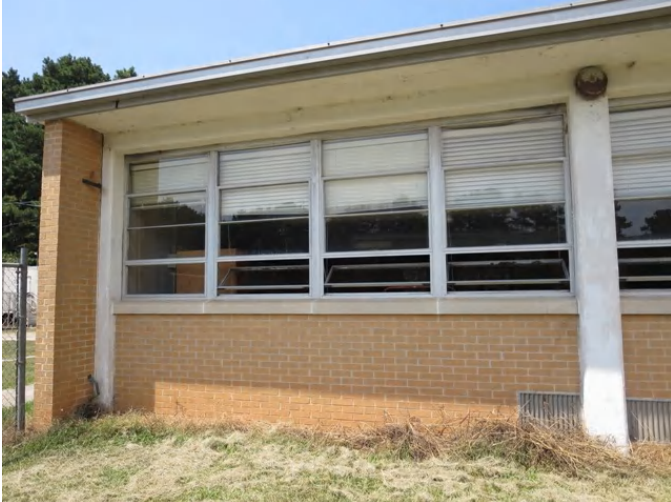
System: B2020 - Exterior Windows

Location: Throughout Building

Distress: Beyond Service Life

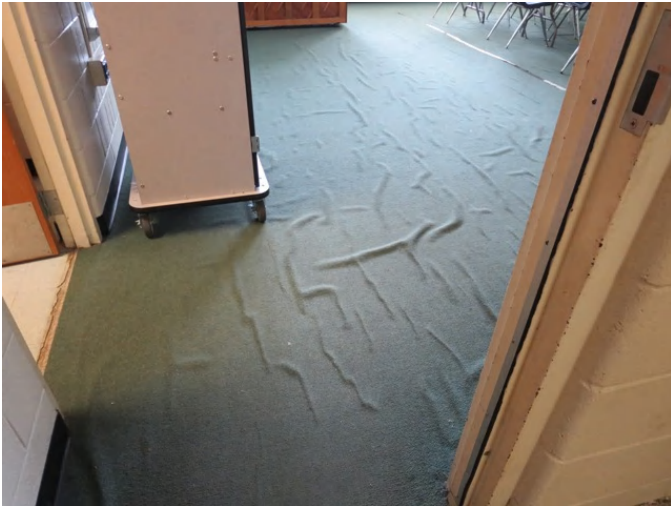
System: C3020 - Floor Finishes - Carpet

Location: Music

Distress: Beyond Service Life

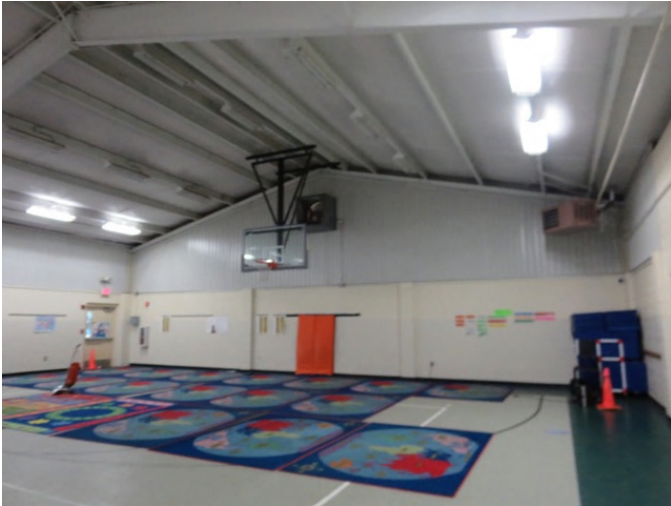
System: C3010 - Wall Finishes - Paint

Location: Throughout Building

Distress: Beyond Service Life

Notes: The painted wall finishes are beyond their expected service life, faded and stained, and should be replaced.

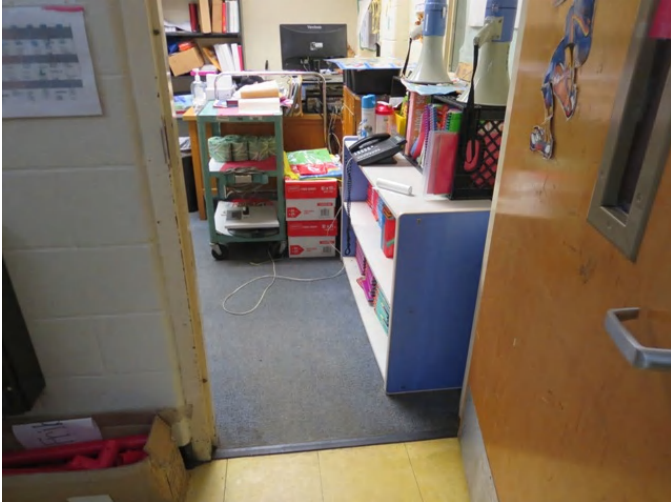
System: C3020 - Floor Finishes - Carpet

Location: Offices

Distress: Beyond Service Life

Notes: The carpet in the office room is stained, showing signs of failure, and should be replaced.

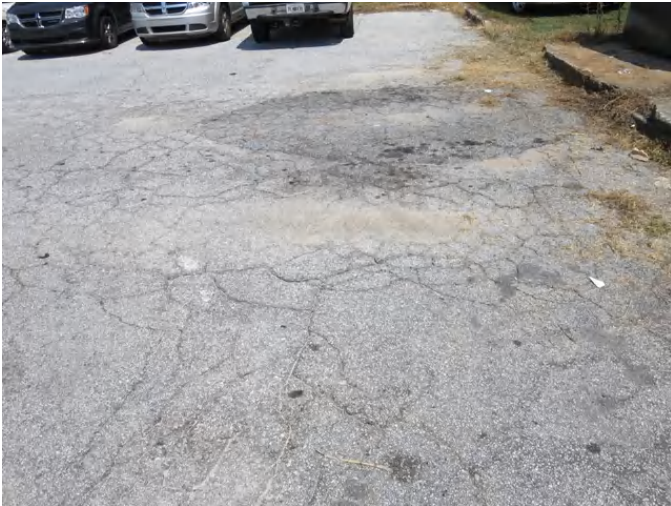
System: G2010 - Roadways

Location: Site

Distress: Beyond Service Life

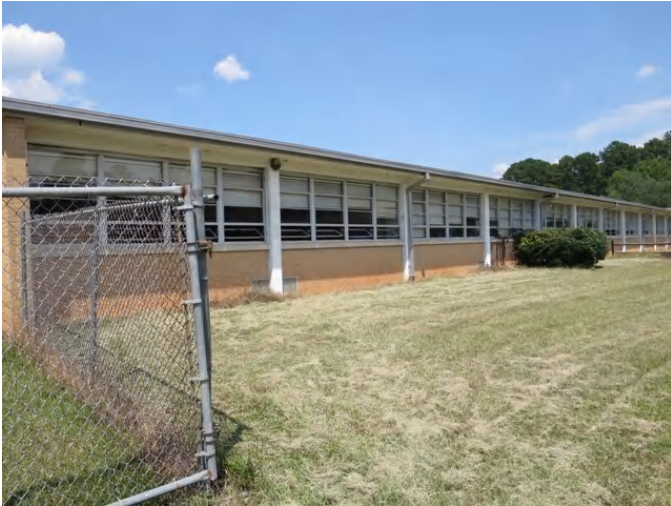
System: G2040 - Fencing & Guardrails

Location: Site

Distress: Beyond Service Life

Notes: Fencing is beyond its expected service life, rusted, and should be scheduled for replacement.

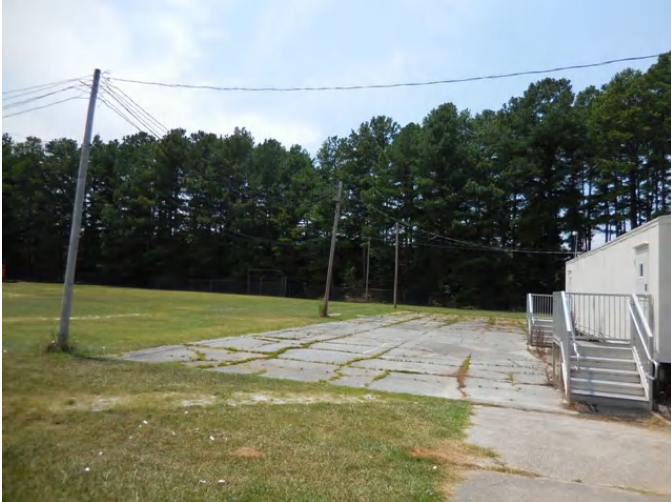
System: G2040 - Hard Surface Play Area

Location: Site

Distress: Beyond Service Life
