DeKalb County School District/Elementary Schools

Toney Elementary

School Assessment Report

May 20, 2016

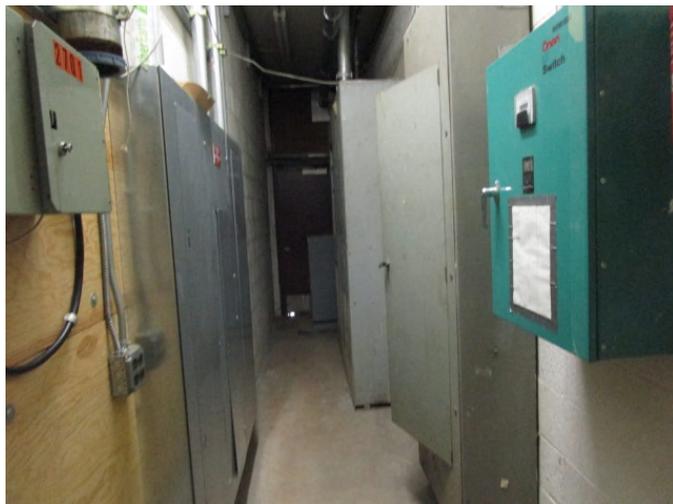
System: D5010 - Electrical Service/Distribution

Location: Main Switch Room/Throughout Building

Distress: Beyond Service Life

Notes: The electrical service/distribution system is beyond its expected service life and should be scheduled for replacement. The electrical equipment does not have adequate working clearance around it and the electrical room is not adequately ventilated.

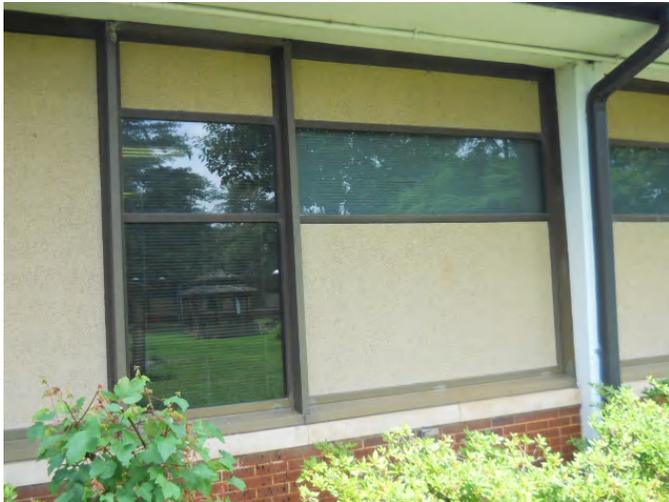
System: B2020 - Exterior Windows

Location: Throughout Building

Distress: Beyond Service Life

Notes: The exterior window system is beyond its expected service life, not energy efficient, does not lock/seal properly, and should be replaced.

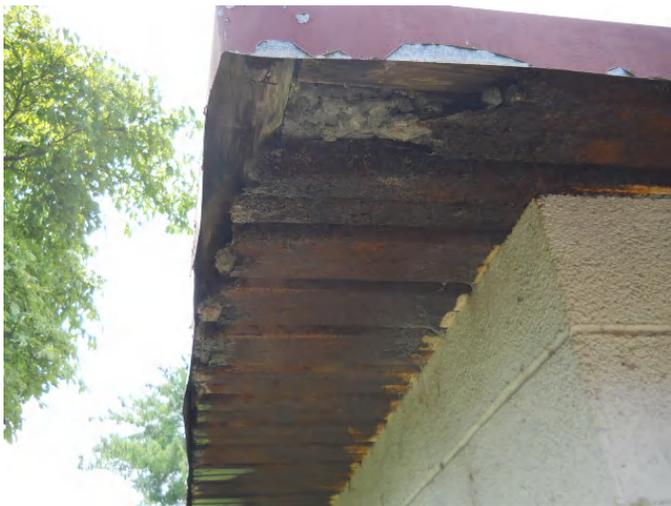
System: B1020 - Roof Construction

Location: Roof

Distress: Damaged

Notes: The steel decking has failed due to roof leaks and should be replaced.

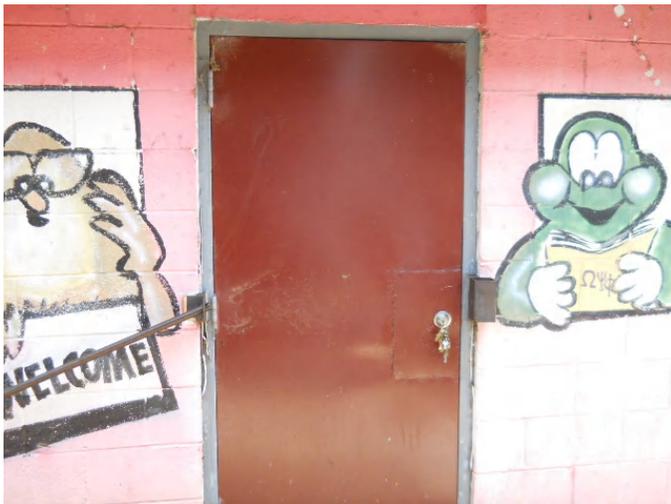
System: B2030 - Exterior Doors

Location: Exterior Wall

Distress: Beyond Service Life

Notes: The door is beyond its expected service life, damaged, and should be replaced.

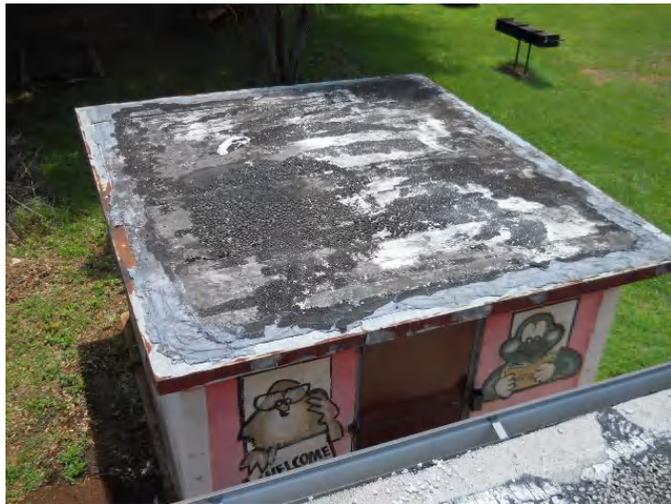
System: B3010 - Roof Coverings

Location: Roof

Distress: Beyond Service Life

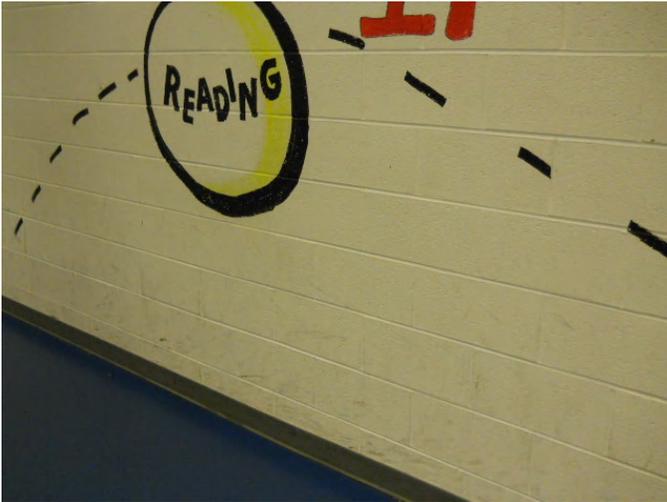
System: C3010 - Wall Finishes - Paint

Location: Throughout Building

Distress: Beyond Service Life

Notes: The painted wall surfaces are beyond service life and should be repainted/renewed.

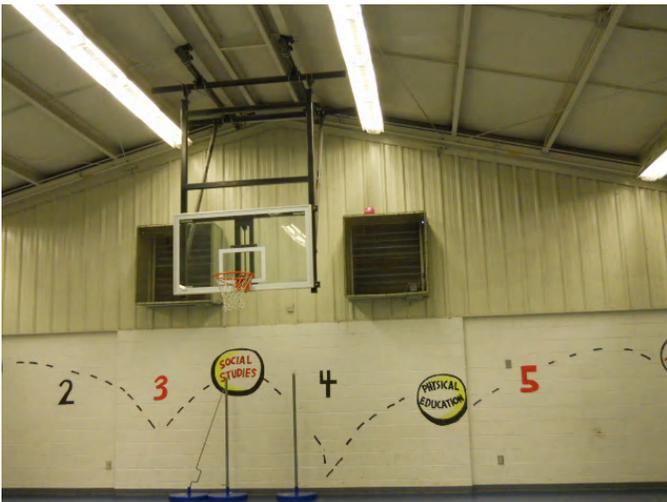
System: D3050 - Terminal & Package Units

Location: Throughout Building

Distress: Inadequate

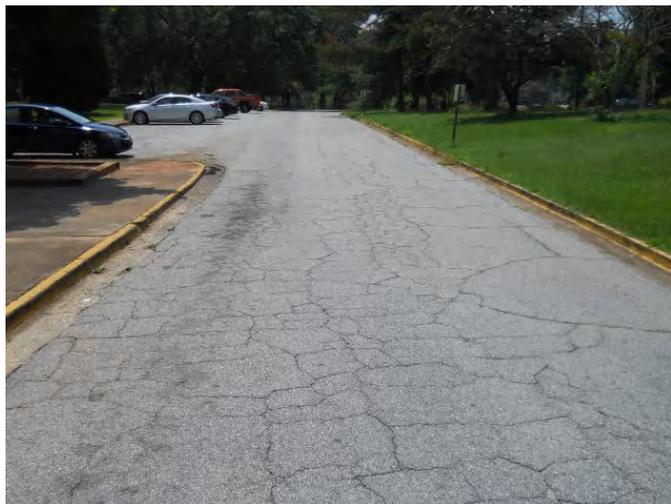
System: G4020 - Site Lighting

Location: Site

Distress: Beyond Service Life

Notes: Site lighting is missing and should be provided for safety/security reasons.
