DeKalb County School District/Education Other

# Avondale High/DeKalb School of the Arts

## School Assessment Report

May 19, 2016

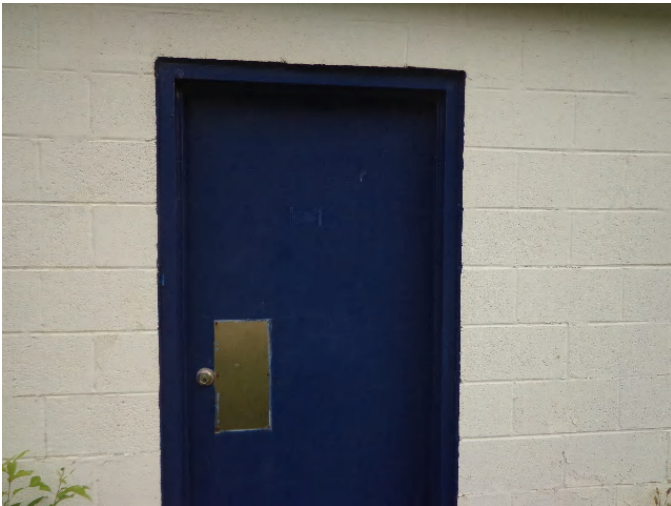
#### System: B2030 - Exterior Doors

**Location:** Exterior Walls

**Distress:** Beyond Service Life

**Notes:** The original exterior doors are aged, rusted, and should be replaced.

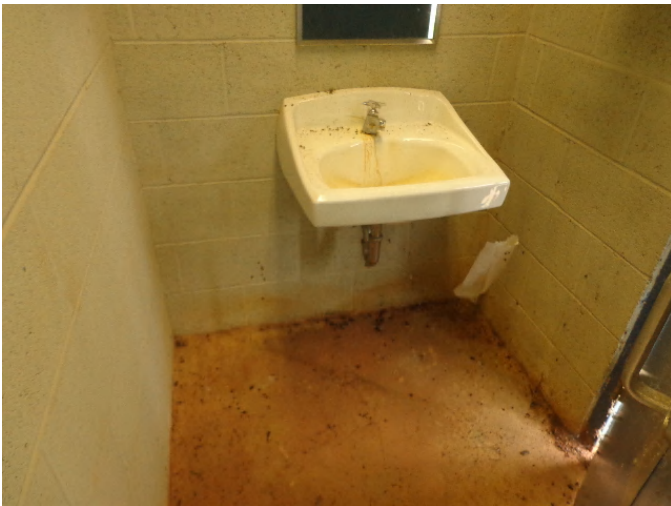
**System: C3010 - Wall Finishes**

**Location:** Throughout Building  
**Distress:** Beyond Service Life  
**Category:** Deferred Maintenance  
**Priority:** 3 Priority  
**Correction:** Renew System  
**Qty:** 380.00  
**Unit of Measure:** S.F.  
**Estimate:** \$581.00  
**Assessor Name:** Eduardo Lopez  
**Date Created:** 09/02/2015

**Notes:** The painted wall finish is aged and stained, and should be replaced.

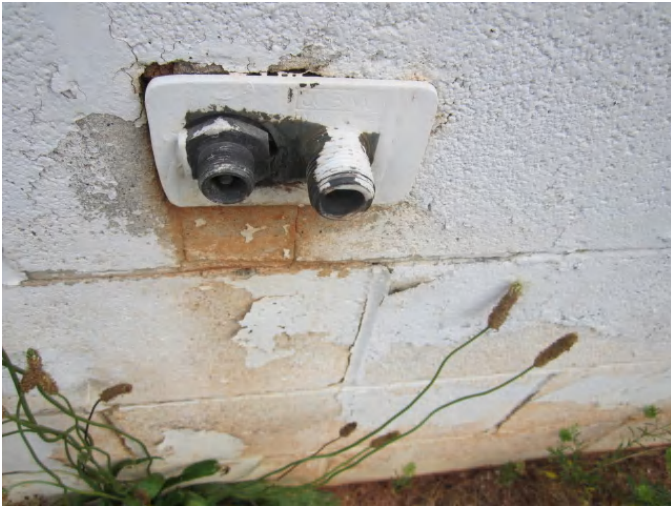
**System: D2020 - Domestic Water Distribution**

**Location:** Throughout Building  
**Distress:** Beyond Service Life  
**Category:** Deferred Maintenance  
**Priority:** 3 Priority  
**Correction:** Renew System  
**Qty:** 380.00  
**Unit of Measure:** S.F.  
**Estimate:** \$1,292.00  
**Assessor Name:** Eduardo Lopez  
**Date Created:** 09/03/2015

**Notes:** The domestic water distribution system is beyond its expected service life and should be scheduled for replacement.

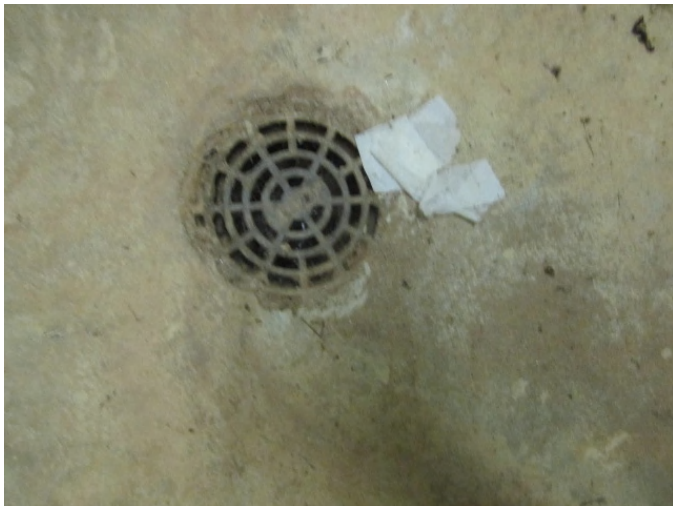
**System: D2030 - Sanitary Waste**

**Location:** Throughout Building

**Distress:** Beyond Service Life

**Notes:** The sanitary waste system is beyond its expected service life and should be scheduled for replacement.

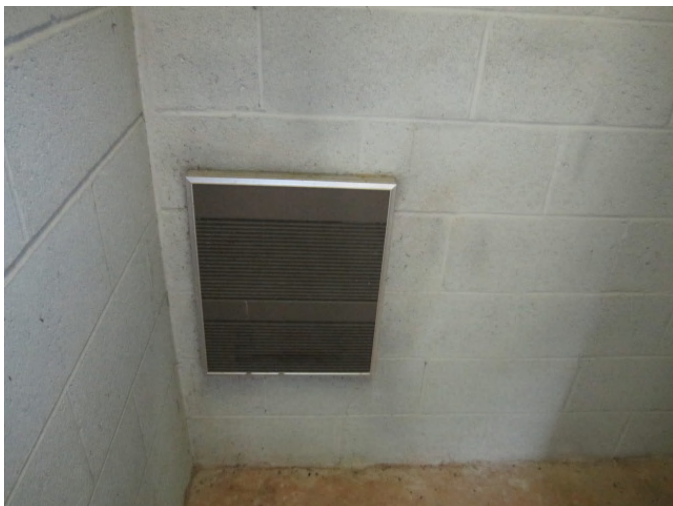
**System: D3050 - Terminal & Package Units**

**Location:** Throughout Building

**Distress:** Beyond Service Life

**Notes:** The terminal and package system is beyond its expected service life and should be scheduled for replacement.

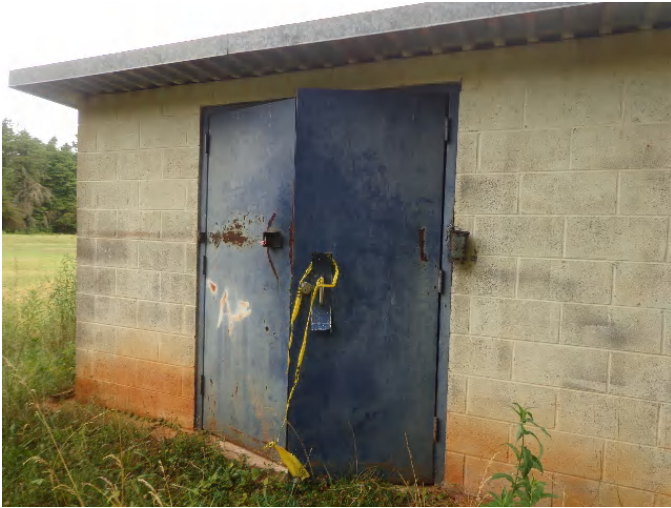
#### System: B2030 - Exterior Doors

**Location:** Exterior Wall

**Distress:** Beyond Service Life

**Notes:** The original exterior doors are aged, rusted, and should be replaced.

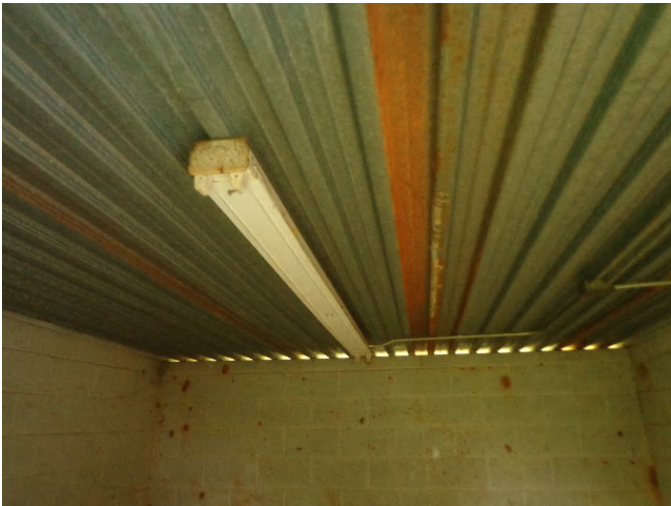
#### System: D5020 - Lighting and Branch Wiring

**Location:** Throughout Building

**Distress:** Beyond Service Life

**Notes:** The original lighting and branch wiring system is aged, in poor condition, and should be scheduled for replacement.

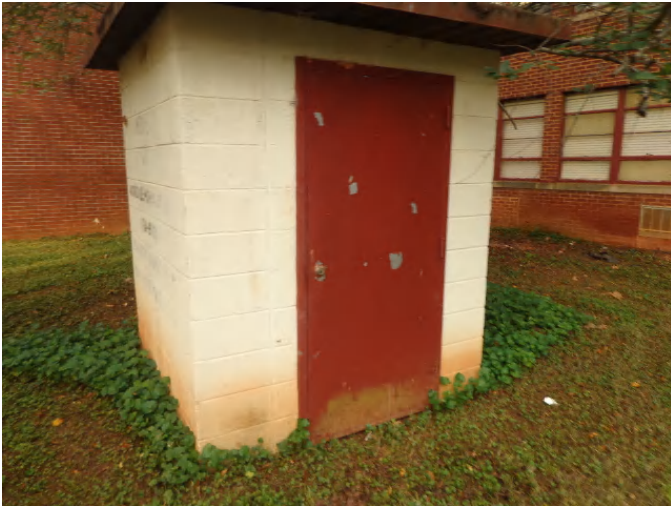
#### System: B2030 - Exterior Doors

**Location:** Exterior Wall

**Distress:** Beyond Service Life

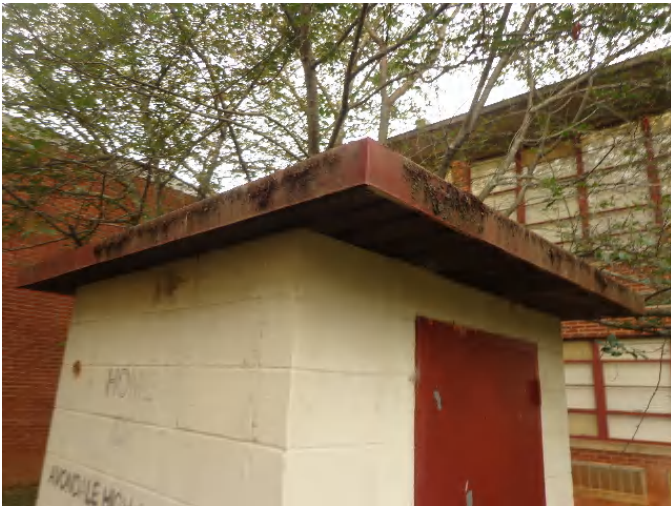
#### System: B3010 - Roof Coverings

**Location:** Roof

**Distress:** Beyond Service Life

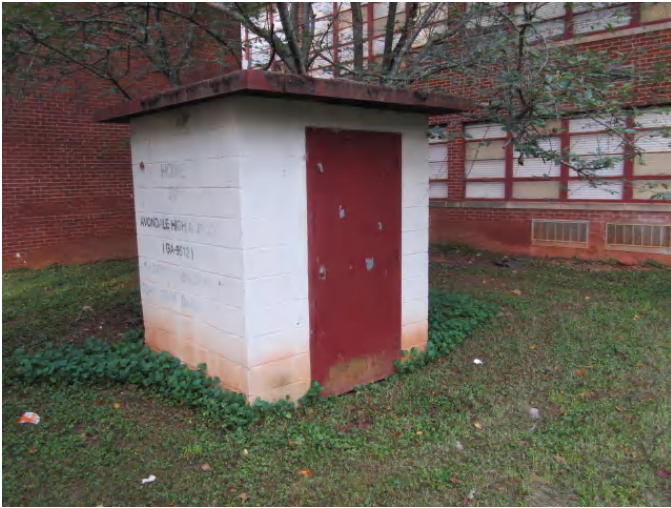
### **System: D20 - Sewer - Lift Station (2)**

**Distress:** Beyond Service Life

**Notes:** The lift station process equipment for site sanitary waste is beyond its expected service life, maintenance intensive, and should be scheduled for replacement. School staff reports that there are two lift station facilities.

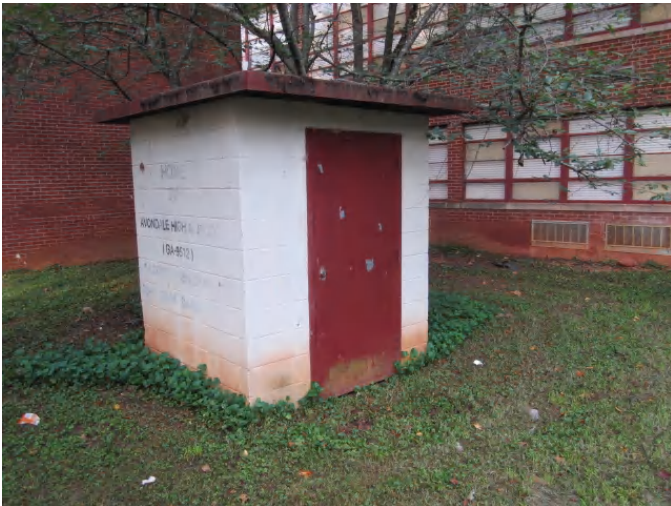
### **System: D5010 - Electrical Service/Distribution**

**Distress:** Beyond Service Life

**Notes:** The electric service/distribution system is beyond its expected service life and should be scheduled for replacement.

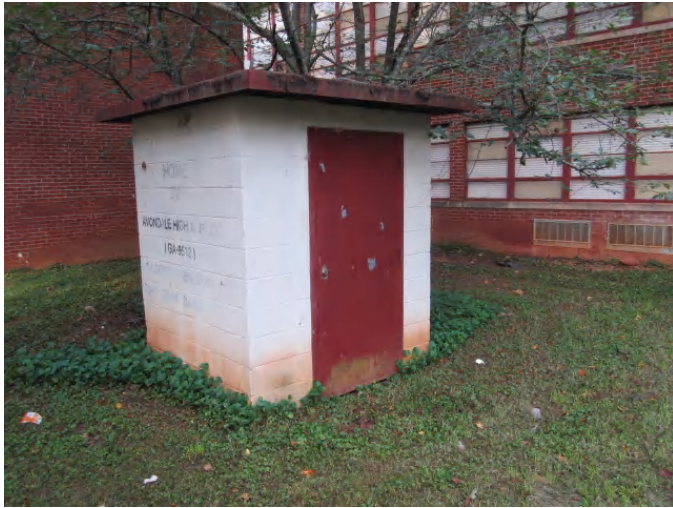
**System: D5020 - Lighting and Branch Wiring**

**Distress:** Beyond Service Life

**Notes:** The lighting and branch wiring system is beyond its expected service life and should be scheduled for replacement.

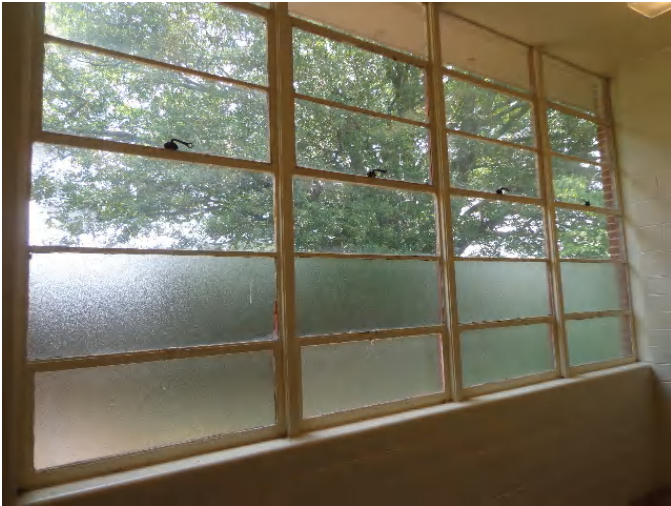
#### **System: B2020 - Exterior Windows**

**Distress:** Beyond Service Life

**Notes:** The aluminum frame, operable, single pane windows are aged, not energy efficient, and should be replaced. Window glazing and caulking was identified as ACM by others.

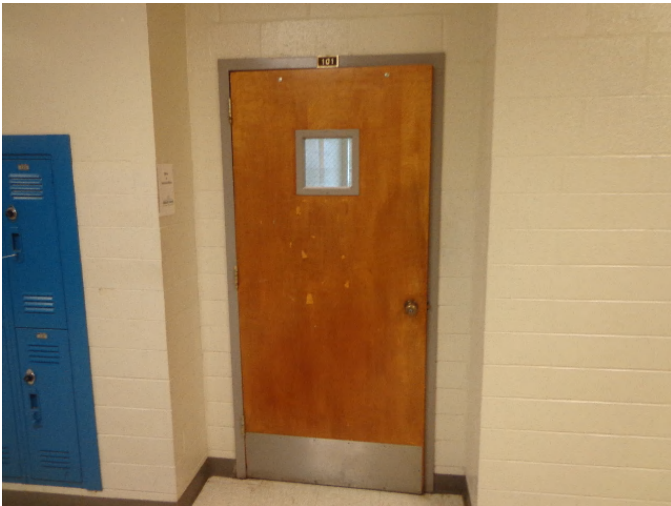
**System: C1020 - Interior Doors**

**Distress:** Beyond Service Life

**Notes:** The interior doors are aged, failing, (hardware is) not ADA compliant, and should be replaced.

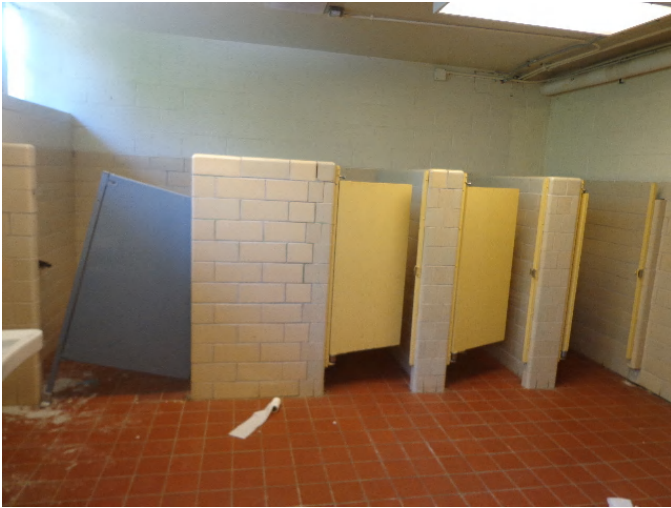
**System: C1030 - Fittings**

**Distress:** Beyond Service Life

**Notes:** Fittings, such as toilet partitions, lockers and signage, are aged, and in poor condition, room signage are not ADA compliant, and the entire system should be replaced.

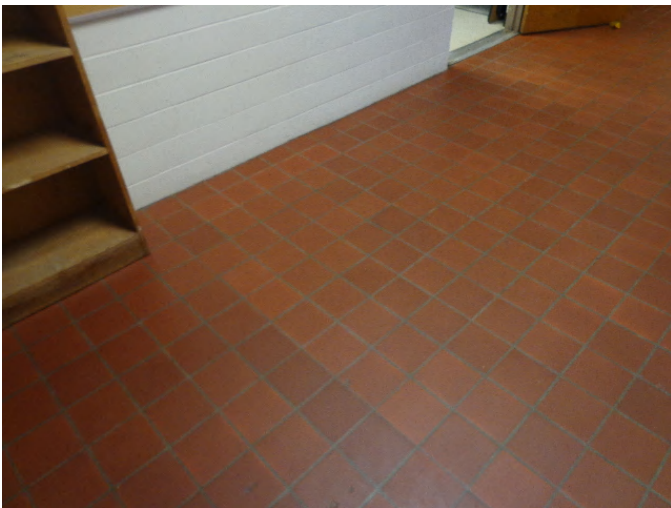
**System: C3020 - Floor Finishes - Ceramic & Quarry Tile**

**Distress:** Beyond Service Life

**Notes:** The original quarry tile is aged, chipped, cracked, patched and worn, and should be replaced.

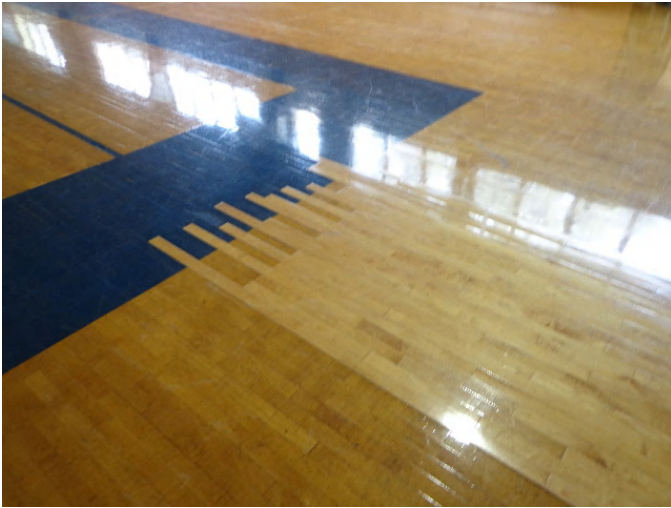
**System: C3020 - Floor Finishes - Wood**

**Distress:** Beyond Service Life

**Notes:** The original wood flooring is in poor condition, with different areas patched and separating, and should be replaced.

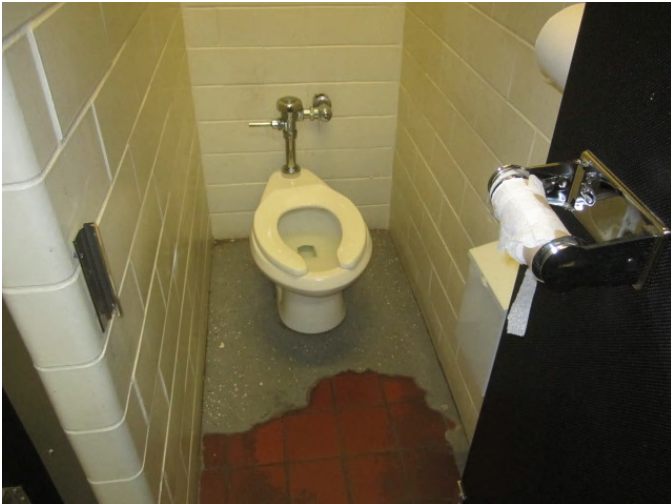
**System: D2010 - Plumbing Fixtures**

**Distress:** Beyond Service Life

**Notes:** The plumbing fixtures are beyond its expected service life and should be scheduled for replacement. Building does not have any accessible-height drinking fountains and some protrude more than four inches beyond corridor walls, which is not in accordance with ADA standards.

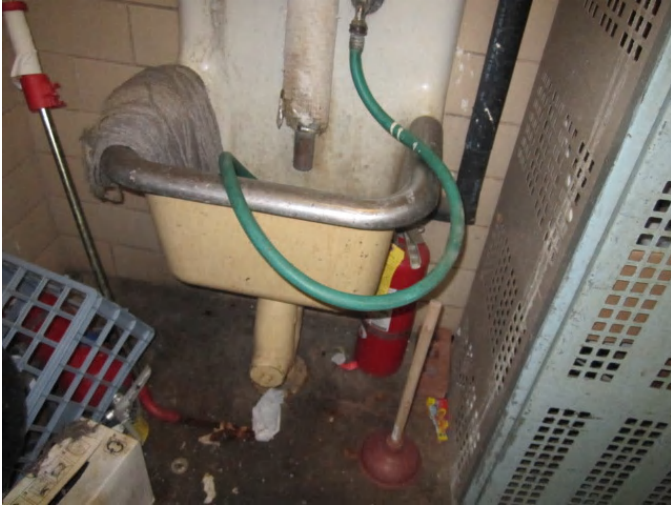
**System: D2020 - Domestic Water Distribution**

**Distress:** Beyond Service Life

**Notes:** The domestic water distribution system is beyond its expected service life, not building code compliant, and should be scheduled for replacement. School staff reports that water is not clear after a long weekend or holiday.

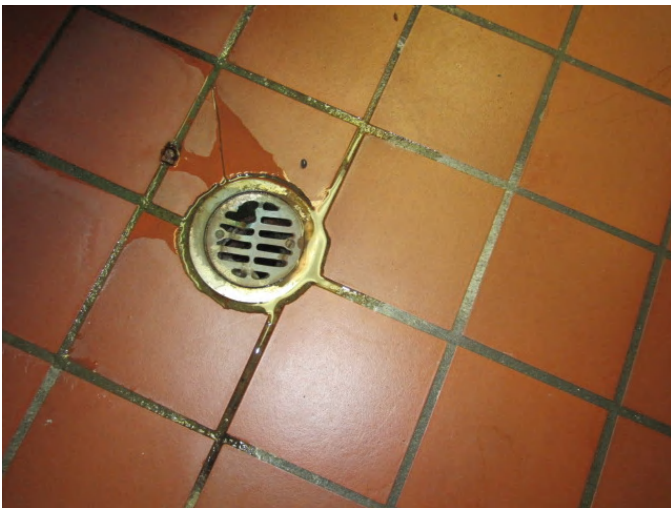
**System: D2030 - Sanitary Waste**

**Distress:** Beyond Service Life

**Notes:** The sanitary waste system is beyond its expected service life and should be scheduled for replacement.

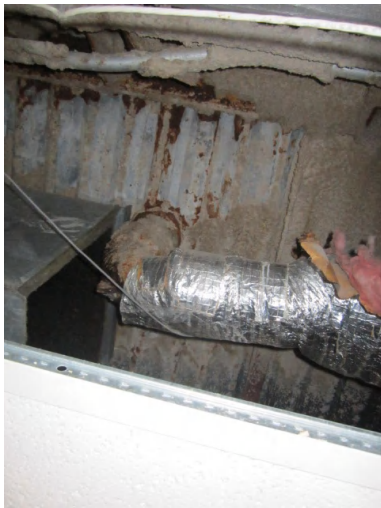
**System: D3040 - Distribution Systems & Exhaust Systems**

**Location:** Throughout Building  
**Distress:** Beyond Service Life  
**Category:** Deferred Maintenance / Environmental  
**Priority:** 3 Priority  
**Correction:** Renew System  
**Qty:** 106,700.00  
**Unit of Measure:** S.F.  
**Estimate:** \$613,845.00  
**Assessor Name:** Ben Nixon  
**Date Created:** 06/28/2015

**Notes:** The distribution and exhaust system is beyond its expected service life and should be scheduled for replacement. School staff reports indoor air quality problems.

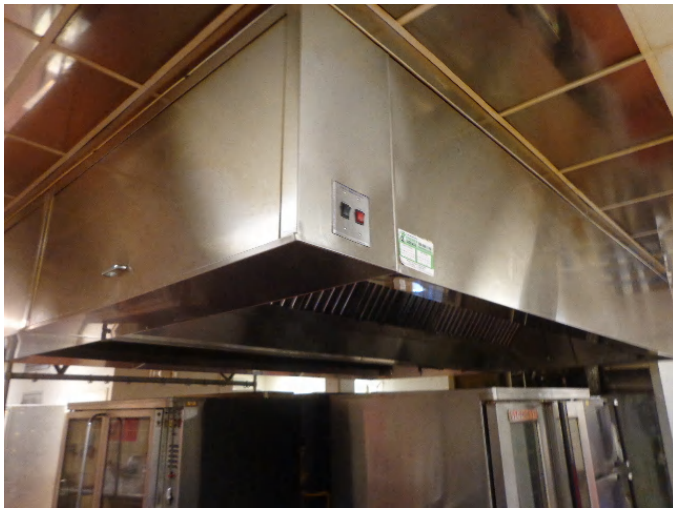
**System: D3090 - Other HVAC Systems/Equip - Kitchen Hood**

**Distress:** Beyond Service Life

**Notes:** The original kitchen hood and exhaust system is operational, but is aged, becoming logistically un-supportable, and should be scheduled for replacement.

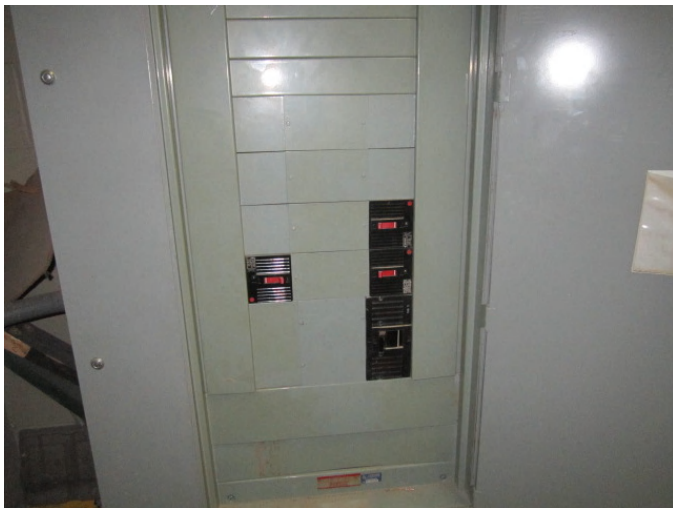
**System: D5010 - Electrical Service/Distribution**

**Distress:** Beyond Service Life

**Notes:** The electric service and distribution system is beyond its expected service life and should be scheduled for replacement.

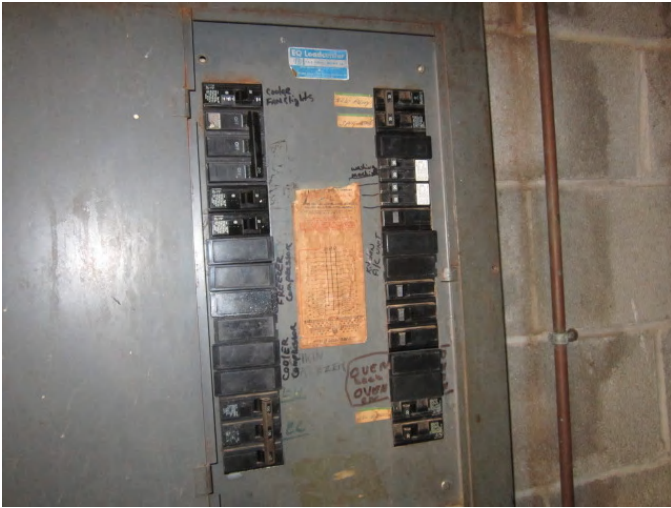
**System: D5020 - Branch Wiring**

**Distress:** Beyond Service Life

**Notes:** Branch wiring is beyond its expected service life and should be scheduled for replacement. GFI outlets are missing in wet areas.

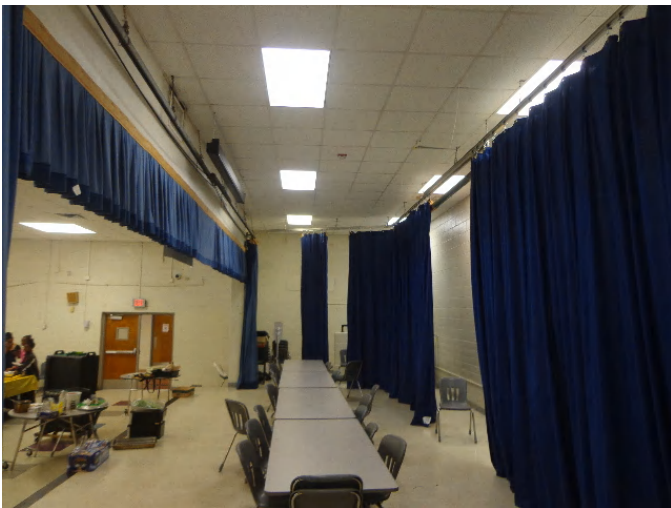
**System: E1020 - Institutional Equipment**

**Distress:** Beyond Service Life

**Notes:** Institutional equipment, such as theater and stage equipment and audio-visual equipment, is beyond its expected service life and should be scheduled for replacement.

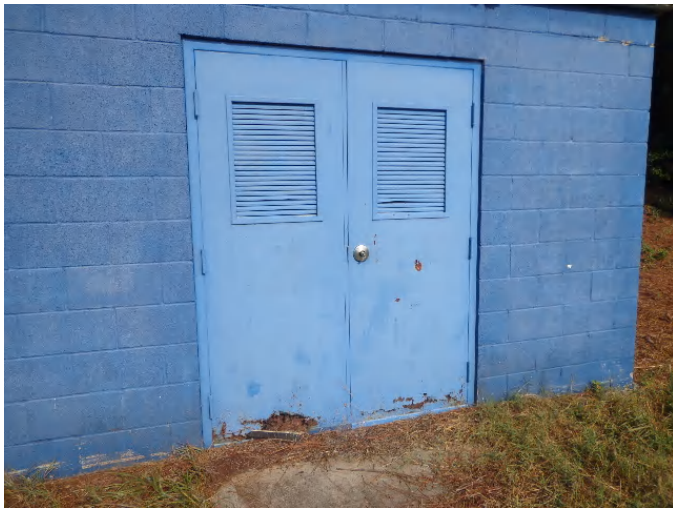
#### **System: B2030 - Exterior Doors**

**Distress:** Beyond Service Life

**Notes:** The original exterior doors are aged, rusted, and should be replaced.

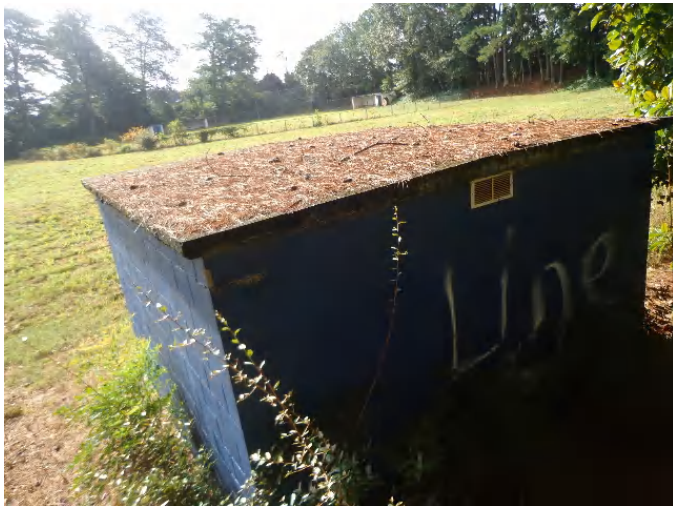
#### **System: B3010 - Roof Coverings**

**Distress:** Beyond Service Life

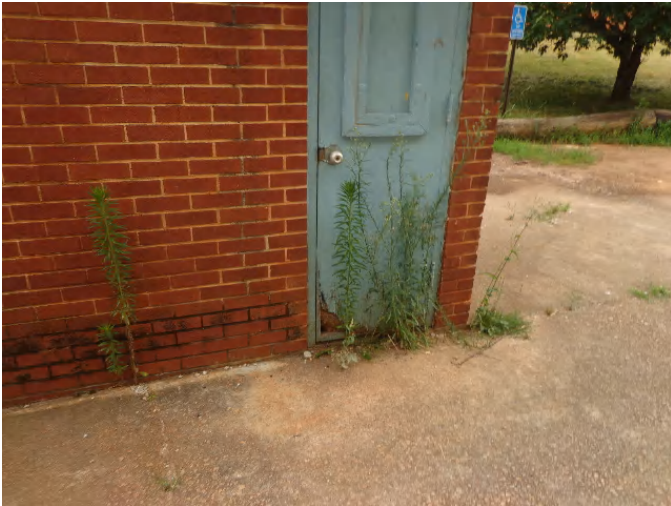
#### **System: B2030 - Exterior Doors**

**Location:** Exterior Wall

**Distress:** Beyond Service Life

**Notes:** The wooden exterior door is aged, in poor condition, and should be replaced.

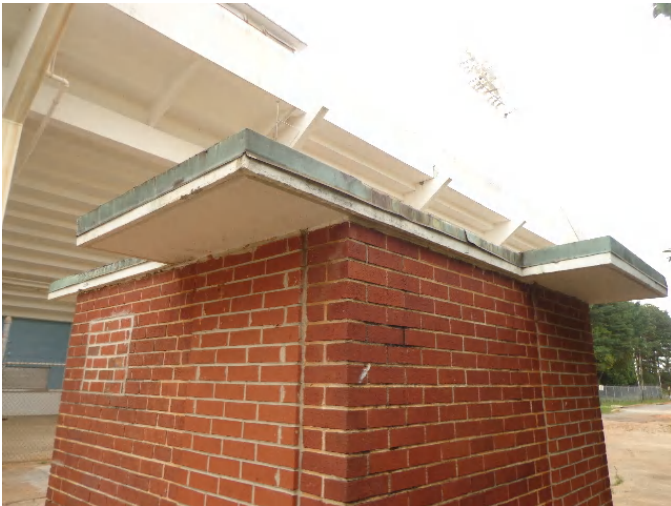
#### **System: B3010 - Roof Coverings**

**Location:** Roof

**Distress:** Beyond Service Life

**Notes:** The roof covering is beyond its expected service life and should be replaced.

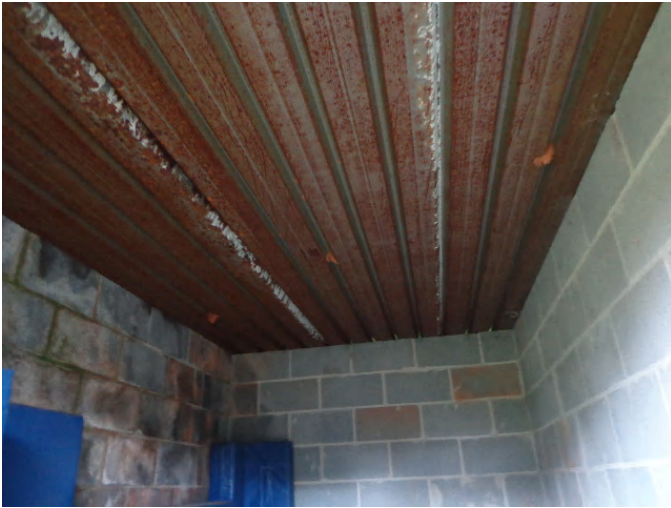
#### System: B1020 - Roof Construction

**Location:** Roof

**Distress:** Beyond Service Life

**Notes:** The original metal roof is aged, rusted, and should be replaced.

**Correction:** Replace entire roof (\$13.54/sf)

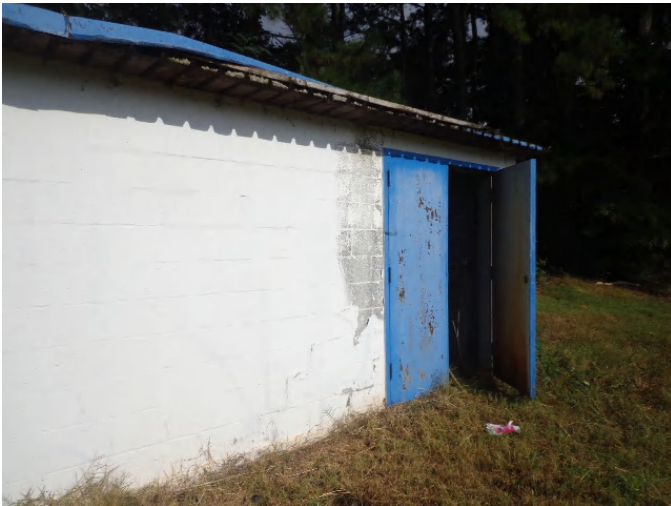
#### System: B2010 - Exterior Walls

**Location:** Exterior Walls

**Distress:** Inadequate

**Notes:** The painted exterior wall finish is aged, stained and peeling, and should be replaced.

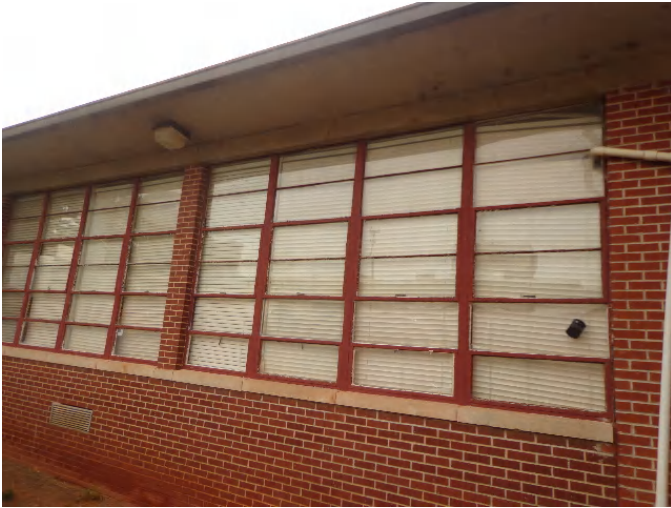
#### **System: B2020 - Exterior Windows**

**Location:** Exterior Walls

**Distress:** Beyond Service Life

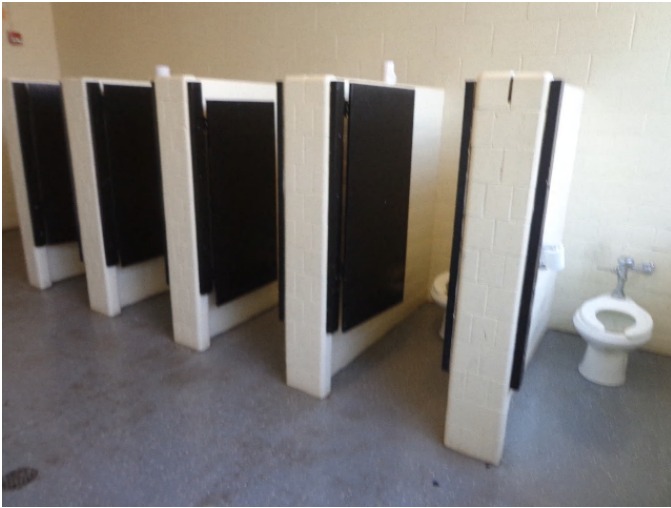
**System: C1030 - Fittings**

**Location:** First Floor Restrooms

**Distress:** Beyond Service Life

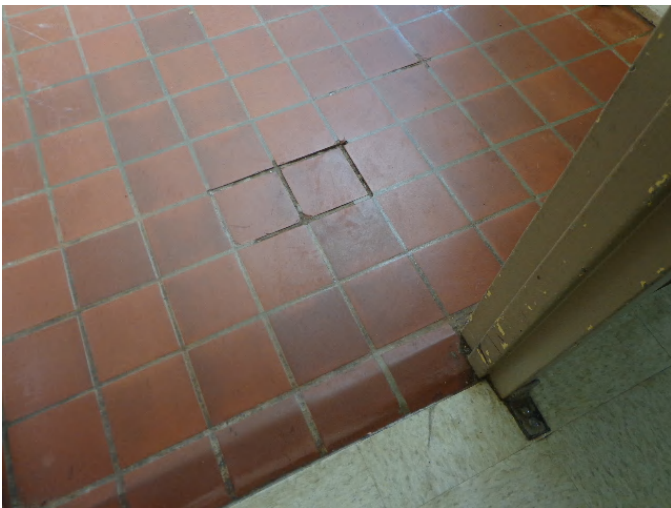
**System: C3020 - Floor Finishes - Ceramic & Quarry Tile**

**Location:** Throughout Building

**Distress:** Beyond Service Life

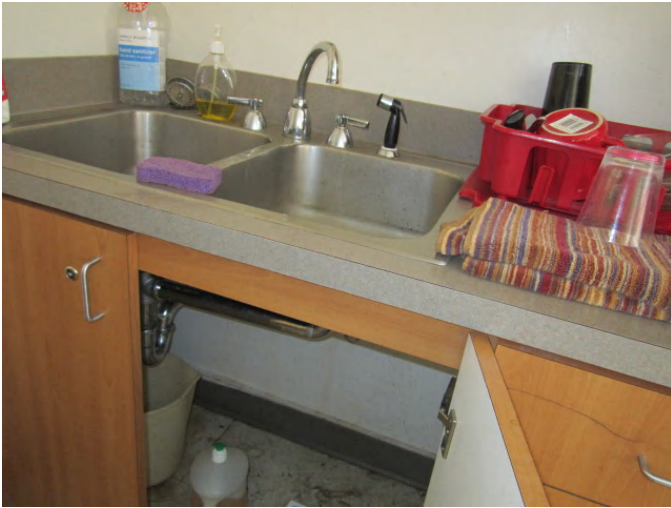
**System: D2010 - Plumbing Fixtures**

**Location:** Throughout Building

**Distress:** Beyond Service Life

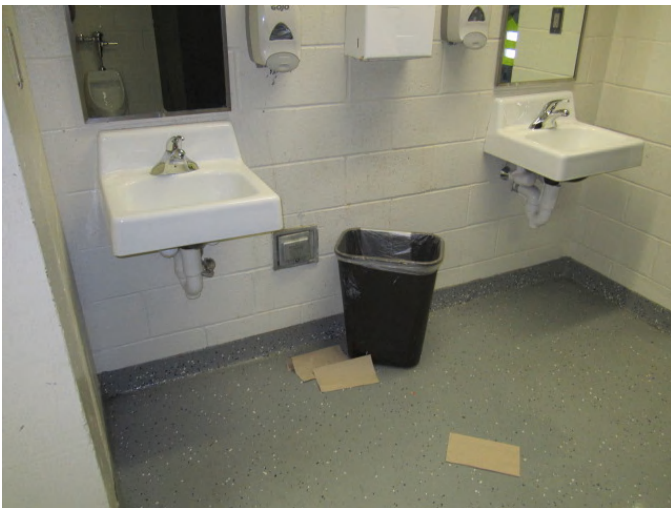
**System: D2020 - Domestic Water Distribution**

**Location:** Throughout Building

**Distress:** Beyond Service Life

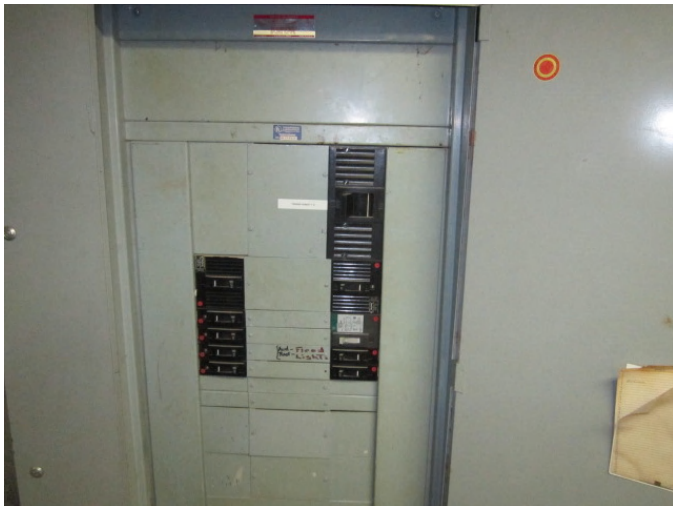
**System: D5020 - Branch Wiring**

**Location:** Throughout Building

**Distress:** Beyond Service Life

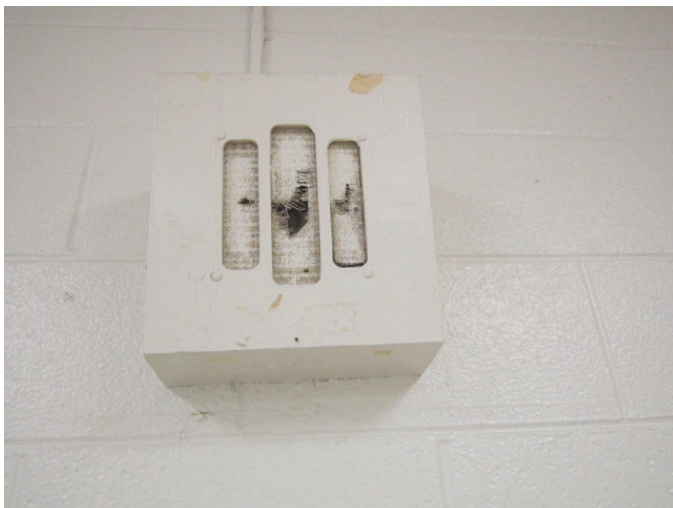
**System: D5030 - Communications and Security - PA & Clock Systems**

**Location:** Throughout Building

**Distress:** Beyond Service Life

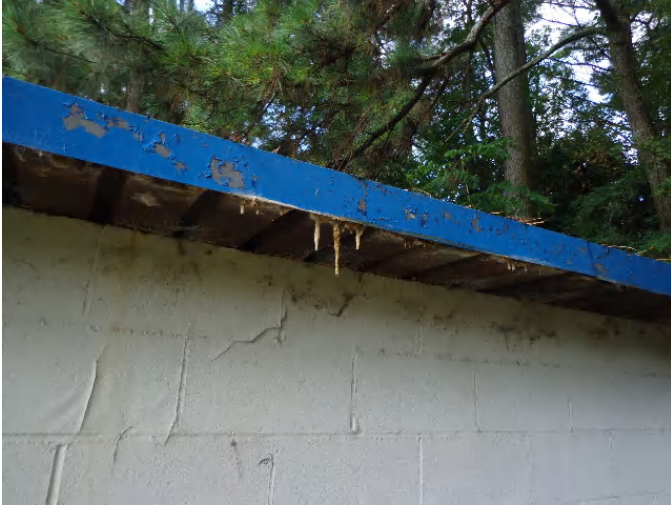
#### System: B1020 - Roof Construction

**Location:** Roof

**Distress:** Beyond Service Life

**Notes:** The original metal roof is aged, rusted, and should be replaced.

**Correction:** Replace entire roof (\$13.54/sf)

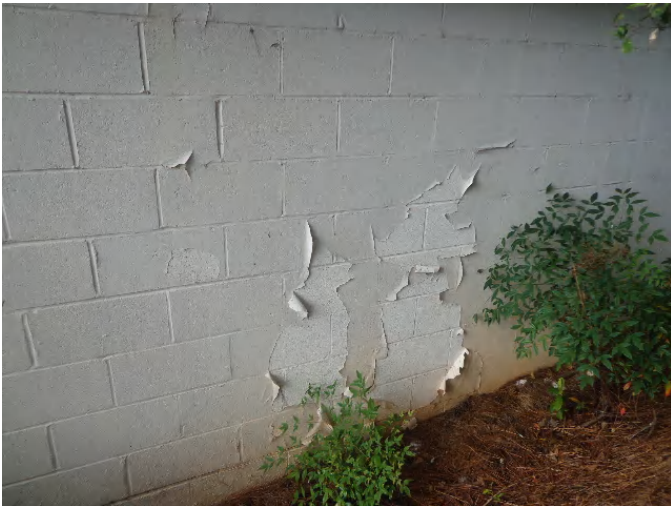
#### System: B2010 - Exterior Walls

**Location:** Exterior Walls

**Distress:** Inadequate

**Notes:** The painted exterior wall finish is aged, stained and peeling, and should be replaced.

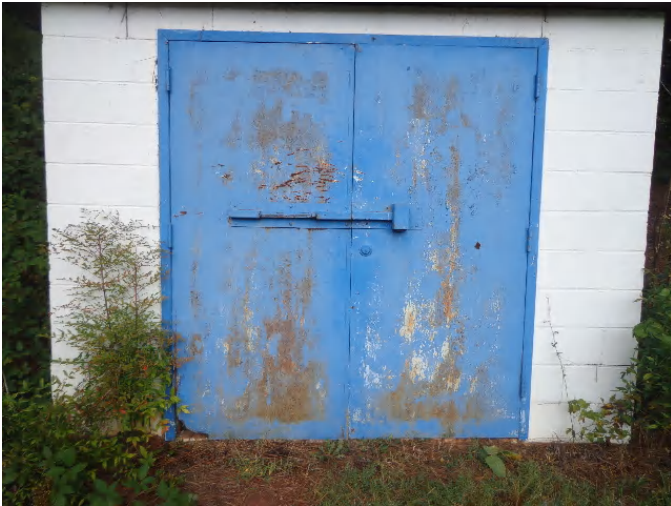
**System: B2030 - Exterior Doors**

**Location:** Exterior Wall  
**Distress:** Beyond Service Life  
**Category:** Deferred Maintenance  
**Priority:** 3 Priority  
**Correction:** Renew System  
**Qty:** 200.00  
**Unit of Measure:** S.F.  
**Estimate:** \$1,135.00  
**Assessor Name:** Eduardo Lopez  
**Date Created:** 04/11/2015

**Notes:** The original exterior doors are aged, rusted, and should be replaced.

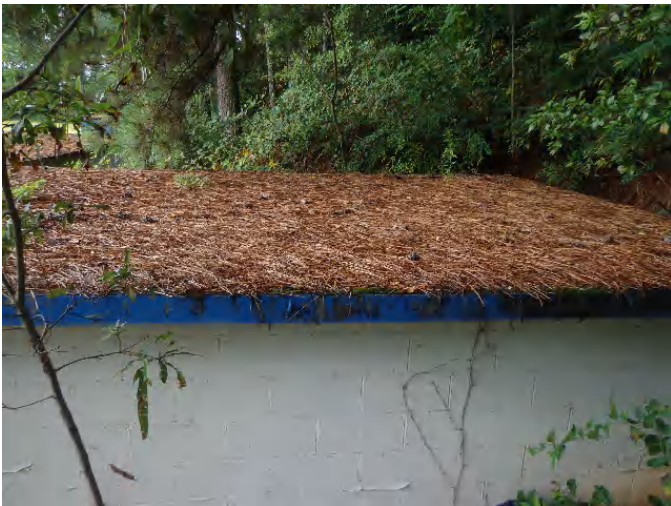
**System: B3010 - Roof Coverings**

**Location:** Roof  
**Distress:** Beyond Service Life  
**Category:** Deferred Maintenance  
**Priority:** 3 Priority  
**Correction:** Renew System  
**Qty:** 200.00  
**Unit of Measure:** S.F.  
**Estimate:** \$3,694.00  
**Assessor Name:** Eduardo Lopez  
**Date Created:** 04/11/2015

**Notes:** The built-up roof covering is aged, showing signs of failure, and should be replaced.

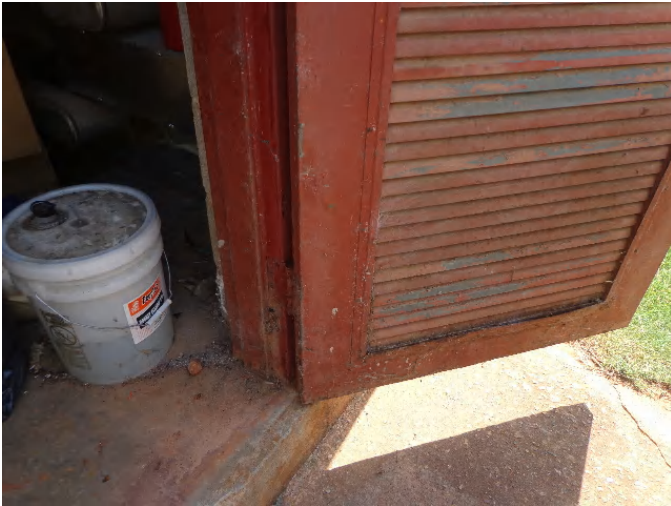
#### **System: B2030 - Exterior Doors**

**Location:** Exterior Wall

**Distress:** Beyond Service Life

**Notes:** The original exterior door is aged, rusted, and should be replaced.

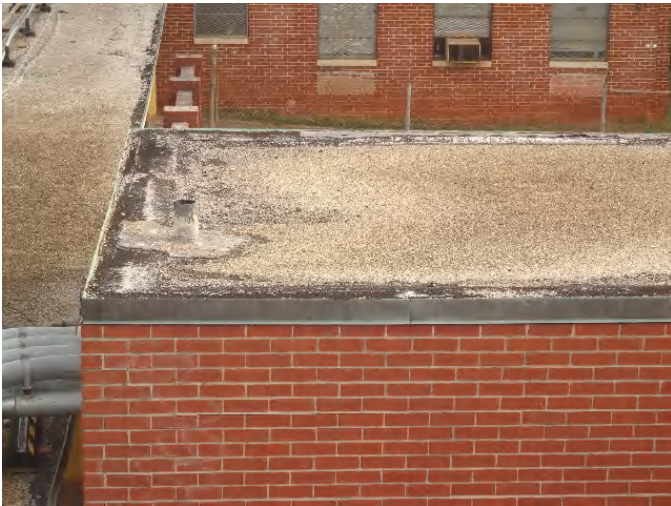
#### **System: B3010 - Roof Coverings**

**Location:** Roof

**Distress:** Beyond Service Life

**Notes:** The built-up roof covering is aged, showing signs of failure, and should be replaced.

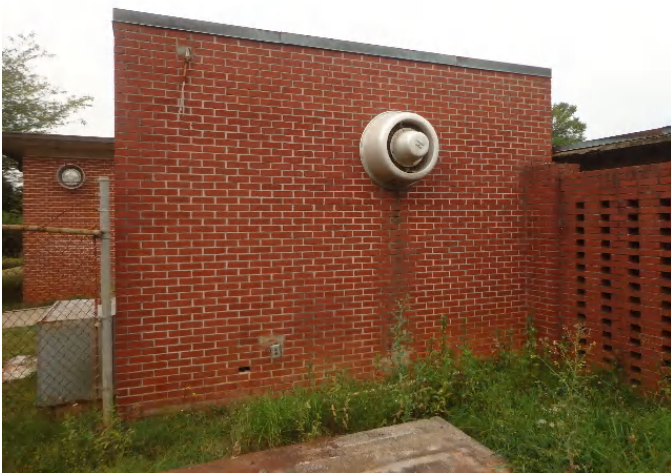
**System: D3040 - Distribution Systems**

**Location:** Exterior Wall  
**Distress:** Beyond Service Life  
**Category:** Deferred Maintenance  
**Priority:** 3 Priority  
**Correction:** Renew System  
**Qty:** 225.00  
**Unit of Measure:** S.F.  
**Estimate:** \$978.00  
**Assessor Name:** Eduardo Lopez  
**Date Created:** 09/03/2015

**Notes:** The distribution system is aged and should be replaced.

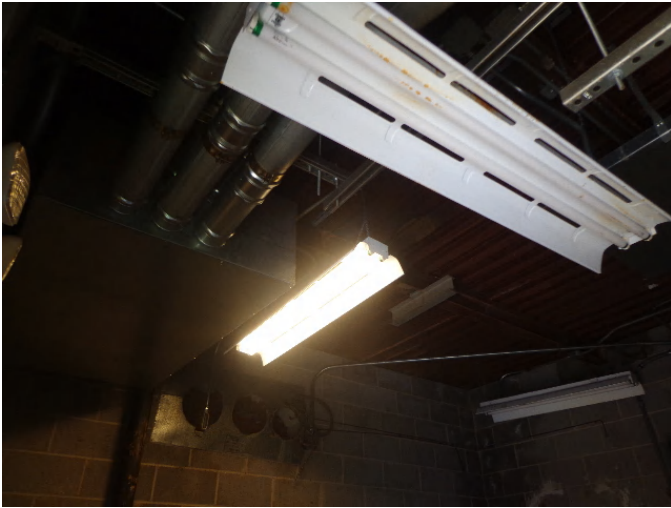
**System: D5020 - Lighting and Branch Wiring**

**Location:** Throughout Building

**Distress:** Beyond Service Life

**Notes:** The original lighting and branch wiring system is operational, but is aged, in poor condition, and should be scheduled for replacement.

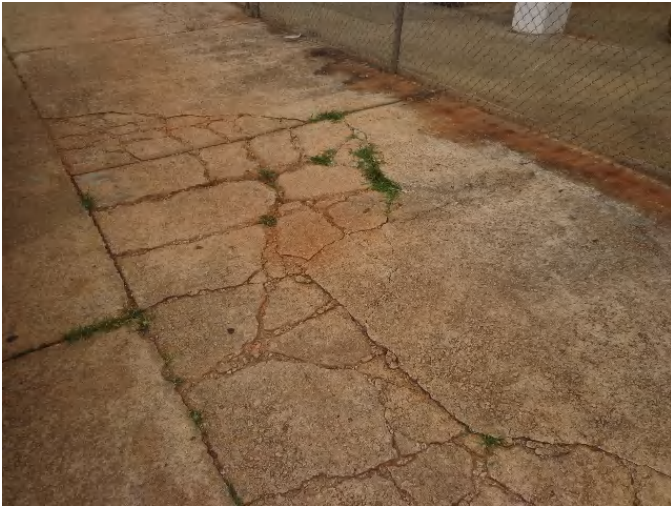
#### System: G2010 - Roadways

**Distress:** Beyond Service Life

**Notes:** Roadways are aged, have many road cuts, cracks and potholes, and should be replaced.

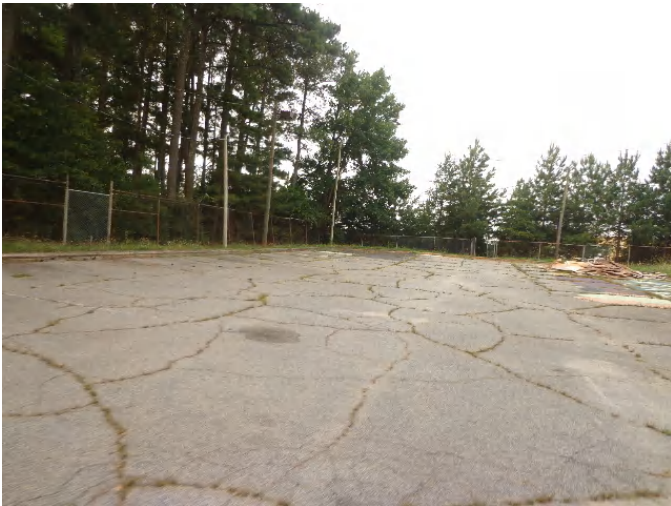
#### System: G2020 - Parking Lots

**Distress:** Beyond Service Life

**Notes:** The parking lot is beyond its expected service life, has many cracks and potholes, is inadequate, and should be repaved and re-stripped. There are insufficient van-accessible parking spaces and signage needs to be provided and/or heights adjusted per minimum ADA standards.

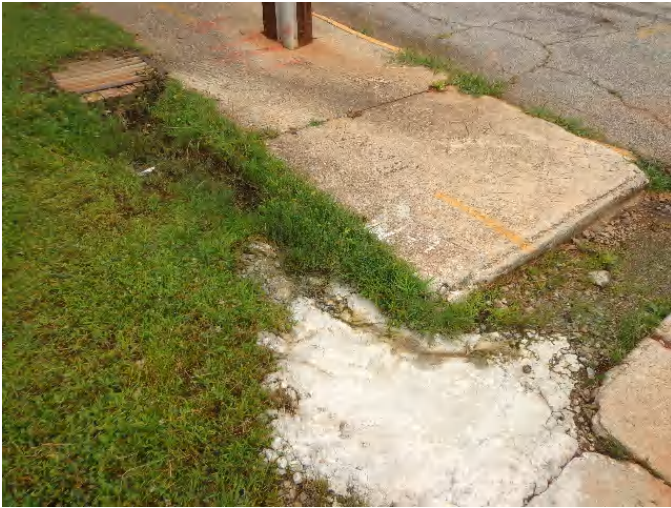
**System: G2030 - Pedestrian Paving**

**Distress:** Beyond Service Life

**Notes:** Pedestrian paving is beyond its expected service life, damaged with cracks, and should be replaced to include missing ramps per ADA standards.

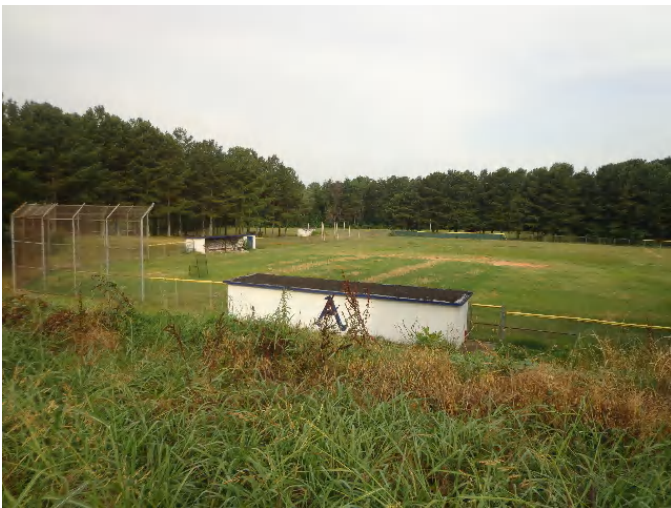
**System: G2040 - Baseball Field**

**Distress:** Beyond Service Life

**Notes:** The baseball field is beyond its expected service life and should be scheduled for replacement.

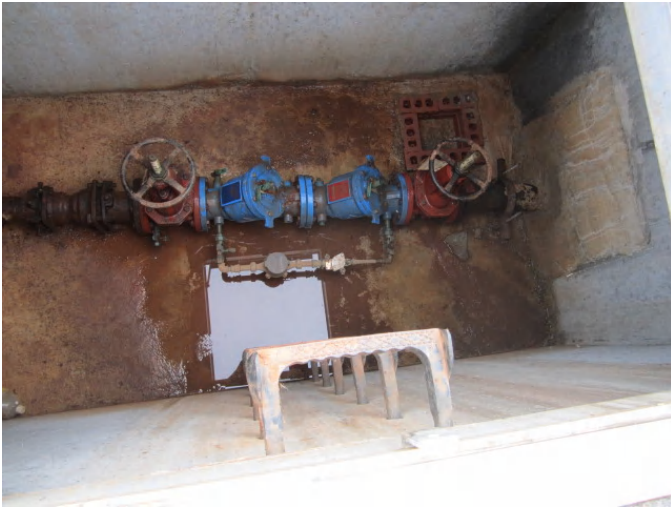
### **System: G3010 - Water Supply**

**Distress:** Beyond Service Life

**Notes:** The water supply system is beyond its expected service life and should be scheduled for replacement.

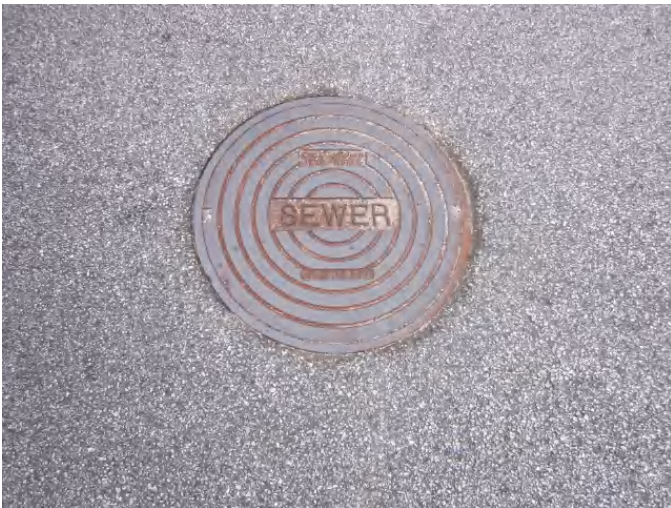
### **System: G3020 - Sanitary Sewer**

**Distress:** Beyond Service Life

**Notes:** The sanitary sewer system is beyond its expected service life and should be scheduled for replacement. School staff reports that there are two sanitary sewer lift stations onsite and the operation of these facilities may be causing problems. Staff reports that the sanitary sewer system backs up into restrooms located at lower elevation at rear of the site during heavy rains.

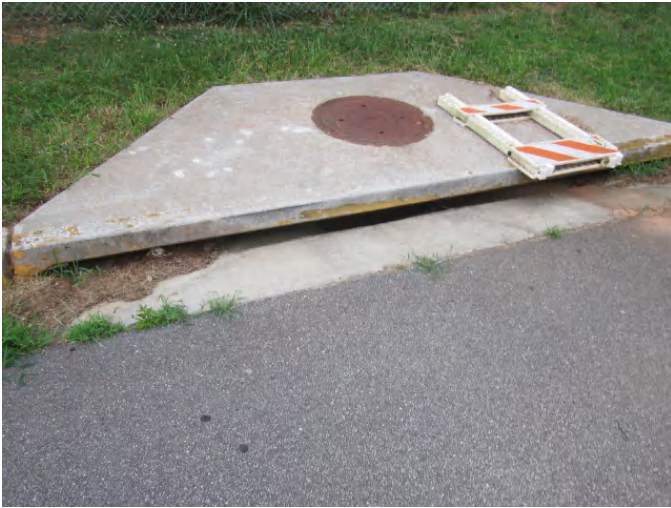
**System: G3030 - Storm Sewer**

**Distress:** Beyond Service Life

**Notes:** The storm sewer system is beyond its expected service life and should be scheduled for replacement.

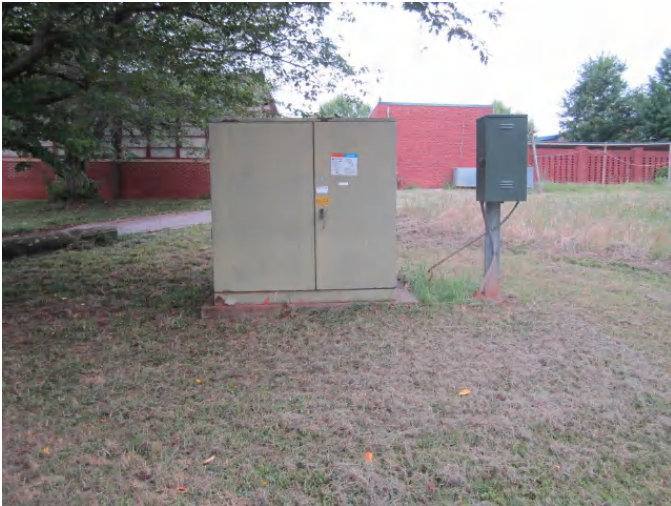
**System: G4010 - Electrical Distribution**

**Distress:** Beyond Service Life

**Notes:** The electrical distribution system is beyond its expected service life and should be scheduled for replacement.
