Facility Condition Assessment Report

DeKalb County School System1701 Mountain Industrial Blvd
Stone Mountain, GA 30083COMET4 Facility Report
Administrative and Instructional Complex Facility Executive Summary ReportReport Date: 24 Jun 2011

Administrative and Instructional Complex Weighted FCI Report

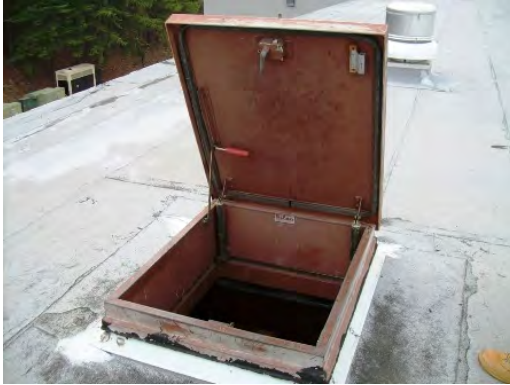
Sat, 23-Apr-2011

Assembly: **B3020**
System: **Roof Openings**
Material: **Roof Hatches, Skylights**
Distress: **Needs Remediation**
Category: **Safety**
Correction: **Replace Roof Hatches, Skylights**
Note: **The roof opening does not follow OSHA guidelines and should be replaced.**

Raw Cost	\$1,973.84
Plus or (Minus) Additional Cost	\$750.06
Total Estimated Amount	\$2,723.90

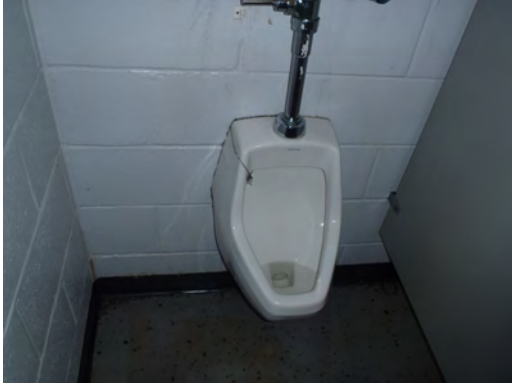
Thu, 03-Mar-2011

Assembly: **D2010**
System: **Plumbing Fixtures**
Material: **System**
Distress: **Beyond Service Life**
Category: **Deferred Maintenance**
Correction: **Renew System**
Note: **Plumbing fixtures are aged and should be replaced.**

Raw Cost	\$10,082.33
Plus or (Minus) Additional Cost	\$3,831.28
Total Estimated Amount	\$13,913.61

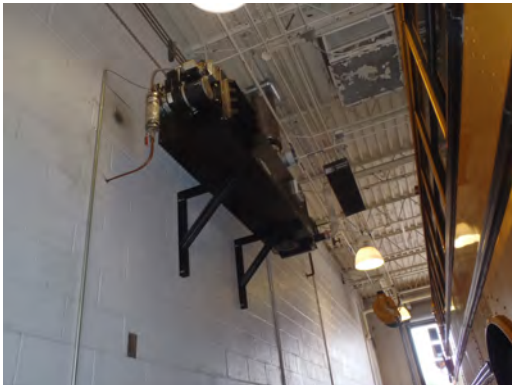
Fri, 25-Mar-2011

Assembly: **D3050**
System: **Terminal & Package Units**
Material: **System**
Distress: **Beyond Service Life**
Category: **Deferred Maintenance**
Correction: **Renew System**
Note: **Heating system is beyond its service life and should be replaced.**

Raw Cost	\$63,588.53
Plus or (Minus) Additional Cost	\$24,163.64
Total Estimated Amount	\$87,752.17

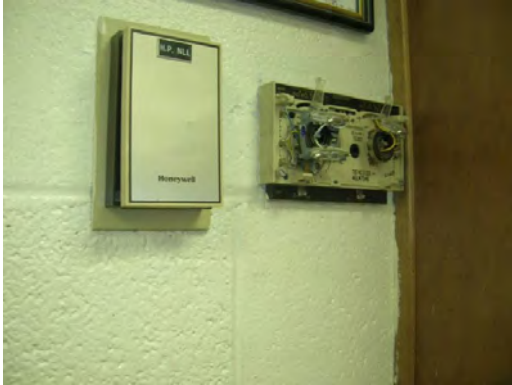
Fri, 25-Mar-2011

Assembly: **D3060**
System: **Controls & Instrumentation System**
Material: **Beyond Service Life**
Distress: **Deferred Maintenance**
Category: **Renew System**
Correction: **Control system is aged and should be replaced.**
Note:

Raw Cost	\$2,495.63
Plus or (Minus) Additional Cost	\$948.34
Total Estimated Amount	\$3,443.97

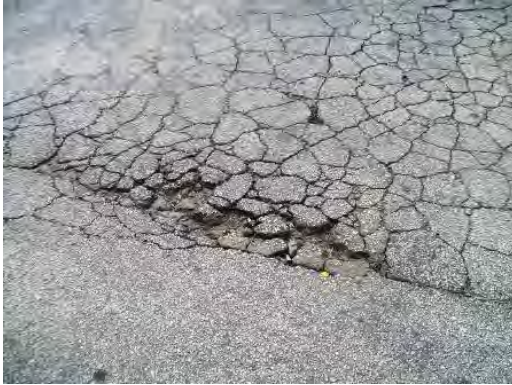
Sat, 18-Jun-2011

Assembly: **G2010**
System: **Roadways**
Material: **Paving**
Distress: **Damaged**
Category: **Deferred Maintenance**
Correction: **Re-pave parking lot / roadways**
Note: **The asphaltic roadways are damaged with cracks and potholes and should be resurfaced and restriped.**

Raw Cost	\$3,205.00
Plus or (Minus) Additional Cost	\$833.30
Total Estimated Amount	\$4,038.30
