# **Facility Condition Assessment Report**

**Cedar Grove Middle Facility Executive Summary Report**Report Date: 24 Jun 2011

**Facility:** \Middle Schools\Cedar Grove Middle  
**Address:** 2300 Wildcat Road, Decatur, GA 30034**Attributes:****Facility Code** 0200  
**Super Cluster** 4**General Information:****Function:** Middle School  
**Gross Area:** 162,926 S.F.  
**Year Built:**  
**Last Renovation:****Facility Description:**

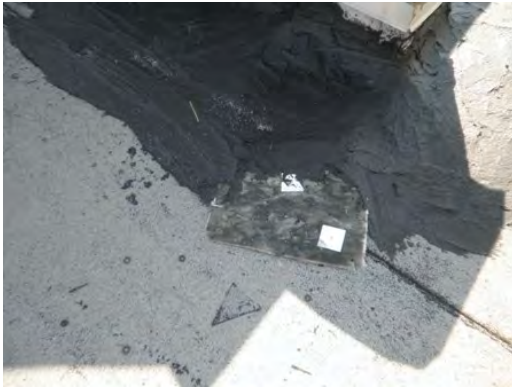
Assembly: **B3010**  
System: **Roof Coverings - BUR System**  
Material: **Needs Remediation**  
Distress: **Needs Remediation**  
Category: **Deferred Maintenance**  
Correction: **Renew System**  
Note:

The built up roof covering has rapidly aged, as evidenced by several roof leaks, blisters, and patches along flashing edges and along the mechanical mezzanine roof. The entire roof should therefore be replaced.

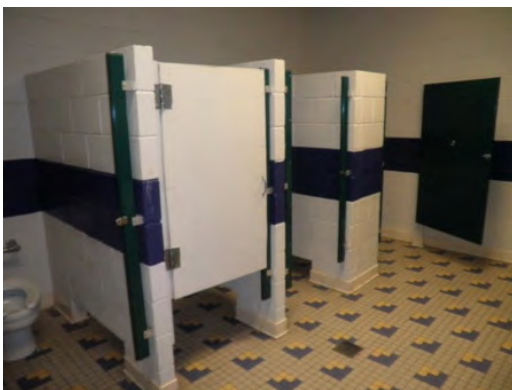
Assembly: **C1030**  
System: **Fittings**  
Material: **System**  
Distress: **Needs Remediation**  
Category: **Deferred Maintenance**  
Correction: **Renew System**  
Note:

Fittings, such as chalk and tack boards, lockers, toilet and bath accessories, toilet partitions, shelving, and building signage are beyond their service life and should be replaced.

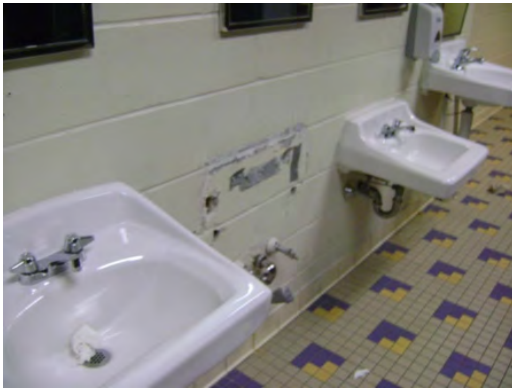
Assembly: **D2010**  
System: **Plumbing Fixtures System**  
Material: **Damaged**  
Distress: **Damaged**  
Category: **Deferred Maintenance**  
Correction: **Renew System**  
Note: **Many of the plumbing fixtures are broken, inoperative, and in some cases missing. Replacement of the plumbing fixtures is need.**

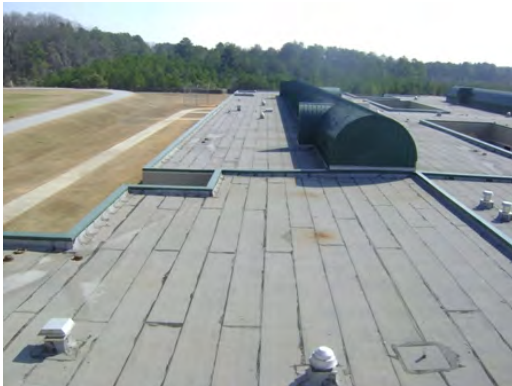
Assembly: **D3040**  
System: **Distribution Systems & Exhaust Systems**  
Material: **Roof Exhaust Fan Systems**  
Distress: **Needs Remediation**  
Category: **Deferred Maintenance**  
Correction: **Replace Roof Exhaust Fan up to 800 CFM**  
Note: **Exhaust fans in the building are reported as inoperative and should be replaced.**

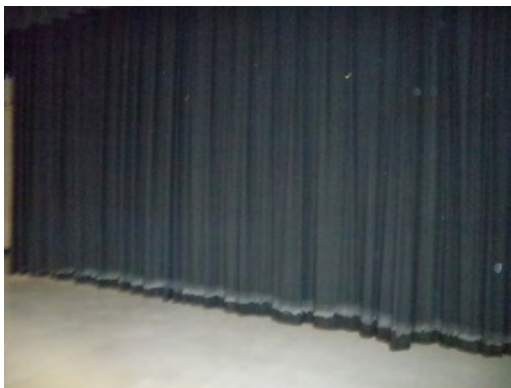
Assembly: **E1020**  
System: **Institutional Equipment System**  
Material: **System**  
Distress: **Damaged**  
Category: **Deferred Maintenance**  
Correction: **Renew System**

Note: **The stage curtain has been damaged by water and cleaning solution and should be replaced.**

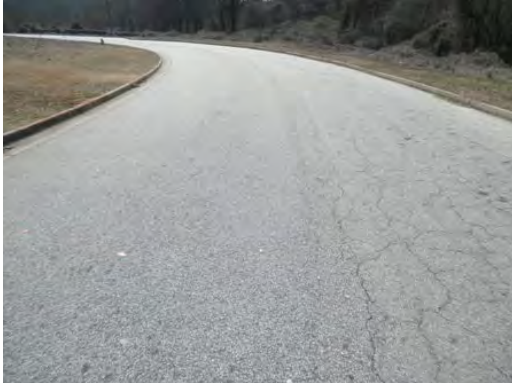
Assembly: **G2010**  
System: **Roadways**  
Material: **System**  
Distress: **Needs Remediation**  
Category: **Deferred Maintenance**  
Correction: **Renew System**  
Note: **The roadways are beginning to show damage and cracking, and should be sealed, coated, and restriped.**

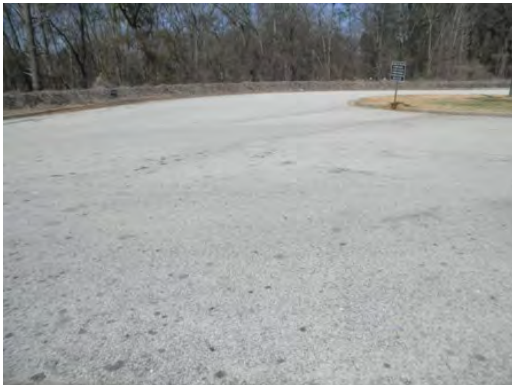
Assembly: **G2020**  
System: **Parking Lots**  
Material: **System**  
Distress: **Needs Remediation**  
Category: **Deferred Maintenance**  
Correction: **Renew System**  
Note: **The parking lots are beginning to show damage and cracking, and should be sealed, coated, and restriped.**

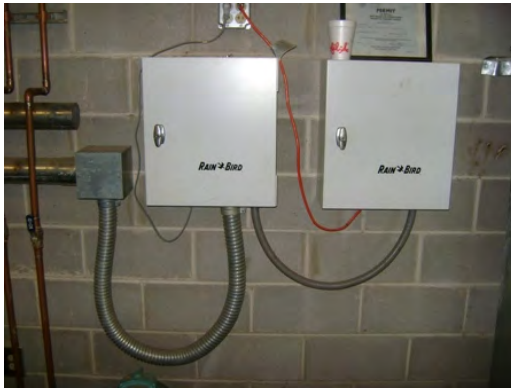
Assembly: **G2050**  
 System: **Landscaping**  
 Material: **Landscaping**  
 Distress: **Needs Remediation**  
 Category: **Deferred Maintenance**  
 Correction: **Replace Irrigation System; per SF of Building Area**

Note: **The irrigation system is inoperative and should be replaced.**

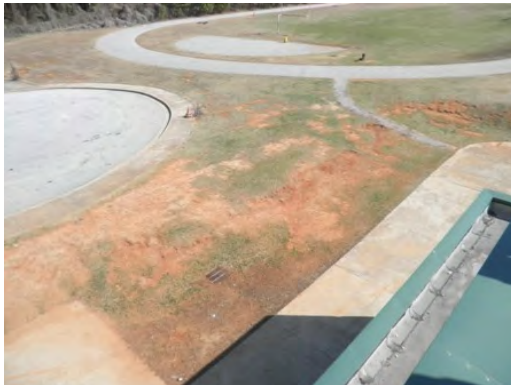
Note: **The grass between the track and art room has eroded away and needs to be resloped and regraded to prevent further erosion and damage.**

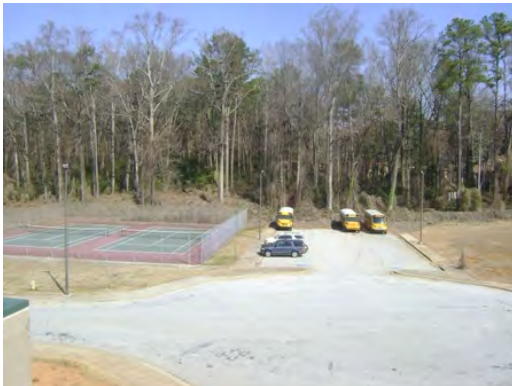
Assembly: **G4020**  
 System: **Site Lighting**  
 Material: **Lighting Site**  
 Distress: **Needs Remediation**  
 Category: **Deferred Maintenance**  
 Correction: **Install additional site lighting**  
 Note: **One of the site lights is reported as inoperative and one is missing at the driveway adjacent to the tennis courts. Repair and replacement of the site lighting is needed.**

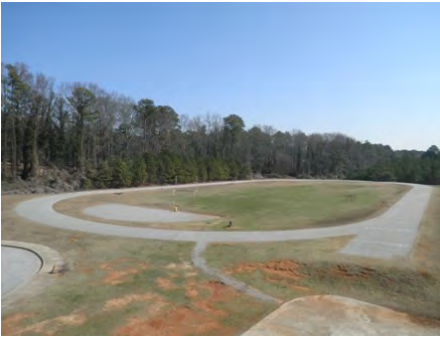
Track at Cedar Grove Middle School

Track Building Systems								\$116,050	\$30,173	\$146,223			
F1040		Special Facilities - Running Track Surface & Curbing	System	Beyond Service Life	Renew System	1	Ea.	\$116,050 \$116,050	\$30,173 \$30,173	\$146,223 \$146,223	Recommended	Deferred Maintenance	The track hard surface is cracking and should be sealed and restriped.

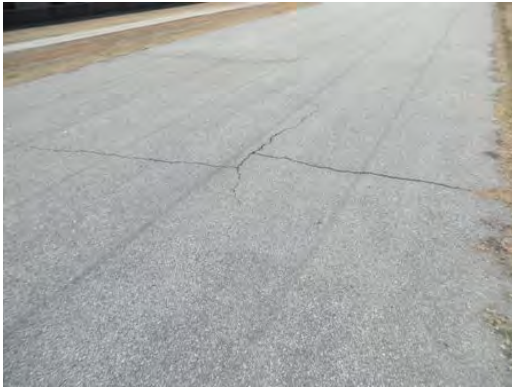
Correction: **The track hard surface is cracking and should be sealed and restriped.**
