Facility Condition Assessment Report

COMET4 Facility Report

Hightower Elementary Facility Executive Summary ReportReport Date: 01 Jul 2011

Facility: \Elementary Schools\Hightower Elementary**Address:** 4236 Tilly Mill Road, Doraville, GA 30360**Attributes:****Facility Code** 4058
Super Cluster 1**General Information:****Function:** Elementary School
Gross Area: 54,213 S.F.**Year Built:**
Last Renovation:**Facility Description:**

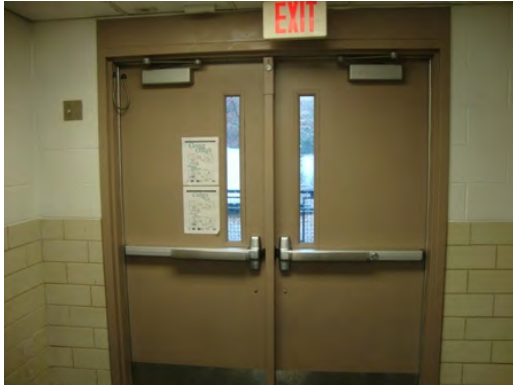
Assembly: **B2030**
System: **Exterior Doors**
Material: **System**
Distress: **Damaged**
Category: **Deferred Maintenance**
Correction: **Renew System**
Note: **The original metal exterior doors are aged, rusted, and damaged, and should be replaced.**

Raw Cost	\$33,773.36
Plus or (Minus) Additional Cost	\$12,833.87
Total Estimated Amount	\$46,607.23

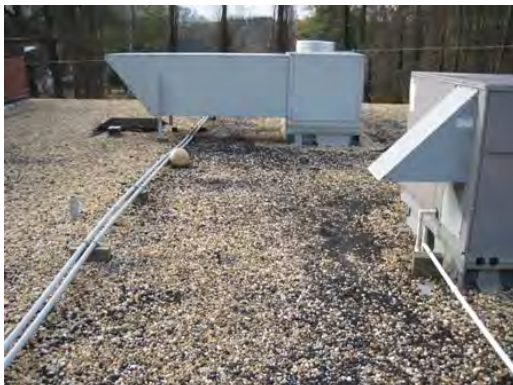
Assembly: **B3010**
System: **Roof Coverings - BUR**
Material: **System**
Distress: **Needs Remediation**
Category: **Deferred Maintenance**
Correction: **Renew System**
Note: **The built-up roofing is reported to have been replaced in 2000, but is prematurely aging, has reported leaks, and should be replaced.**

Raw Cost	\$215,506.17
Plus or (Minus) Additional Cost	\$81,892.34
Total Estimated Amount	\$297,398.51

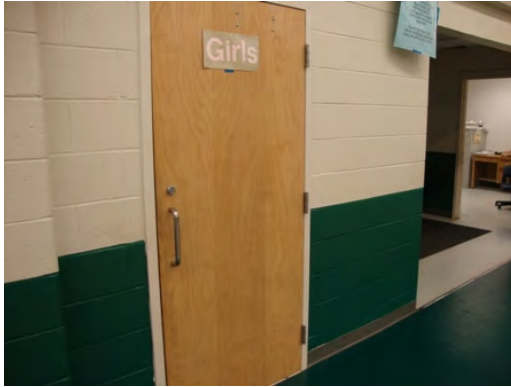
Assembly: **C1020**
 System: **Interior Doors**
 Material: **System**
 Distress: **Beyond Service Life**
 Category: **Deferred Maintenance**
 Correction: **Renew System**

Note: **The original wood interior doors are aged and worn and should be replaced.**

Raw Cost	\$58,871.88
Plus or (Minus) Additional Cost	\$22,371.31
Total Estimated Amount	\$81,243.19

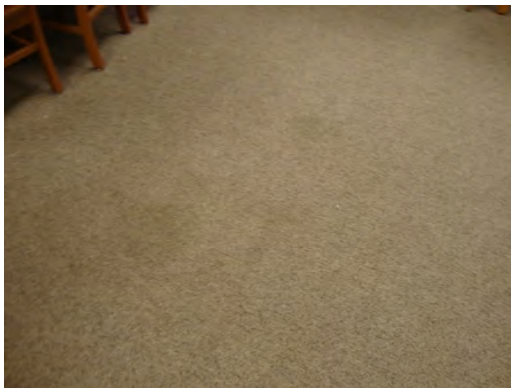
Assembly: **C3020**
 System: **Floor Finishes - Carpet**
 Material: **System**
 Distress: **Damaged**
 Category: **Deferred Maintenance**
 Correction: **Renew System**

Note: **The carpet is aged, worn, stained, and frayed, and should be replaced.**

Raw Cost	\$45,833.70
Plus or (Minus) Additional Cost	\$17,416.81
Total Estimated Amount	\$63,250.51

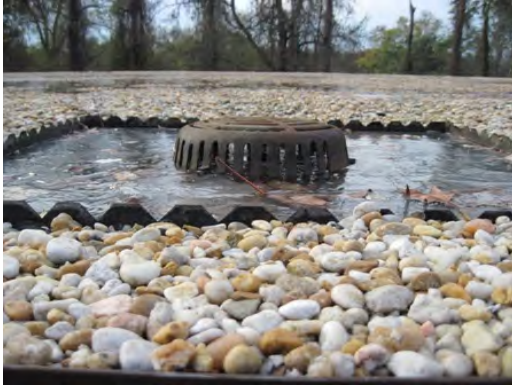
Assembly: **D2040**
System: **Rain Water Drainage System**
Material: **Damaged**
Distress: **Damaged**
Category: **Deferred Maintenance**
Correction: **Renew System**

Note: **The original cast iron rain water drainage system is aged, worn, has stoppages, and should be replaced.**

Raw Cost	\$34,309.44
Plus or (Minus) Additional Cost	\$13,037.59
Total Estimated Amount	\$47,347.03

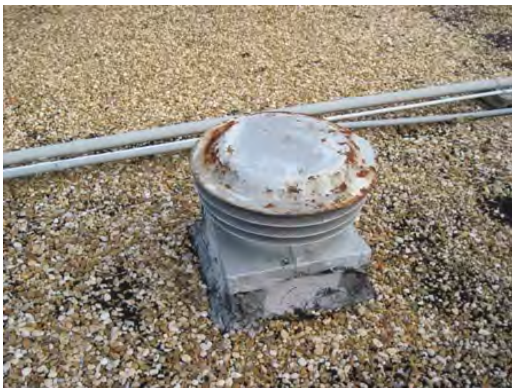
Assembly: **D3040**
System: **Distribution & Exhaust Systems**
Material: **Roof Exhaust Fan Systems**
Distress: **Needs Remediation**
Category: **Deferred Maintenance**
Correction: **Replace the Exhaust Fan System**
Note: **The original exhaust and distribution system is aged and should be replaced.**

Raw Cost	\$75,784.48
Plus or (Minus) Additional Cost	\$28,798.10
Total Estimated Amount	\$104,582.58

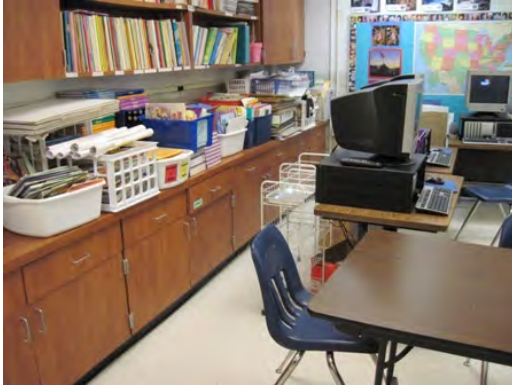
Assembly: **E2010**
System: **Fixed Furnishings**
Material: **System**
Distress: **Damaged**
Category: **Deferred Maintenance**
Correction: **Renew System**

Note: **Fixed furnishings, such as the base/wall cabinets, counter tops, window shades, and fixed seating, are worn and damaged, and should be replaced.**

Raw Cost	\$164,042.01
Plus or (Minus) Additional Cost	\$62,335.96
Total Estimated Amount	\$226,377.97

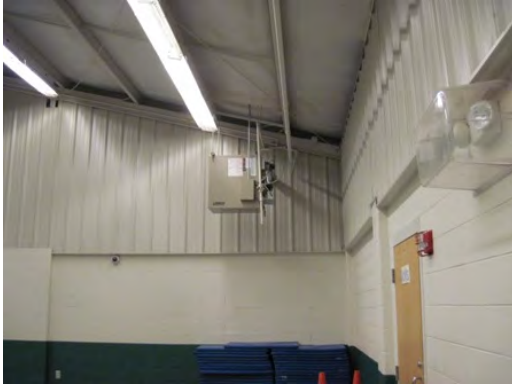
Assembly: **D3050**
System: **Terminal & Package Units**
Material: **Packaged A/C, Elec. Ht., Const. Volume**
Distress: **Missing**
Category: **Capital Improvement**
Correction: **Install Package A/C - 20 ton**
Note: **An air conditioning system is missing in the gymnasium and should be installed.**

Raw Cost	\$40,691.00
Plus or (Minus) Additional Cost	\$15,462.58
Total Estimated Amount	\$56,153.58

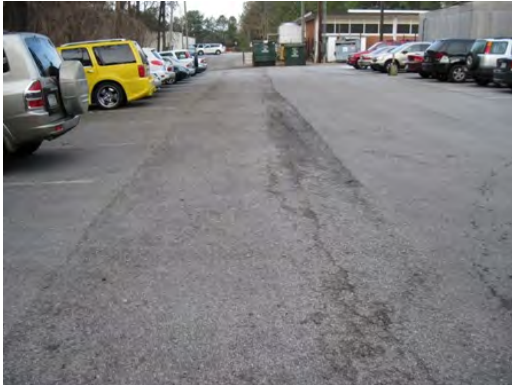
Assembly: **G2020**
System: **Parking Lots**
Material: **System**
Distress: **Damaged**
Category: **Deferred Maintenance**
Correction: **Renew System**
Note: **The asphaltic parking lots are aged, have cuts and repairs, and should be resurfaced and restriped.**

Raw Cost	\$69,772.13
Plus or (Minus) Additional Cost	\$18,140.75
Total Estimated Amount	\$87,912.88

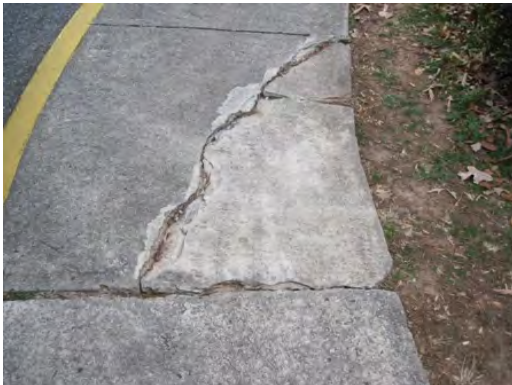
Assembly: **G2030**
System: **Pedestrian Paving**
Material: **System**
Distress: **Damaged**
Category: **Deferred Maintenance**
Correction: **Renew System**
Note: **The sidewalks are aged, cracked, and damaged, and should be replaced.**

Raw Cost	\$78,120.93
Plus or (Minus) Additional Cost	\$20,311.44
Total Estimated Amount	\$98,432.37

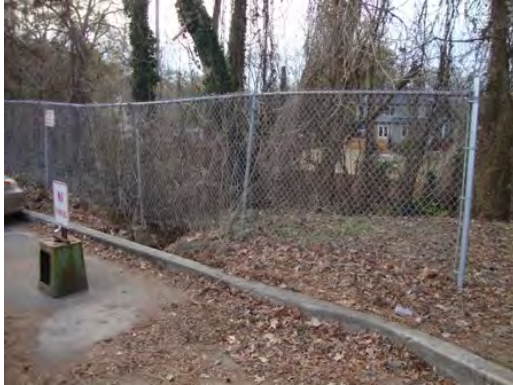
Note: **The fencing around the property is aged, rusted, and damaged, and should be replaced.**

Raw Cost	\$85,114.41
Plus or (Minus) Additional Cost	\$22,129.75
Total Estimated Amount	\$107,244.16

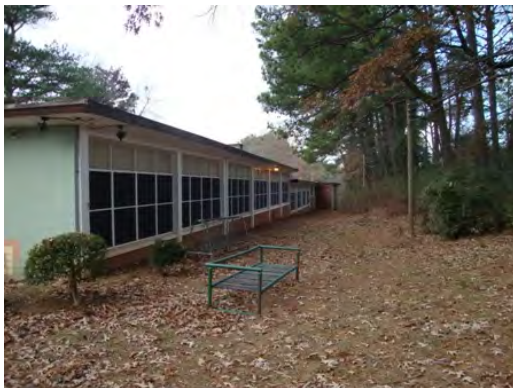
Assembly: **G4020**
System: **Site Lighting System**
Material: **System**
Distress: **Inadequate**
Category: **Deferred Maintenance**
Correction: **Renew System**

Note: **The original site lighting is inadequate for safety and security reasons and should be replaced.**

Raw Cost	\$32,798.87
Plus or (Minus) Additional Cost	\$8,527.70
Total Estimated Amount	\$41,326.57

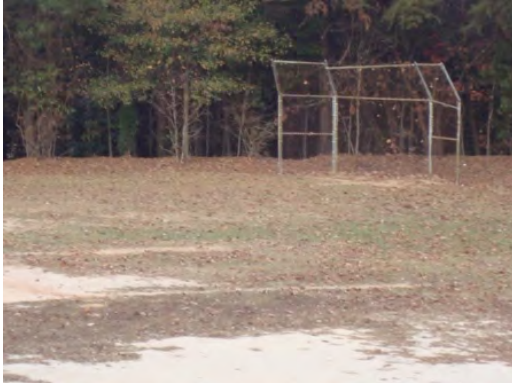
Assembly: **F1040**
 System: **Special Facilities - Sports Field - Natural Turf System**
 Material: **Beyond Service Life**
 Distress: **Beyond Service Life**
 Category: **Deferred Maintenance**
 Correction: **Renew System**
 Note: **The softball field grass is damaged and should be reseeded.**

Raw Cost	\$21,560.00
Plus or (Minus) Additional Cost	\$5,605.60
Total Estimated Amount	\$27,165.60
